MINERALS PROGRAM INSPECTION REPORT
PHONE: (303) 866-3567

MINE NAME: Bunn Ranch Pit	MINE/PROSPECTING ID#: M-1980-131	MINERAL: Sand and gravel	COUNTY: Moffat
INSPECTION TYPE: Monitoring	INSPECTOR(S): Zach Trujillo	INSP. DATE: September 1, 2022	INSP. TIME: 08:00
OPERATOR: Elam Construction, Inc.	OPERATOR REPRESENTATIVE: None	TYPE OF OPERATION: 112c - Construction Regular Operation	
REASON FOR INSPECTION: Normal I&E Program	BOND CALCULATION TYPE: Complete Bond	BOND AMOUNT: \$333,452.00	
DATE OF COMPLAINT: NA	POST INSP. CONTACTS: None	JOINT INSP. AGENCY: None	
WEATHER: Clear	INSPECTOR'S SIGNATURE:

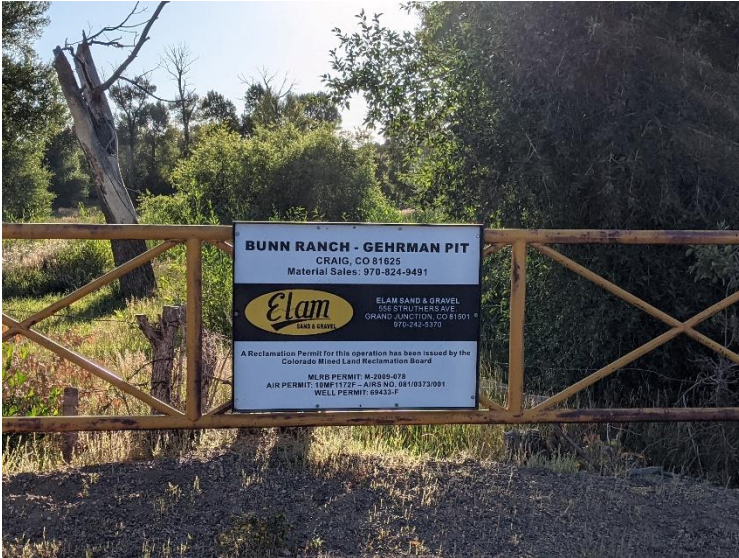
The mine identification sign was located at the entrance of the site off 1st Street.

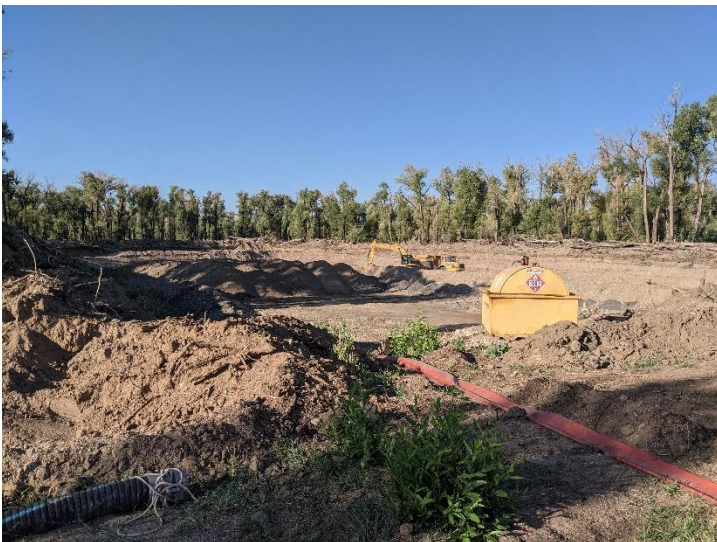
No new reclamation has occurred since the last inspection. New mining excavation has occurred this year with "Pond 5" based on the 2021 annual report. Current excavation and haulage to stockpile areas within the mine was observed during the inspection. The active area was being dewatered. Water from the pit was being pumped north to the adjacent pond.

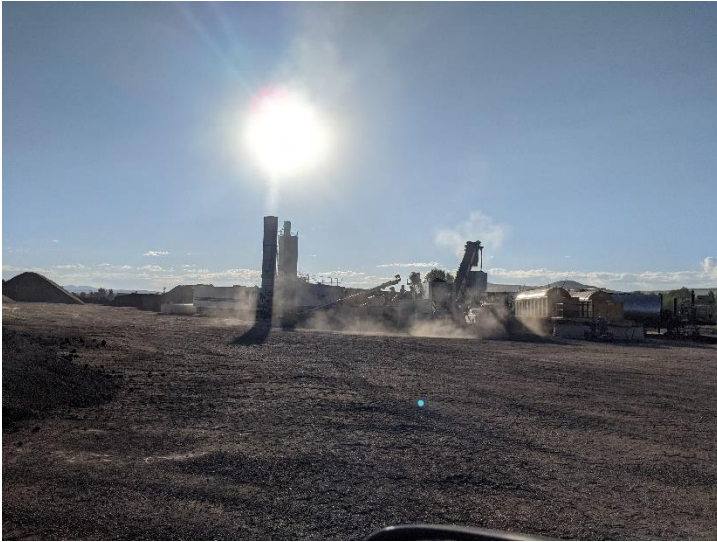
The mine processing areas were active at the time of the inspection. A significant amount of hauling was

observed, several trucks were lined up to be loaded. There were several large stockpiles of various material types neatly stored. Both the wash plant and asphalt hot plant were in operation at the time of the inspection. The scale, scale house and office remain on site and in use.
