MINERALS PROGRAM INSPECTION REPORT
PHONE: (303) 866-3567

MINE NAME: Two Rivers Sand, Gravel and Reservoir Project	MINE/PROSPECTING ID#: M-2022-013	MINERAL: Sand and gravel	COUNTY: Weld
INSPECTION TYPE: Preoperation Inspection	INSPECTOR(S): Robert Zuber, P.E.	INSP. DATE: June 14, 2022	INSP. TIME: 07:45
OPERATOR: Raptor Materials LLC	OPERATOR REPRESENTATIVE: Garrett Varra, Bradford Janes, Brad Jones	TYPE OF OPERATION: 112c - Construction Regular Operation	
REASON FOR INSPECTION: Normal I&E Program	BOND CALCULATION TYPE: None	BOND AMOUNT: No Bond Held	
DATE OF COMPLAINT: NA	POST INSP. CONTACTS: None	JOINT INSP. AGENCY: None	
WEATHER: Clear	INSPECTOR'S SIGNATURE:

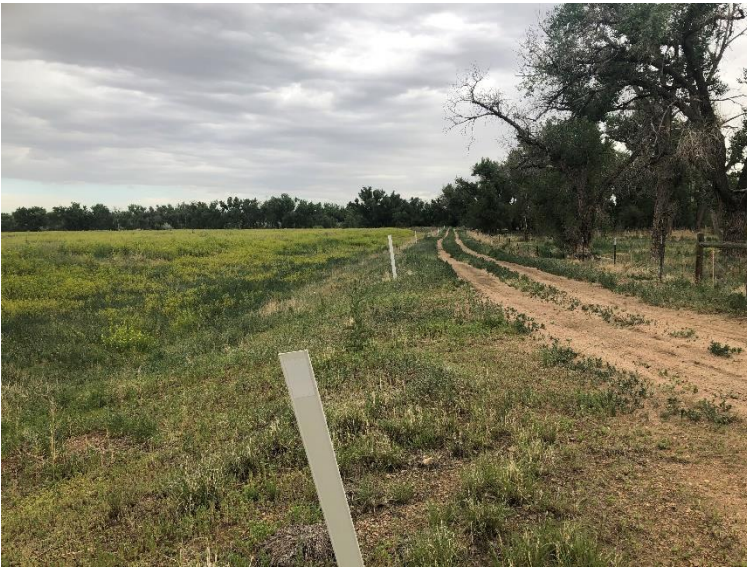
Material from the wetland mitigation bank project has been placed on the site, in the southeast portion of parcel 095934300004 (shown in Exhibit C-1). It was covered with yellow sweet clover during the inspection.

Northeast boundary (looking north)

- Material from mitigation bank on the left side of photo

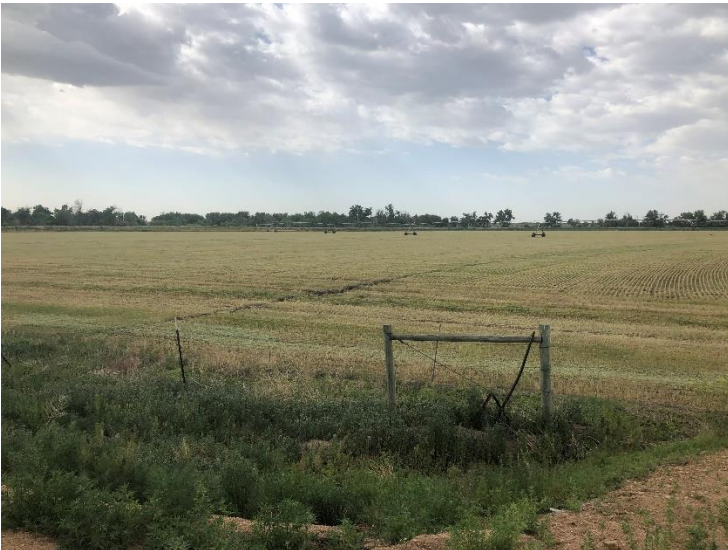
Along the south side of the site, a berm was observed. This berm continues along the rivers on the north and south sides of the site. It varies in height from four feet to 10 feet.

Irrigated field (taken from south side berm)

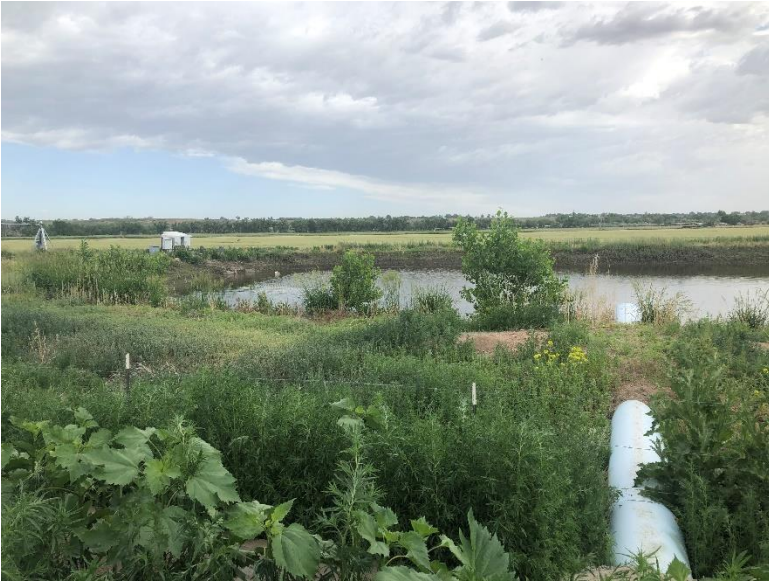
The irrigation pond on the south side of the site held a large amount of water. The proposal is to use this pond during operations, and the outlet of this structure will be the discharge point for a permit with the Water Quality Control Division.

Irrigation pond on south side of site

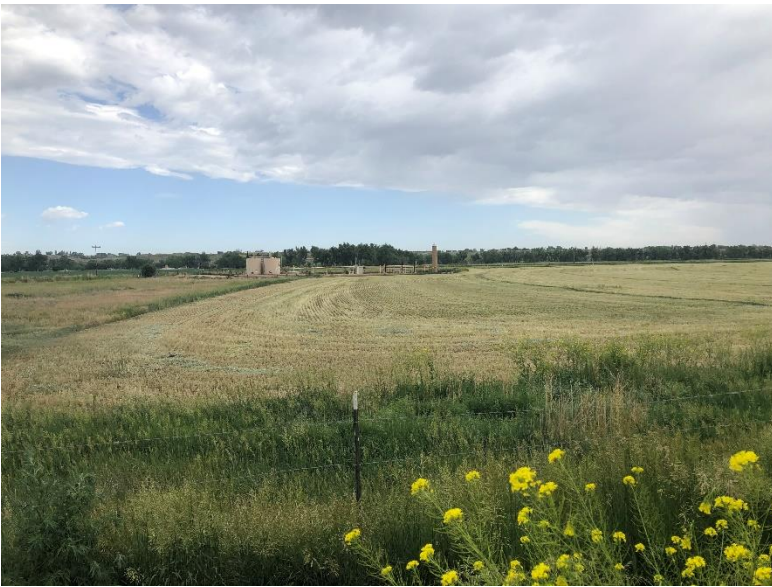
Irrigated field and natural gas facilities, near southwest corner of site

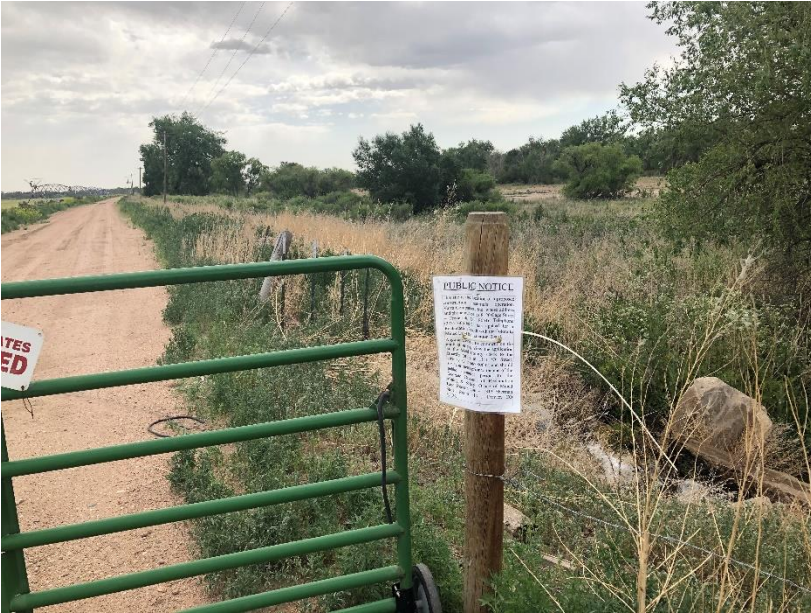
Several notice signs were posted at entrances around the site. All of the observed notices are along the 396 Road (which runs through the site) and 54th Street Road (which runs along the north side of the site).

Notice sign at gate at southwest corner

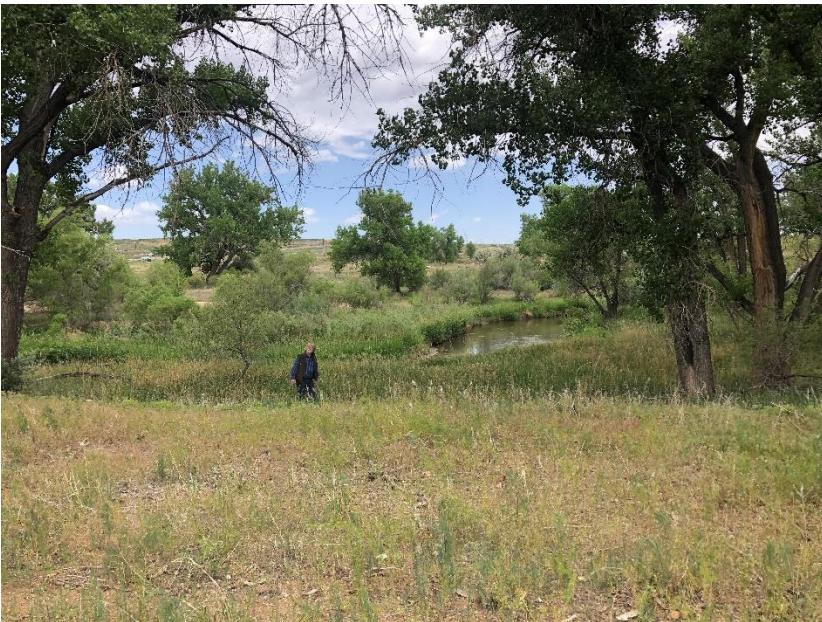
The proposed location of the conveyor crossing was observed. Mr. Janes noted that the location was chosen to minimize the need for pillars impacting the floodplain. The Big Thompson River is narrow at this location, there is a high bank on the south side, and there would be minimal need for tree trimming or removal.

Bradford Janes indicating the proposed location for the conveyor crossing of the Big Thompson River

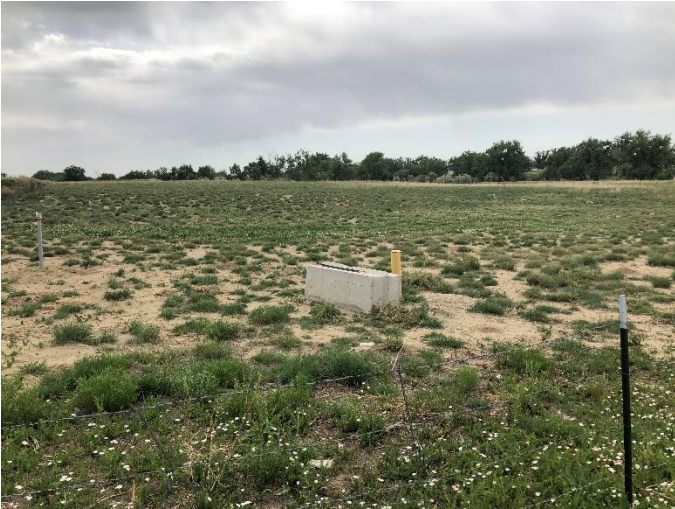
Well near northwest corner of site

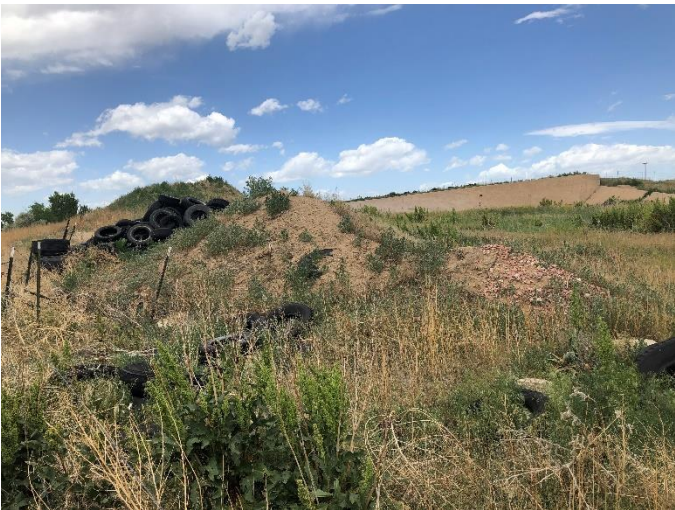
A prairie dog colony is at the proposed area for processing, near the existing silage bins. A large amount of trash is also in this area.

Tires and other trash beside silage bins, near the 54th Street Road
