**MINERALS PROGRAM INSPECTION REPORT**  
**PHONE: (303) 866-3567**

<b>MINE NAME:</b> Wattenberg Lakes	<b>MINE/PROSPECTING ID#:</b> M-2004-051	<b>MINERAL:</b> Aggregate	<b>COUNTY:</b> Weld
<b>INSPECTION TYPE:</b> Monitoring	<b>INSPECTOR(S):</b> Peter Hays	<b>INSP. DATE:</b> September 6, 2022	<b>INSP. TIME:</b> 09:00
<b>OPERATOR:</b> Aggregate Industries - WCR, Inc.	<b>OPERATOR REPRESENTATIVE:</b> Neil Whitmer	<b>TYPE OF OPERATION:</b> 112c - Construction Regular Operation	
<b>REASON FOR INSPECTION:</b> Normal I&E Program	<b>BOND CALCULATION TYPE:</b> None	<b>BOND AMOUNT:</b> \$520,000.00	
<b>DATE OF COMPLAINT:</b> NA	<b>POST INSP. CONTACTS:</b> None	<b>JOINT INSP. AGENCY:</b> None	
<b>WEATHER:</b> Clear	<b>INSPECTOR'S SIGNATURE:</b>

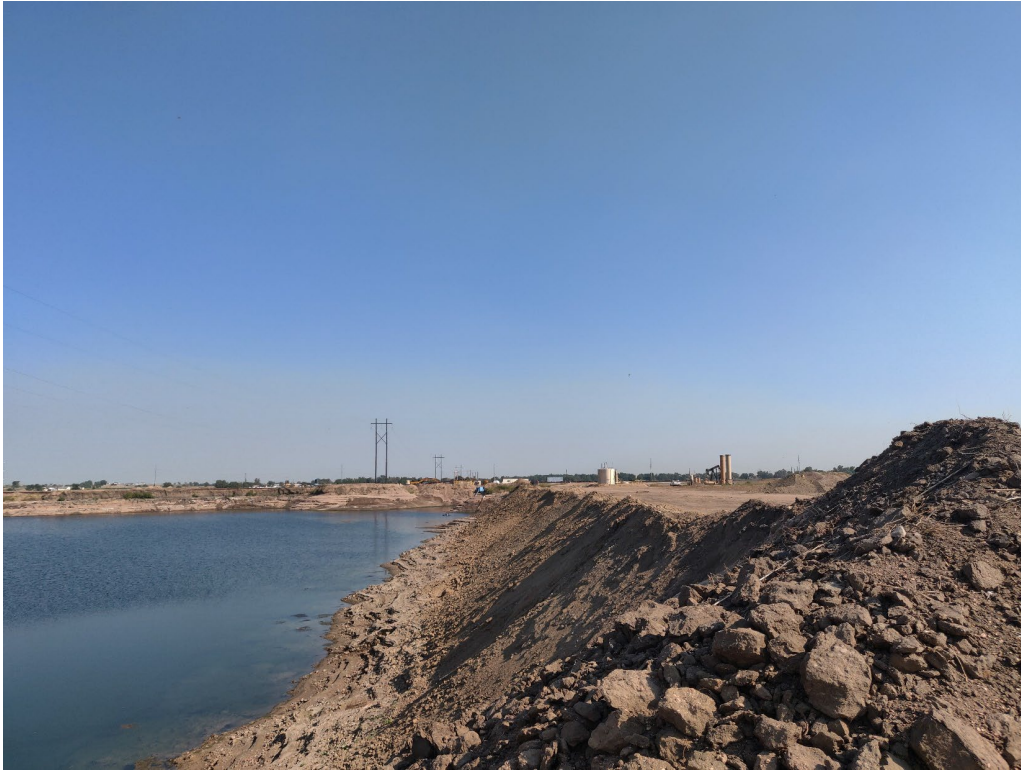
**PROBLEM:** The approved Mining Plan states a minimum 25 foot setback will be maintained from the permit boundary with at least a 40 foot offset from the permit boundary when slurry walls are installed or from county roads. The Operator has allowed the eastern shoreline of the Phase 2 / Pond 1 to erode into the required 40 foot setback. This a problem pursuant to CRS 34-32.5-116(4)(j) for failure to stabilize the affected area and failure to effectively control erosion.

Evidence of the backfilling of the eastern boundary of the Phase 2 / Pond 1 Mining Area was observed during the inspection. However, the Division was unable to verify the required offset from CR32 ¾ during the inspection. County Road 32 ¾ was recently regraded by the oil and gas company which destroyed the survey feathers indicating the permit boundary installed in the road. The Division will require the Operator to resurvey the permit boundary along CR32 ¾ and reinstall the boundary markers. The corrective action due date to reestablish the required 40 foot offset from the eastern permit boundary / County Road 23 ¾ adjacent to the Phase 2 / Pond 1 Mining Area was extended by the Division until November 14, 2022 to allow the Operator time to survey the area.

View of the backfilled eastern slope of Phase 2 / Pond 1 Mining Area from the south end looking north

**CORRECTIVE ACTIONS:** The Division will require the Operator to backfill and grade the Phase 2 / Pond 1 Mining Area to reestablish the required 40 foot offset from the eastern permit boundary / County Road 23 ¾ and provide evidence this has been corrected by the corrective action date.
