## MINERALS PROGRAM INSPECTION REPORT

<b>MINE NAME:</b> Pikeview Quarry	<b>MINE/PROSPECTING ID#:</b> M-1977-211	<b>MINERAL:</b> Limestone (general), granite gneiss and do	<b>COUNTY:</b> El Paso
<b>INSPECTION TYPE:</b> Monitoring	<b>INSPECTOR(S):</b> Zach Trujillo	<b>INSP. DATE:</b> September 7, 2022	<b>INSP. TIME:</b> 10:00
<b>OPERATOR:</b> Continental Materials Corporation	<b>OPERATOR REPRESENTATIVE:</b> Jerry Schnabel	<b>TYPE OF OPERATION:</b> 112c - Construction Regular Operation	
<b>REASON FOR INSPECTION:</b> Normal I&E Program	<b>BOND CALCULATION TYPE:</b> None	<b>BOND AMOUNT:</b> \$13,389,784.00	
<b>DATE OF COMPLAINT:</b> NA	<b>POST INSP. CONTACTS:</b> None	<b>JOINT INSP. AGENCY:</b> None	
<b>WEATHER:</b> Clear	<b>INSPECTOR'S SIGNATURE:</b>

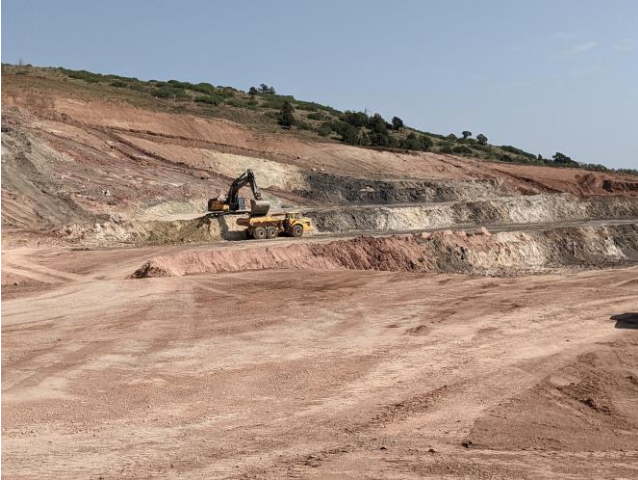
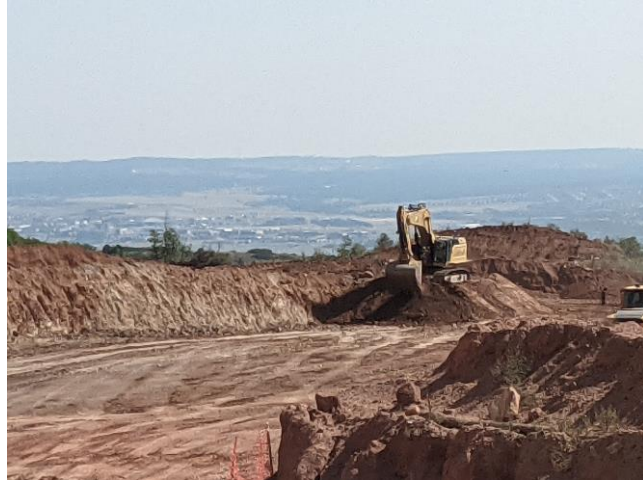
Backfill material was being excavated from the north end and in the area of the old maintenance shop. Multiple benches in the excavation area were observed. A total of two excavators were operating along the benches at the time of the inspection loading haul trucks with backfill material. Backfill was being dumped along the north end of the buttress area along the slope. A dozer was pushing and grading the dumped material. Site representatives confirmed these benches would be graded to a continuous slope for final reclamation after all borrow material has been removed. A second dozer was pushing material from the northern slope located along the city property down to stage for future borrow material for backfill. Import material was observed being trucked to the buttress area as approved per TR-19. The import material was being placed and stockpiled along the southern end for future placement and compaction.

Backfill excavation.

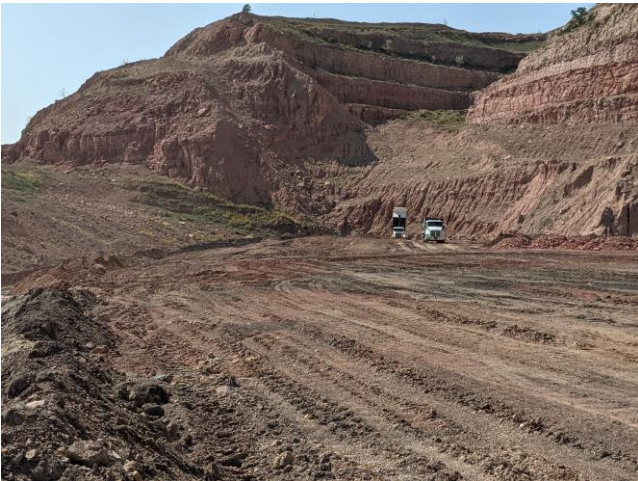
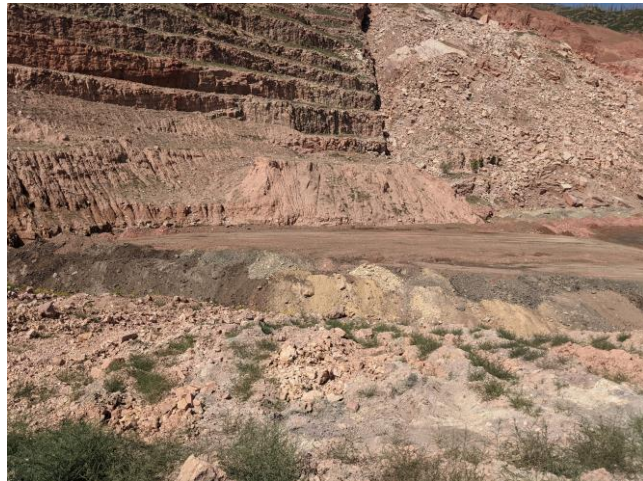
Imported fill placement.

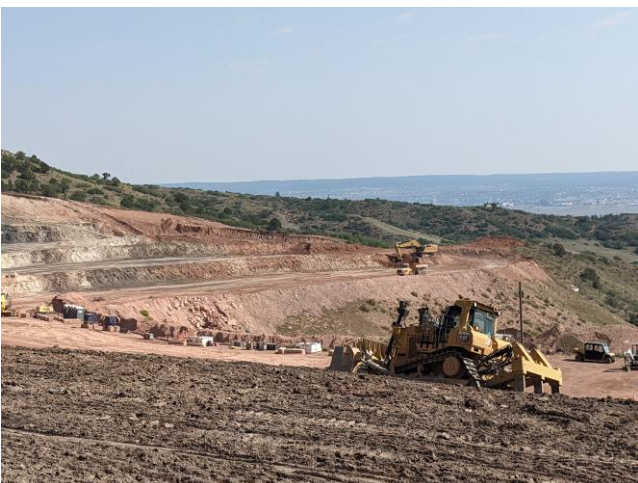
A dozer was observed grading the lower buttress area. This dozer was pushing material to final grade at the toe of the buttress.

Grade work by dozer on buttress.
