## MINERALS PROGRAM INSPECTION REPORT

<b>MINE NAME:</b> Bulldog Project	<b>MINE/PROSPECTING ID#:</b> P-2010-014	<b>MINERAL:</b> Silver, zinc, lead and	<b>COUNTY:</b> Mineral
<b>INSPECTION TYPE:</b> Monitoring	<b>INSPECTOR(S):</b> Lucas West	<b>INSP. DATE:</b> August 31, 2022	<b>INSP. TIME:</b> 09:04
<b>OPERATOR:</b> Rio Grande Silver, Inc.	<b>OPERATOR REPRESENTATIVE:</b> Randy McClure	<b>TYPE OF OPERATION:</b> MP - Mineral Prospecting

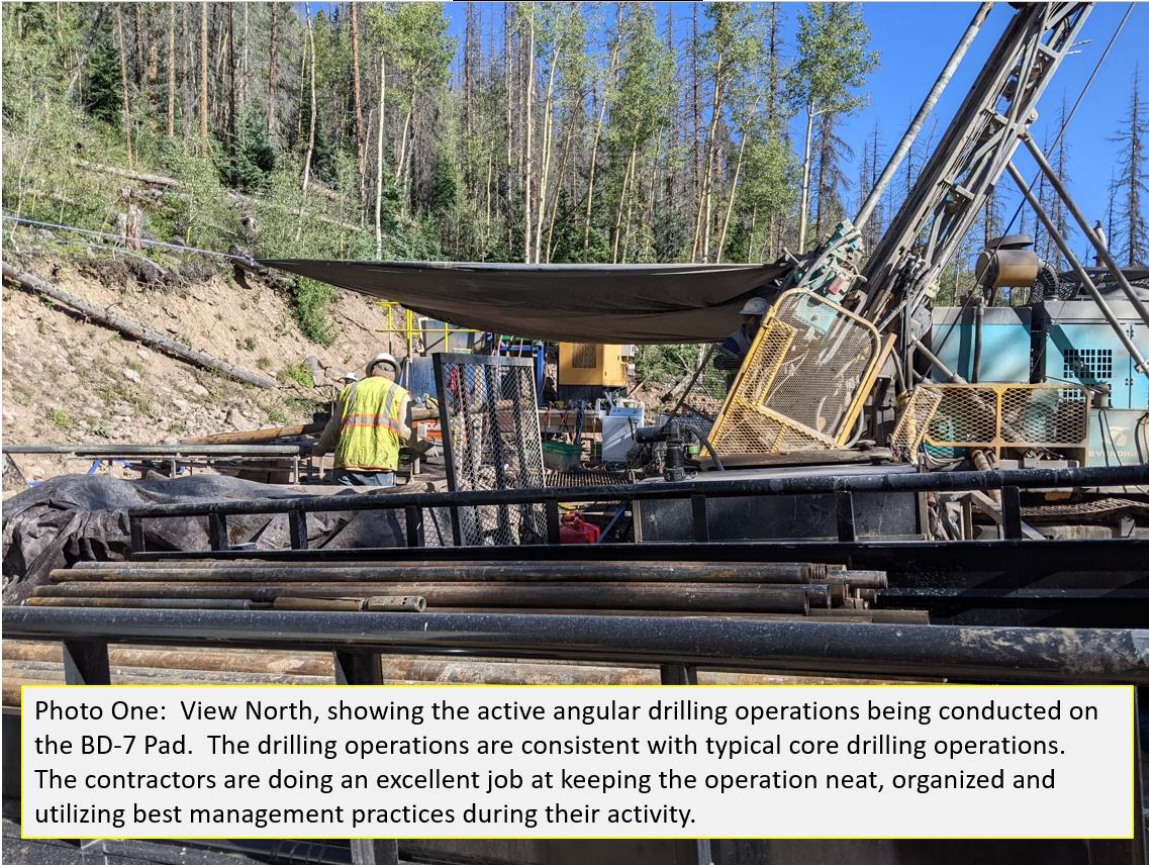
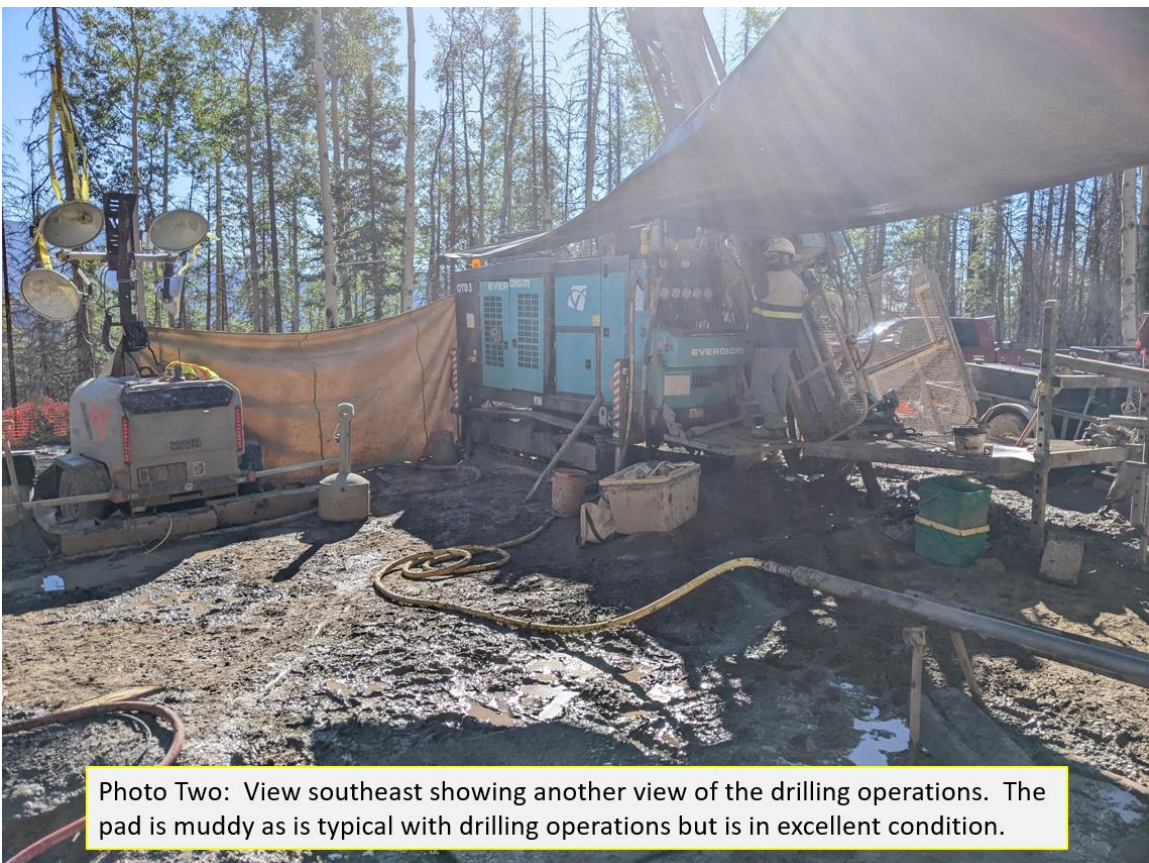
The entire NOI consists of two drill pads, BD-7 and BD-8 along with an access road extending from the San Juan Silver Project NOI and connecting the two drill pads. At the time of the inspection, drilling operations were underway at the BD-7 pad, being conducted by a drilling contractor. Drilling operations are consistent with standard practices for core drilling operations. The track mounted drill rig was set on the pad, drilling angularly, to the west. All drill water was being contained, recirculated and impounded in accordance with the approved plans. Fresh water is delivered to the site by way of a small water line routed from the BD-6 pad of the San Juan Silver Project. Aside from small amounts of fuel and lubricants associated with the drill rig, no hazardous, toxic or acid forming materials are being stored on site. All support items including extra drill steel, water holding tank and gen set are being stored in a neat and orderly fashion. The down gradient side of the pad, to the east, is protected by construction fencing and storm water control features that were all in good condition. Photos One through Three show examples of the drilling operations observed at the time of the inspection.

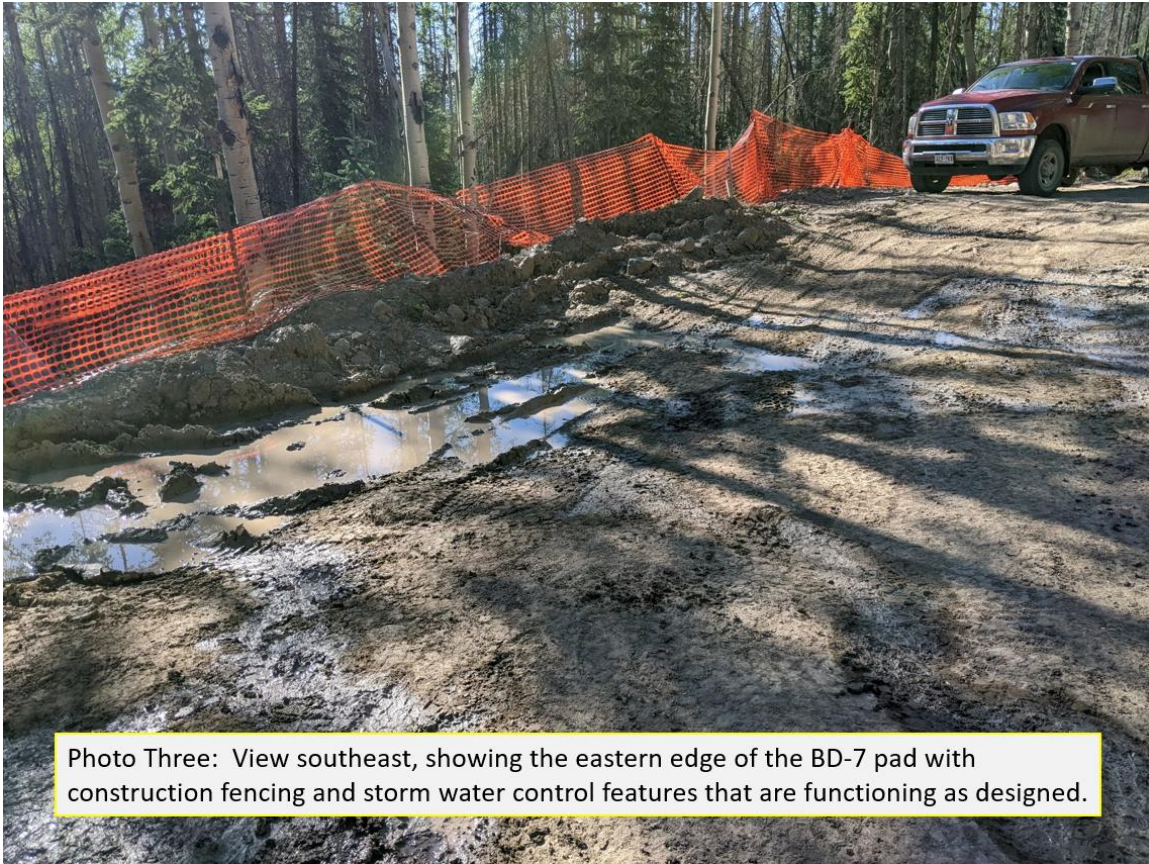
Photo Three: View southeast, showing the eastern edge of the BD-7 pad with construction fencing and storm water control features that are functioning as designed.

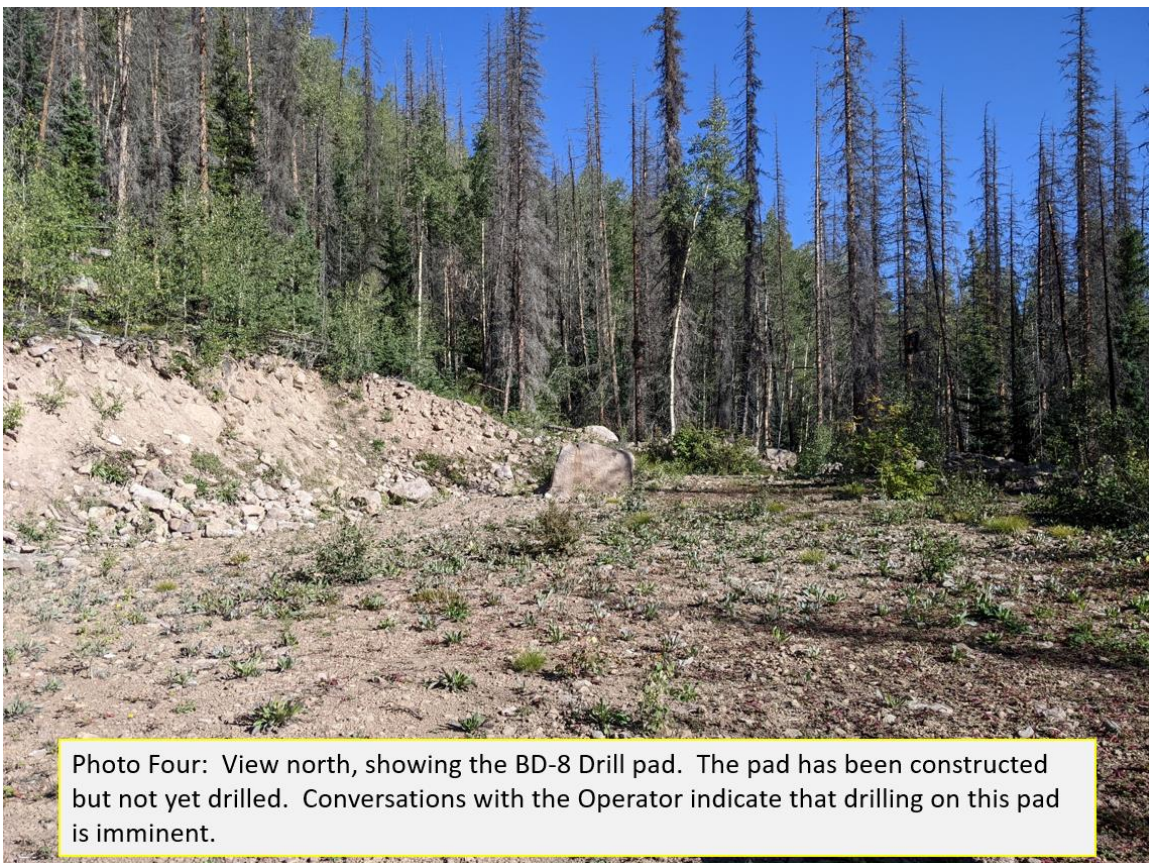
Leading to the north from the BD-7 pad is a constructed access road leading to the BD-8 Pad. The access road has become blocked to vehicle traffic with downed trees and has revegetated itself since the time of construction. The BD-8 pad has been constructed in preparations for drilling operations, however has not been drilled yet. The pad and its cut slope appeared to be stable at the time of the inspection. At the time of construction topsoil and vegetation had been stripped from the site, however since that time vegetation has begun to re-establish with volunteer species. The pad can be seen in Photo Four. On site discussions with the Operator indicate that drilling of the BD-7 pad should happen either this fall or next spring.

Photo Four: View north, showing the BD-8 Drill pad. The pad has been constructed but not yet drilled. Conversations with the Operator indicate that drilling on this pad is imminent.
