Re: Daniels Monthly Report

September 9, 2022
Project No.: 19125

Regarding: Daniels Sand Pit 2, Permit No. M-1973-007-SG
Slope Stability Monthly Monitoring Report

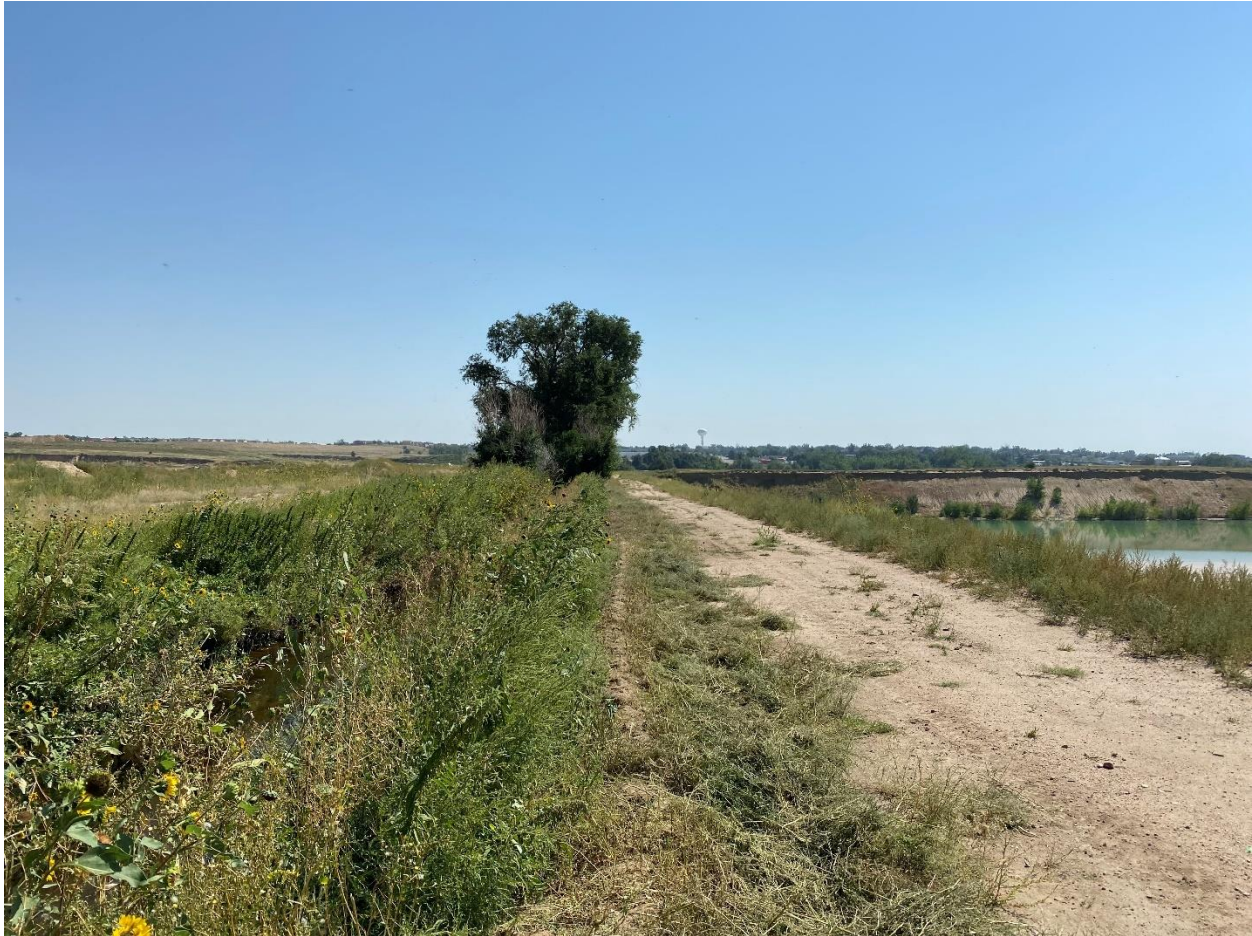
- Weather: 48-76°, sunny to partly cloudy, winds 10-15 mph
- Visual observation of the Fountain Mutual Ditch:
 - No tension cracks
 - No toe erosion that was visible
 - Vegetation growing on banks and at invert of ditch
 - Approximately 1.5 feet of flowing water
 - No sloughed slope surfaces
 - Mowing operations for access road occurring while on site
 - The condition of the ditch is stable

Photo 1. Fountain Mutual Ditch looking east

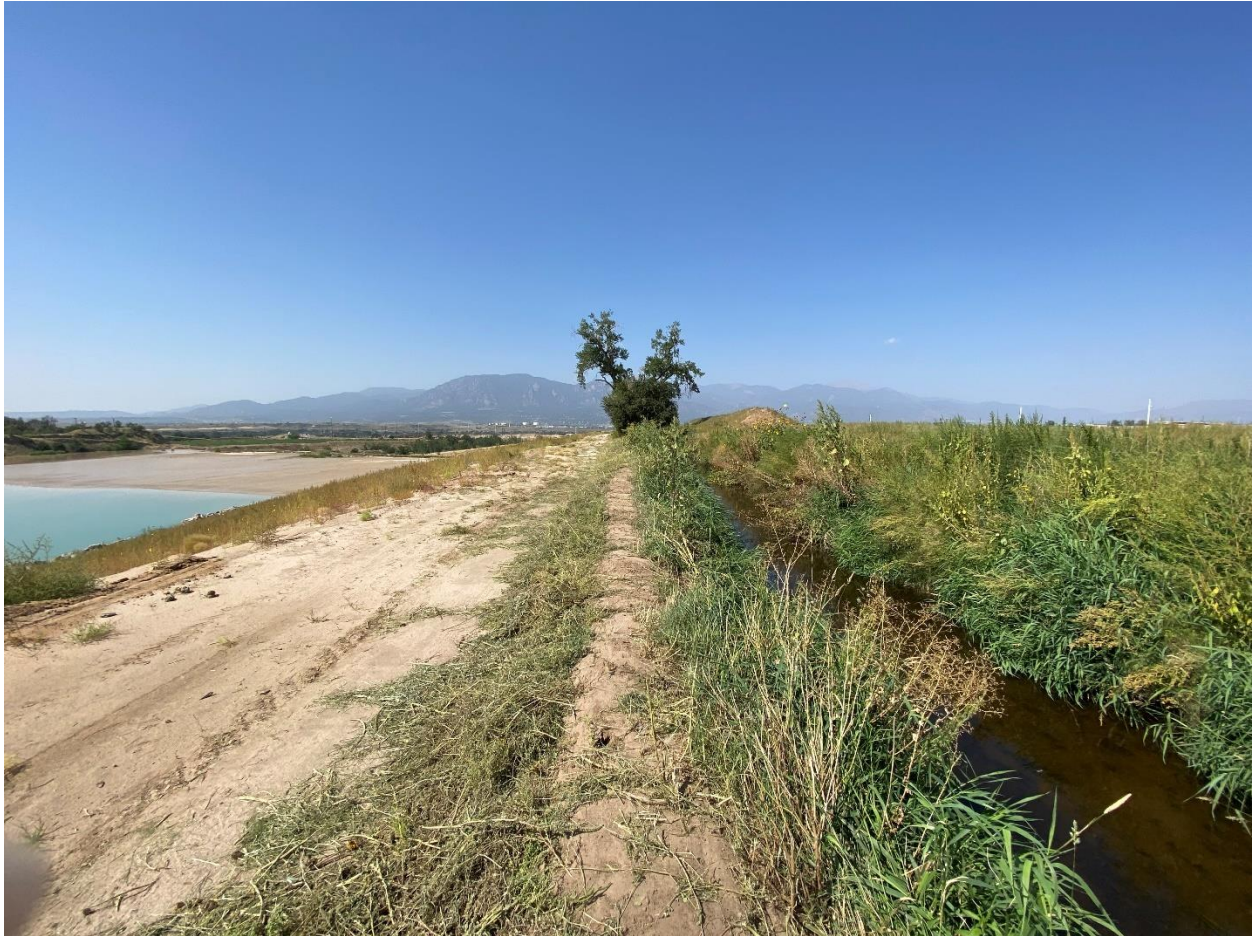
Photo 2. Fountain Mutual Ditch looking west

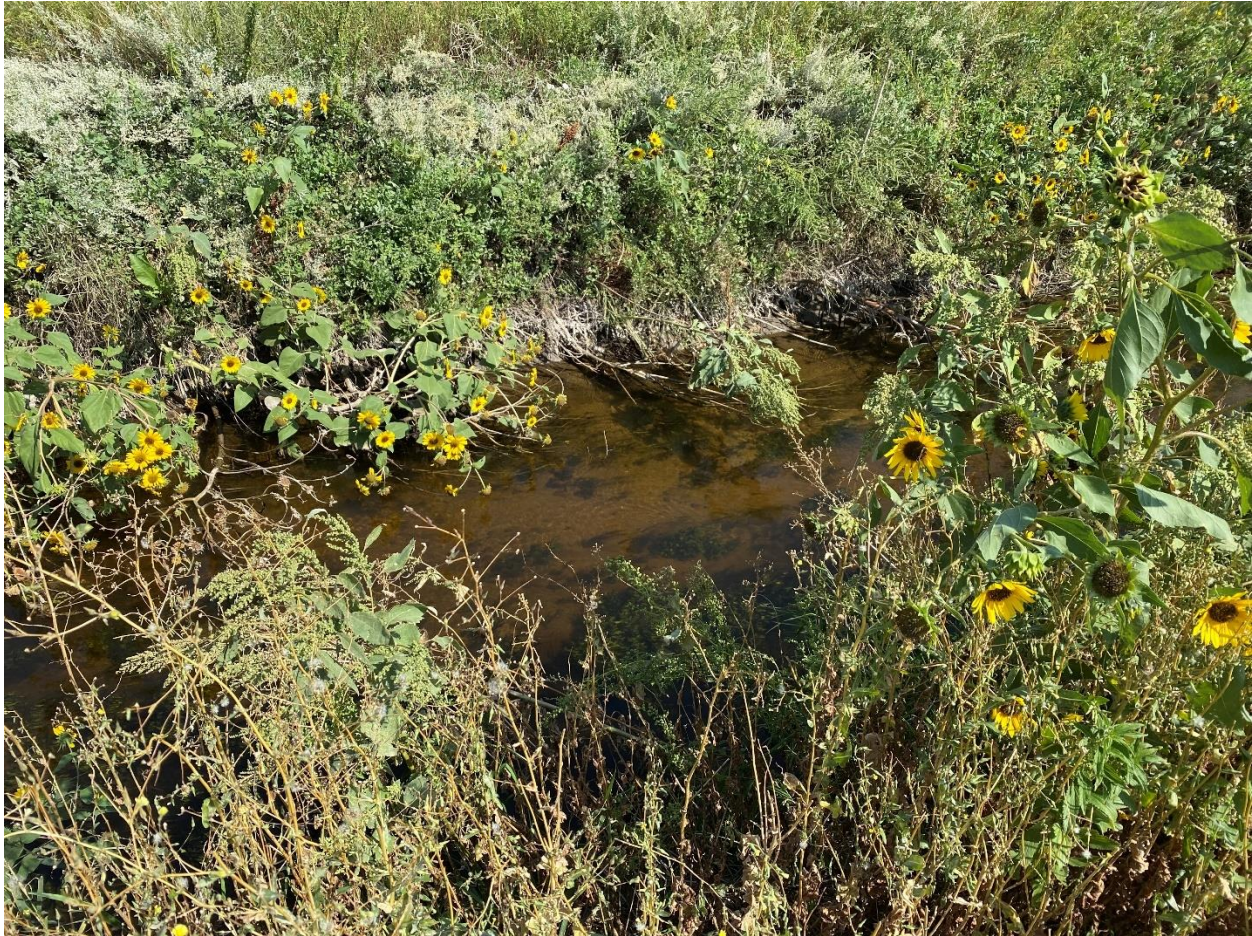
Photo 3. Fountain Mutual Ditch invert looking north (note vegetation)

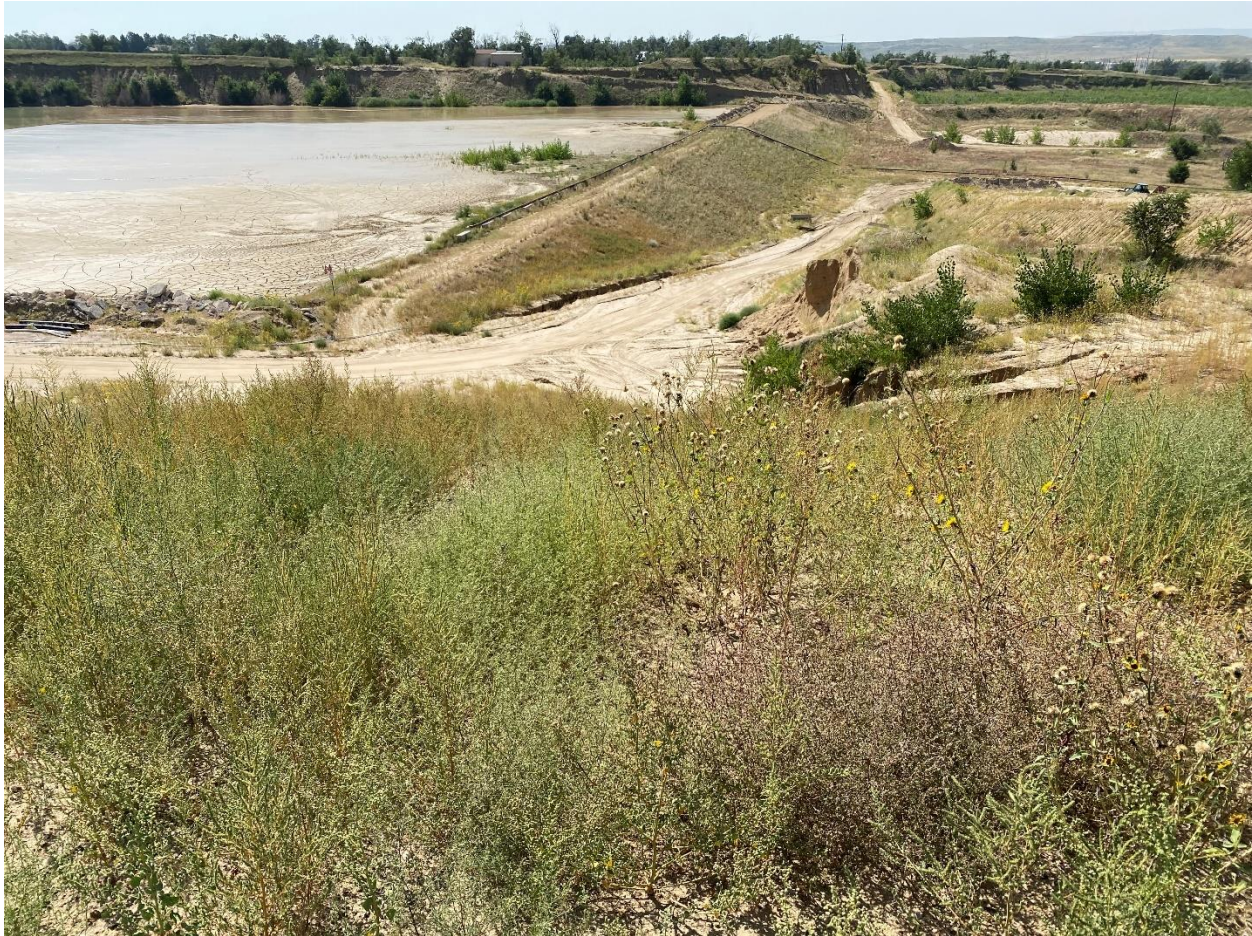
- Visual observations of the Buttress Slope
 - The buttress slope varies from 3H:1V to 4H:1V
 - Vegetation (mainly weeds) are growing in some locations on the buttress
 - Several locations visible evidence of surface water runoff and erosion gullies.
 - On the eastern side of the buttress (less weeds), surface/drainage erosion is present approximately 15 feet from the ditch. Just south of the access road, the erosion gully is approximately 3 to 4 feet wide and deep. S. Myers met Grant Smith at the scale house to discuss the surface drainage/erosion near the access road. Grant was going to look at the location later in the afternoon.

Photo 4. Buttress slope looking south

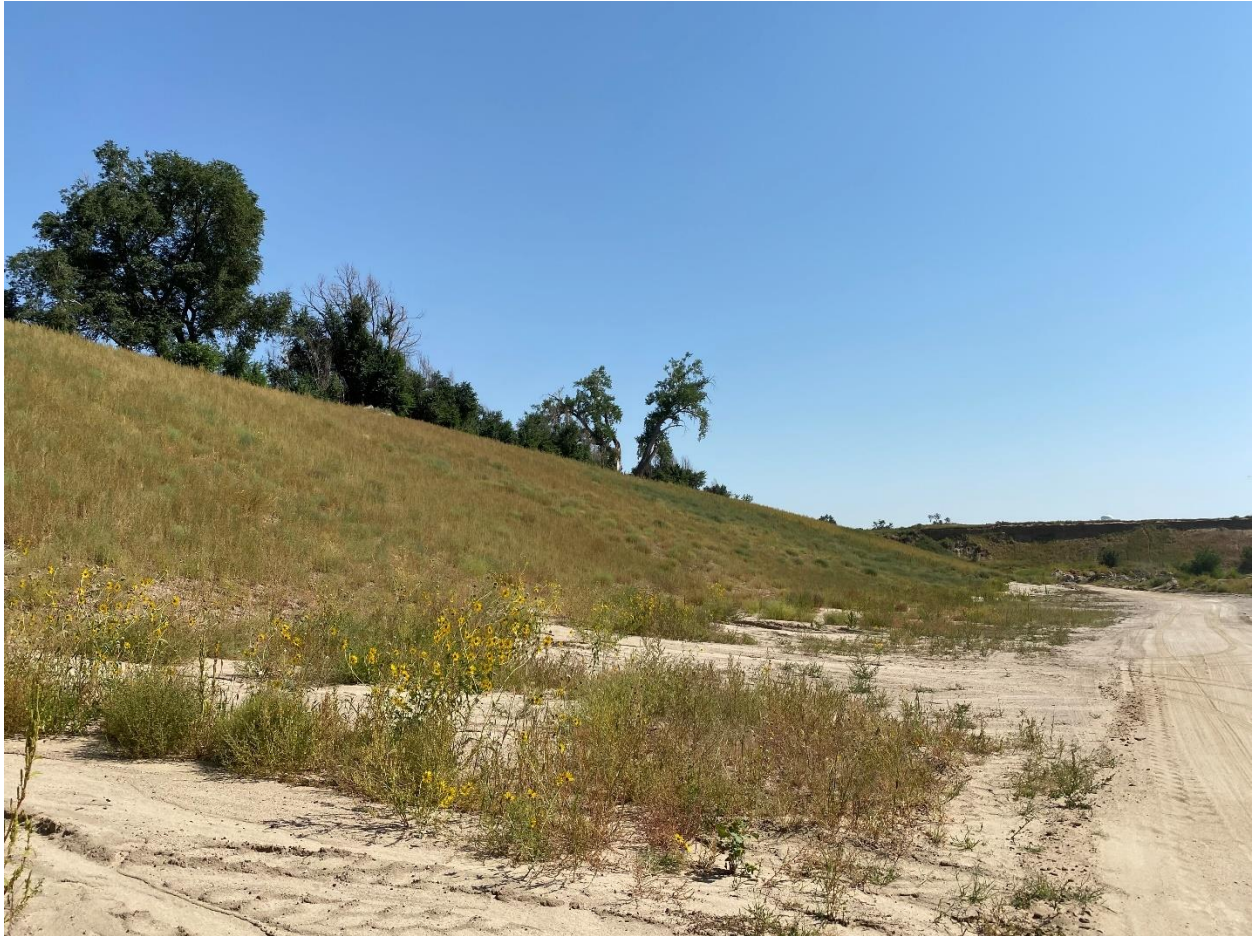
Photo 5. Buttress slope looking east from toe

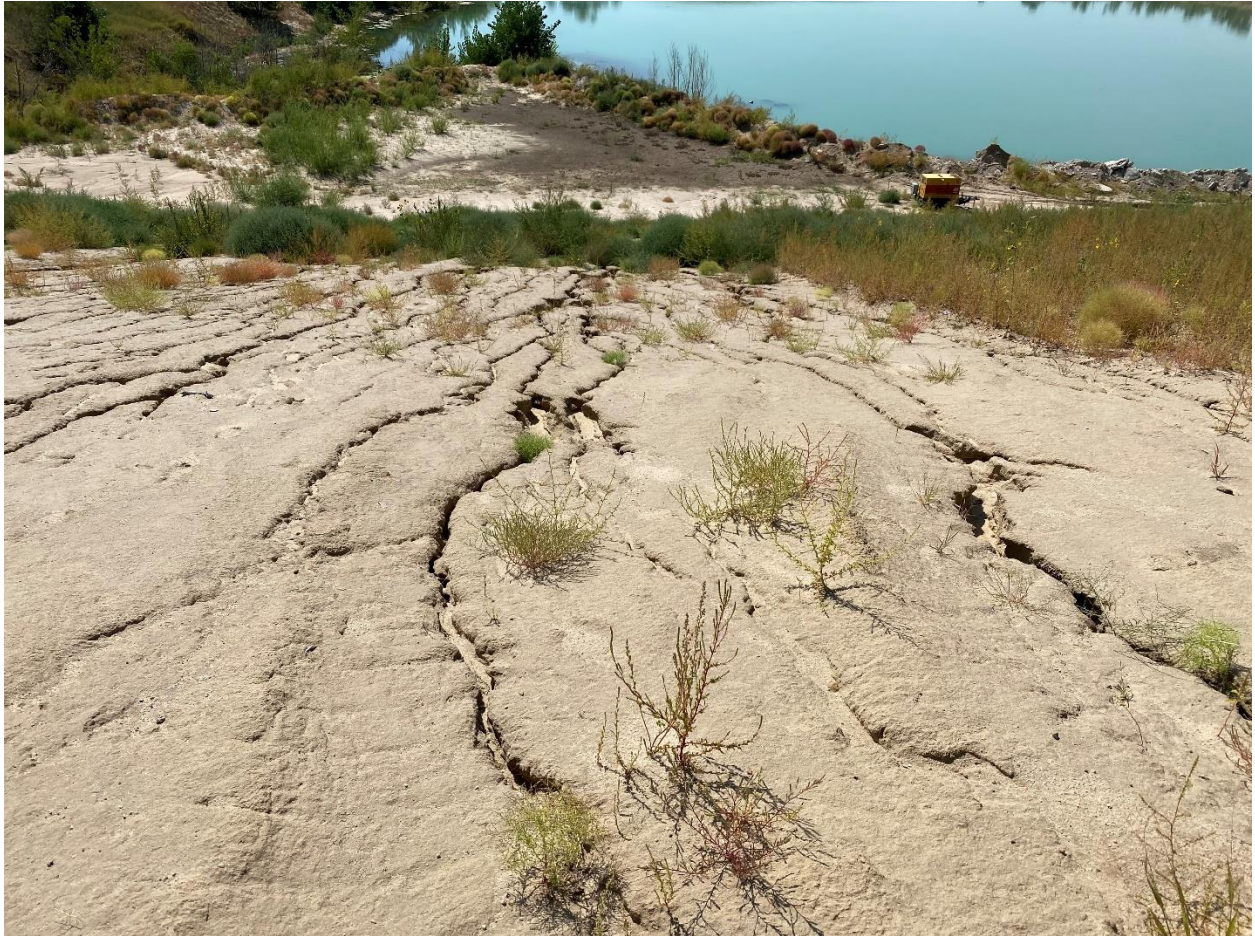
Photo 6. Buttress slope looking south, evidence of surface water drainage/erosion (eastern slope, less weeds)

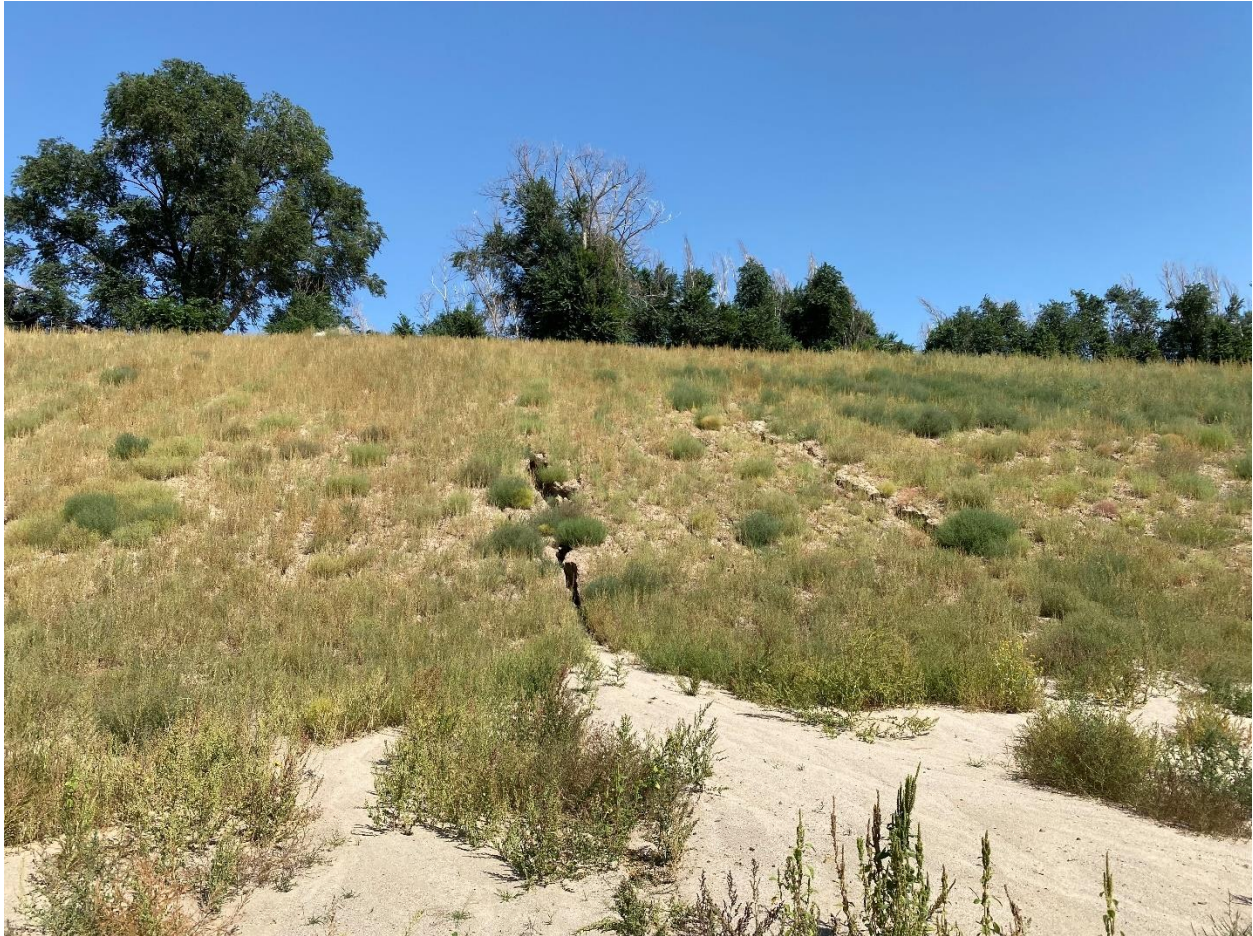
Photo 7. Buttress slope looking north, note expanding evidence of drainage/erosion forming

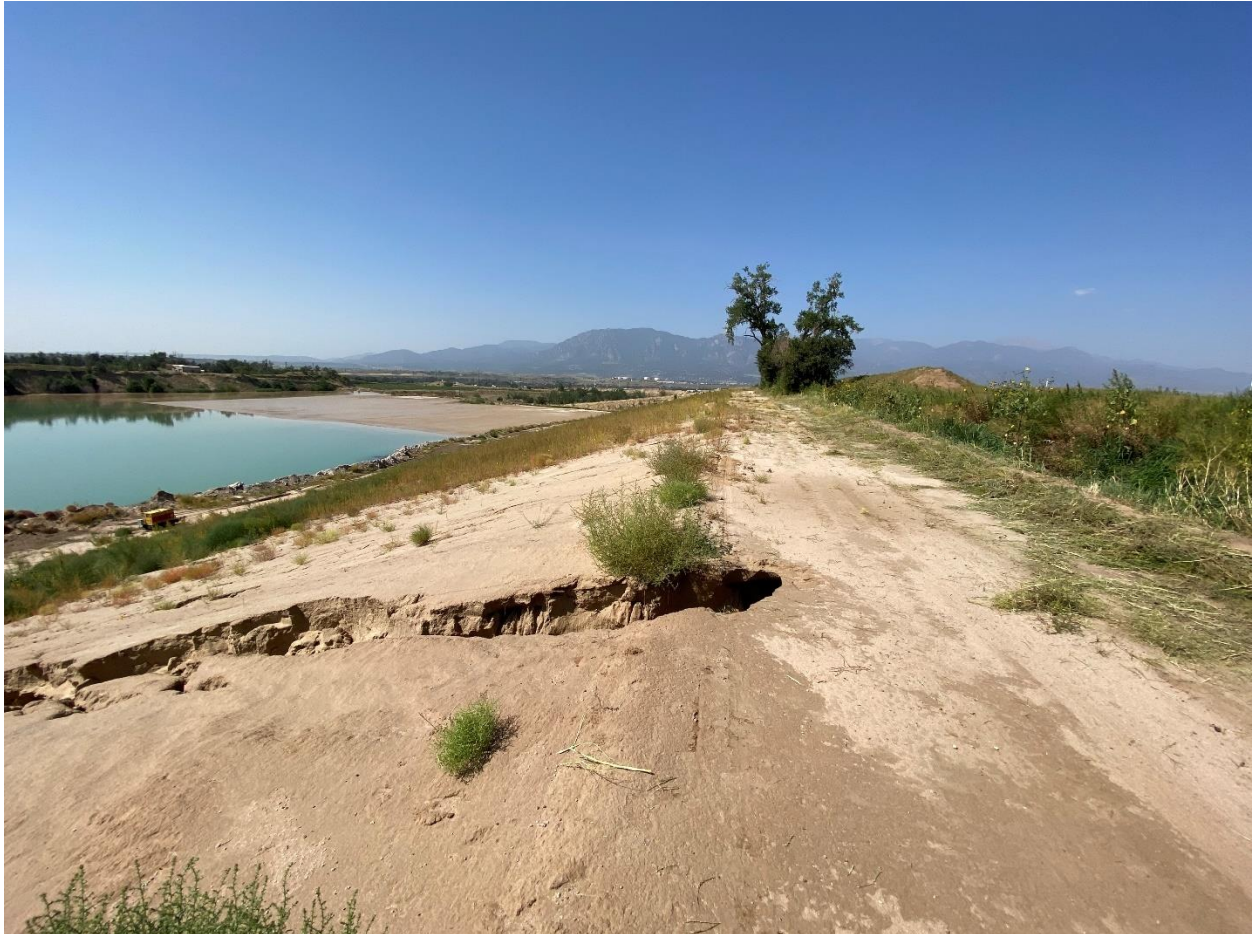
Photo 8. Erosion in relation to access road and ditch

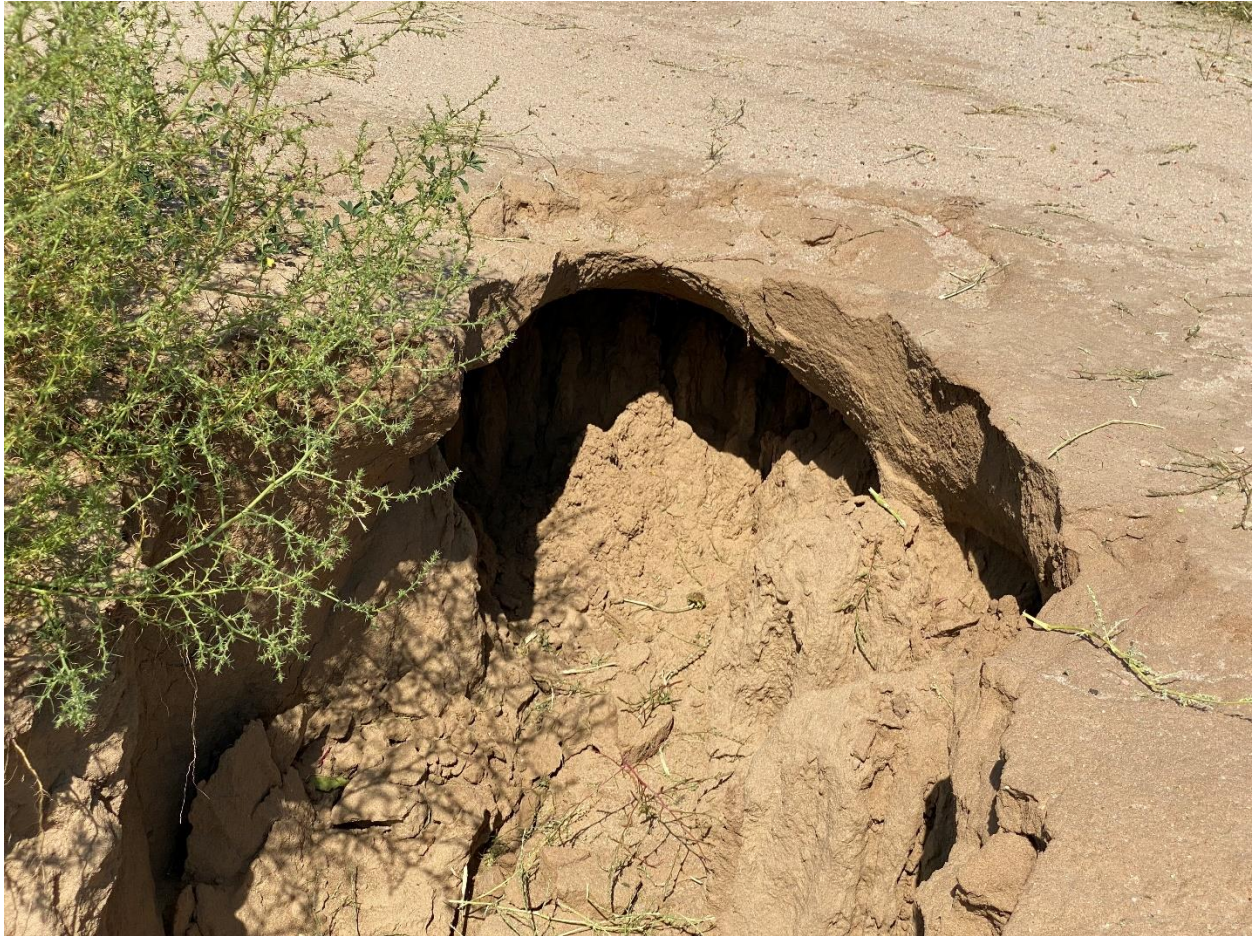
Photo 9. Zoomed in erosion at access road

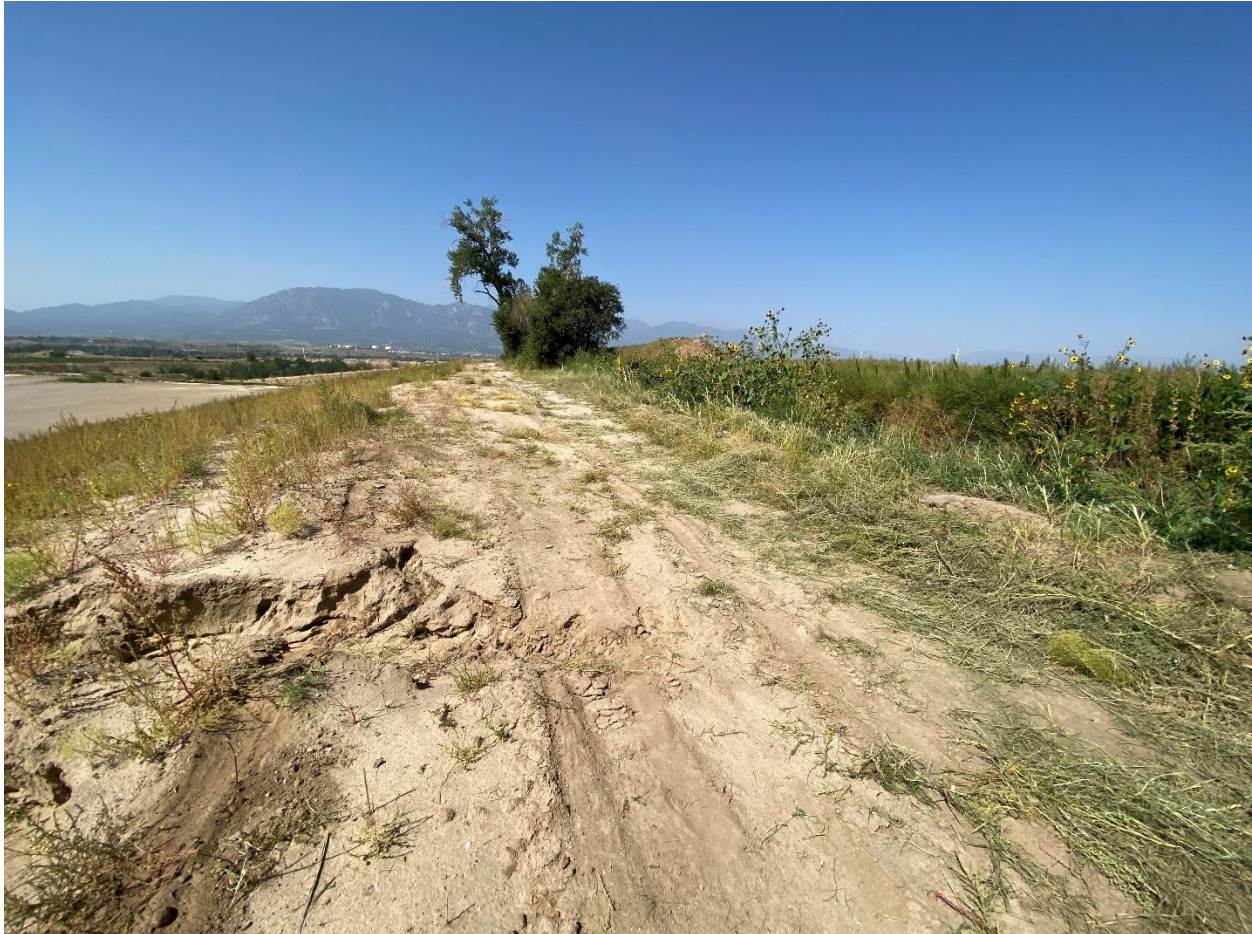
Photo 10. Second location of surface drainage/erosion on access road (shallower)
