**MINERALS PROGRAM INSPECTION REPORT**  
**PHONE: (303) 866-3567**

<b>MINE NAME:</b> White Wolf Construction Borrow Pit	<b>MINE/PROSPECTING ID#:</b> M-2018-029	<b>MINERAL:</b> Borrow material for	<b>COUNTY:</b> Las Animas
<b>INSPECTION TYPE:</b> Monitoring	<b>INSPECTOR(S):</b> Peter Hays	<b>INSP. DATE:</b> August 30, 2022	<b>INSP. TIME:</b> 09:00
<b>OPERATOR:</b> White Wolf Construction & Landscaping, LL	<b>OPERATOR REPRESENTATIVE:</b> Joe Montoya	<b>TYPE OF OPERATION:</b> 111 - Construction by Government Agency

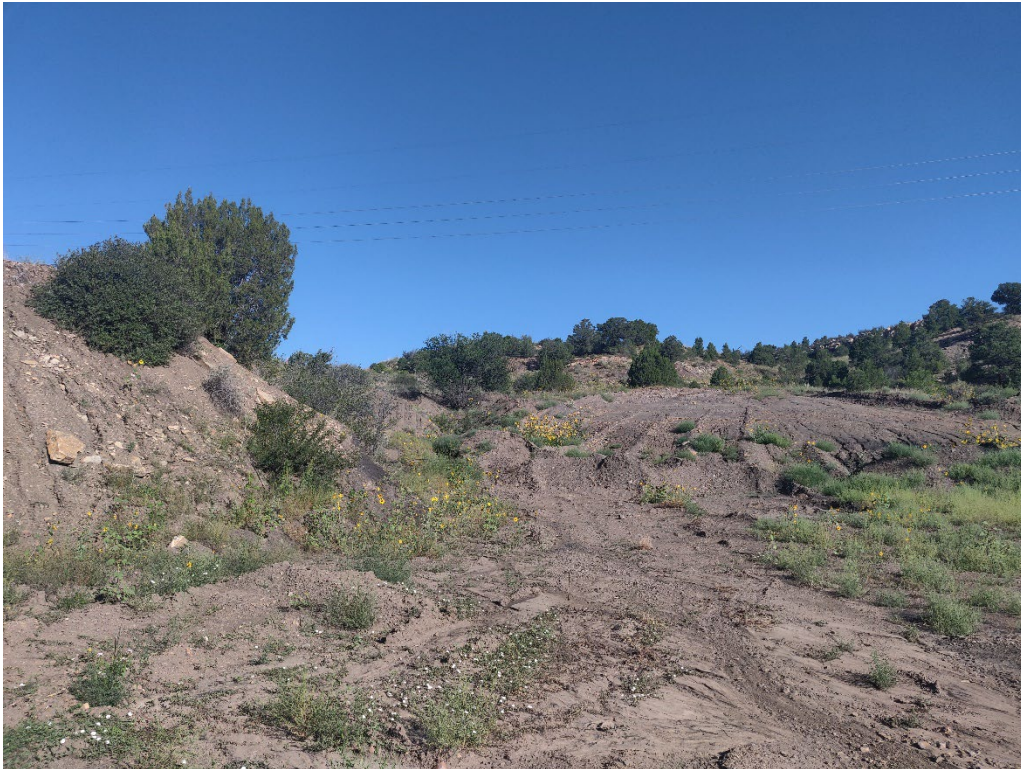
View of the site from the access road looking northwest

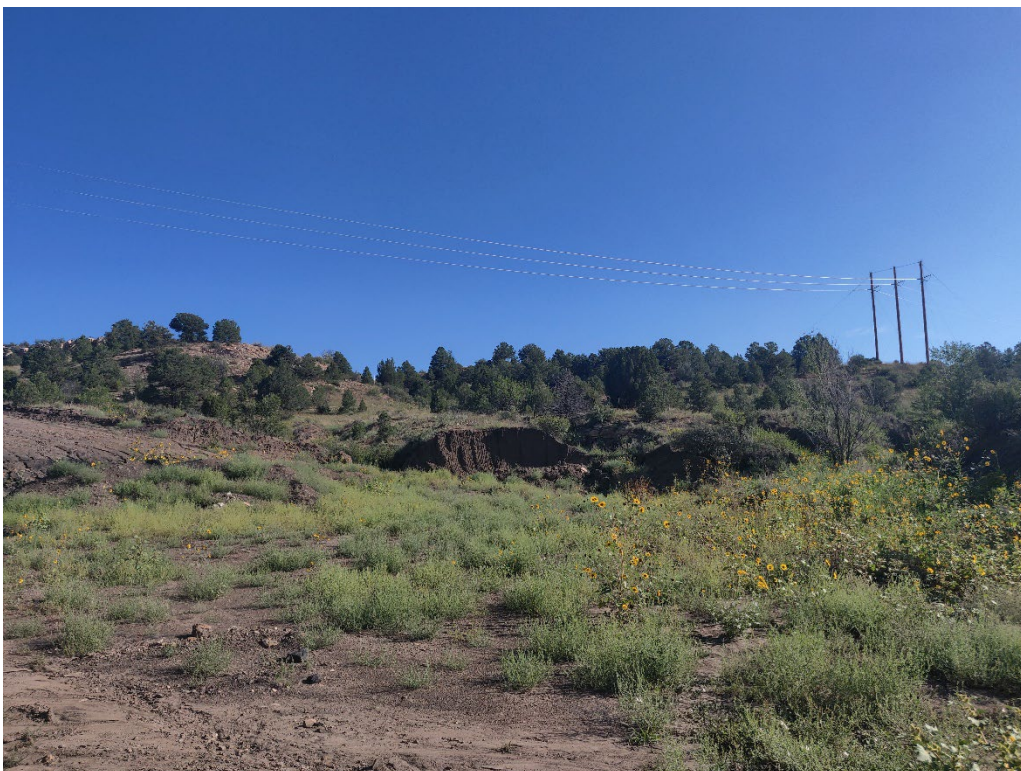
View of the site from the access road looking northeast
