MINERALS PROGRAM INSPECTION REPORT
PHONE: (303) 866-3567

MINE NAME: Canyon Rim Stone Quarry	MINE/PROSPECTING ID#: M-2006-053	MINERAL: Stone	COUNTY: Las Animas
INSPECTION TYPE: Monitoring	INSPECTOR(S): Peter Hays	INSP. DATE: August 29, 2022	INSP. TIME: 14:00
OPERATOR: Canyon Rim Stone, LLC	OPERATOR REPRESENTATIVE: Florence Jackson	TYPE OF OPERATION: 110c - Construction Limited Impact	
REASON FOR INSPECTION: Normal I&E Program	BOND CALCULATION TYPE: Partial Bond	BOND AMOUNT: \$30,009.00	
DATE OF COMPLAINT: NA	POST INSP. CONTACTS: None	JOINT INSP. AGENCY: None	
WEATHER: Clear	INSPECTOR'S SIGNATURE:

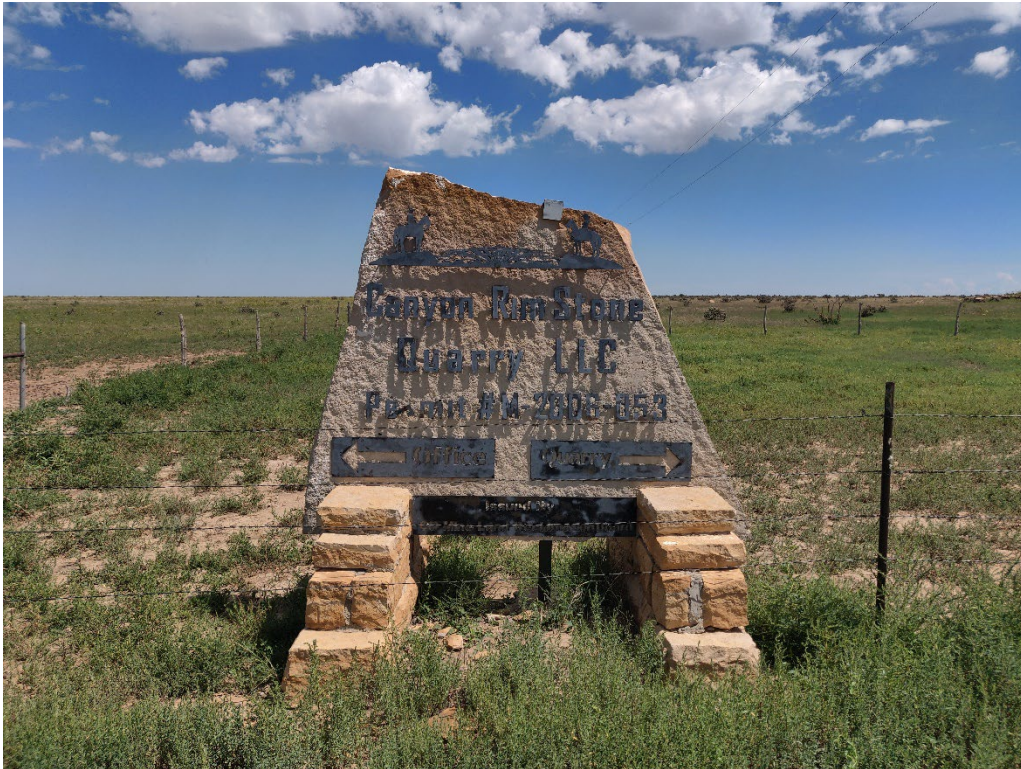
The permit sign was posted at the site entrance and the boundary of the affected areas was clearly marked with t-posts and stones as required by Rule 3.1.12(1) and (2).

Canyon Rim Quarry mine sign

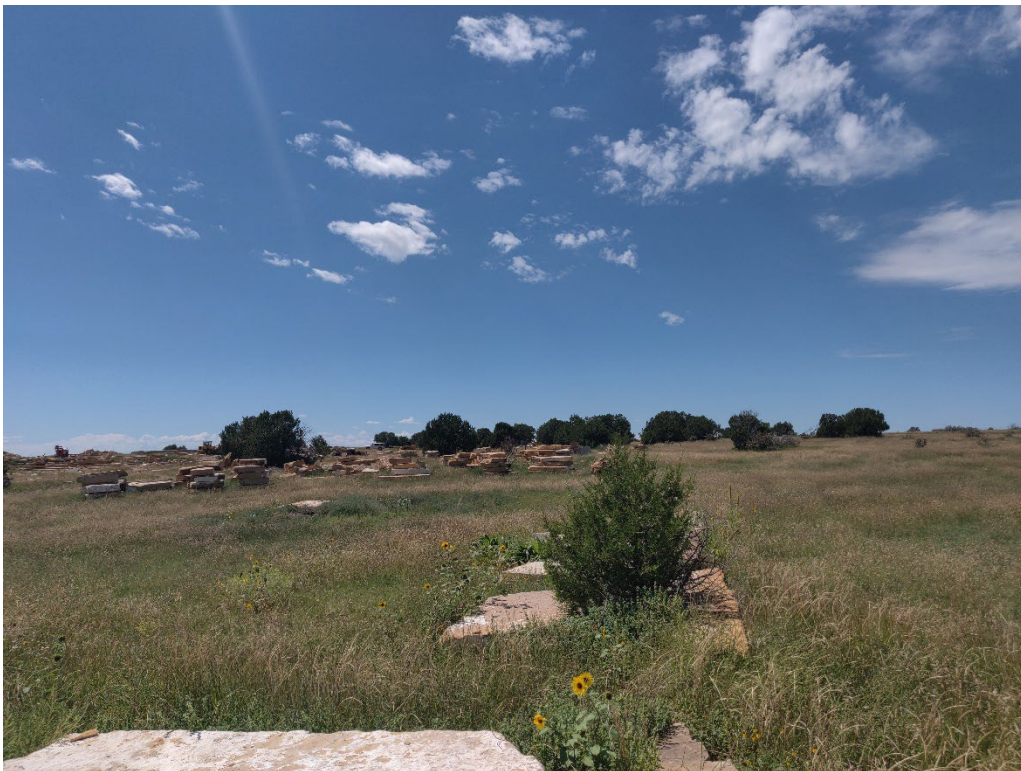
View of the site from the northeast corner looking west

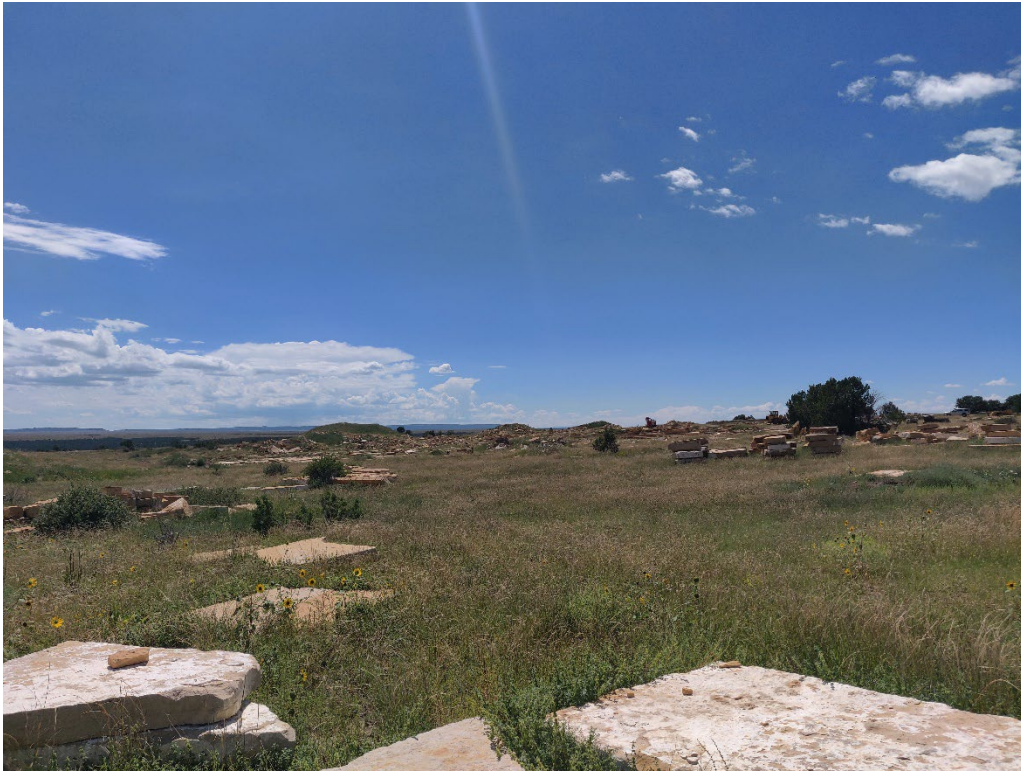
View of the site from the northeast corner looking southwest

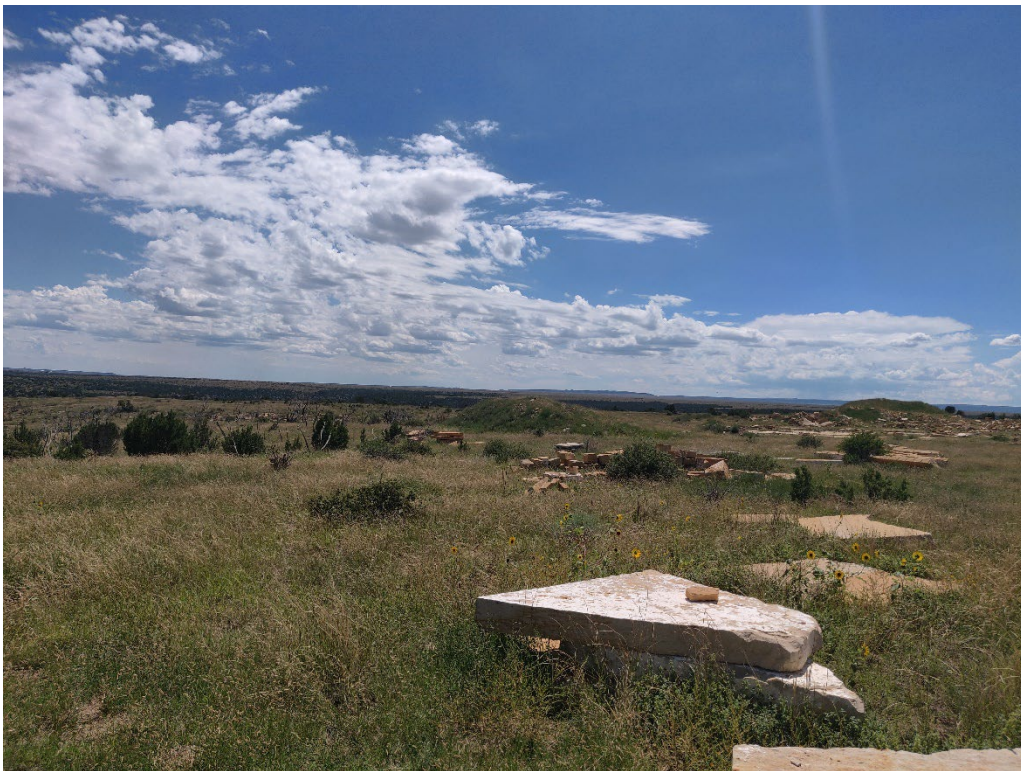
View of the site from the northeast corner looking south

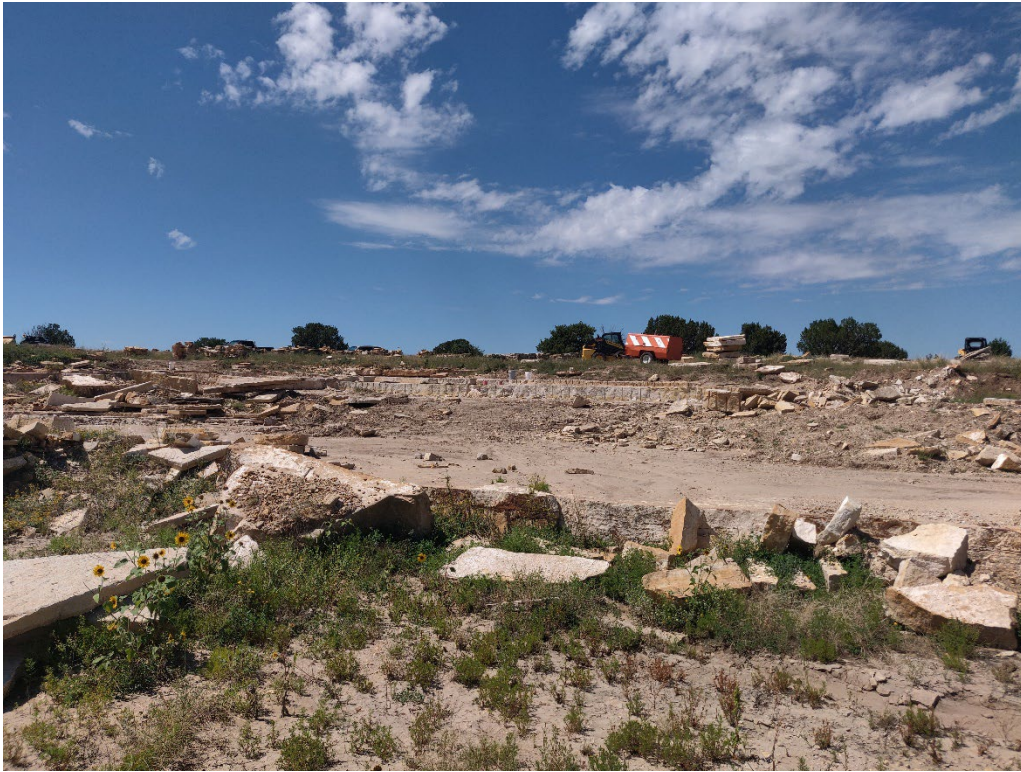
View of the active quarry area

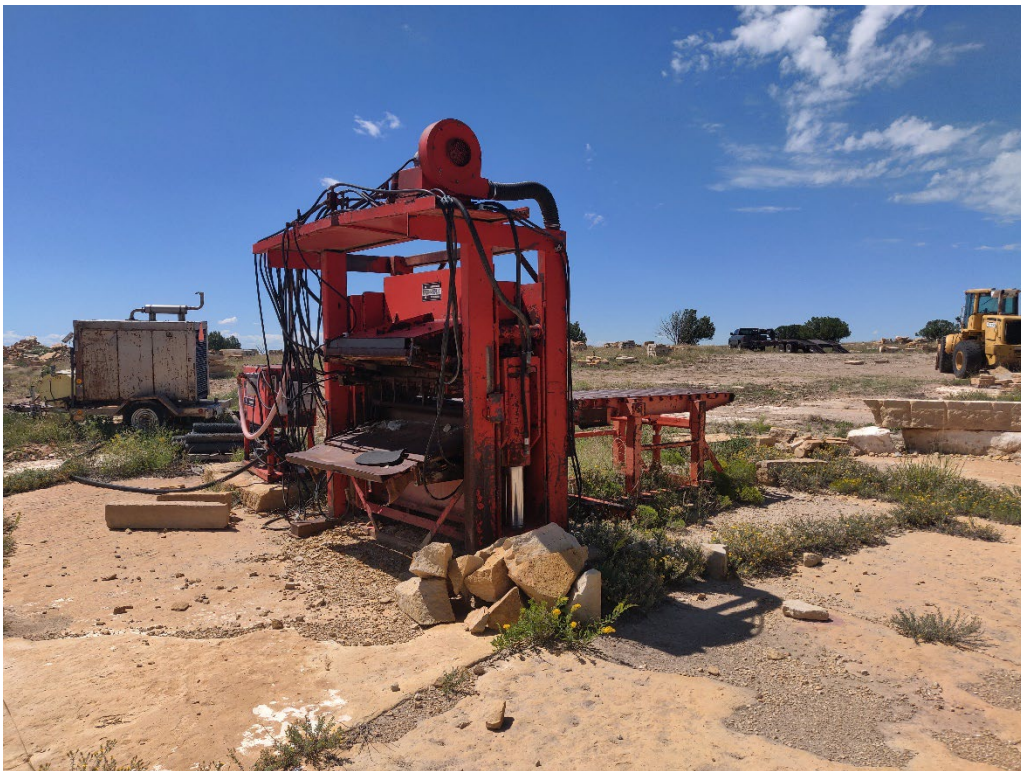
View of the stone cutter

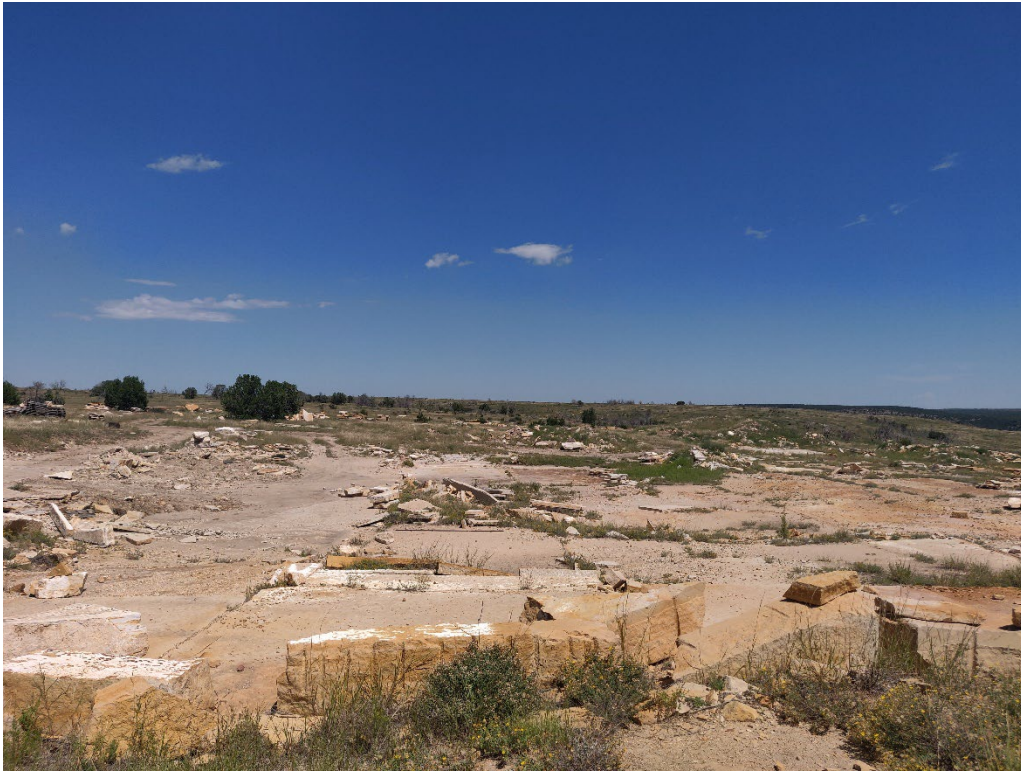
View of the active quarry area from the processing area looking east

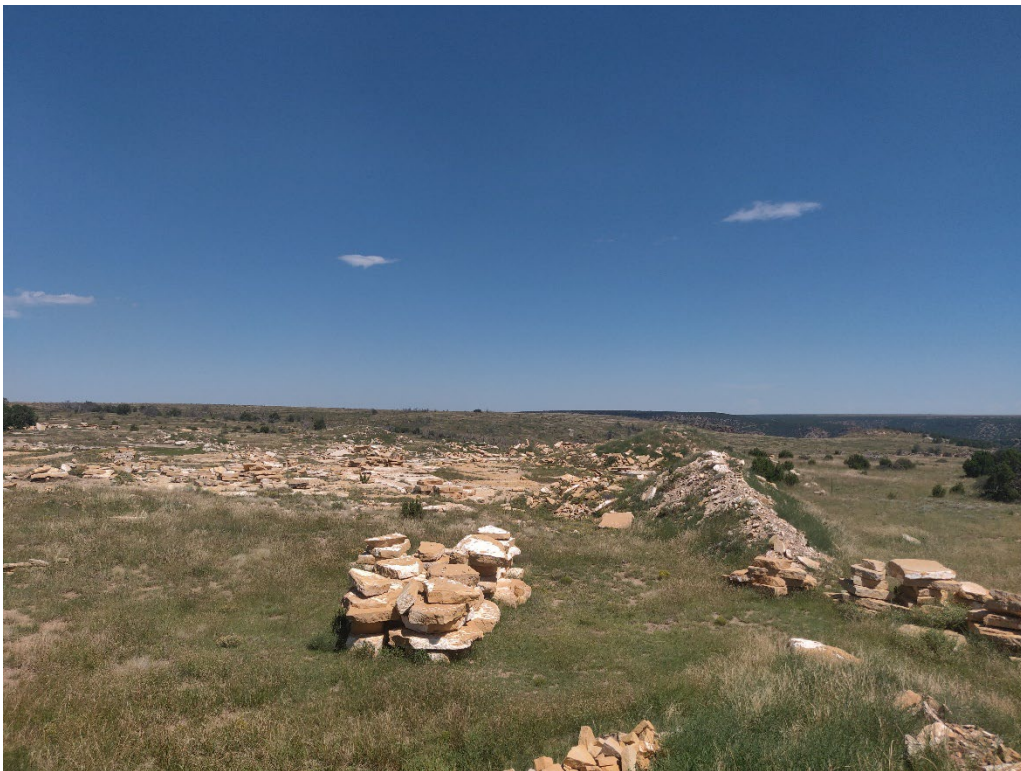
View of the site from the southwest corner looking east

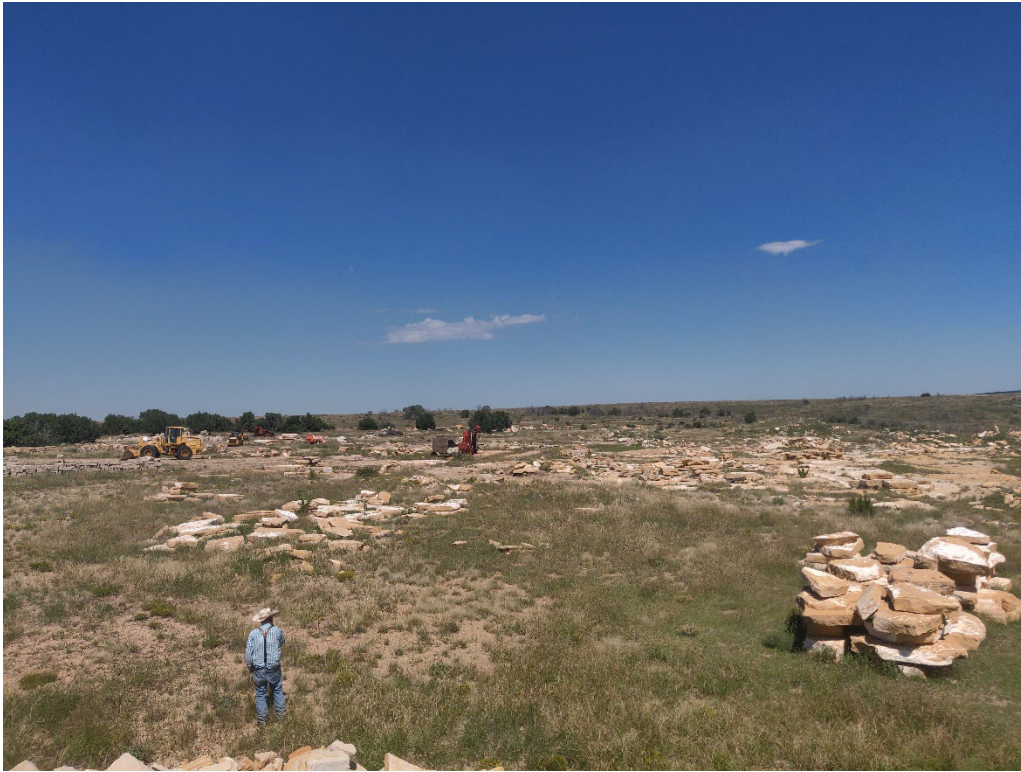
View of the site from the southwest corner looking northeast

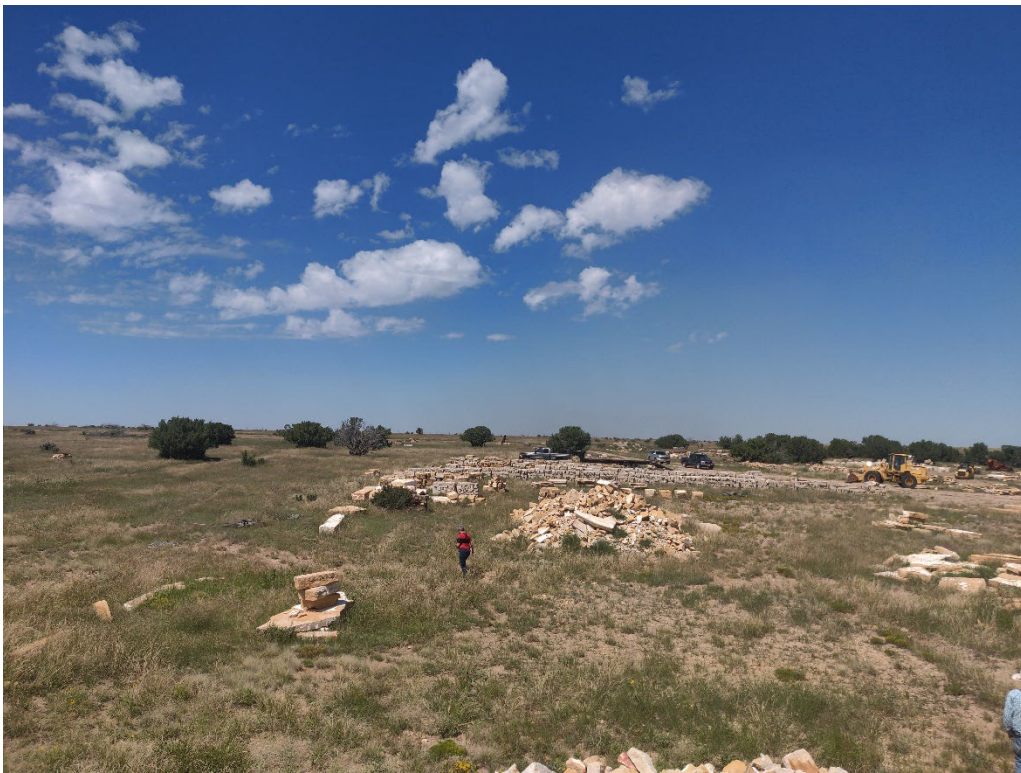
View of the site from the southwest corner looking north
