## MINERALS PROGRAM INSPECTION REPORT PHONE: (303) 866-3567

MINE NAME:		MINE/PROSPECTING ID#:	MINERAL:	COUNTY:	
Pitch Project		M-1977-004	Uranium and borrow Saguache		
			construction		
INSPECTION TYPE:		INSPECTOR(S):	INSP. DATE:	INSP. TIME:	
Monitoring		Dustin Czapla	August 30, 2022	13:30	
OPERATOR:		OPERATOR REPRESENTATIVE:	TYPE OF OPERATION:		
Homestake Mining Company		Dave Wykoff	112d-3 - Designated Mining Operation		
REASON FOR INSPECTION:		BOND CALCULATION TYPE:	BOND AMOUNT:		
Normal I&E Program		Complete Bond	\$24,451,940.00		
DATE OF COMPLAINT:		POST INSP. CONTACTS:	JOINT INSP. AGENCY:		
NA		None	None		
WEATHER:	INSPECTOR'S SIGNATURE:		SIGNATURE DATE:		
Clear	06		September 16, 2022

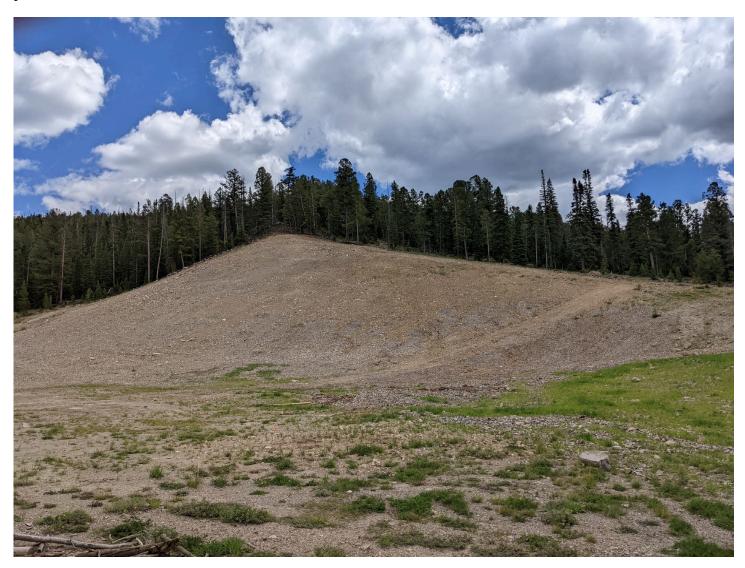
<u>Limestone Quarry</u>: Reclamation grading at the quarry area is complete. The area has been seeded and vegetation is becoming established. The work observed appears to be in accordance with the approved reclamation plan. No problems were noted.

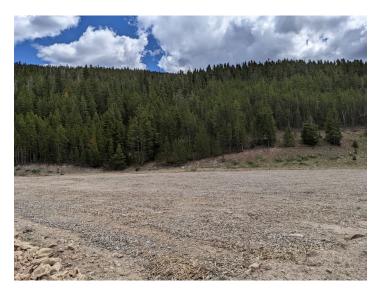
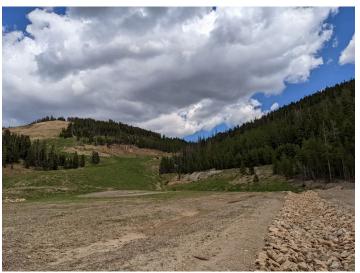
<u>Tie Camp area</u>: The laydown area in the Tie Camp area has been regraded and seeded. Vegetation is becoming established. Drainage structures have been constructed. No problems were noted in this area.

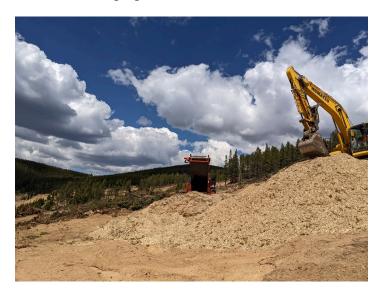
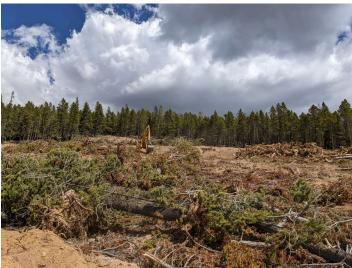
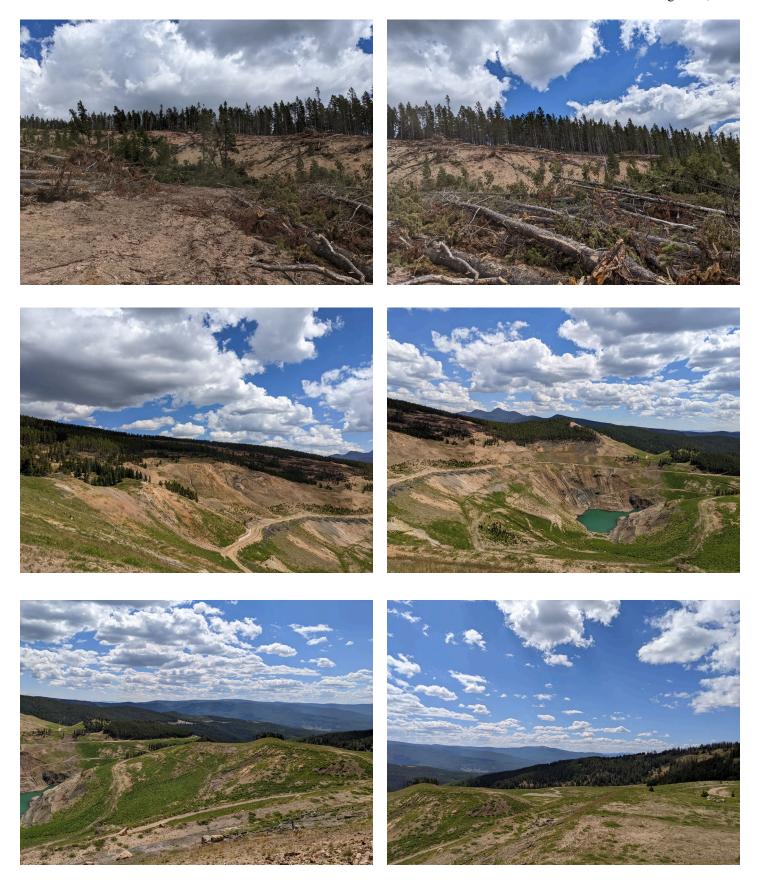
North Pit: Logging is underway to clear-cut the landslide crest area above the North Pit. Trees are to be removed so tension cracks can be filled in to prevent infiltration.

The channel at the 10,500-foot level has been reconstructed to reduce infiltration into the slope and to divert water from the upper Indian drainage around the North Pit Lake. The channel is lined with a geosynthetic clay liner and armored with riprap.

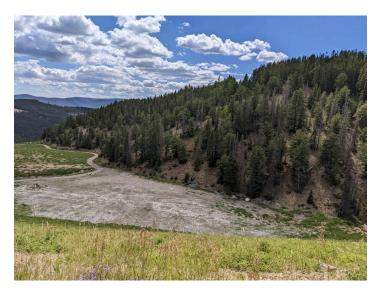
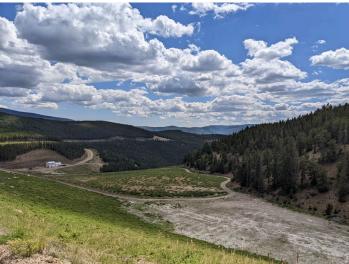
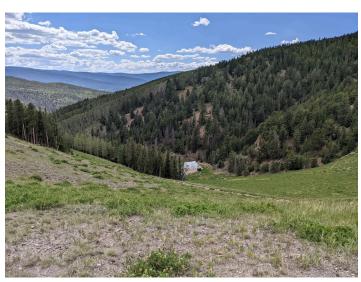
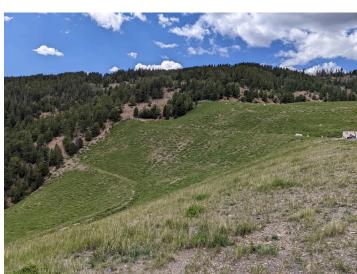
<u>Indian Rock Dump</u>: No problems were noted in the Indian Rock Dump area. Maintenance/improvements have been ongoing to improve drainage of the area. Slopes appeared stable. No erosional issues were noted.

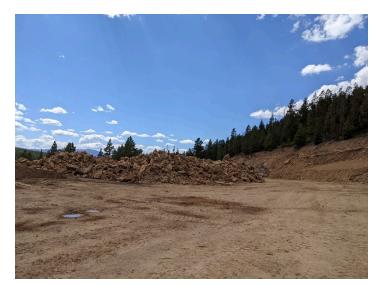
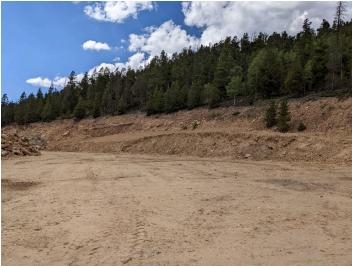
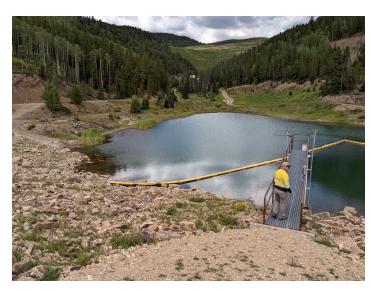
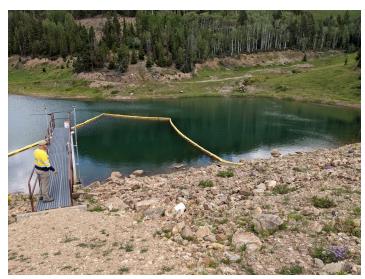
The sandstone quarry is still in use. No problems were noted around the sediment pond area.
