**MINERALS PROGRAM INSPECTION REPORT**  
**PHONE: (303) 866-3567**

<b>MINE NAME:</b> Ignacio Pit	<b>MINE/PROSPECTING ID#:</b> M-1977-446	<b>MINERAL:</b> Sand and gravel	<b>COUNTY:</b> La Plata
<b>INSPECTION TYPE:</b> Monitoring	<b>INSPECTOR(S):</b> Dustin Czapl	<b>INSP. DATE:</b> August 17, 2022	<b>INSP. TIME:</b> 10:00
<b>OPERATOR:</b> Hocker Construction, LLP	<b>OPERATOR REPRESENTATIVE:</b> None	<b>TYPE OF OPERATION:</b> 112c - Construction Regular Operation	
<b>REASON FOR INSPECTION:</b> Normal I&E Program	<b>BOND CALCULATION TYPE:</b> Complete Bond	<b>BOND AMOUNT:</b> \$115,646.00	
<b>DATE OF COMPLAINT:</b> NA	<b>POST INSP. CONTACTS:</b> None	<b>JOINT INSP. AGENCY:</b> None	
<b>WEATHER:</b> Clear	<b>INSPECTOR'S SIGNATURE:</b>

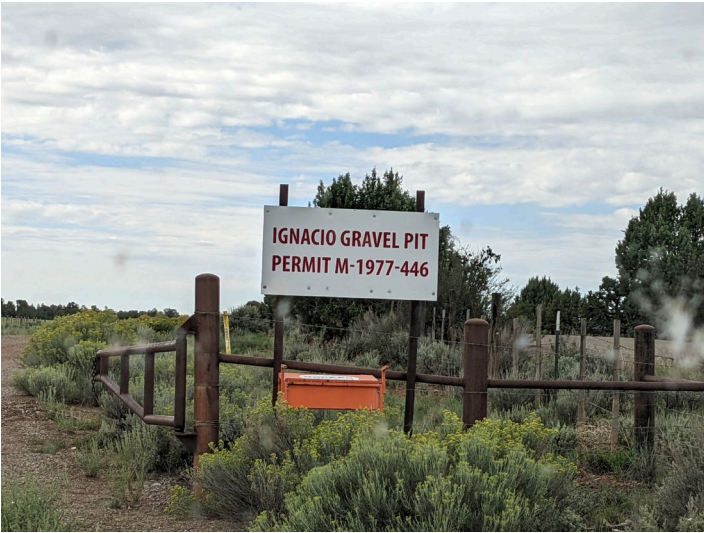
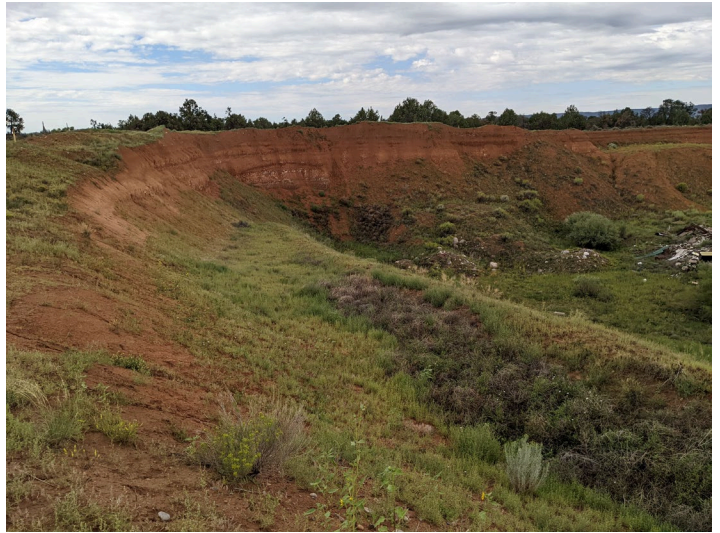
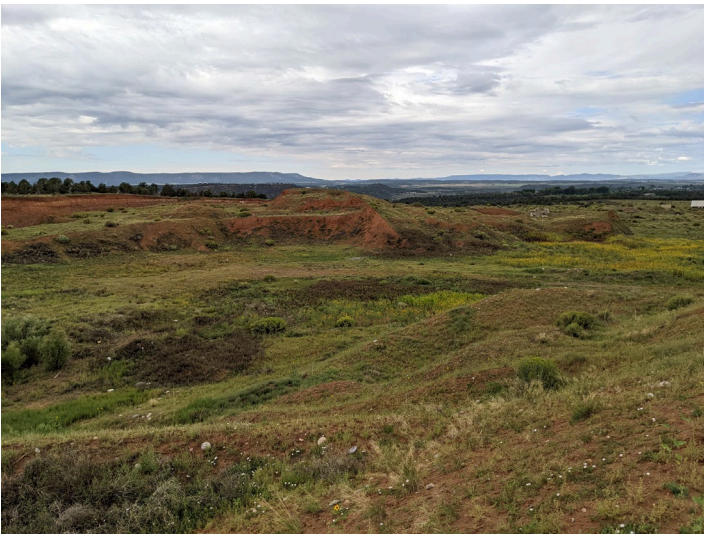
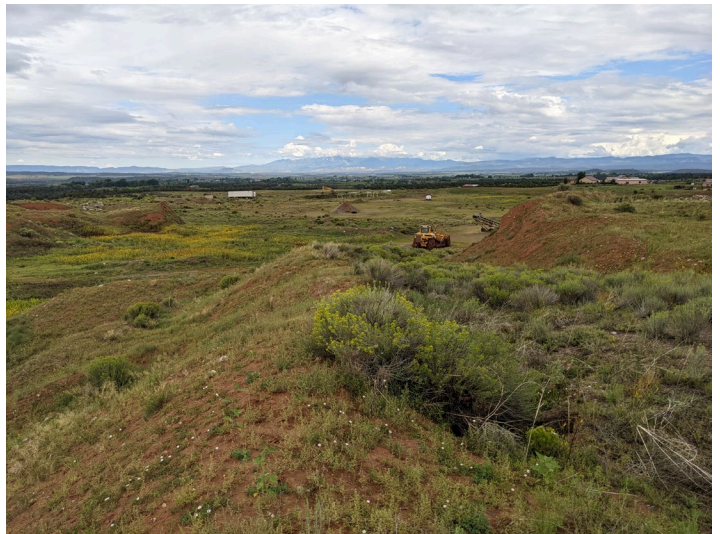
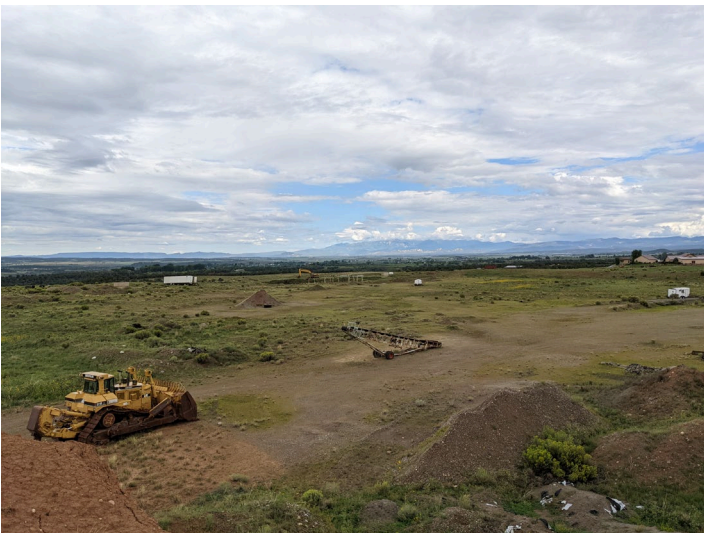
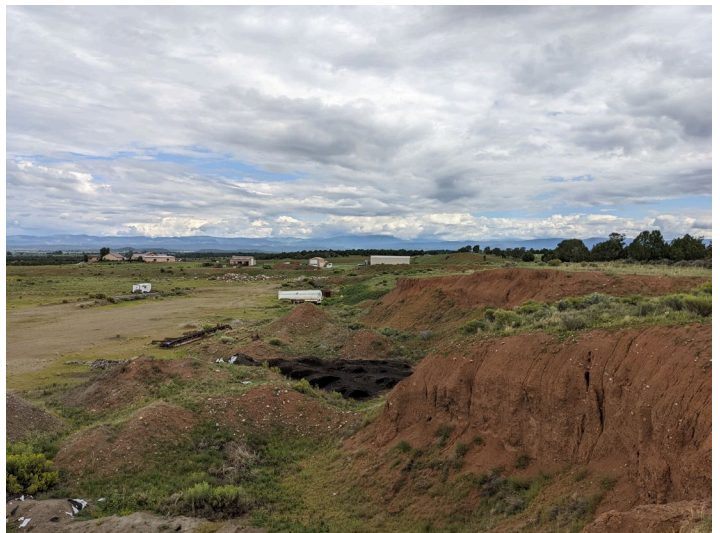
Adequate mine identification signage was noted at the entrance to the site.

The affected area was marked by fencing, posts and berms that were clearly visible and adequate to delineate the affected area boundary.

Little has changed at the site since the Division's last inspection. Materials stockpiles are still located within the pit for intermittent removal. The active mining areas consist of a large highwall, which averages approximately 50 feet high and is approximately 1,200 linear feet in length. Overburden is stockpiled at the base of the highwall for reclamation backfill.

Approximately ten acres on the west side of the permit area have undergone reclamation work. Grading of the area appears stable and no erosional features were noted. The area has also been revegetated and appears adequate in vegetative cover.
