MINERALS PROGRAM INSPECTION REPORT
PHONE: (303) 866-3567

MINE NAME: Texas Creek Grav Pit	MINE/PROSPECTING ID#: M-1980-143	MINERAL: Sand and gravel	COUNTY: La Plata
INSPECTION TYPE: Monitoring	INSPECTOR(S): Dustin Czapla	INSP. DATE: August 17, 2022	INSP. TIME: 08:45
OPERATOR: McCarty Excavation and Construction, Inc.	OPERATOR REPRESENTATIVE:	TYPE OF OPERATION: 110c - Construction Limited Impact	
REASON FOR INSPECTION: Normal I&E Program	BOND CALCULATION TYPE: Complete Bond	BOND AMOUNT: \$7,770.00	
DATE OF COMPLAINT: NA	POST INSP. CONTACTS: None	JOINT INSP. AGENCY: None	
WEATHER: Clear	INSPECTOR'S SIGNATURE:

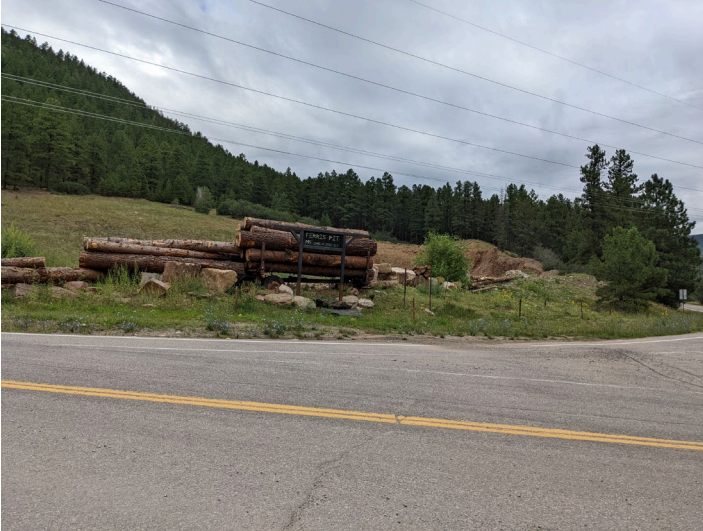
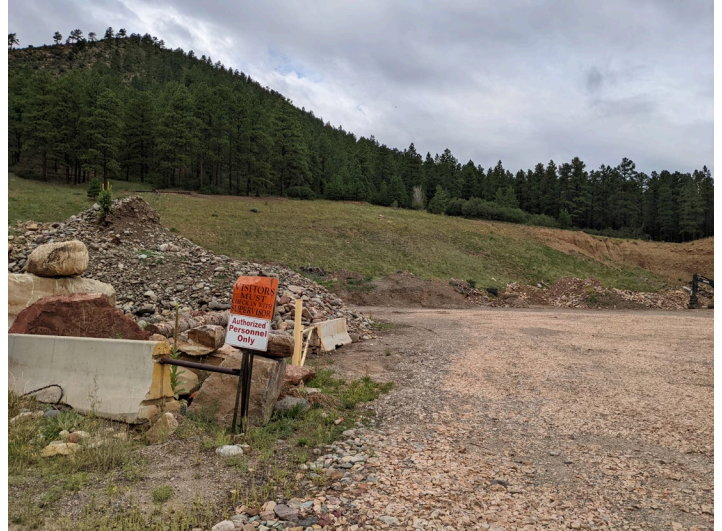
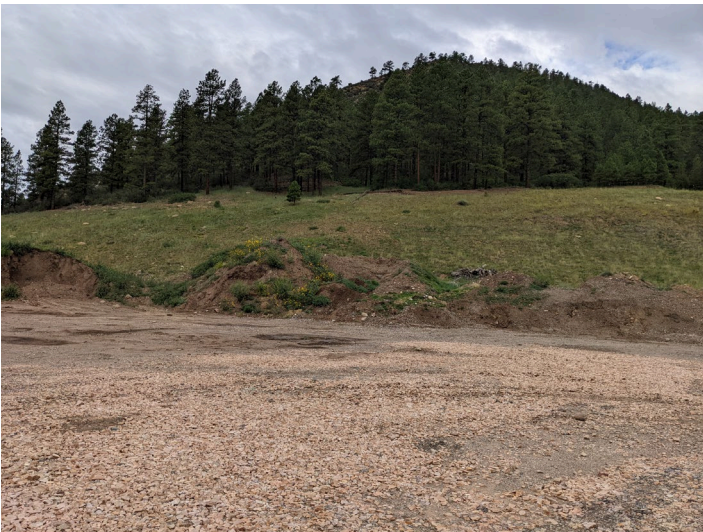
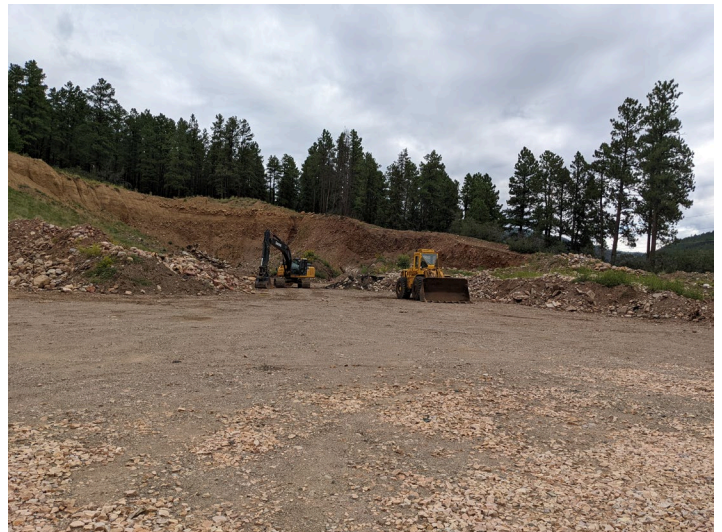
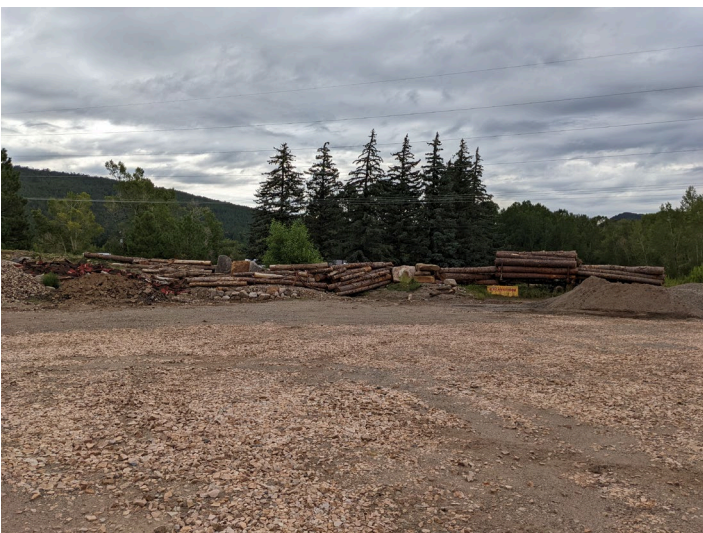
Adequate mine identification signage was noted at the entrance to the site.

The affected area was marked by fencing that was clearly visible and adequate to delineate the affected area boundary.

The pit daylights on the south and east sides. Most of the highwall on the west side of the pit has been regraded to 3H:1V and vegetative cover is becoming well established. A section of near-vertical highwall exists on the north end of the pit, approximately 100 linear feet at approximately 50 feet in height. Topsoil is in place above the highwall and in several piles within the pit.
