MINERALS PROGRAM INSPECTION REPORT
PHONE: (303) 866-3567

MINE NAME: AGRI-DLD Gravel Pit	MINE/PROSPECTING ID#: M-2000-030	MINERAL: Sand and gravel	COUNTY: La Plata
INSPECTION TYPE: Monitoring	INSPECTOR(S): Dustin Czapl	INSP. DATE: August 17, 2022	INSP. TIME: 13:45
OPERATOR: Elam Construction, Inc.	OPERATOR REPRESENTATIVE:	TYPE OF OPERATION: 112c - Construction Regular Operation	
REASON FOR INSPECTION: Normal I&E Program	BOND CALCULATION TYPE: Complete Bond	BOND AMOUNT: \$142,062.19	
DATE OF COMPLAINT: NA	POST INSP. CONTACTS: None	JOINT INSP. AGENCY: None	
WEATHER: Clear	INSPECTOR'S SIGNATURE:

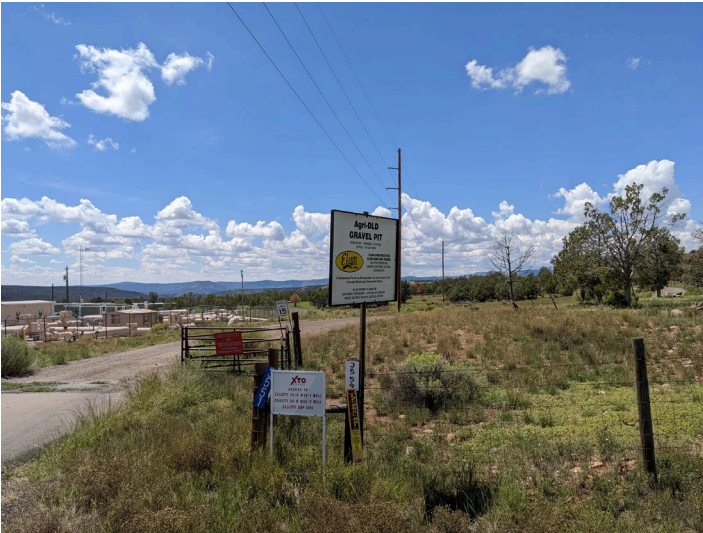
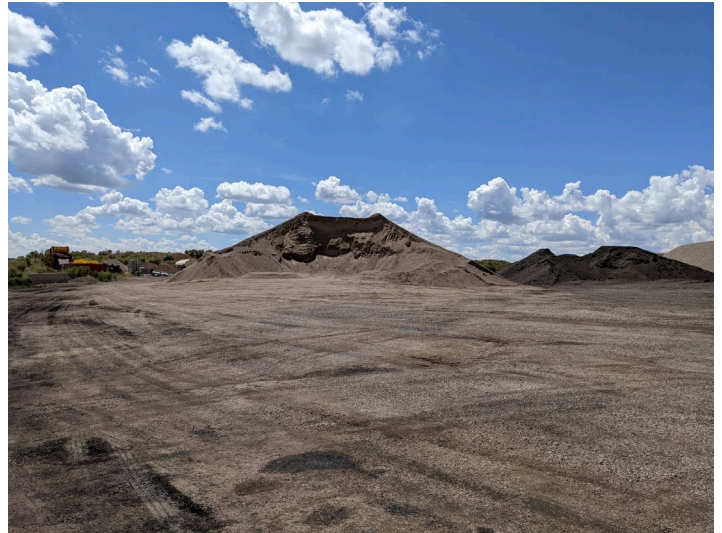
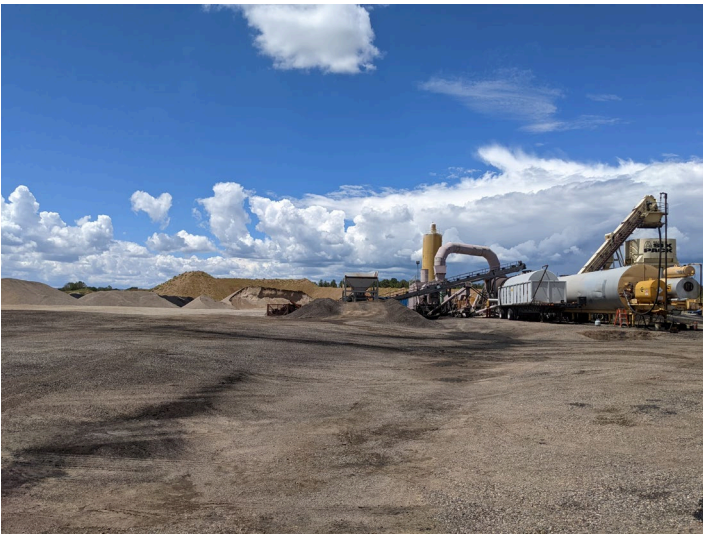
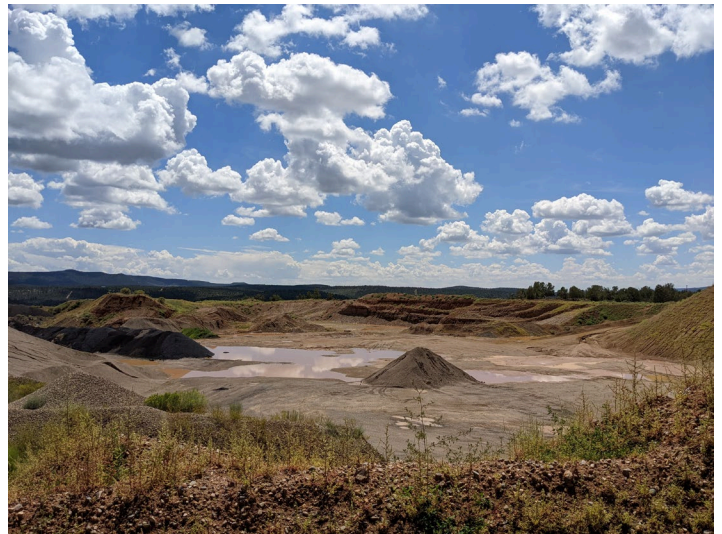
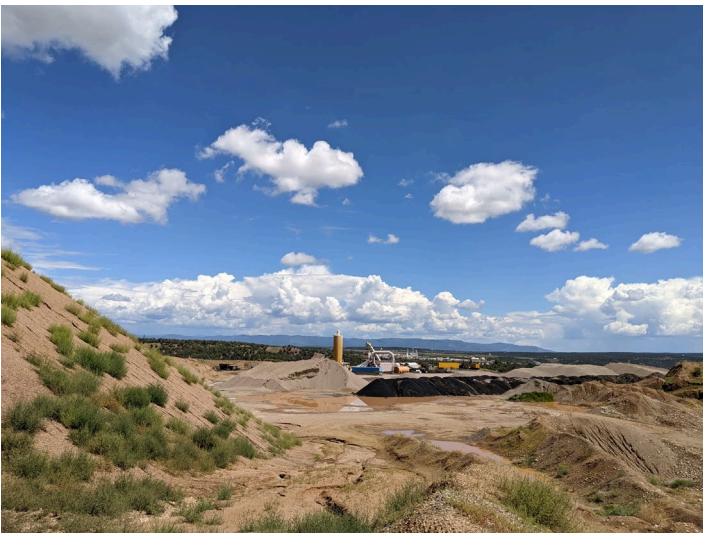
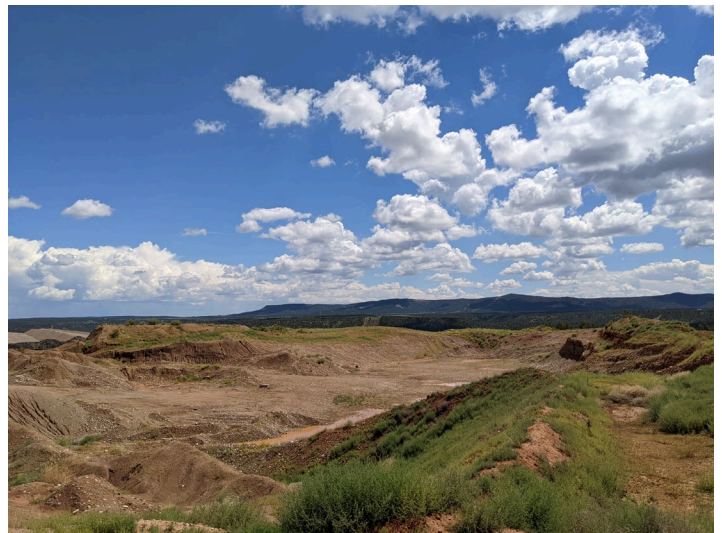
Roughly 20 acres are currently disturbed at the site. The disturbance area is currently within the Phase 1-3 areas. A batch plant is located in the Phase 1 "Staging Area". Mining was not occurring during this inspection. Gravel stockpiles are located throughout the pit area. Topsoil and overburden stockpiles were observed within the pit. Mining appears to be progressing to the south from the Phase 2 area into the Phase 3 area. The various sections of highwall observed appeared stable. No erosional concerns were noted.
