MINERALS PROGRAM INSPECTION REPORT
PHONE: (303) 866-3567

MINE NAME: A.P.S. Trucking and Excavating, Inc.	MINE/PROSPECTING ID#: M-2000-103	MINERAL: Borrow material for	COUNTY: La Plata
INSPECTION TYPE: Monitoring	INSPECTOR(S): Dustin Czapla	INSP. DATE: August 17, 2022	INSP. TIME: 16:30
OPERATOR: Allen P Small Trucking & Excavation, Inc.	OPERATOR REPRESENTATIVE:	TYPE OF OPERATION: 110c - Construction Limited Impact	
REASON FOR INSPECTION: Normal I&E Program	BOND CALCULATION TYPE: Complete Bond	BOND AMOUNT: \$7,500.00	
DATE OF COMPLAINT: NA	POST INSP. CONTACTS: None	JOINT INSP. AGENCY: None	
WEATHER: Clear	INSPECTOR'S SIGNATURE:

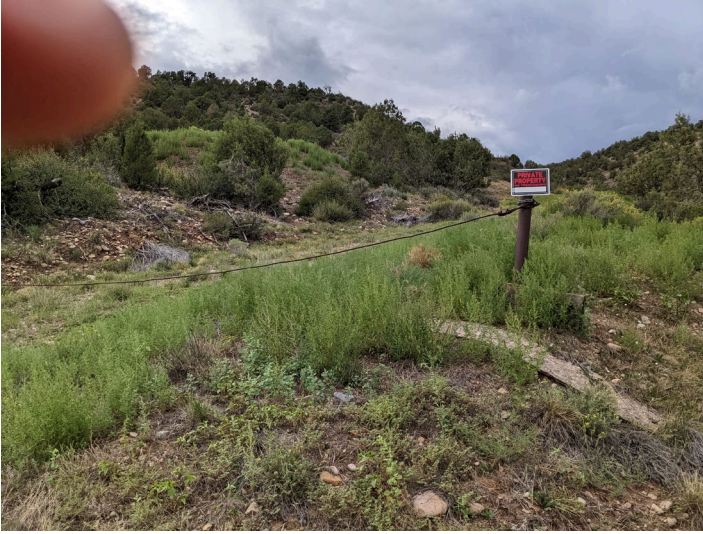
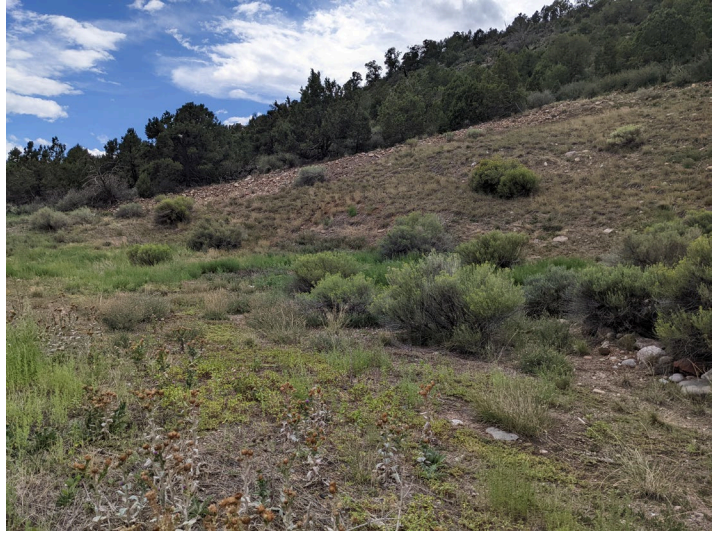
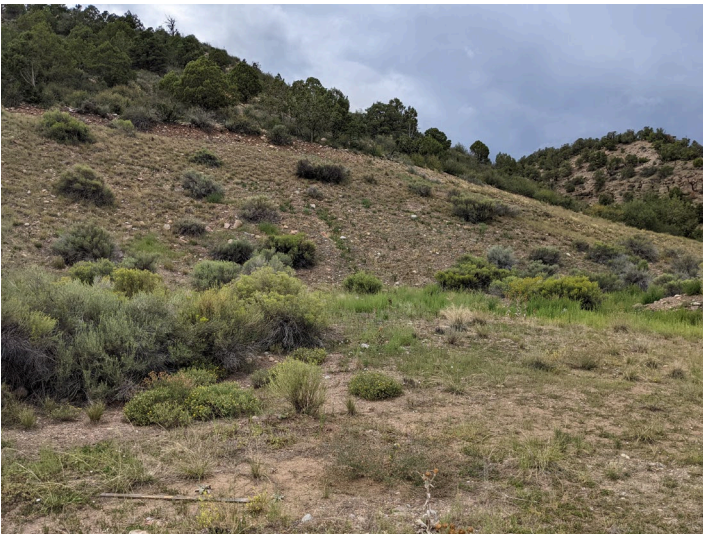
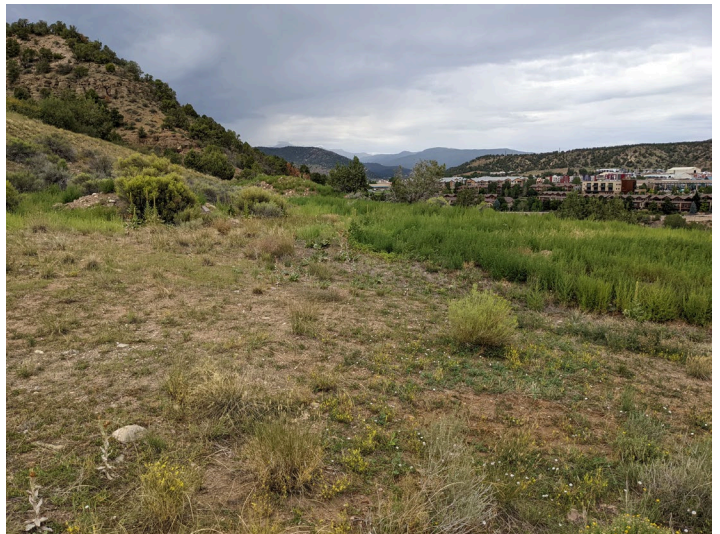
Adequate mine identification signage was not noted at the entrance to the site. The affected area was not clearly marked. The site has undergone reclamation. No mining equipment was located on site. The mined slopes have been graded to blend with the surrounding topography, appear stable, and are becoming well vegetated. The operator has stated in annual reports that weed control efforts are ongoing, however patches of thistle and kochia were observed in the affected area.
