MINERALS PROGRAM INSPECTION REPORT
PHONE: (303) 866-3567

MINE NAME: Hocker Gravel Pit	MINE/PROSPECTING ID#: M-2004-063	MINERAL: Sand and gravel	COUNTY: La Plata
INSPECTION TYPE: Monitoring	INSPECTOR(S): Dustin Czaplá	INSP. DATE: August 17, 2022	INSP. TIME: 10:30
OPERATOR: Hocker Construction, LLP	OPERATOR REPRESENTATIVE: None	TYPE OF OPERATION: 112c - Construction Regular Operation	
REASON FOR INSPECTION: Normal I&E Program	BOND CALCULATION TYPE: None	BOND AMOUNT: \$26,676.00	
DATE OF COMPLAINT: NA	POST INSP. CONTACTS: None	JOINT INSP. AGENCY: None	
WEATHER: Clear	INSPECTOR'S SIGNATURE:

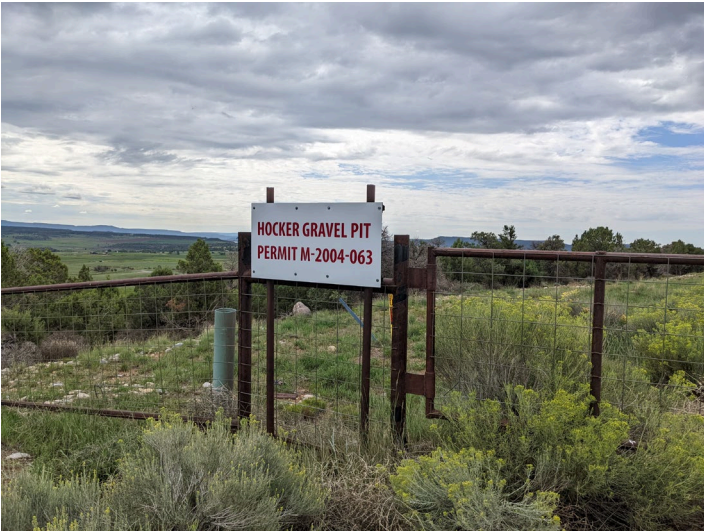
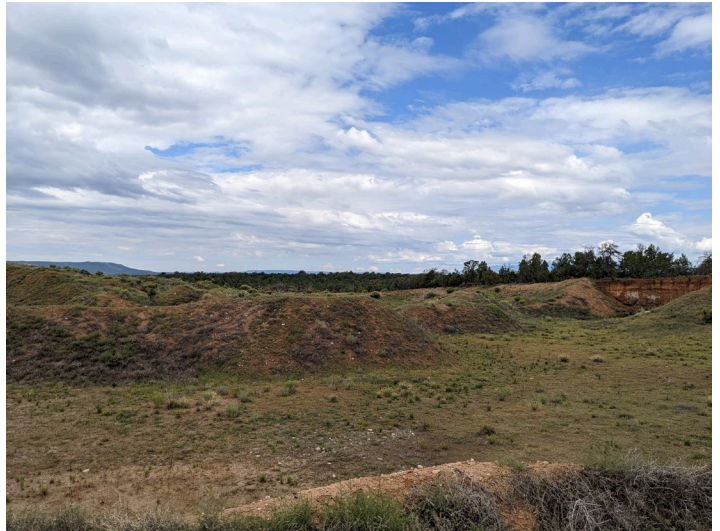
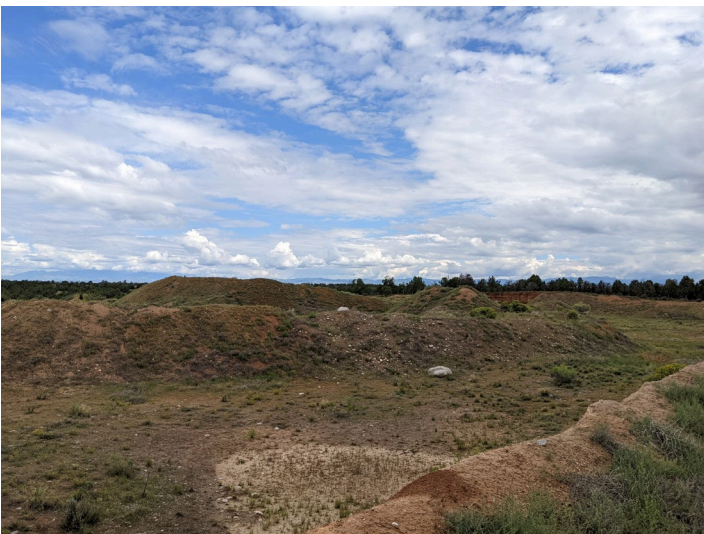
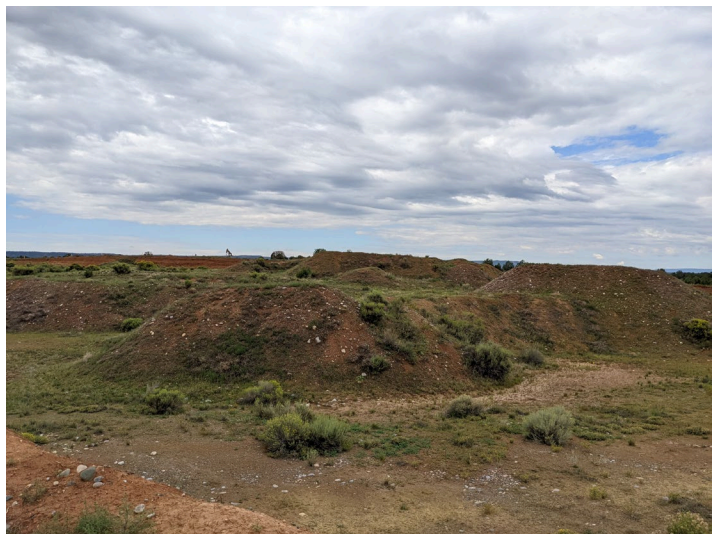
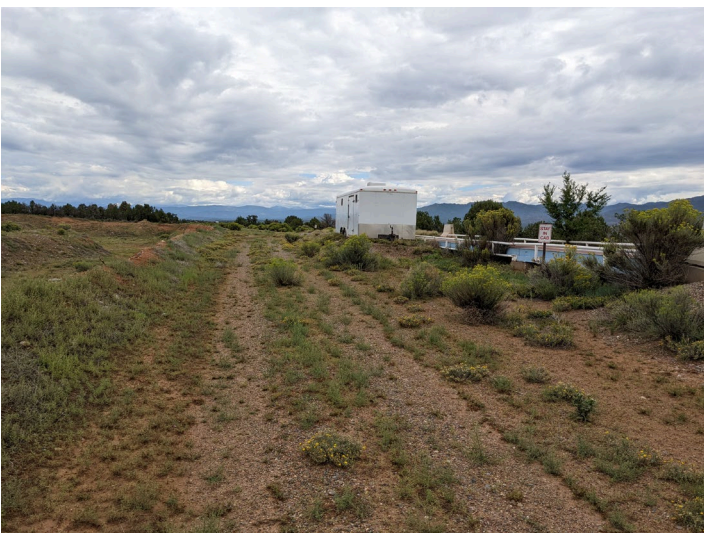
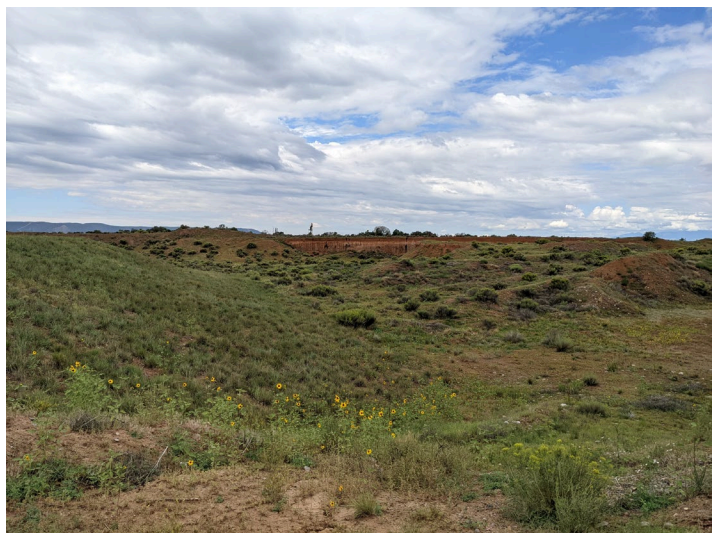
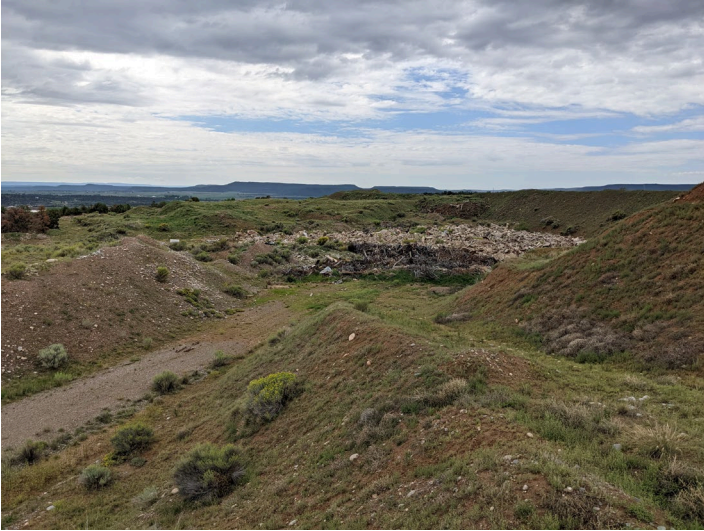
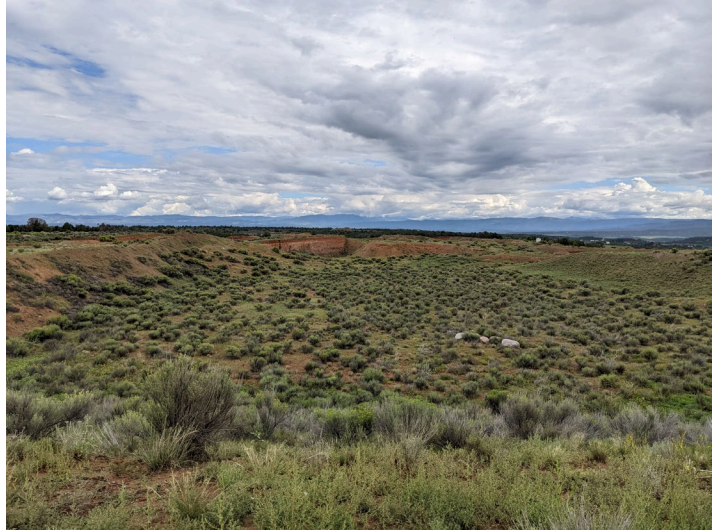
Adequate mine identification signage was noted at the east entrance to the site.

The affected area was marked by fencing that was clearly visible and adequate to delineate the affected area boundary.

Mining was not occurring during this inspection. Conditions at the site are similar to the Division's last inspection. There is a vertical highwall on the east side of the Phase 1 / Phase 2 area, approximately 400 lineal feet and 25 feet high. Backfill material is stockpiled near the highwall for reclamation. Slopes in the Phase 3 area have been reduced and additional overburden material is available in this area for reclamation. Construction debris has been placed in the pit area for burial as approved by TR-01 in 2011. Overburden and topsoil stockpiles were located throughout the site. Several small piles of crushed gravel remain on site.
