MINERALS PROGRAM INSPECTION REPORT
PHONE: (303) 866-3567

MINE NAME: Crossfire Bonds Gravel Pit	MINE/PROSPECTING ID#: M-2015-001	MINERAL: Gravel and sand	COUNTY: La Plata
INSPECTION TYPE: Monitoring	INSPECTOR(S): Dustin Czapla	INSP. DATE: August 17, 2022	INSP. TIME: 12:00
OPERATOR: Crossfire Aggregate Services LLC	OPERATOR REPRESENTATIVE: None	TYPE OF OPERATION: 112c - Construction Regular Operation	
REASON FOR INSPECTION: Normal I&E Program	BOND CALCULATION TYPE: Complete Bond	BOND AMOUNT: \$225,851.57	
DATE OF COMPLAINT: NA	POST INSP. CONTACTS: None	JOINT INSP. AGENCY: None	
WEATHER: Clear	INSPECTOR'S SIGNATURE:

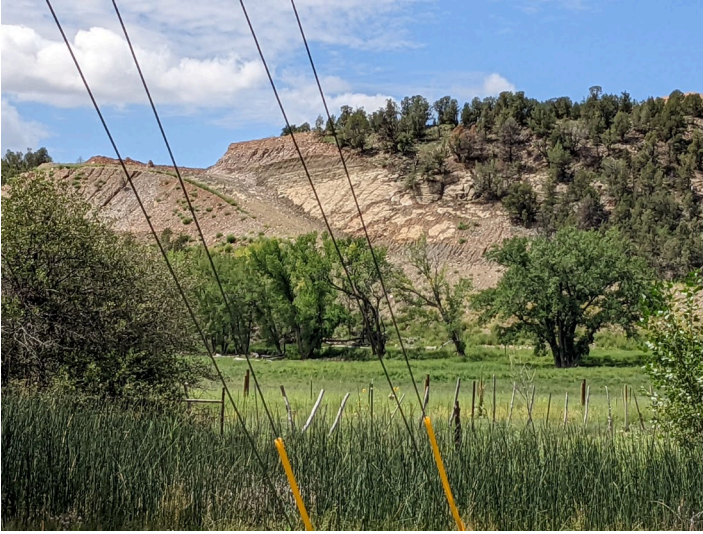
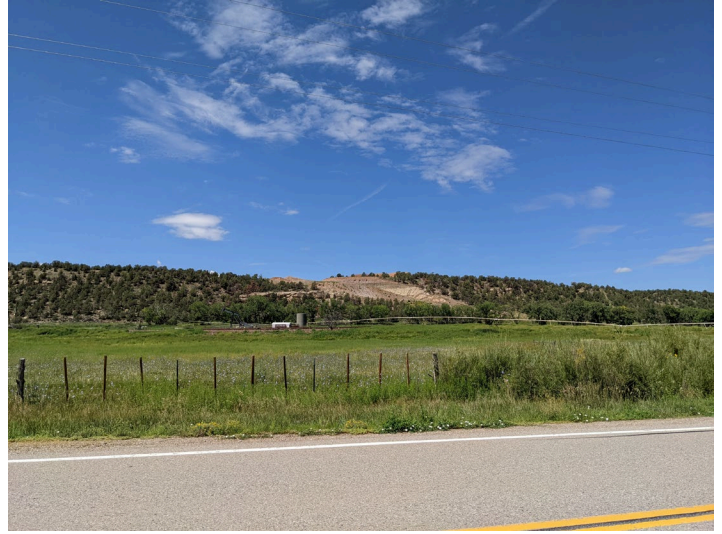
The operation has not yet commenced. Construction of the access road, which is outside the permit area, has begun, but is not yet tied into CR 213. The access road will tie into the permit area through the Phase 9 and Phase 7 areas.

Construction of access road underway, as viewed from CR 213
