MINERALS PROGRAM INSPECTION REPORT
PHONE: (303) 866-3567

MINE NAME: Boullion King Mine Reclamation Project	MINE/PROSPECTING ID#: M-2019-011	MINERAL: Unknown commodity	COUNTY: Gunnison
INSPECTION TYPE: Monitoring	INSPECTOR(S): Dustin Czapla	INSP. DATE: August 25, 2022	INSP. TIME: 11:45
OPERATOR: Arthur Corona	OPERATOR REPRESENTATIVE: None	TYPE OF OPERATION: 110(2) - Hard Rock Limited Impact	
REASON FOR INSPECTION: Normal I&E Program	BOND CALCULATION TYPE: Complete Bond	BOND AMOUNT: \$10,000.00	
DATE OF COMPLAINT: NA	POST INSP. CONTACTS: None	JOINT INSP. AGENCY: None	
WEATHER: Clear	INSPECTOR'S SIGNATURE:

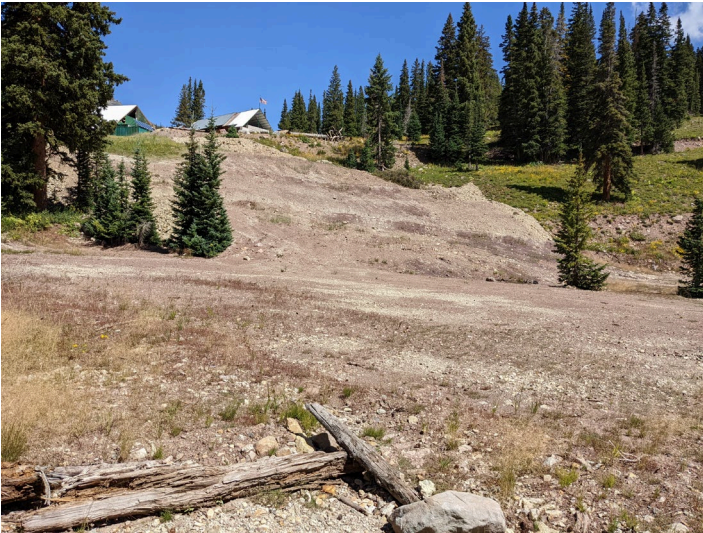
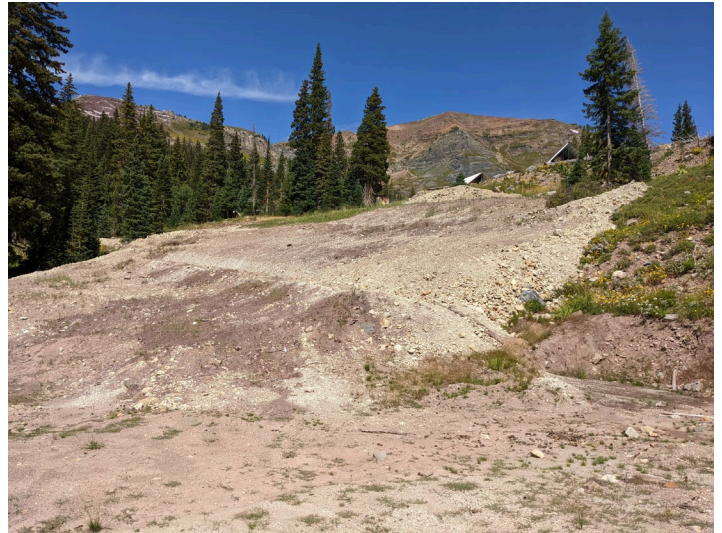
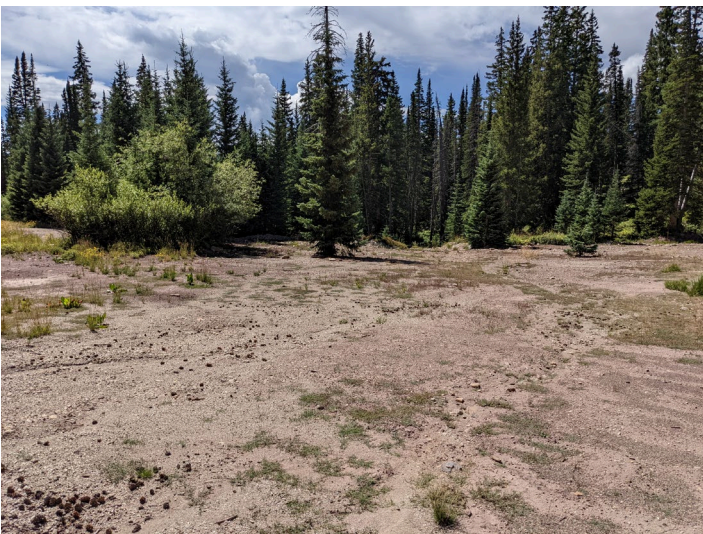
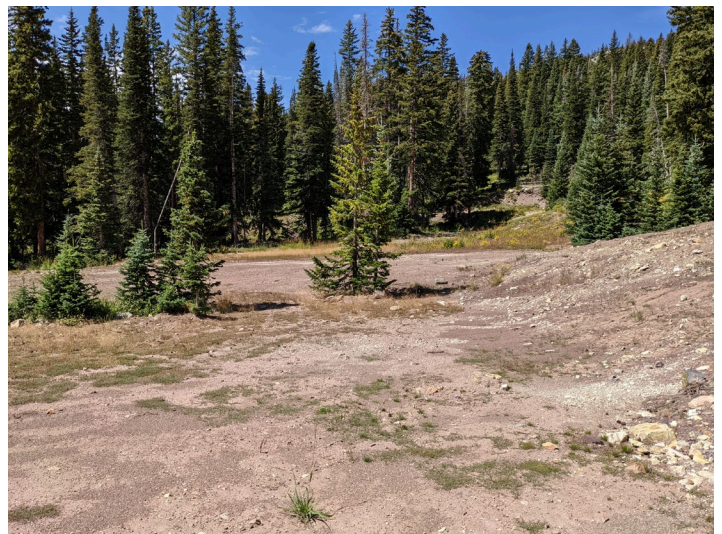
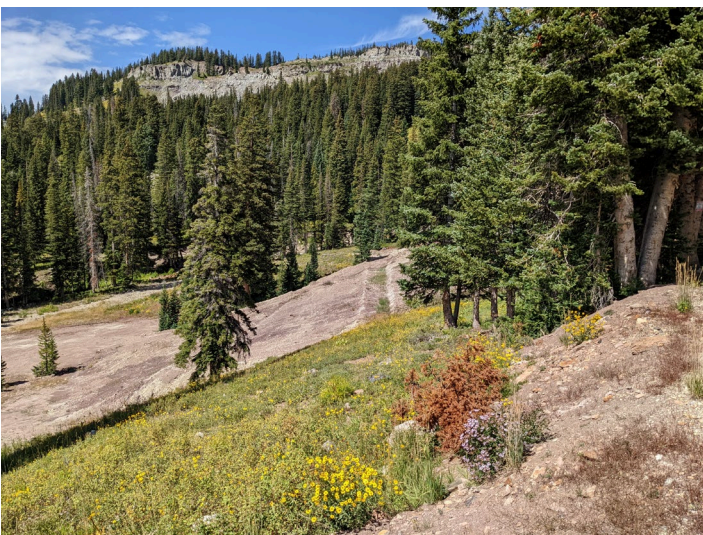
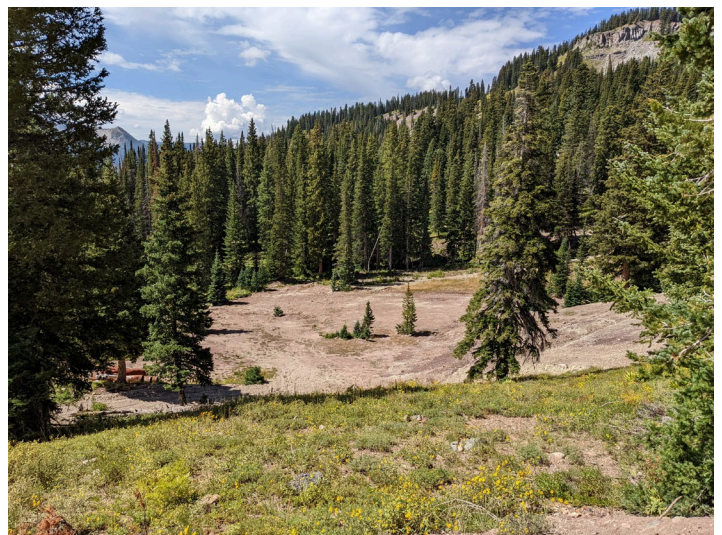
Reclamation work has commenced at the site. The waste rock piles have been shaped to final grade. The discharge pipe has been sealed and the ponds have been filled in and shaped to final grade. All grading appears adequate and in compliance with the approved Reclamation Plan. It did not appear that seeding had taken place yet. Vegetation is not yet established in the reclamation area. Noxious weed infestations were not noted.
