MINERALS PROGRAM INSPECTION REPORT
PHONE: (303) 866-3567

MINE NAME: Two Sheep for One Brick Mine	MINE/PROSPECTING ID#: M-2020-047	MINERAL: Clay (general), gravel	COUNTY: Gunnison
INSPECTION TYPE: Monitoring	INSPECTOR(S): Dustin Czaplá	INSP. DATE: August 25, 2022	INSP. TIME: 13:30
OPERATOR: Delta Brick & Climate Company Ltd	OPERATOR REPRESENTATIVE:	TYPE OF OPERATION: 110c - Construction Limited Impact	
REASON FOR INSPECTION: Normal I&E Program	BOND CALCULATION TYPE: Complete Bond	BOND AMOUNT: \$2,500.00	
DATE OF COMPLAINT: NA	POST INSP. CONTACTS: None	JOINT INSP. AGENCY: None	
WEATHER: Clear	INSPECTOR'S SIGNATURE:

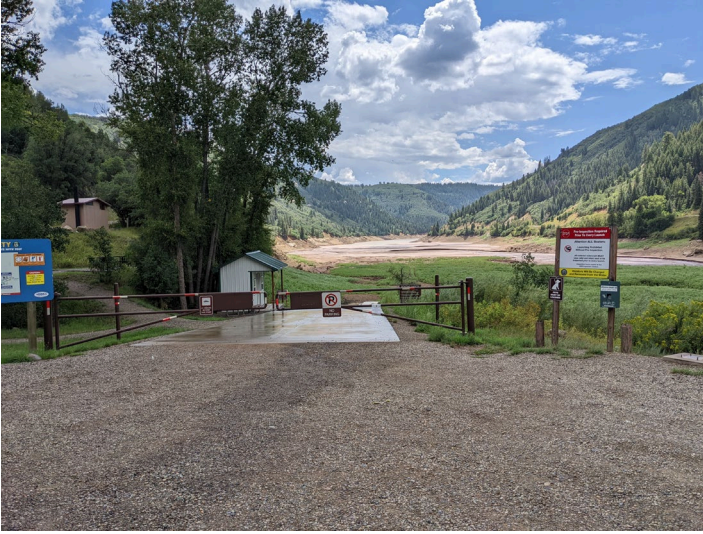
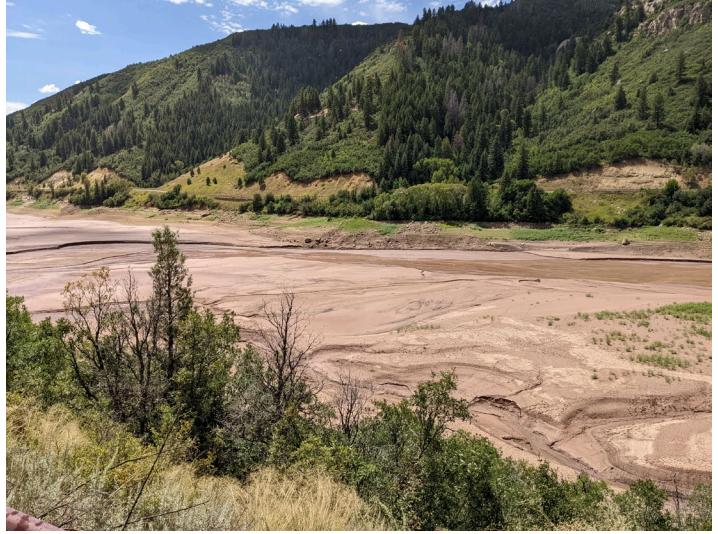
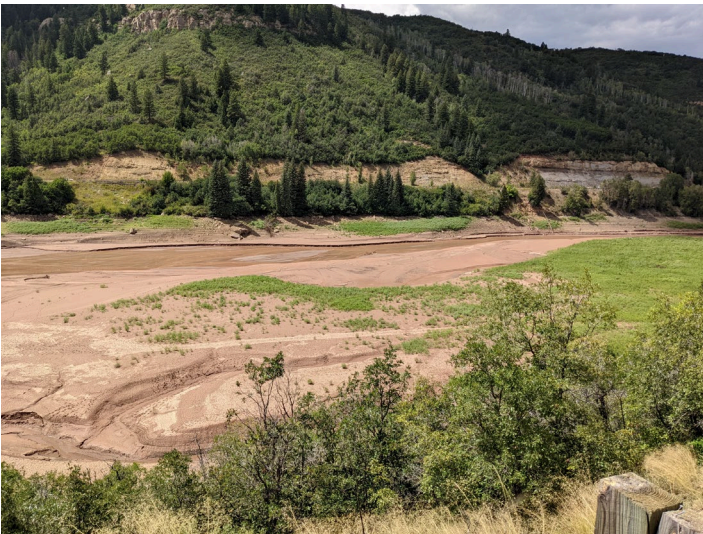
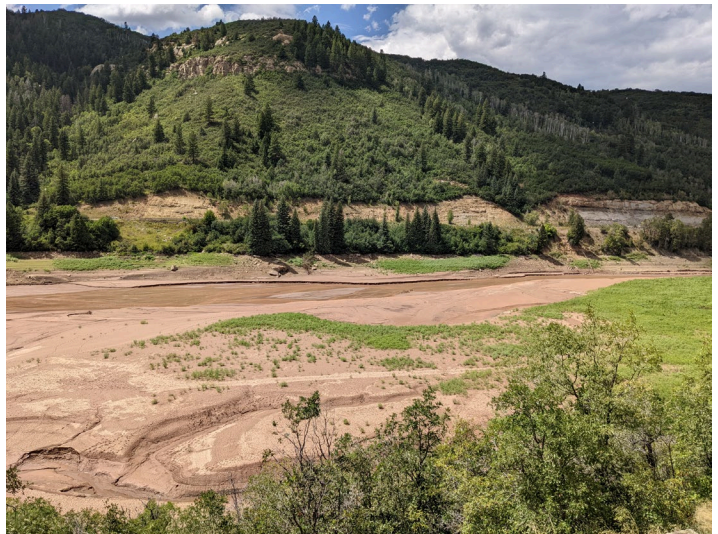
The operation removes sediment that accumulates in the reservoir for use in ceramics manufacturing. Excavation was not occurring during this inspection. Mining equipment is not stored on site. The excavation area is inundated seasonally and refills with sediment. The excavation area is indiscernible from the surrounding area.

No problems or violations were noted during this inspection.
