MINERALS PROGRAM INSPECTION REPORT
PHONE: (303) 866-3567

MINE NAME: J & J Pit	MINE/PROSPECTING ID#: M-1985-001	MINERAL: Sand and gravel	COUNTY: La Plata
INSPECTION TYPE: Monitoring	INSPECTOR(S): Dustin Czapla	INSP. DATE: August 17, 2022	INSP. TIME: 16:40
OPERATOR: Glacier Gravel Products	OPERATOR REPRESENTATIVE: None	TYPE OF OPERATION: 110c - Construction Limited Impact

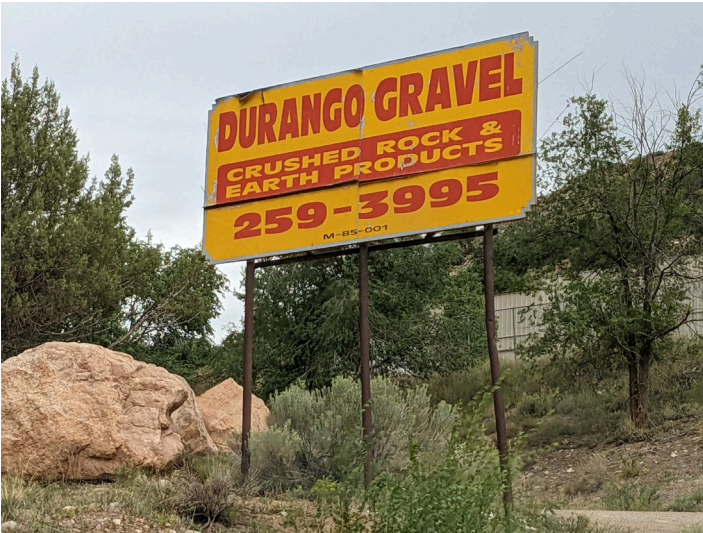
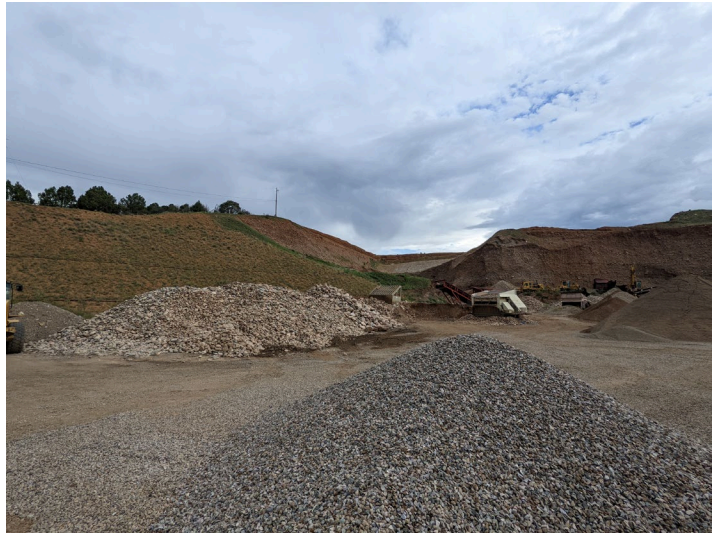
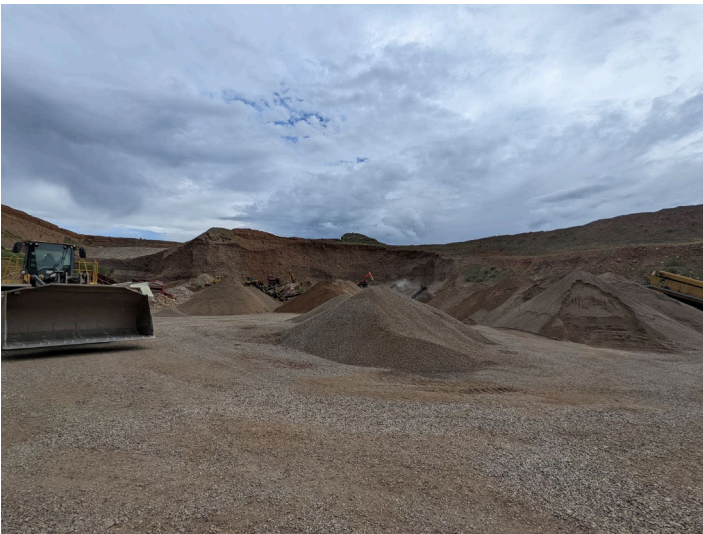
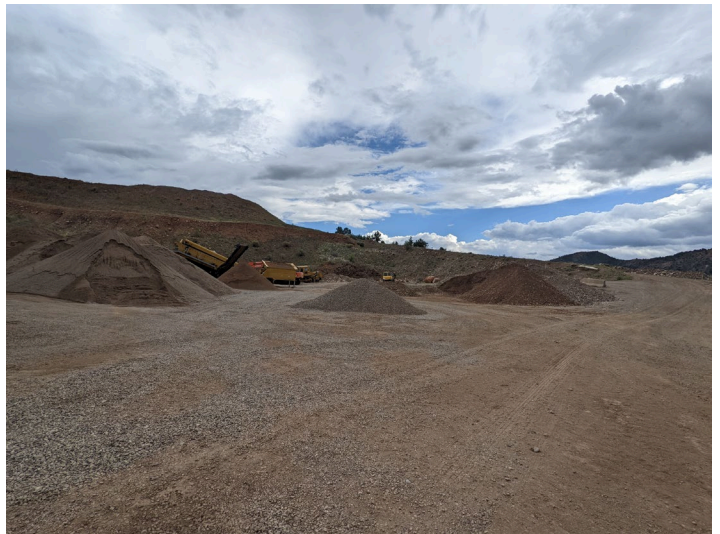
Mining was active during this inspection. The highwall on the north end of the pit has been regraded to 2H:1V and vegetation is becoming well established. In the northeast corner of the pit (Lot B area), mining is progressing to the east. The mined slope is approximately 1H:1V. South of that (Lot C area) mining is progressing south and east. The highwall in this area is near vertical.

Various stockpiles, mining and processing equipment are located within the pit area. Overall, the pit appears to be well maintained and orderly.
