MINERALS PROGRAM INSPECTION REPORT
PHONE: (303) 866-3567

| MINE NAME: High Flume Gravel Pit | MINE/PROSPECTING ID#: M-1990-093 | MINERAL: Gravel | COUNTY: La Plata |
| INSPECTION TYPE: Monitoring | INSPECTOR(S): Dustin Czapla | INSP. DATE: August 17, 2022 | INSP. TIME: 12:20 |

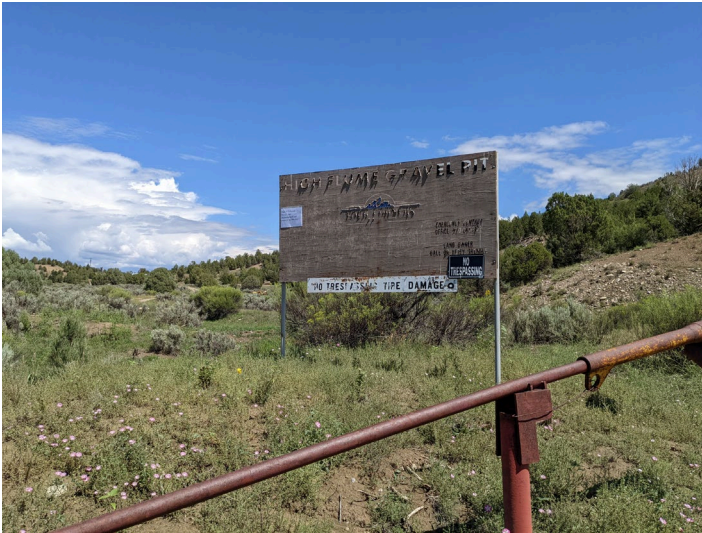
Adequate mine identification signage was noted at the entrance to the site.

Mine identification sign at entrance

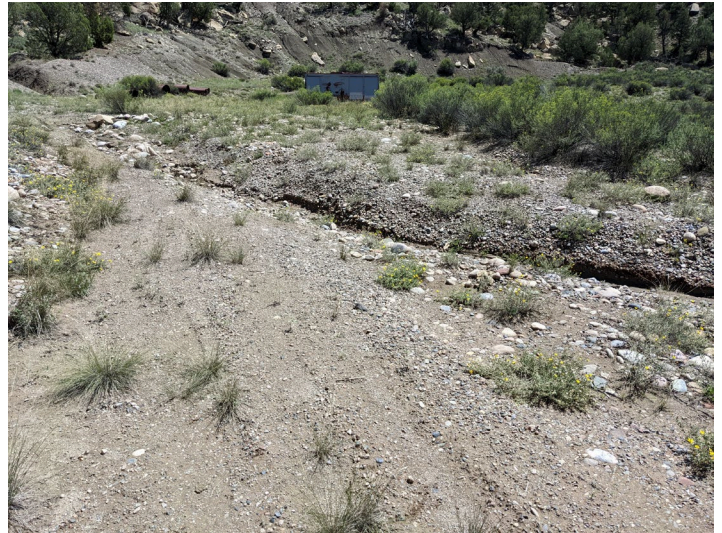
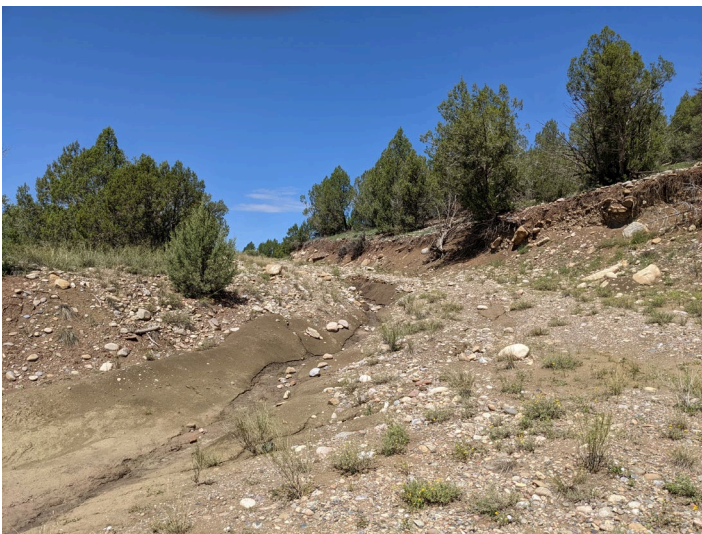
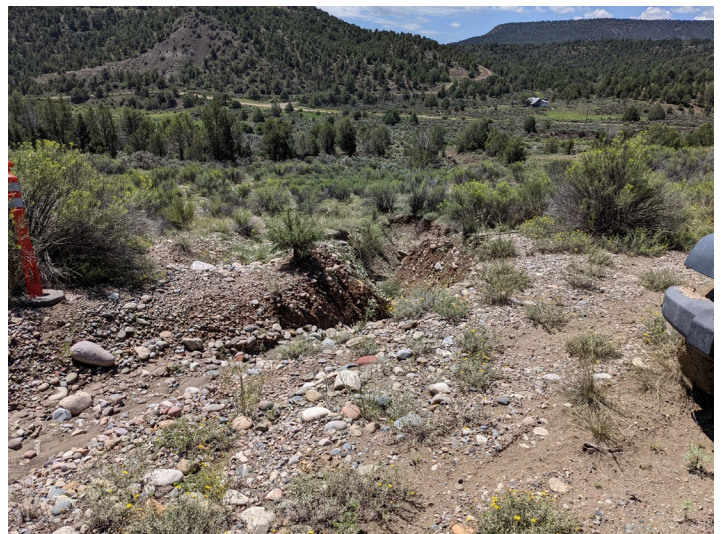
Mining has not occurred at this site since 2007. Consequently, the access road is extremely eroded. The inspector was unable to access the pit area due to the unpassable condition of the access road. Pursuant to Rule 1.13.5, an Operator must file a Notice of Temporary Cessation (TC) if the mining operation temporarily ceases production for 180 days or more. The Operator did not file a Notice of Temporary Cessation at the time production ceased. Pursuant to Rule 1.13.9, in no case can TC be continued for more than 10 years. Therefore, the Operator must commence final reclamation. Pursuant to Rule 3.1.3, all reclamation must be completed within 5 years. This has been noted as a problem on page one of this report.

Access road erosion near scalehouse

CORRECTIVE ACTIONS: Notify the Division, in writing, of the Operators proposed schedule for completing reclamation at the site. The schedule must comply with 5 year time limit pursuant to Rule 3.1.3.

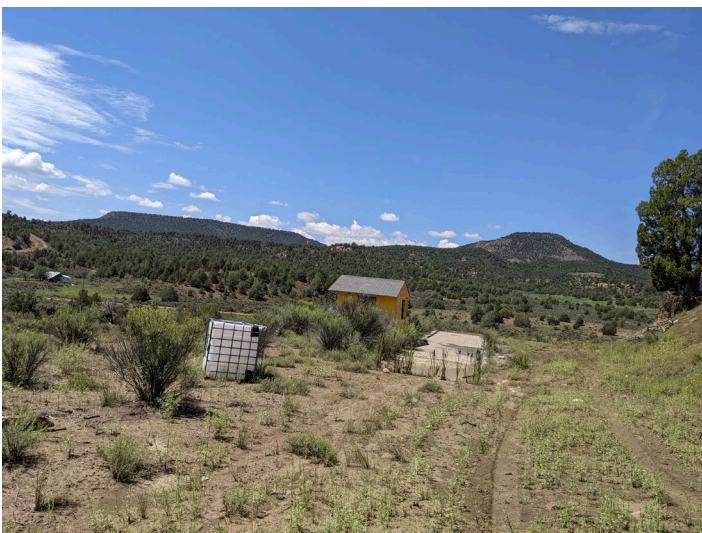
Most of the dilapidated equipment has been removed from the scalehouse area. The scale and scalehouse remain on site.

Scale and scalehouse
