**MINERALS PROGRAM INSPECTION REPORT**  
**PHONE: (303) 866-3567**

<b>MINE NAME:</b> Colo Alabaster	<b>MINE/PROSPECTING ID#:</b> M-1989-077	<b>MINERAL:</b> Alabaster	<b>COUNTY:</b> Larimer
<b>INSPECTION TYPE:</b> Monitoring	<b>INSPECTOR(S):</b> Brock Bowles	<b>INSP. DATE:</b> September 16, 2022	<b>INSP. TIME:</b> 09:00
<b>OPERATOR:</b> Colorado Alabaster Supply	<b>OPERATOR REPRESENTATIVE:</b> Stan Jones	<b>TYPE OF OPERATION:</b> 110(1) - Hard Rock Limited Impact	
<b>REASON FOR INSPECTION:</b> Normal I&E Program	<b>BOND CALCULATION TYPE:</b> None	<b>BOND AMOUNT:</b> \$2,250.00	
<b>DATE OF COMPLAINT:</b> NA	<b>POST INSP. CONTACTS:</b> None	<b>JOINT INSP. AGENCY:</b> None	
<b>WEATHER:</b> Clear	<b>INSPECTOR'S SIGNATURE:</b>

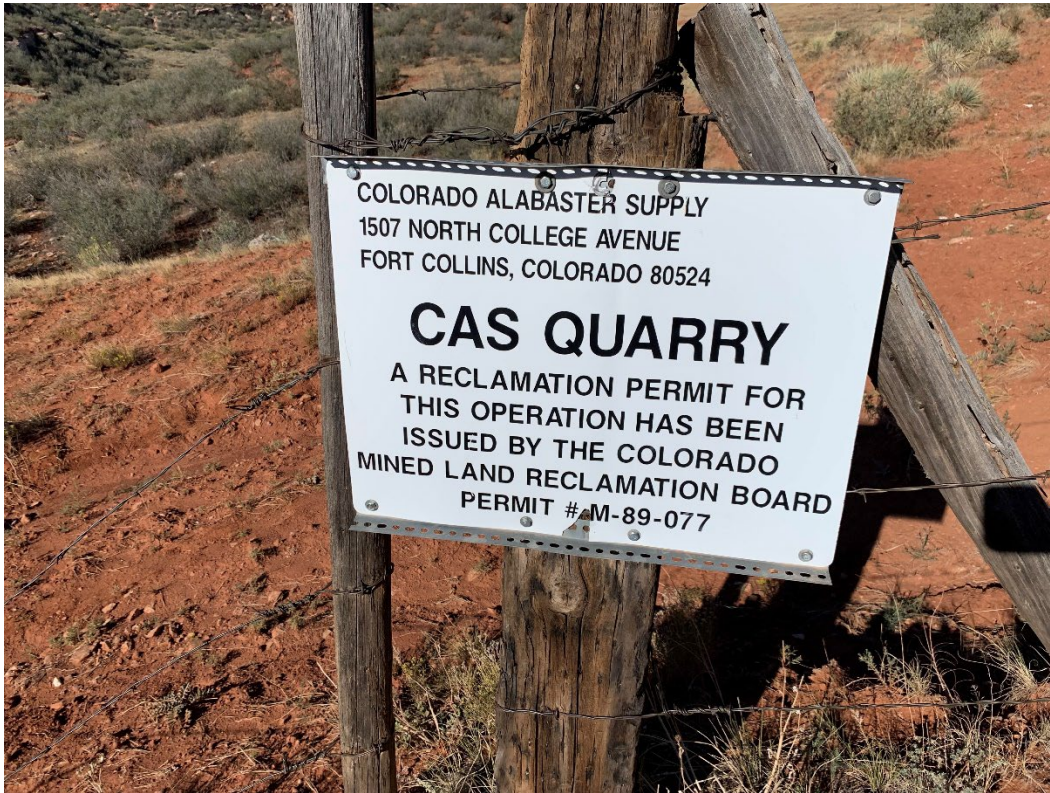
The mine entrance sign was in place (photo 1) and an electric fence was around the disturbed area.

Photo 1 – Mine entrance sign

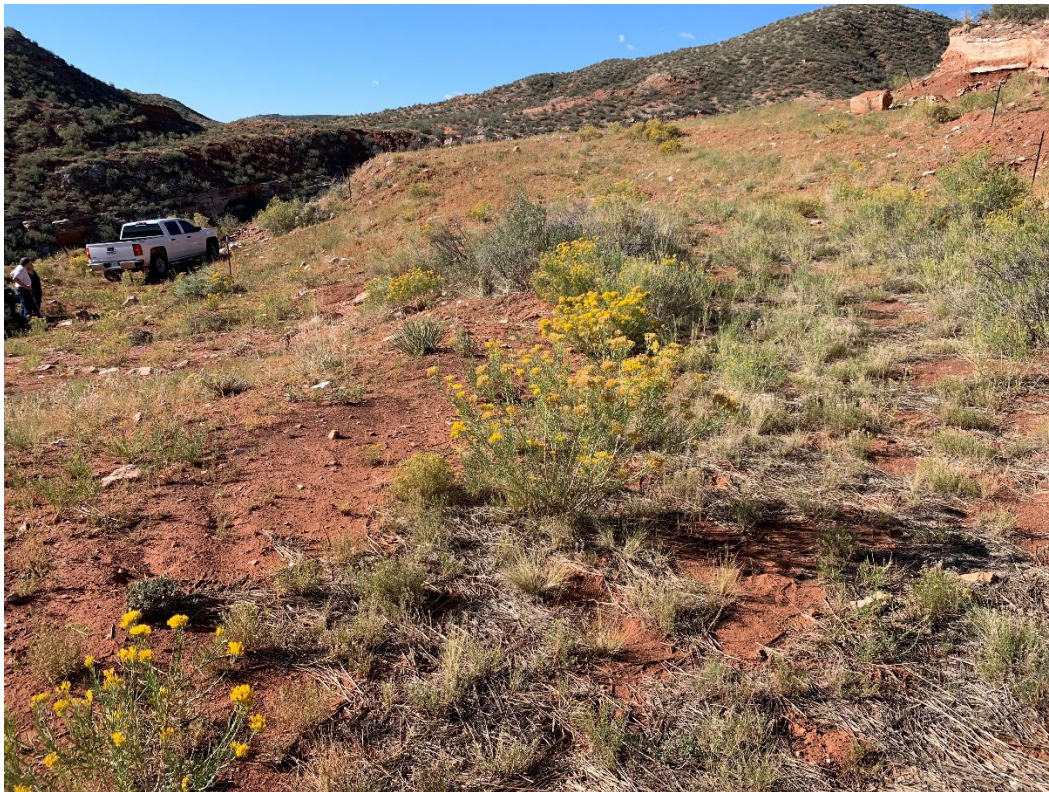
The permit states that slopes will be graded to 4h:1v or less. The slopes were graded less than 4h:1v and were blended in with the surrounding landscape (photo 2). The topsoil has been distributed across the mine site.

Photo 2 – The east side of mine site facing west

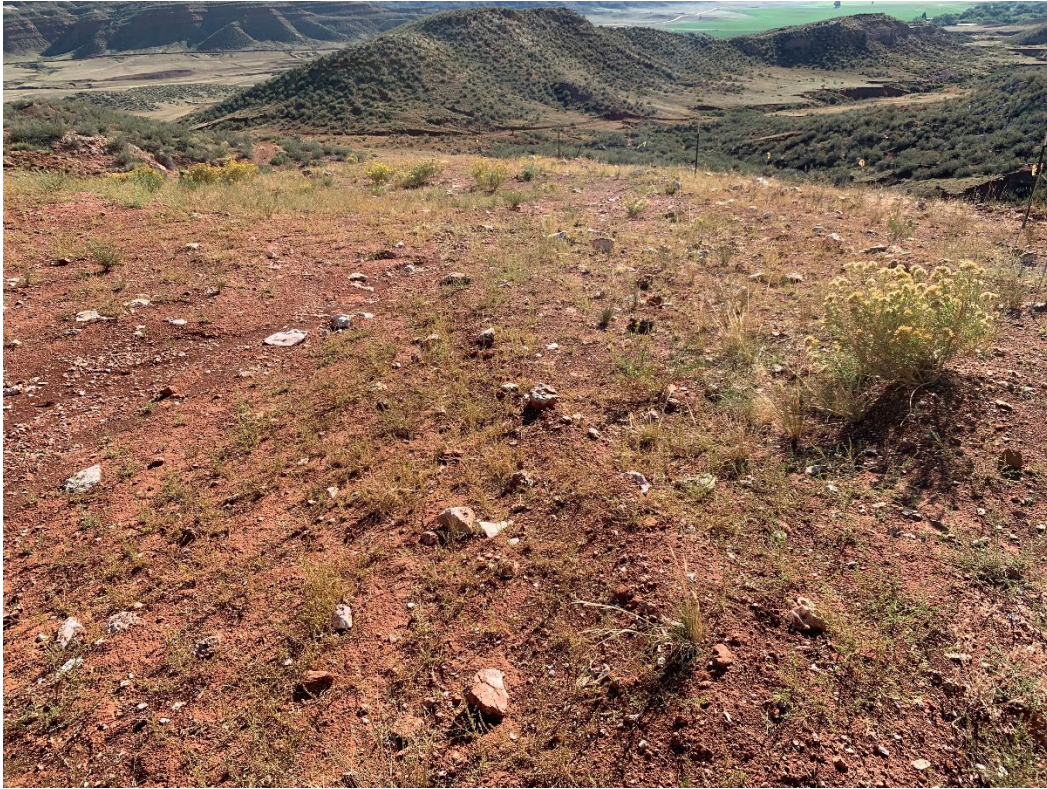
Photo 3 – west end of reclamation facing east
