MINERALS PROGRAM INSPECTION REPORT
PHONE: (303) 866-3567

MINE NAME: Bottomless Pit	MINE/PROSPECTING ID#: M-2001-068	MINERAL: Gravel and sand	COUNTY: Las Animas
INSPECTION TYPE: Surety Release Inspection	INSPECTOR(S): Peter Hays	INSP. DATE: August 29, 2022	INSP. TIME: 11:00
OPERATOR: Tamrock Gravel LLC	OPERATOR REPRESENTATIVE:	TYPE OF OPERATION: 112c - Construction Regular Operation	
REASON FOR INSPECTION: Surety Release Requested	BOND CALCULATION TYPE:	BOND AMOUNT: \$56,204.00	
DATE OF COMPLAINT: NA	POST INSP. CONTACTS: None	JOINT INSP. AGENCY: None	
WEATHER: Clear	INSPECTOR'S SIGNATURE:

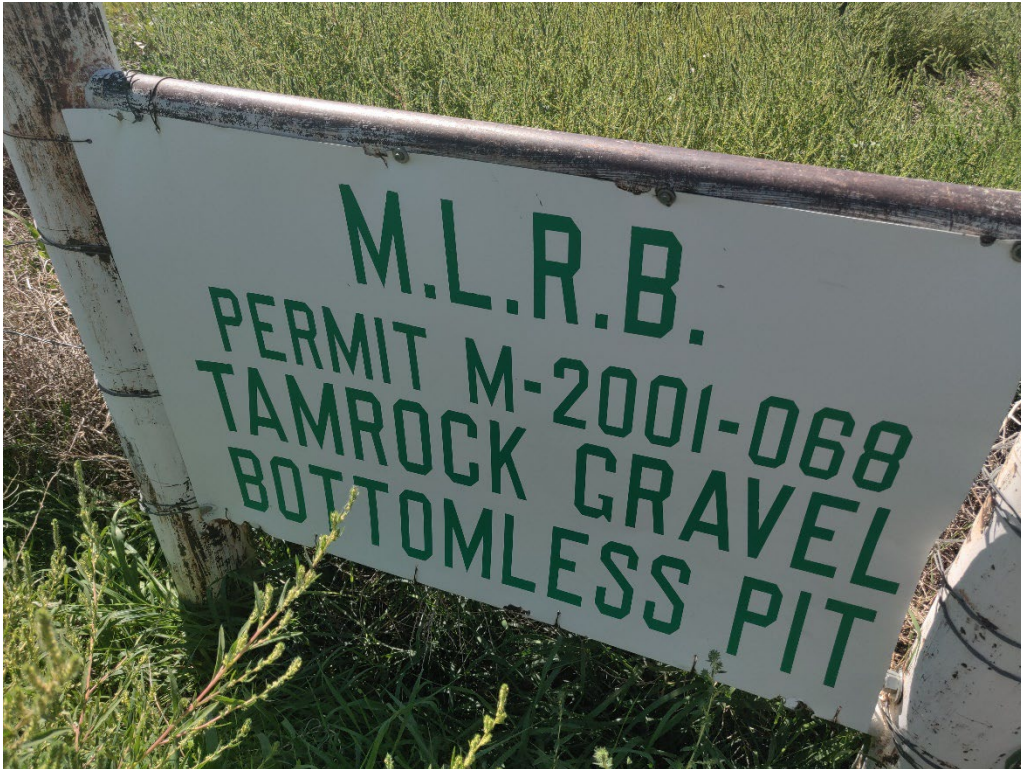
The mine identification sign and affected area boundary markers were observed pursuant to Rule 3.1.12. The financial warranty in the amount of \$56,204.00 will be released by the Division within thirty (30) days pursuant to Rule 4.17.2(5). No comments were received by the Division during the public comment period for the release request from the landowner or other state agencies.

Bottomless Pit mine sign

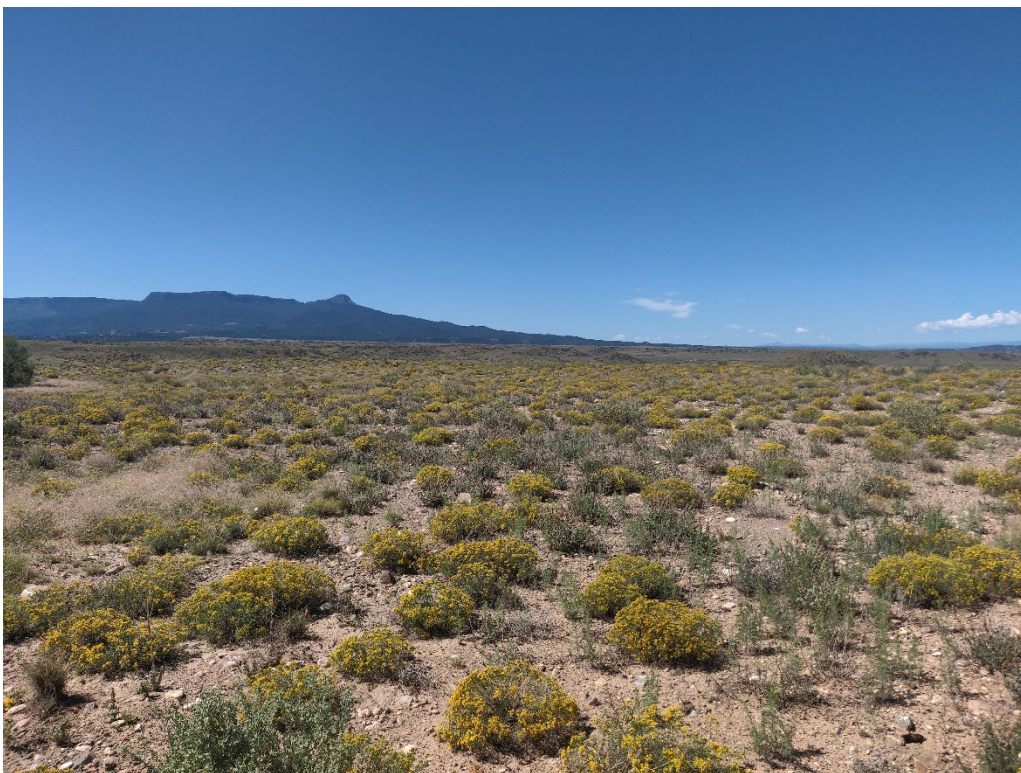
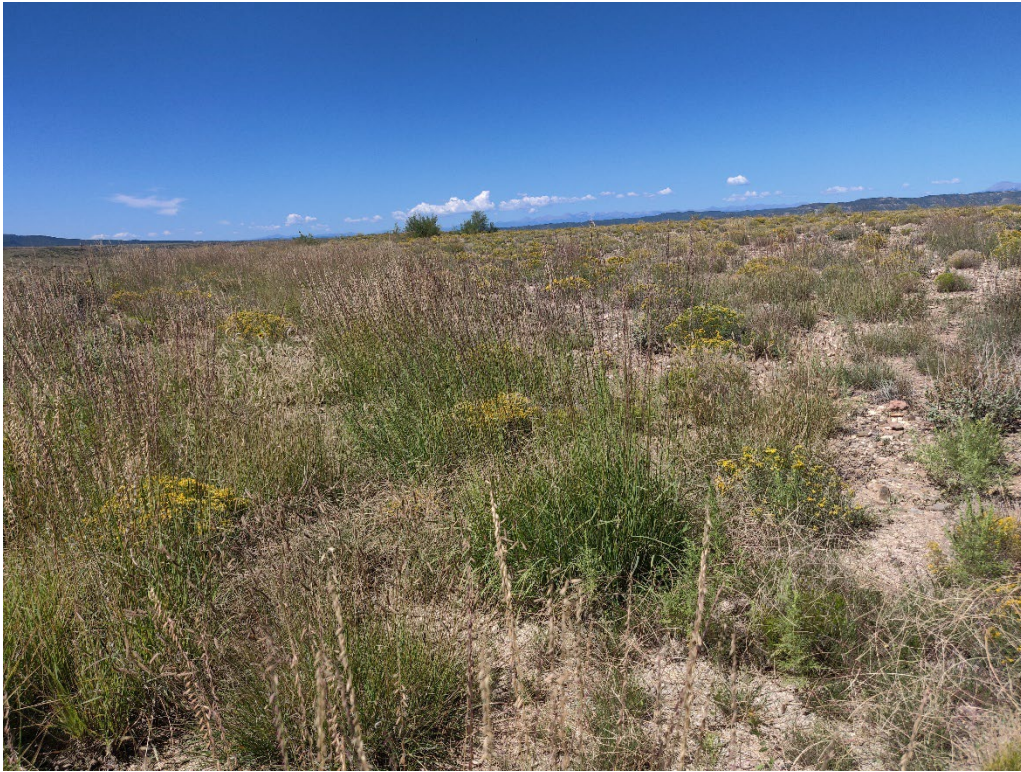
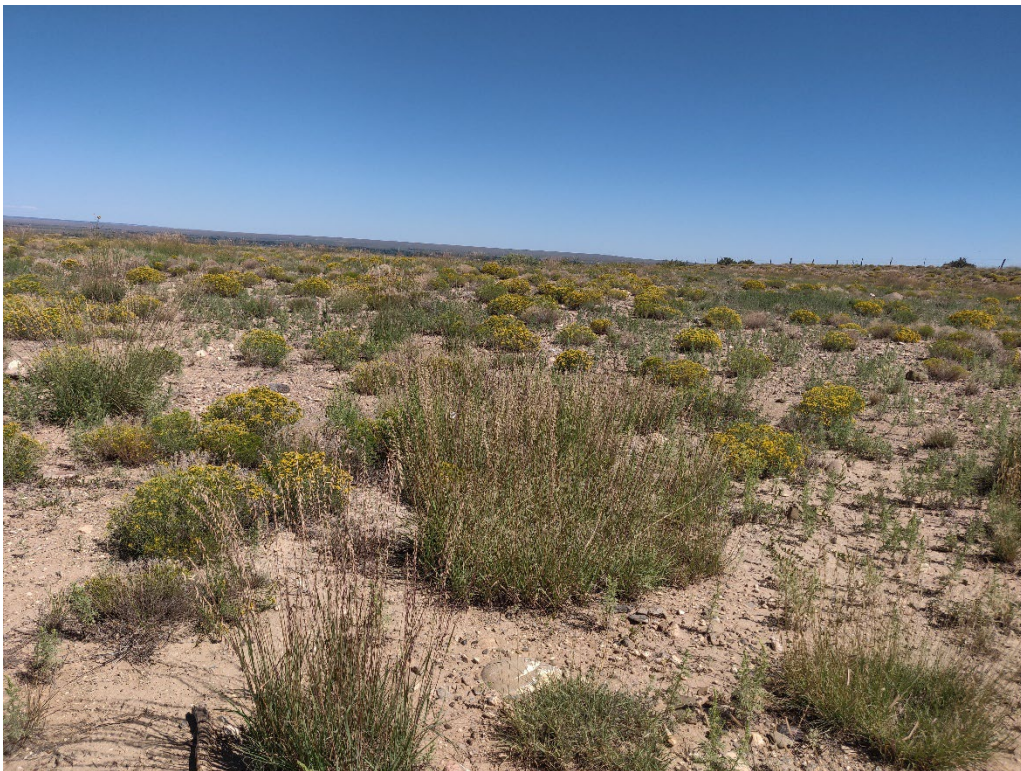
The site consists of two (2) mining areas; a northern area and the southern area. The northern area was reclaimed several years ago. The vegetation in the area consisted of well-established reclamation grasses and volunteered vegetation including: cactus, rabbit brush and snakeweed. The reclamation vegetation displayed evidence of several growth cycles and contained seed heads. The southern area was reclaimed a few years ago. The area consisted of well-established reclamation grasses with fewer volunteered species compared to the northern area. Annual weeds including kochia and sunflowers were observed during the inspection. The reclamation and native grasses and shrubs appeared to be outcompeting the annual weeds. Overall, the site vegetation well-established, self-sustaining and was consistent with the vegetation observed in the rangeland adjacent to the site.

View of the vegetation in the northern area

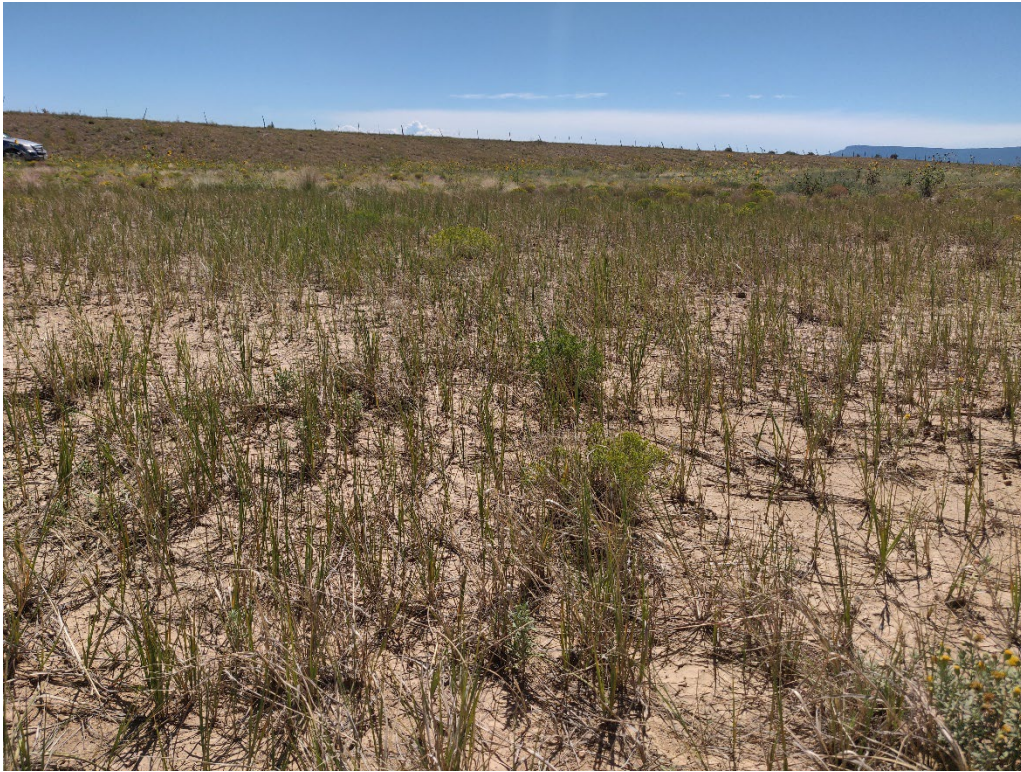
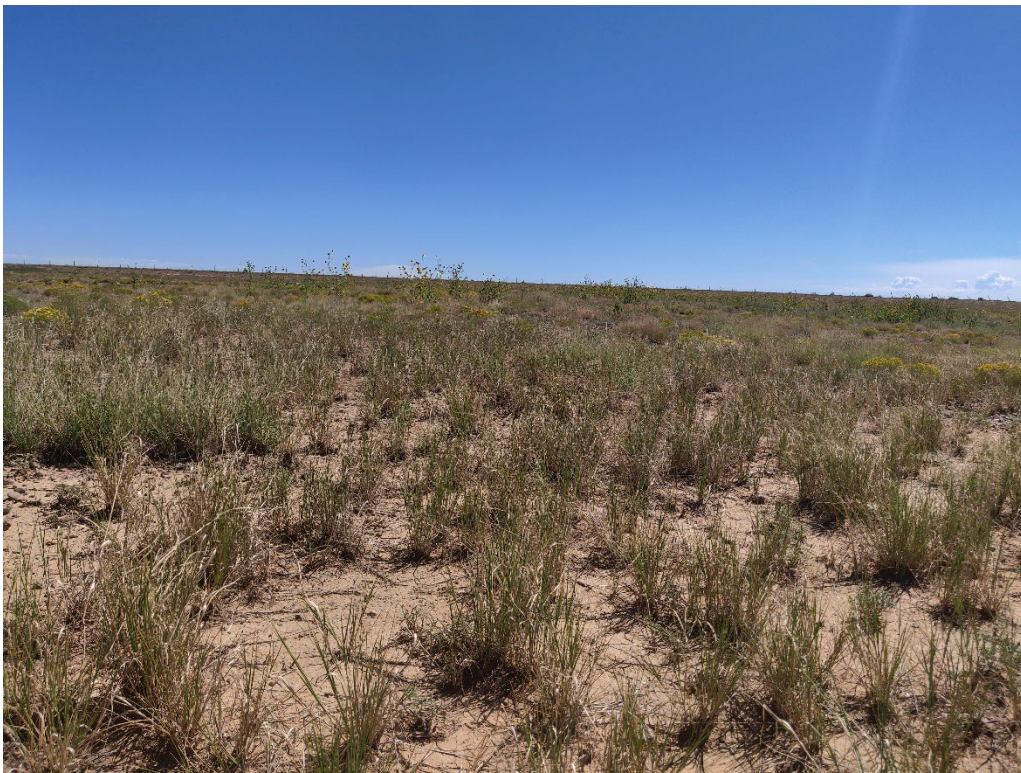
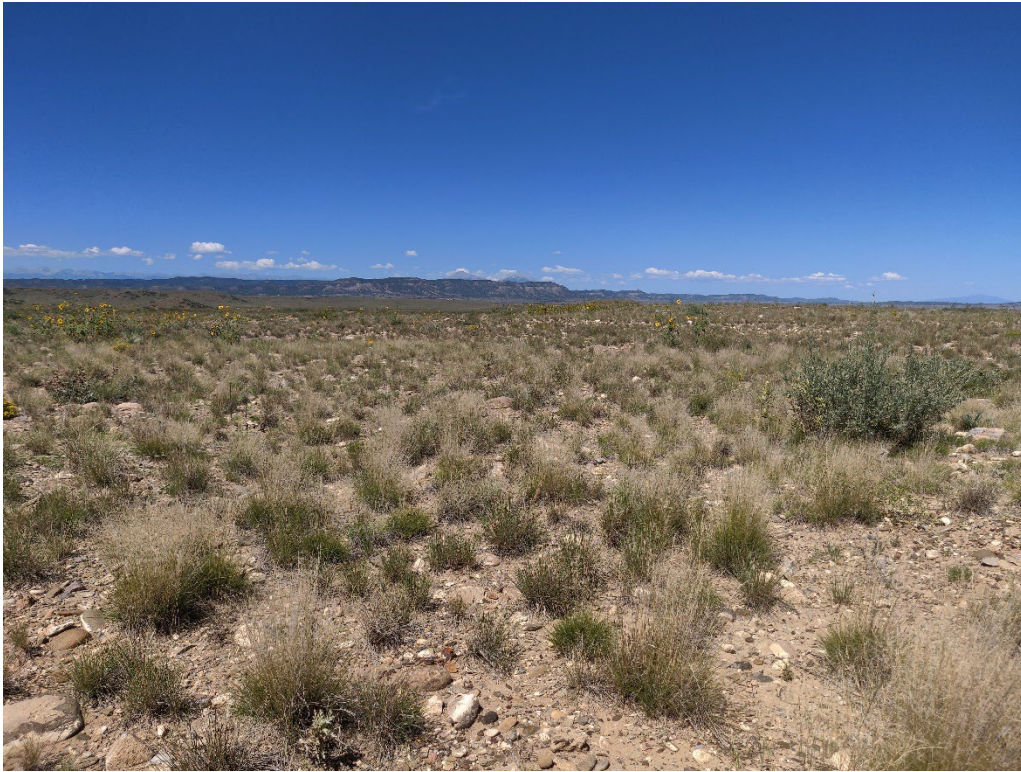
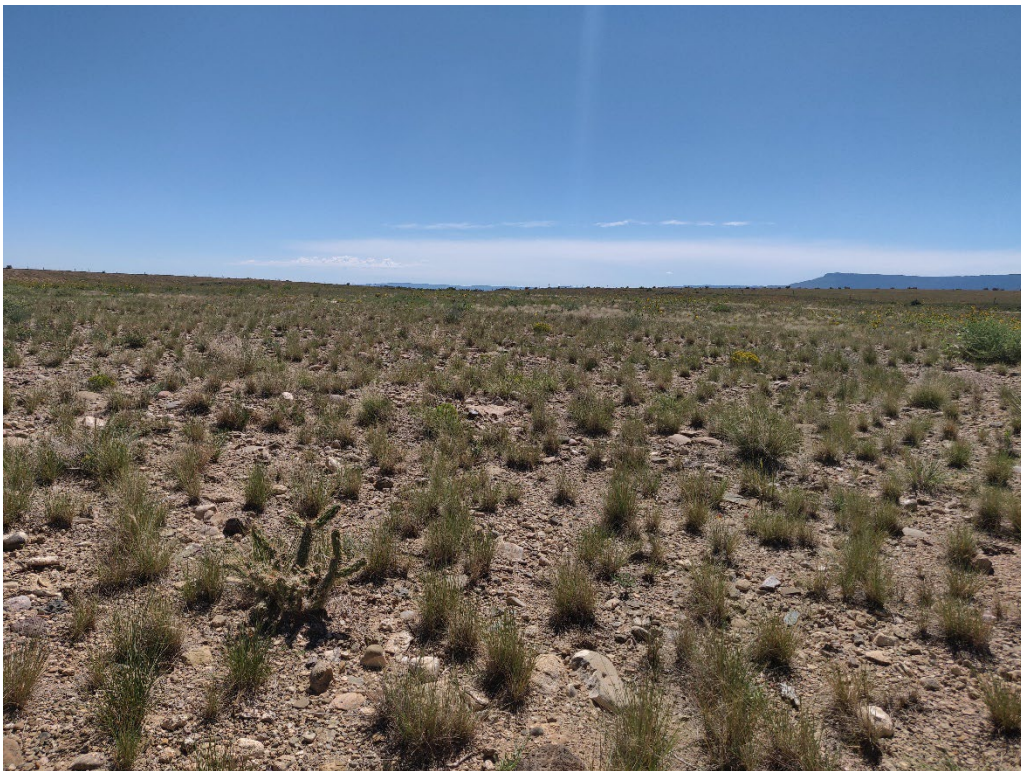
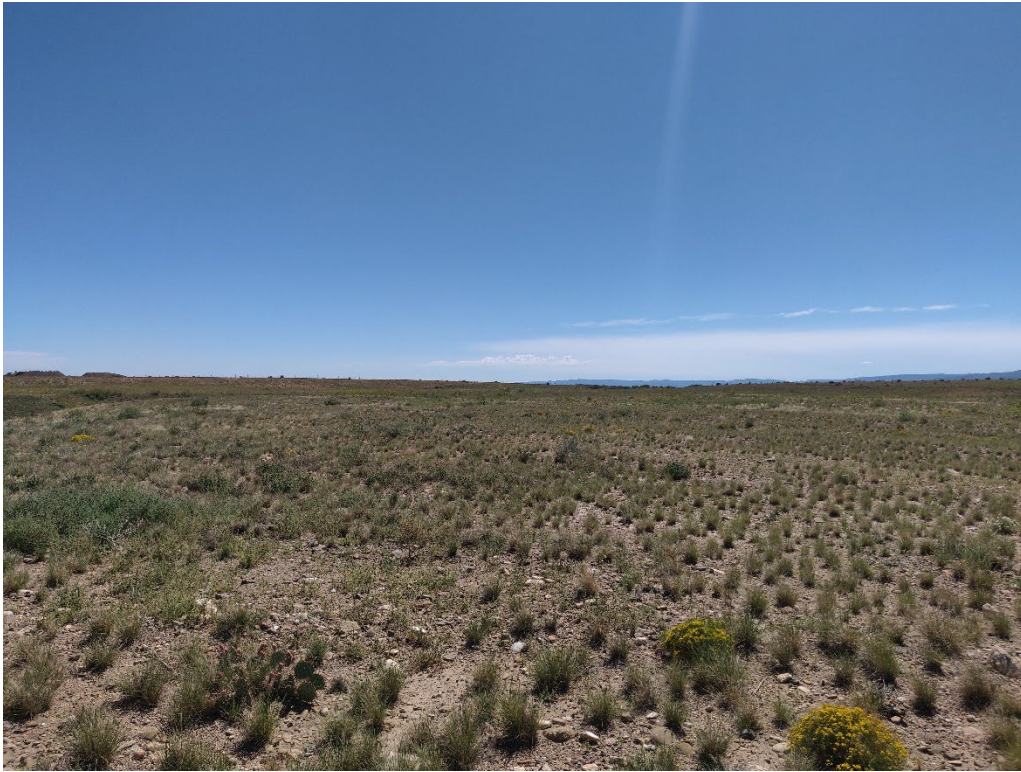
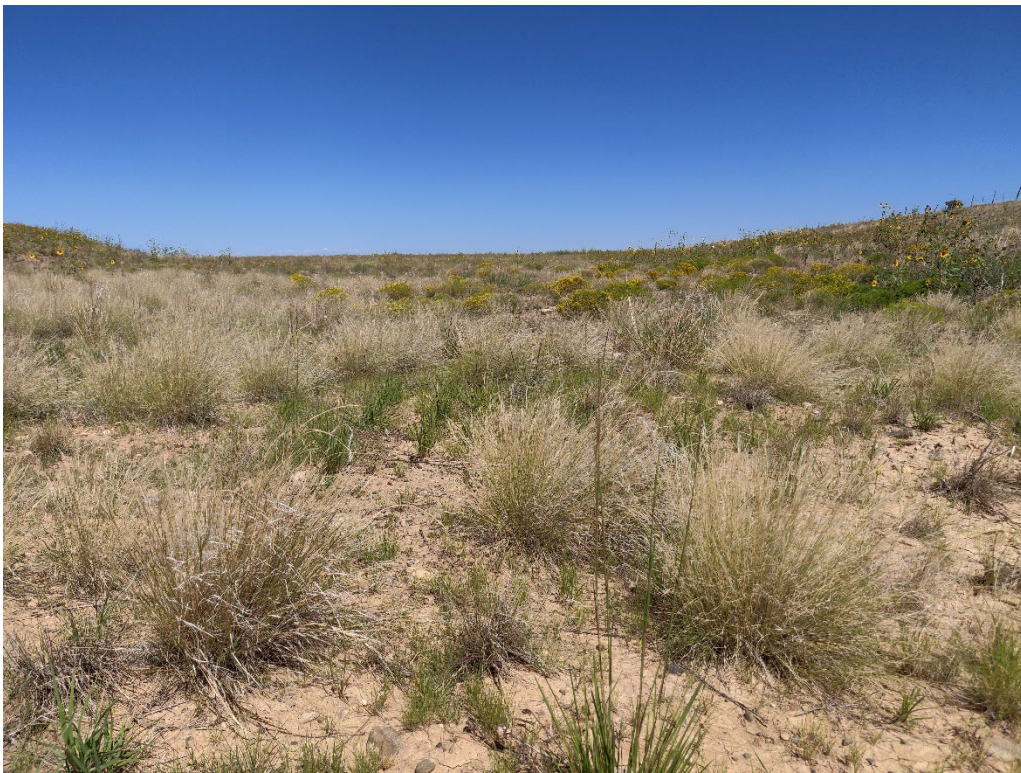
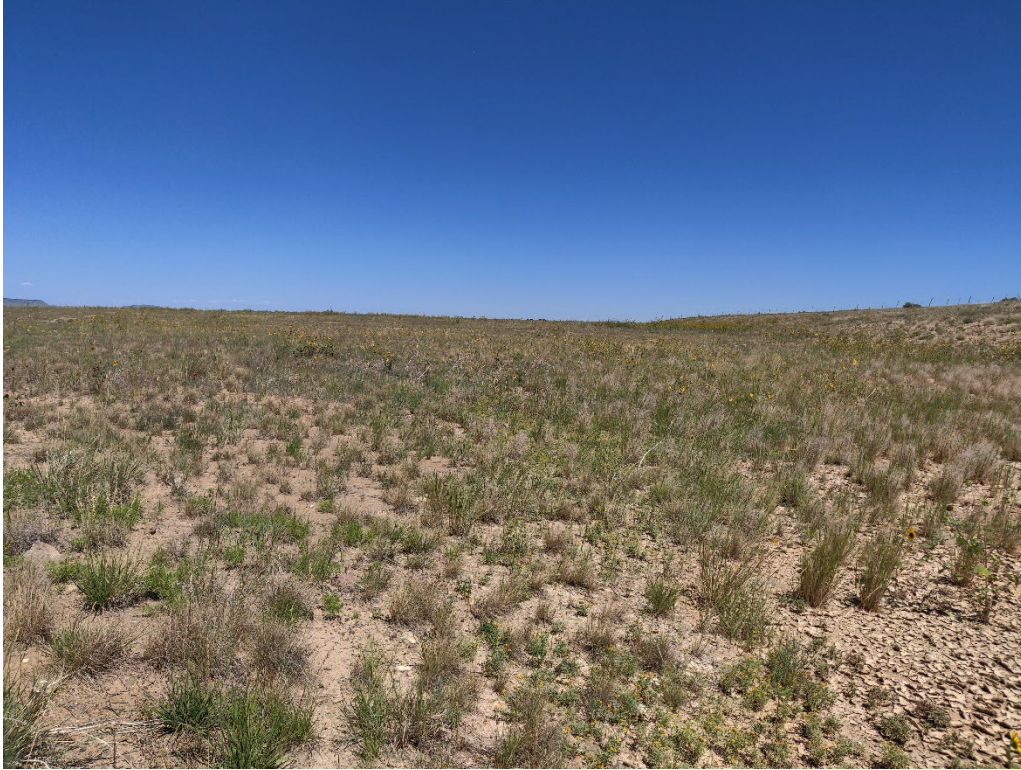
View of the vegetation in the southern area

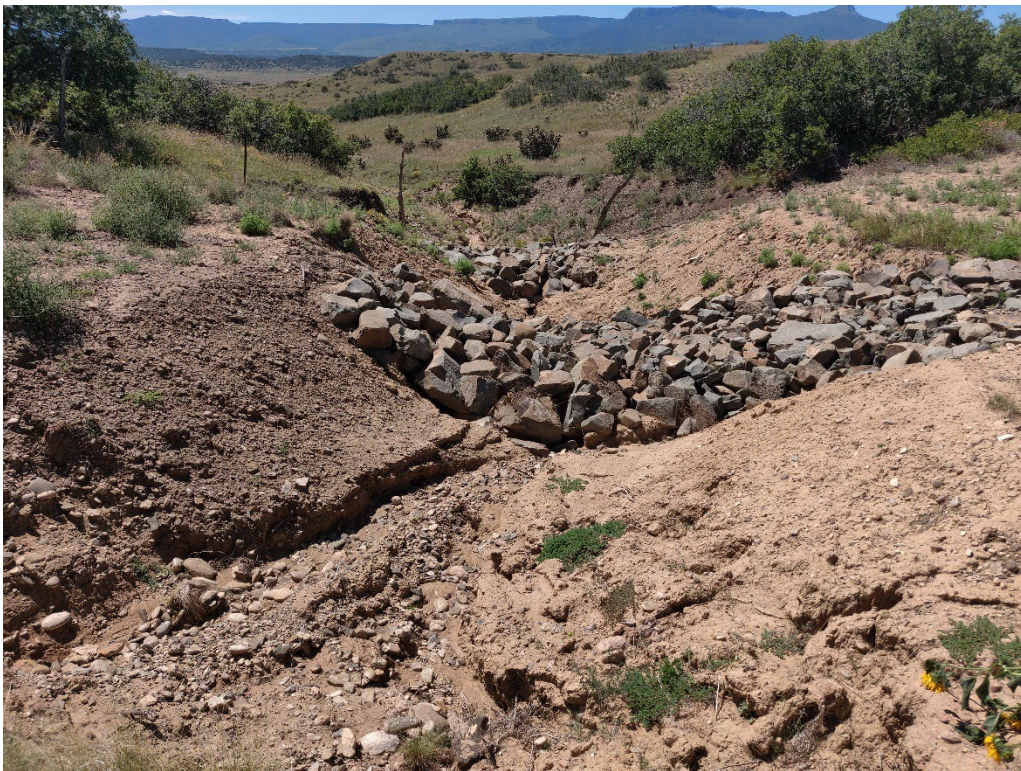
View of the repaired erosion feature in the southeast corner of the site
