## MINERALS PROGRAM INSPECTION REPORT

<b>MINE NAME:</b> Castle Gulch	<b>MINE/PROSPECTING ID#:</b> M2022-039	<b>MINERAL:</b> Unknown	<b>COUNTY:</b> Boulder
<b>INSPECTION TYPE:</b> Possible Illegal(Unpermitted Operation)	<b>INSPECTOR(S):</b> Patrick Lennberg	<b>INSP. DATE:</b> September 15, 2022	<b>INSP. TIME:</b> 08:30
<b>OPERATOR:</b> Unknown	<b>REPRESENTATIVES:</b> Eric Harms, Laura Engel	<b>TYPE OF OPERATION:</b> ILL – Illegal (Possible)

## **OBSERVATIONS**

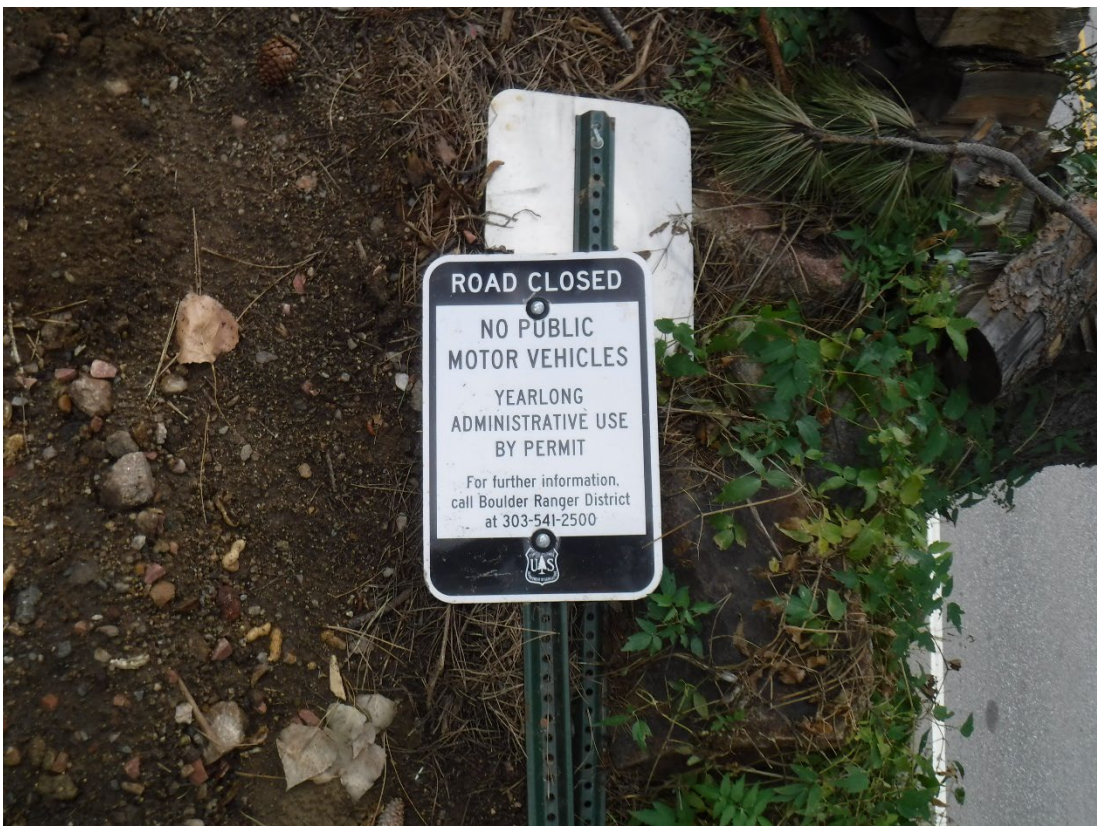
**Photo 2:** Signage on the ground adjacent to garage under construction

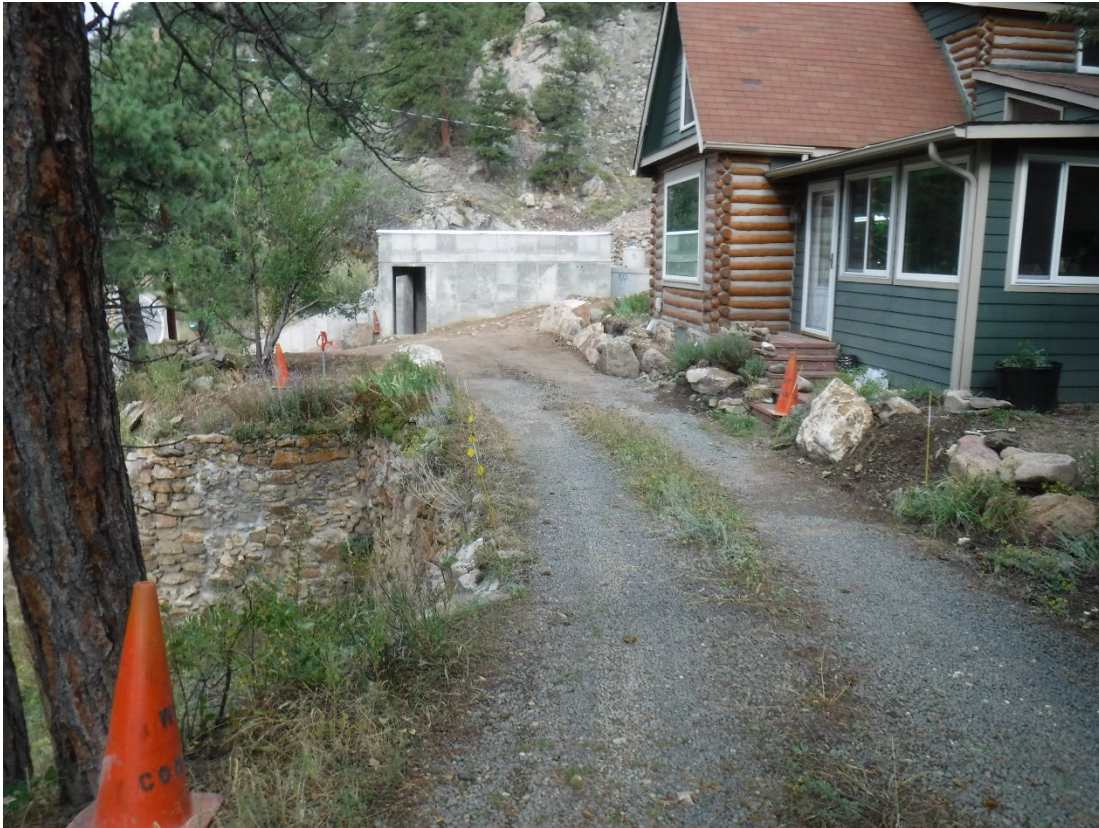
**Photo 5:** USFS 287.1A as it passes in front of house

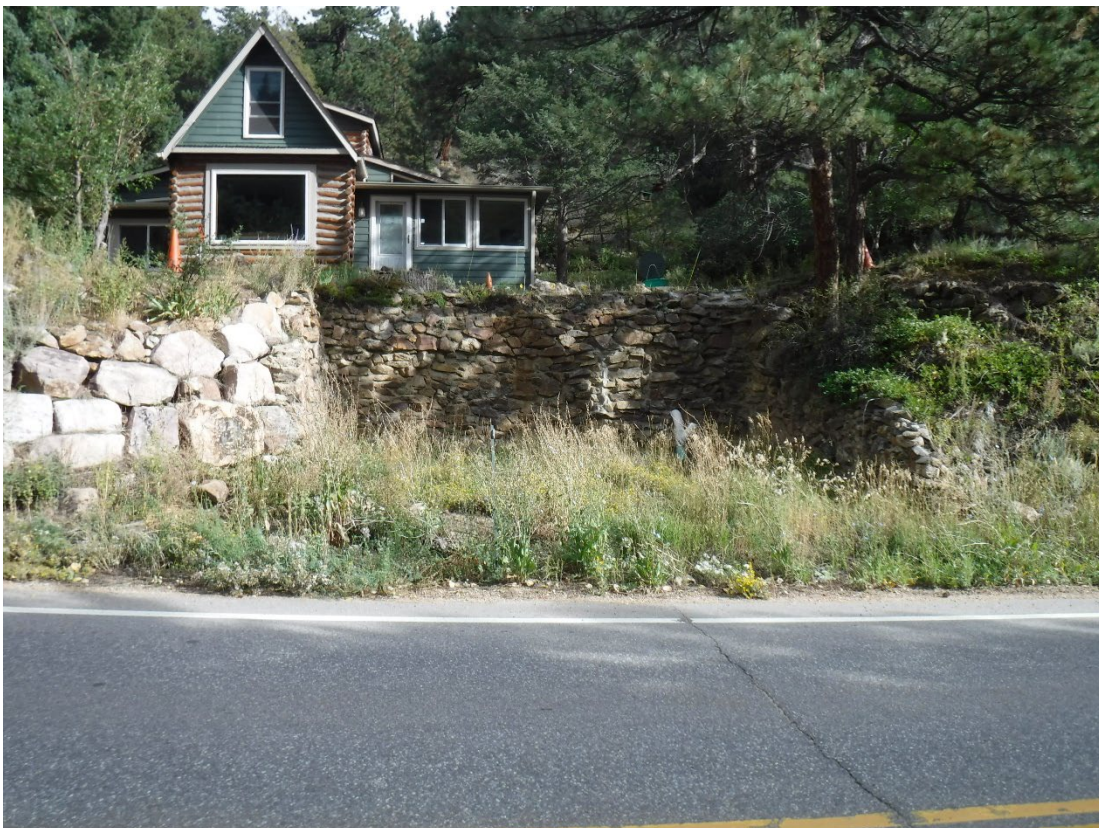
**Photo 6:** Looking from James Canyon Drive at USFS 287.1A as it passes in front of house

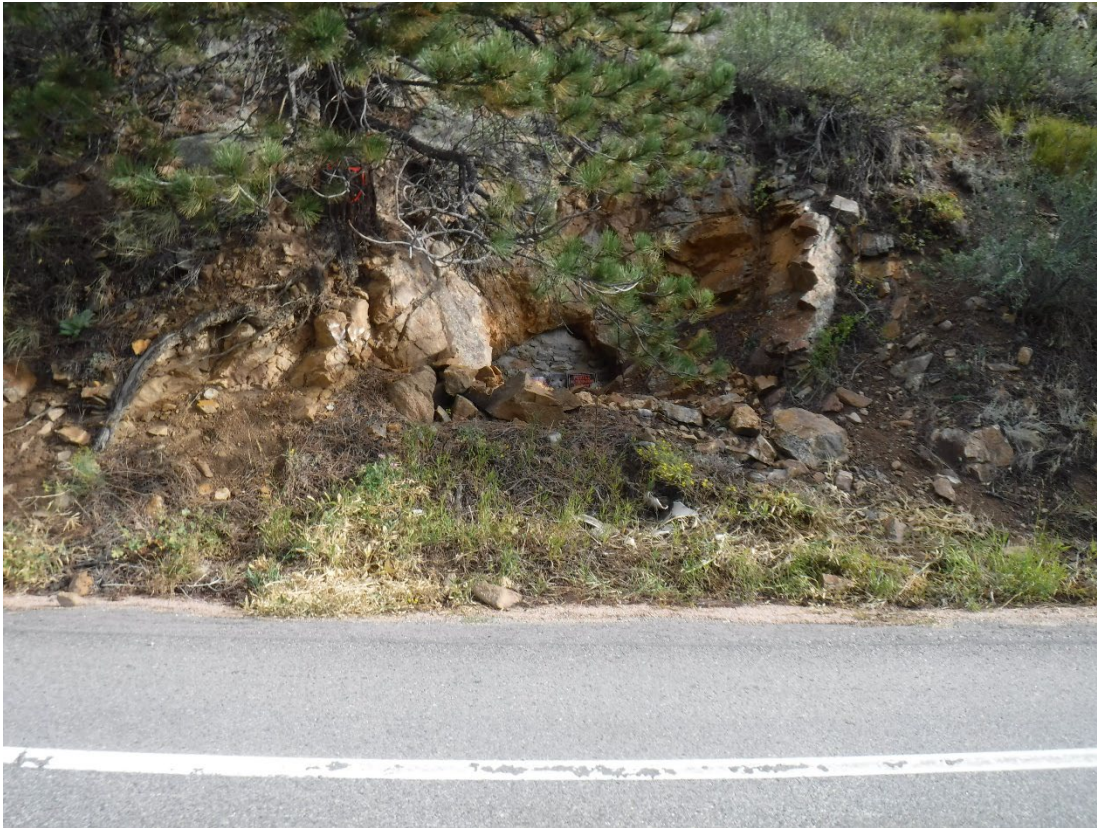
**Photo 7:** West Adit, Portal #7 viewed from James Canyon Drive

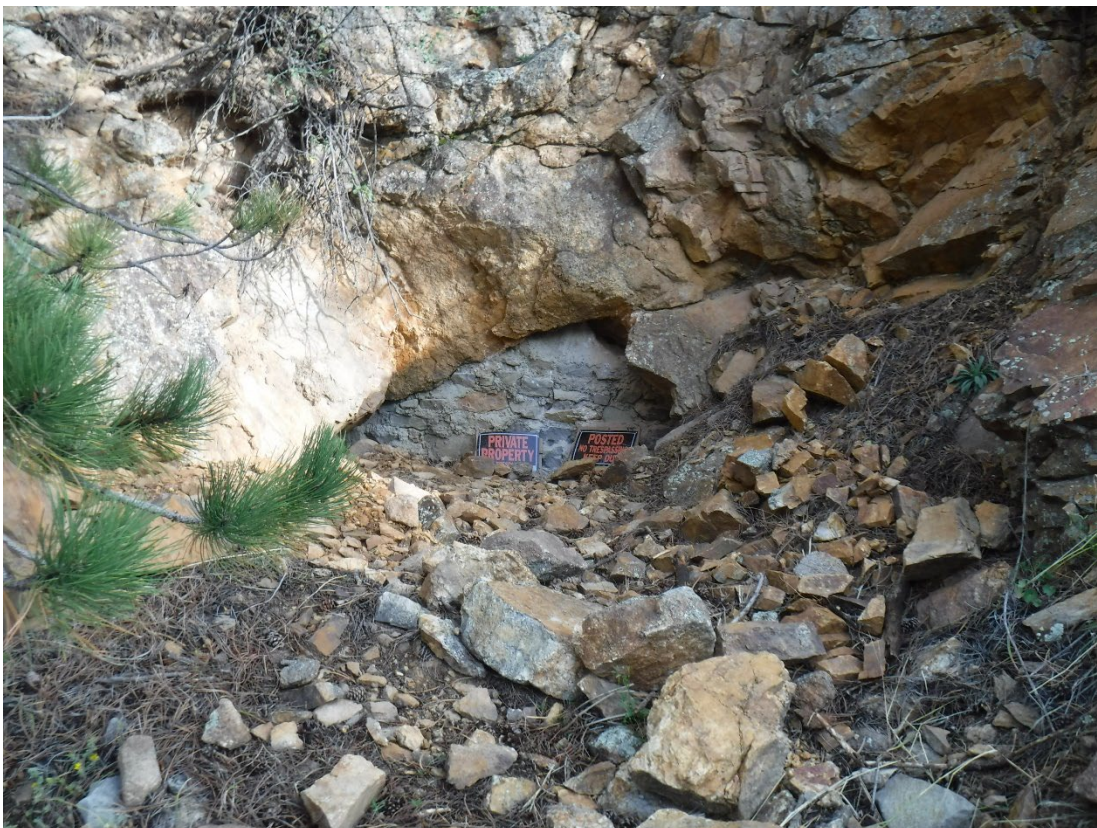
**Photo 8:** West Adit, Portal #7, note stone bulkhead

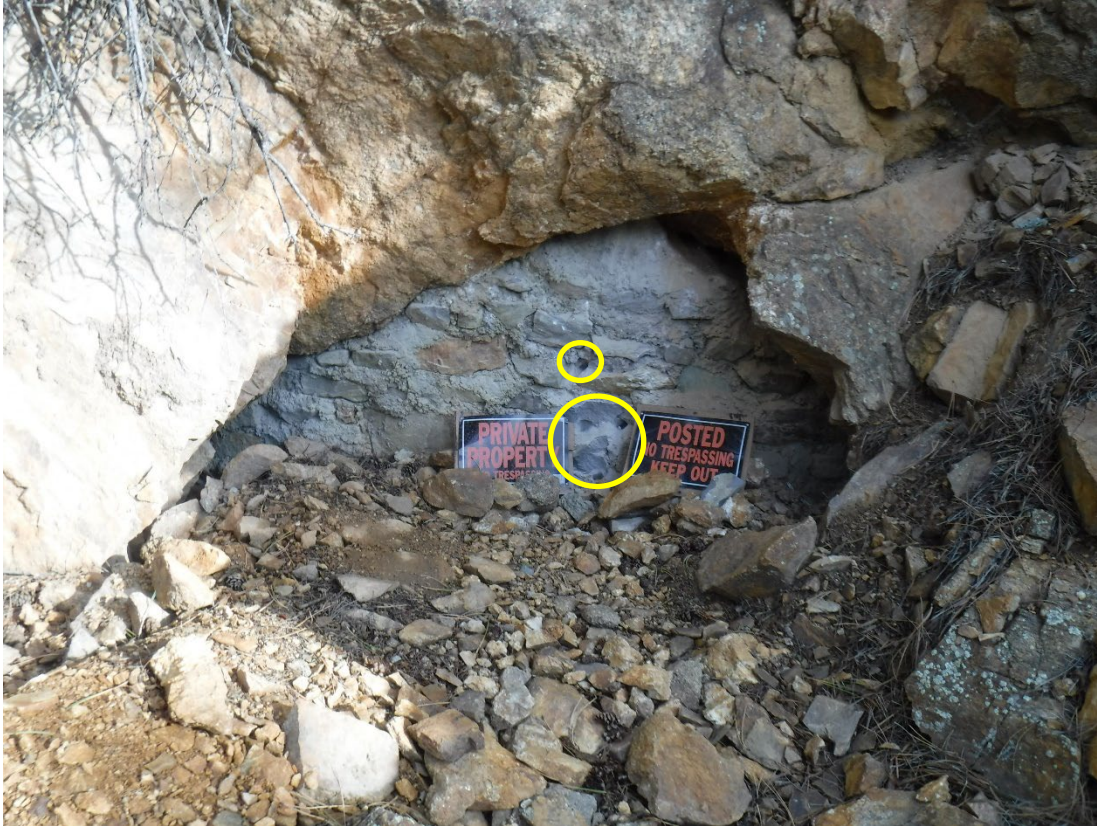
evidence the bulkhead had been drilled into and there hand tools near the entrance. In speaking to JL Mining they were the ones that attempted to breach the bulkhead but were actually looking for the East Adit and were at the wrong location. Once it was determined they were in the wrong location they moved to the East Adit area. The damage to the bulkhead was superficial.

**Photo 9:** West Adit, Portal #7, shallow drill holes highlighted

The Division informed JL Mining that both adits are not part of the approved NOI, P2013-019, and any further disturbances to the adits will be considered mining or prospecting without a permit or approval and possible violations issued. Additionally, the exact location of the East Adit seems to be disputed and its location should be verified to determine whose property it is actually located on before any further work is completed in the area. The Division should be contacted prior to any work being done on the adits to determine what proper permitting is needed for the proposed work.

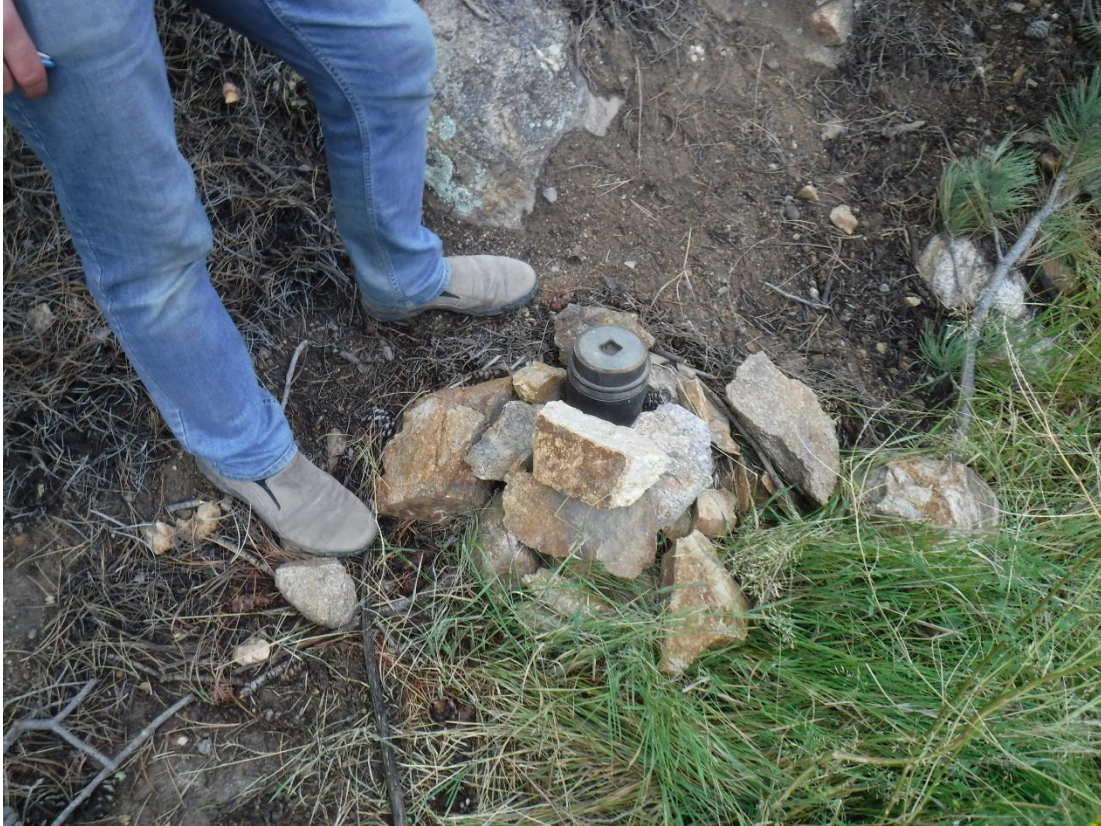
**Photo 15:** Pipe chase at adit

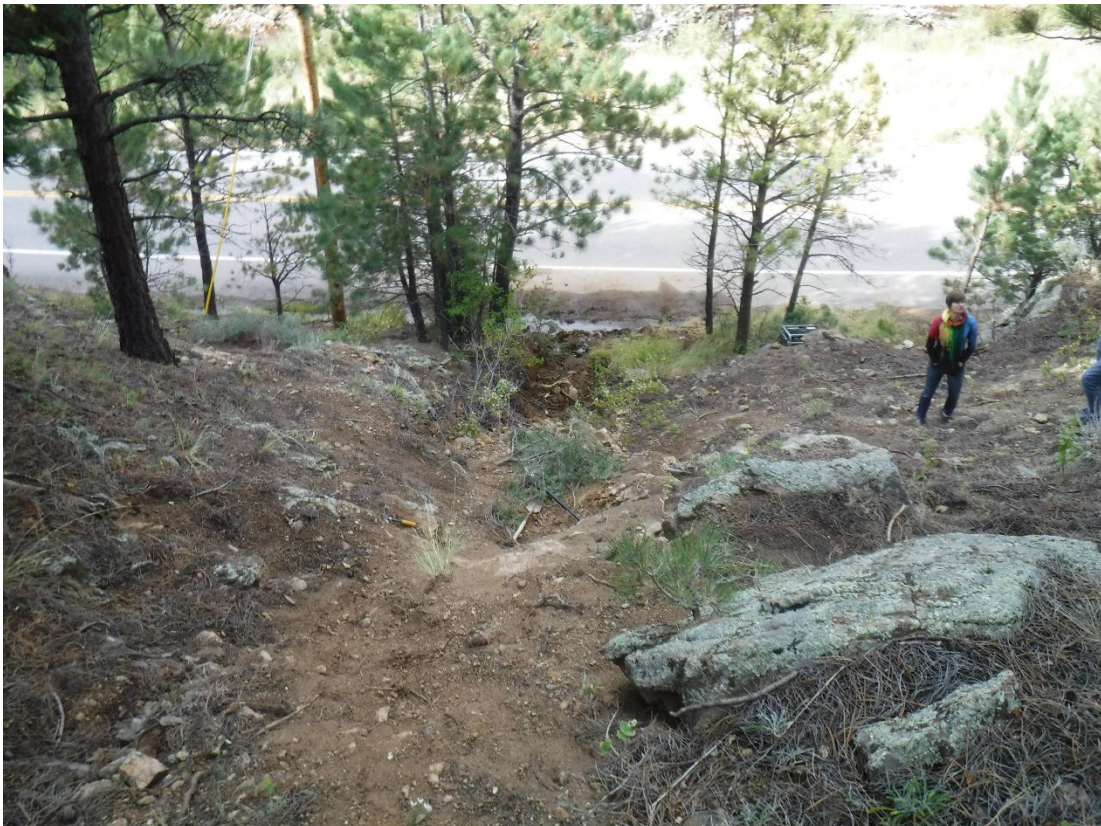
**Photo 16:** Looking towards James Canyon Drive above adit

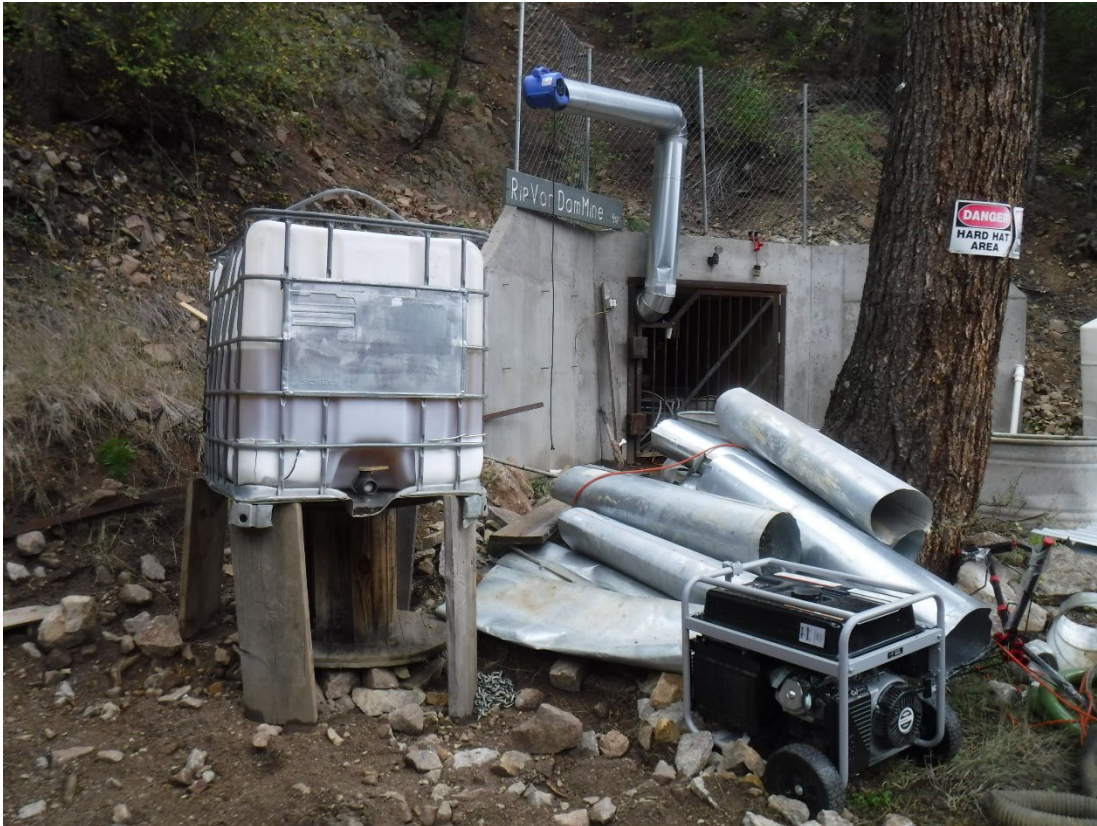
**Photo 21:** Equipment at the Rip Van Dam portal

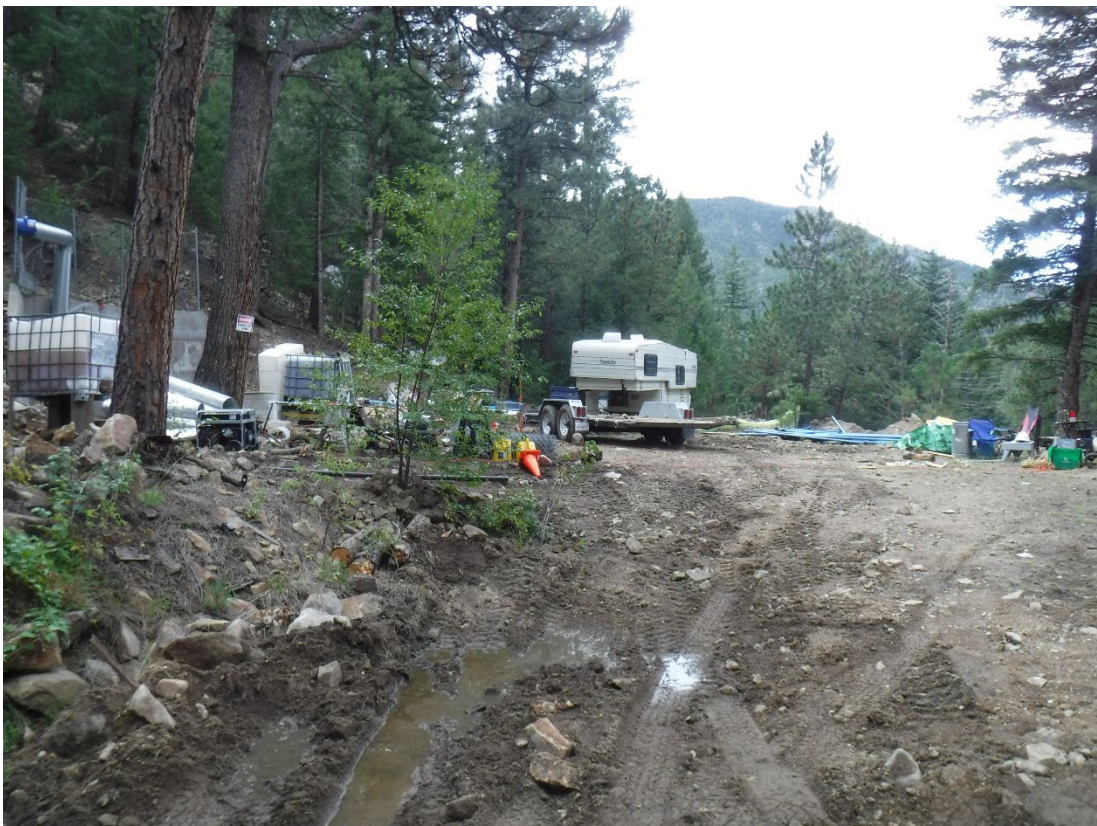
**Photo 22:** Equipment laydown area adjacent to the Rip Van Dam portal to the right of the picture is where the shed is located

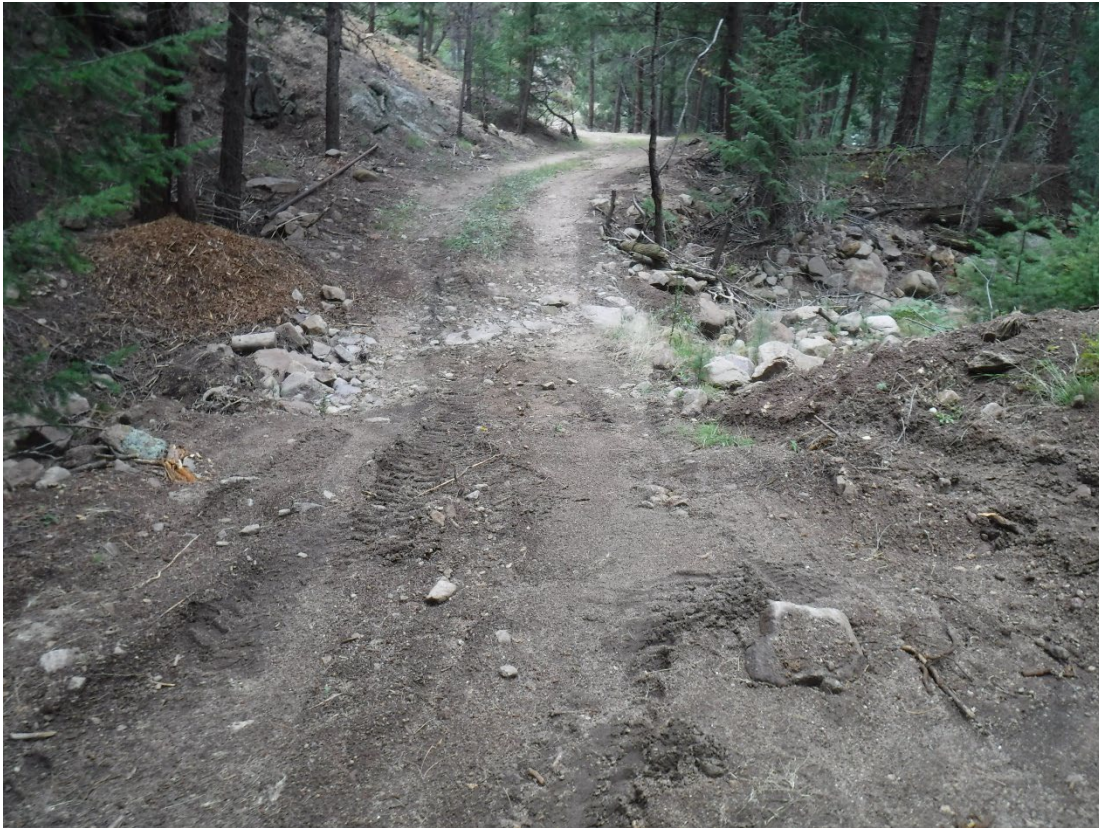
**Photo 23:** Low water crossing
