## MINERALS PROGRAM INSPECTION REPORT

<b>MINE NAME:</b> Castle Gulch	<b>MINE/PROSPECTING ID#:</b> M2022-039	<b>MINERAL:</b> Unknown	<b>COUNTY:</b> Boulder
<b>INSPECTION TYPE:</b> Possible Illegal(Unpermitted Operation)	<b>INSPECTOR(S):</b> Patrick Lennberg	<b>INSP. DATE:</b> September 15, 2022	<b>INSP. TIME:</b> 08:30
<b>OPERATOR:</b> Unknown	<b>REPRESENTATIVES:</b> Eric Harms, Laura Engel	<b>TYPE OF OPERATION:</b> ILL – Illegal (Possible)

NOI P2013-019

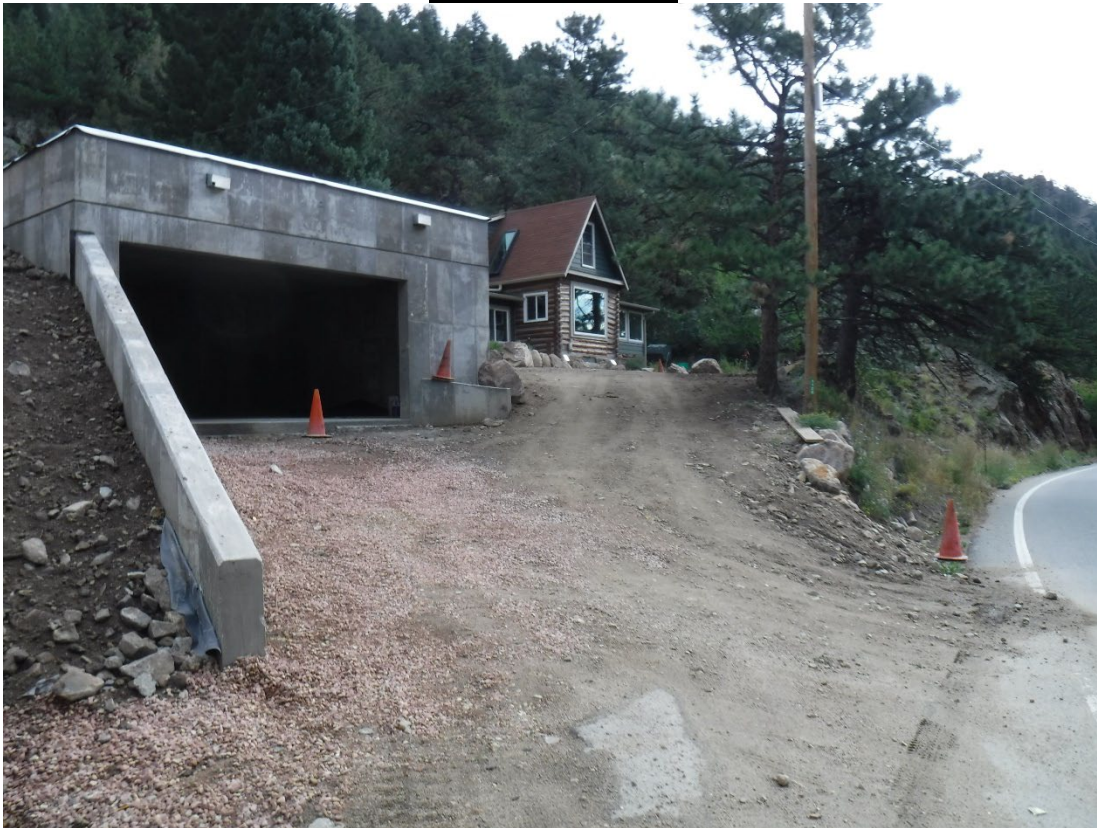
**Photo 1:** USFS 287.1 as it crosses onto 1126 James Canyon Drive

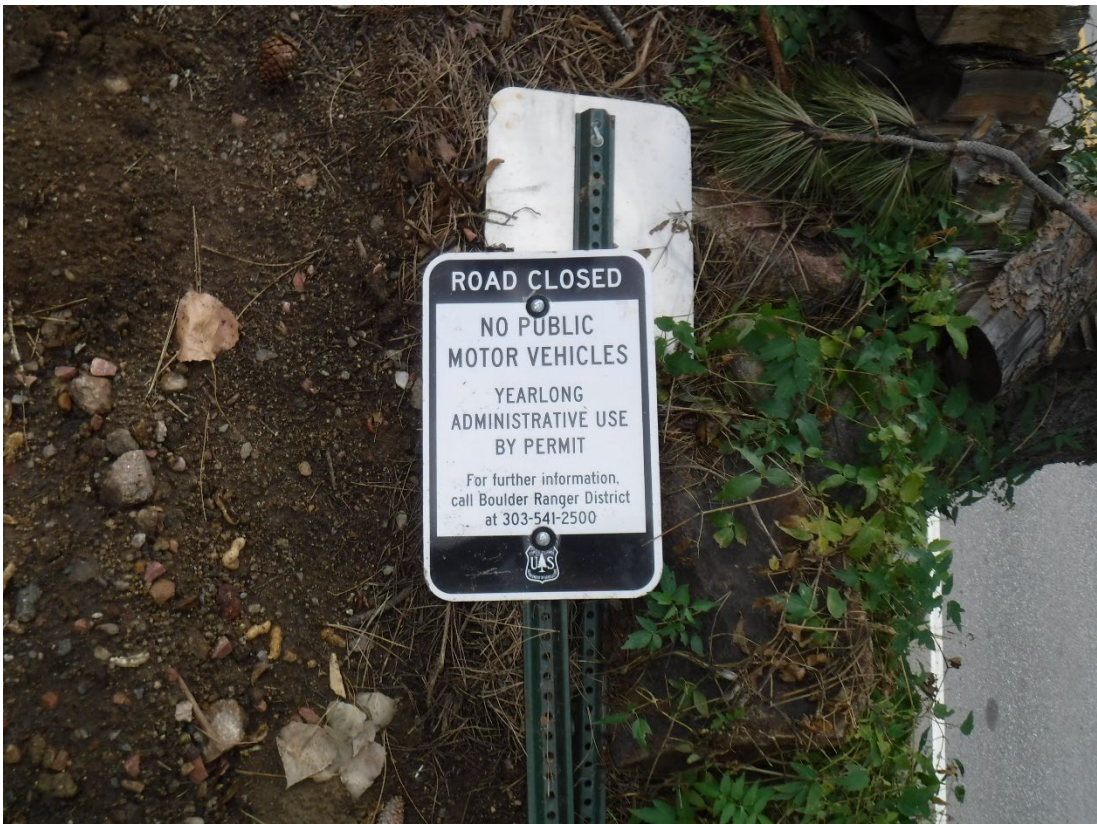
**Photo 2:** Signage on the ground adjacent to garage under construction

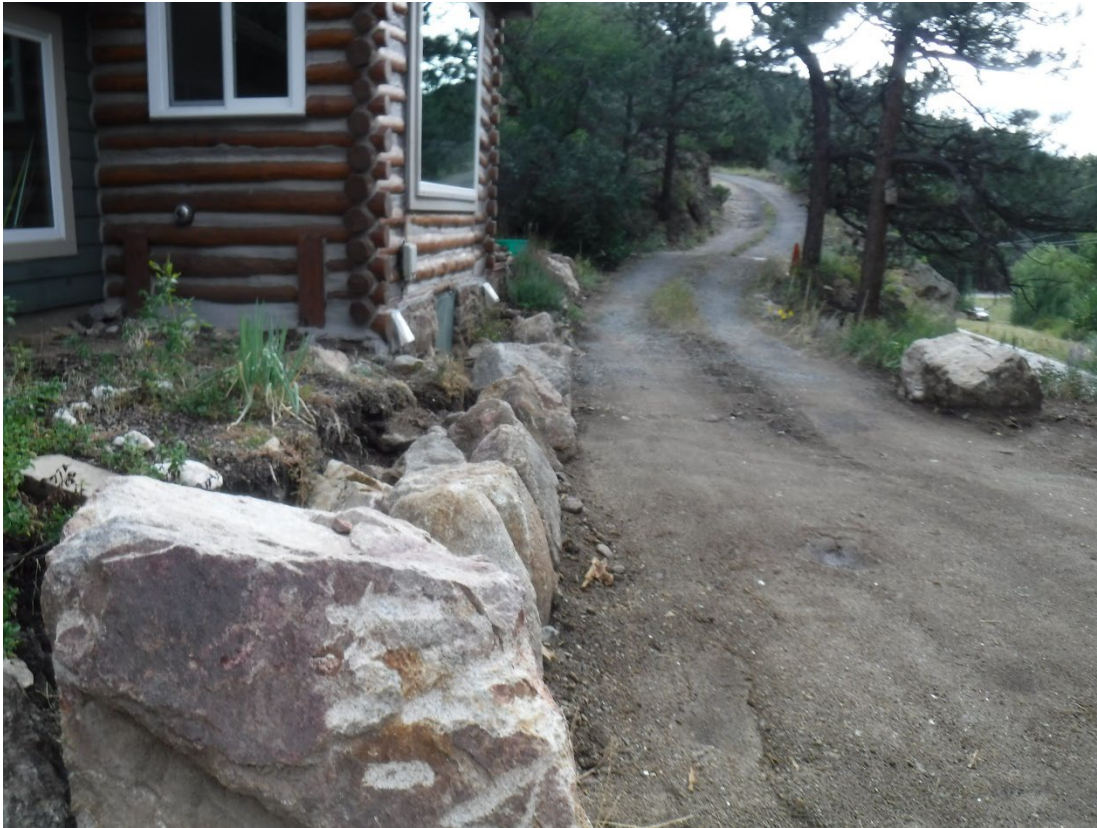
**Photo 3:** USFS 287.1 as it passes in front of house

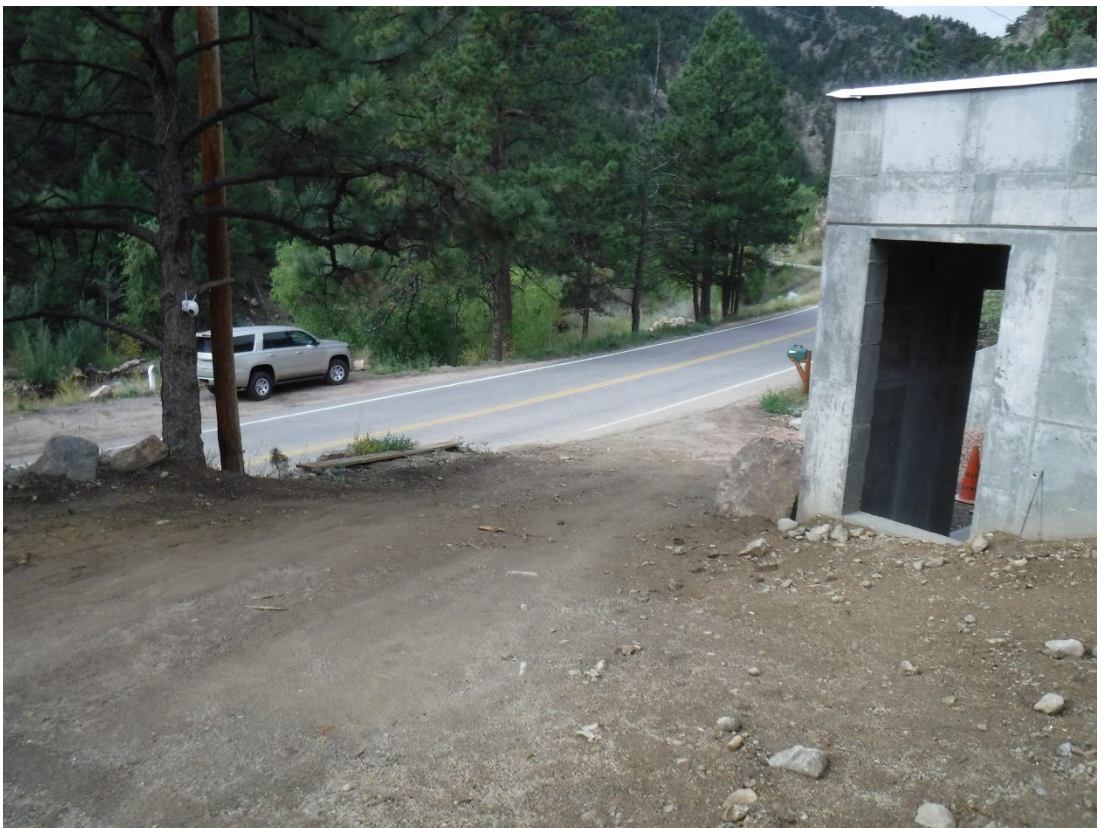
**Photo 4:** USFS 287.1 looking from the house back towards James Canyon Drive

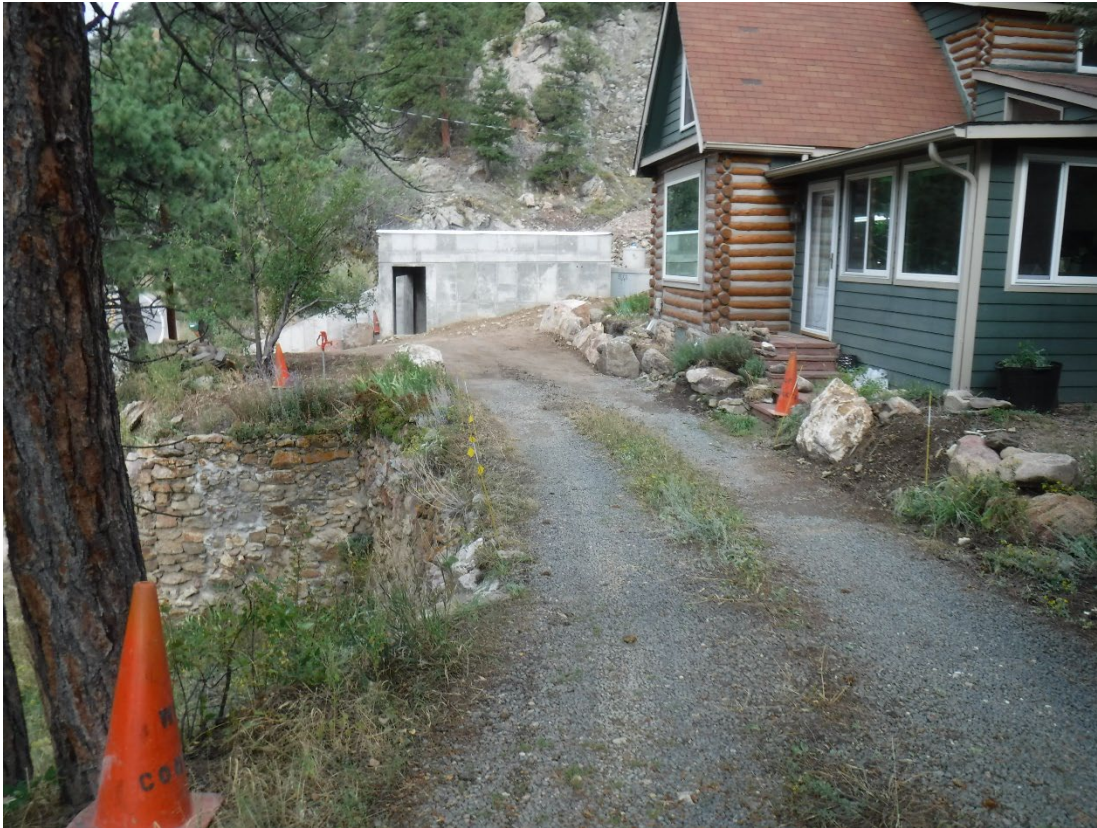
**Photo 5:** USFS 287.1 as it passes in front of house

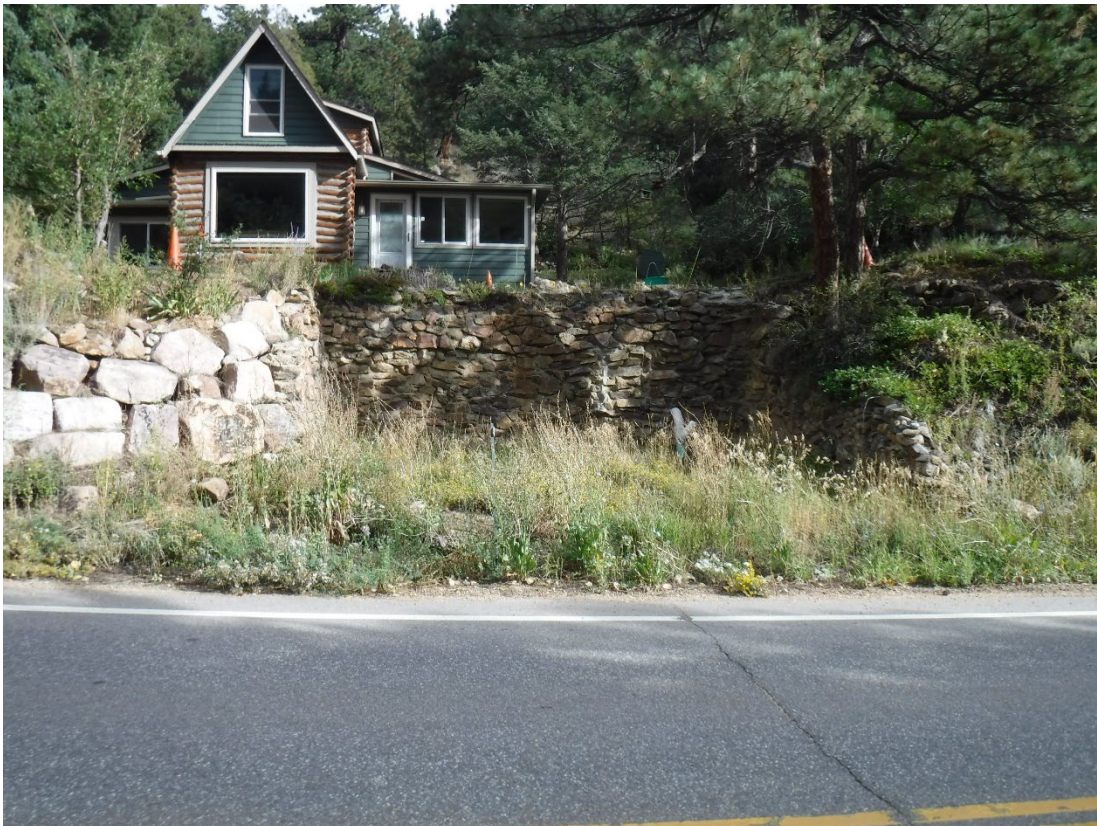
**Photo 6:** Looking from James Canyon Drive at USFS 287.1 as it passes in front of house

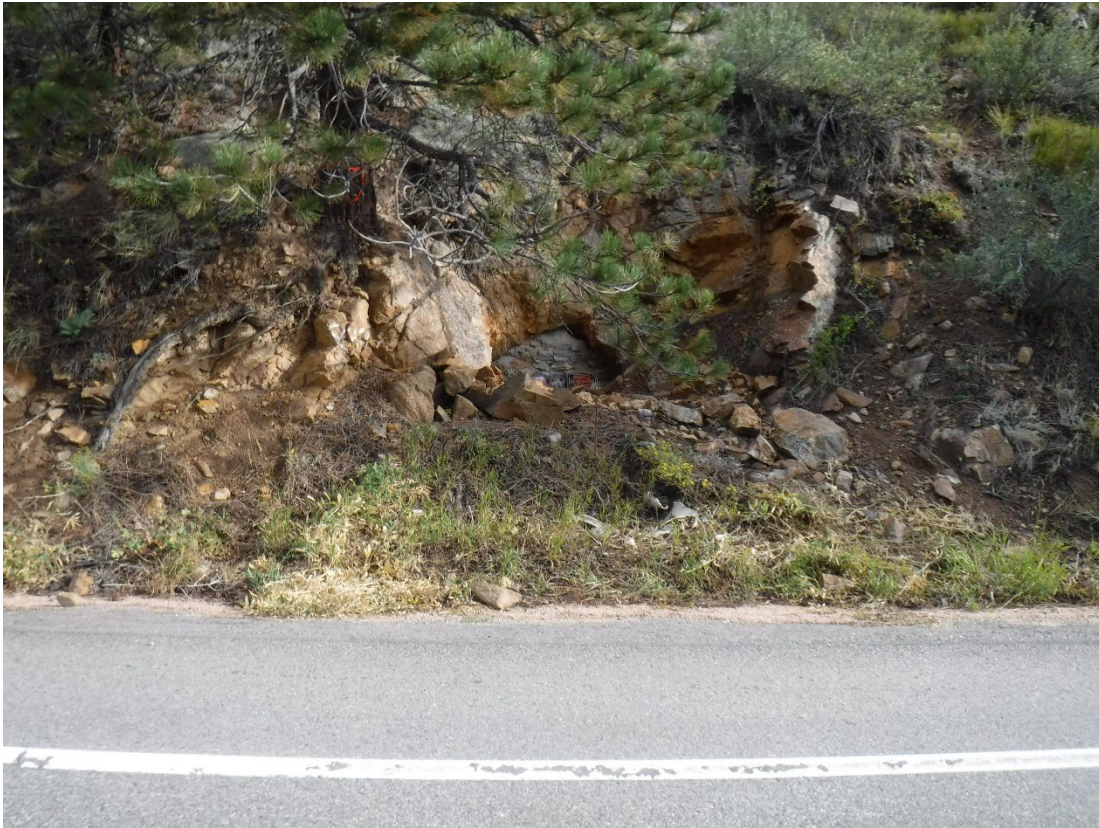
**Photo 7:** West Adit, Portal #7 viewed from James Canyon Drive

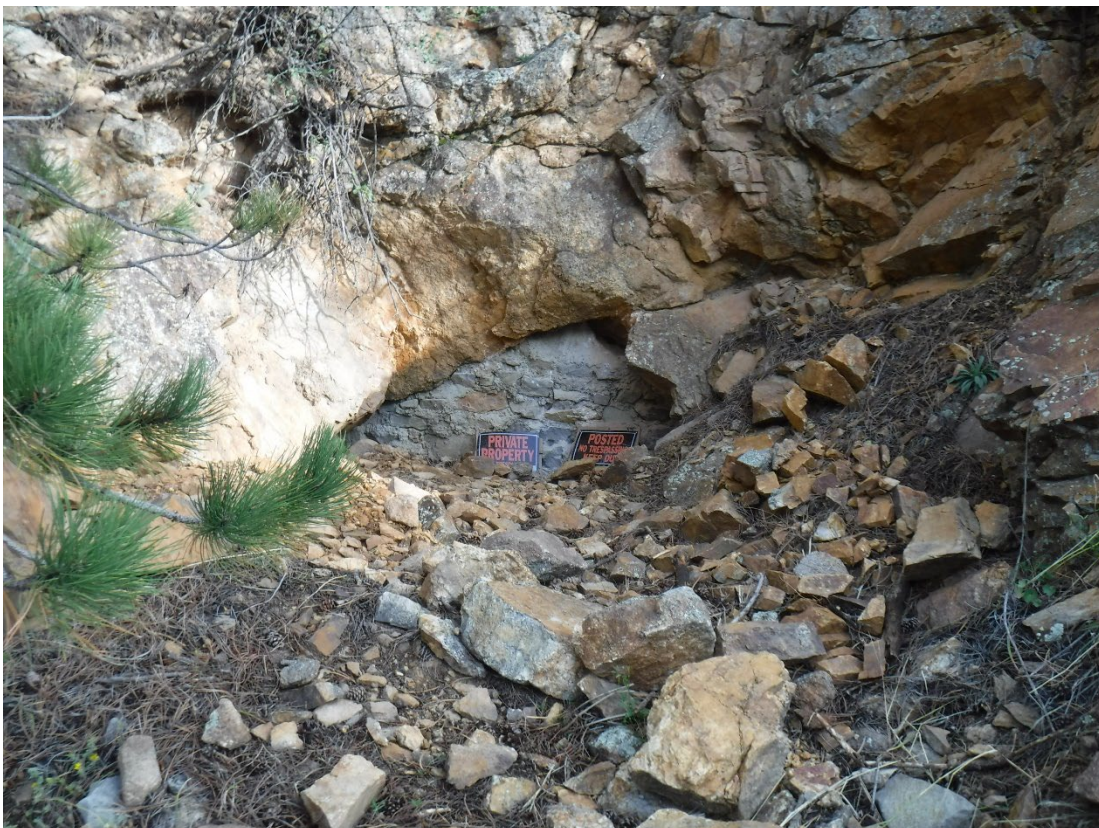
evidence the bulkhead had been drilled into and there hand tools near the entrance. In speaking to JL Mining they were the ones that attempted to breach the bulkhead but were actually looking for the East Adit and were at the wrong location. Once it was determined they were in the wrong location they moved to the East Adit area. The damage to the bulkhead was superficial.

**Photo 8:** West Adit, Portal #7, note stone bulkhead

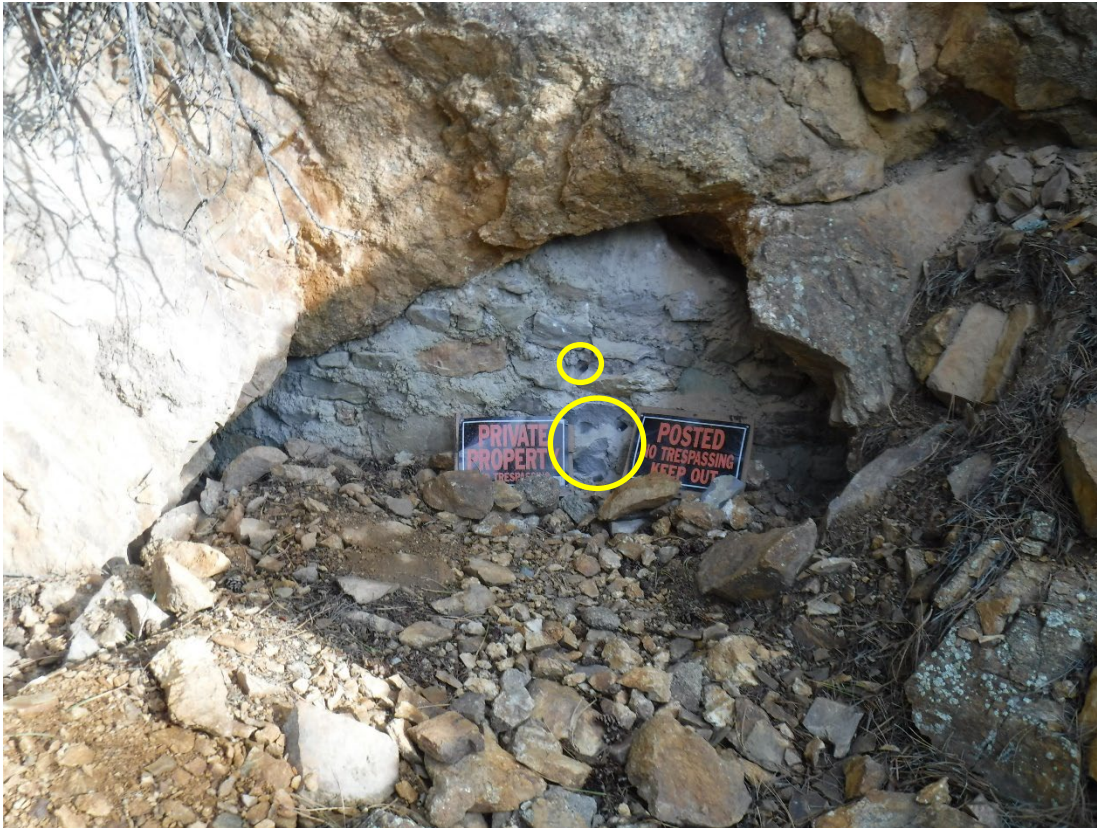
**Photo 9:** West Adit, Portal #7, shallow drill holes highlighted

The Division informed JL Mining that both adits are not part of the approved NOI, P2013-019, and any further disturbances to the adits will be considered mining or prospecting without a permit or approval and possible violations issued. Additionally, the exact location of the East Adit seems to be disputed and its location should be verified to determine whose property it is actually located on before any further work is completed in the area. The Division should be contacted prior to any work being done on the adits to determine what proper permitting is needed for the proposed work.

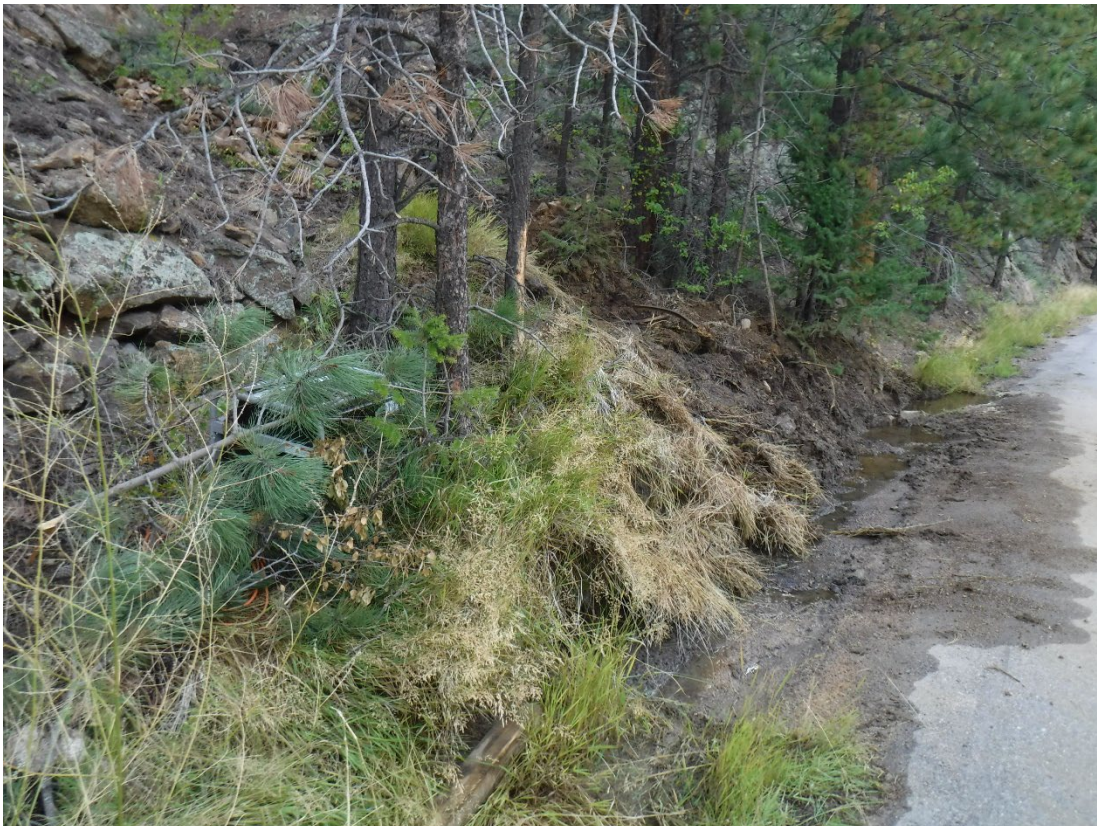
During the inspection of the East Adit the Division observed the area where digging had occurred. Eric indicated digging was done with a combination of hand-tools and mini-excavator. JL Mining stated the mini-excavator only moved minor amounts of dirt around totaling no more than a bucket's worth of dirt. The Division noted water flowing at the surface from where the disturbance was located. The water was estimated to be flowing at less than one (1) gallon per minute. The water was clear and neutral in color, carrying no sediment, and it had no odor. The Division also observed dense grass vegetation in the ditch immediately adjacent to and downgradient of the disturbance. As water flowed into the ditch it quickly dispersed into the vegetation and surface flow gradually diminished downgradient of the disturbance. As mentioned earlier, the Division was able to locate what appear to be two pipe cleanout chases. One is located just upgradient of the disturbance and the other was located at a culvert downgradient. No flow was observed into or out of the culvert crossing under James Canyon Drive. The disturbance area had been backfilled and it appeared stable.

**Photo 10:** East Adit, Portal #6, looking east along James Canyon Drive

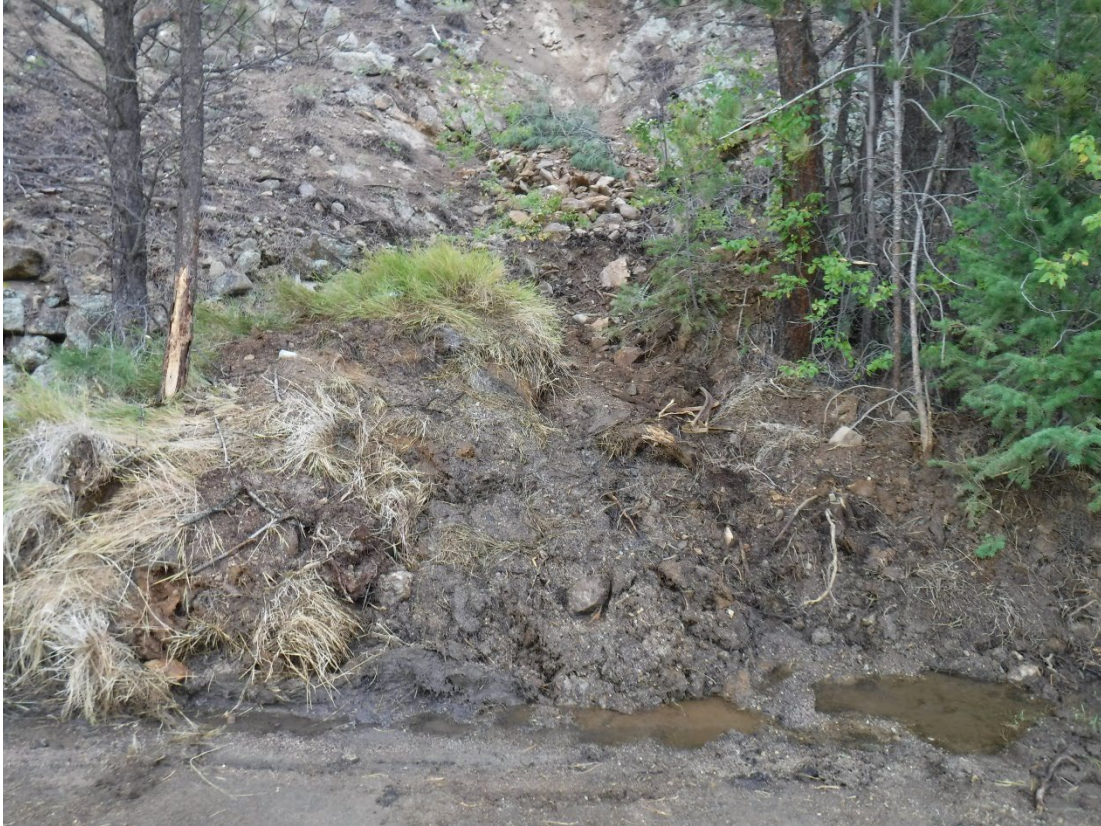
**Photo 11:** East Adit, Portal #6, looking north from James Canyon Drive

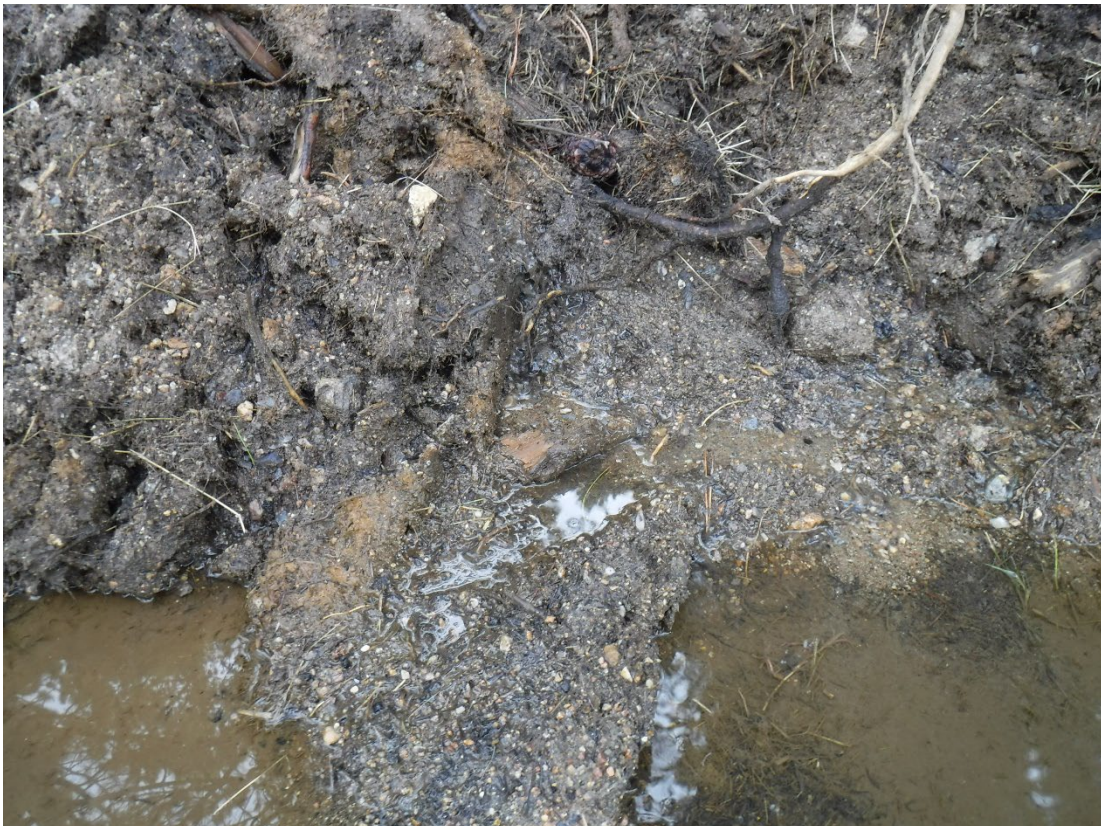
**Photo 12:** Surface water discharge

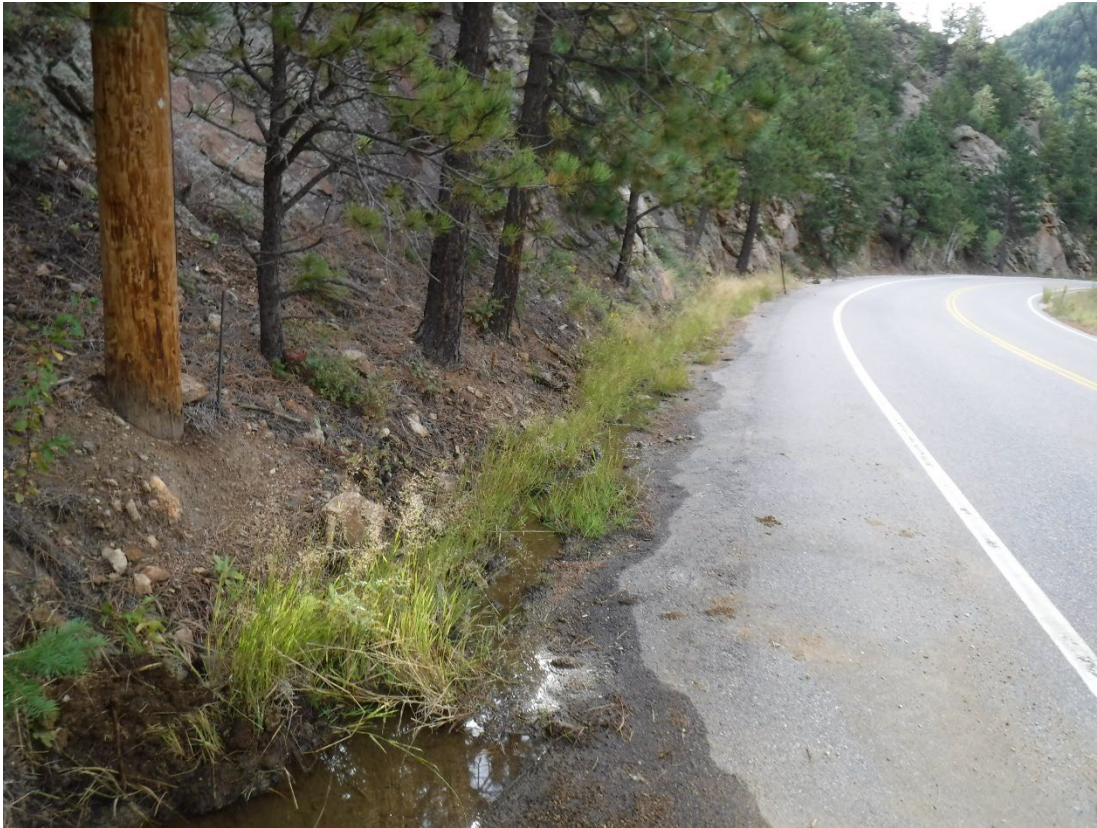
**Photo 13:** Surface water discharge down gradient of portal, water dissipates into vegetation in ditch

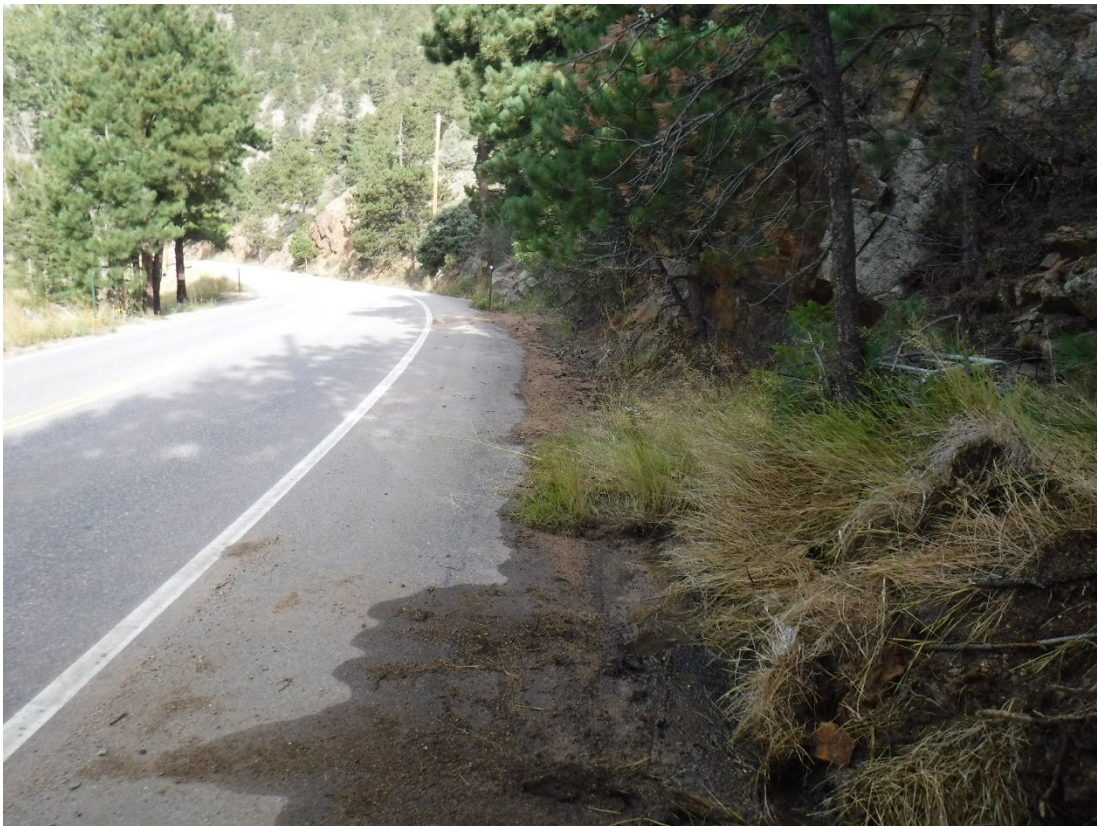
**Photo 14:** Ditch conditions upgradient of adit

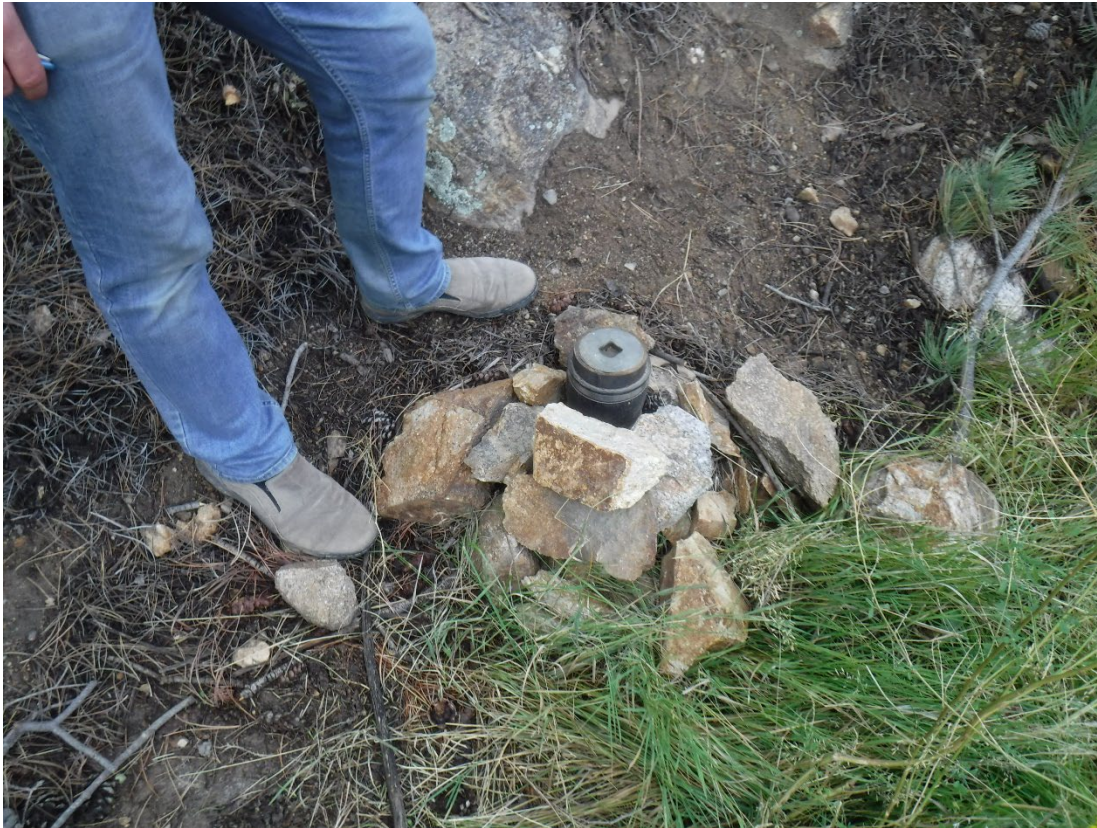
**Photo 15:** Pipe chase at adit

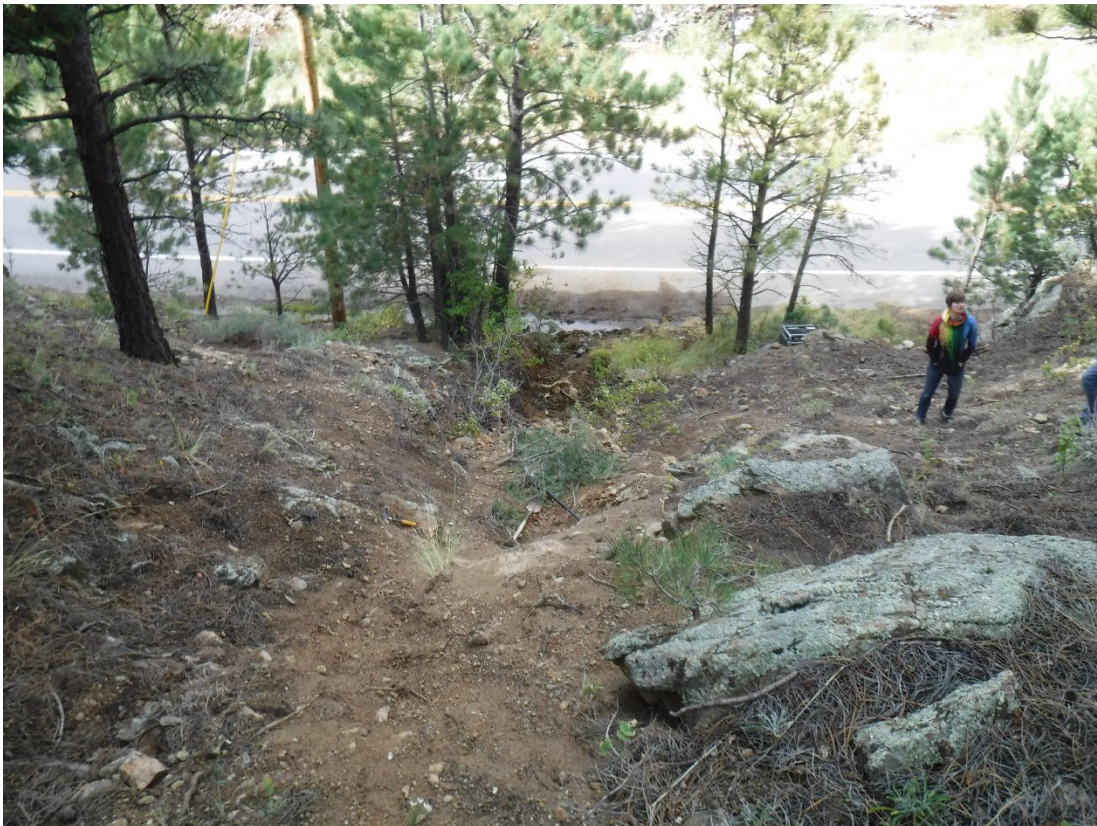
**Photo 16:** Looking towards James Canyon Drive above adit

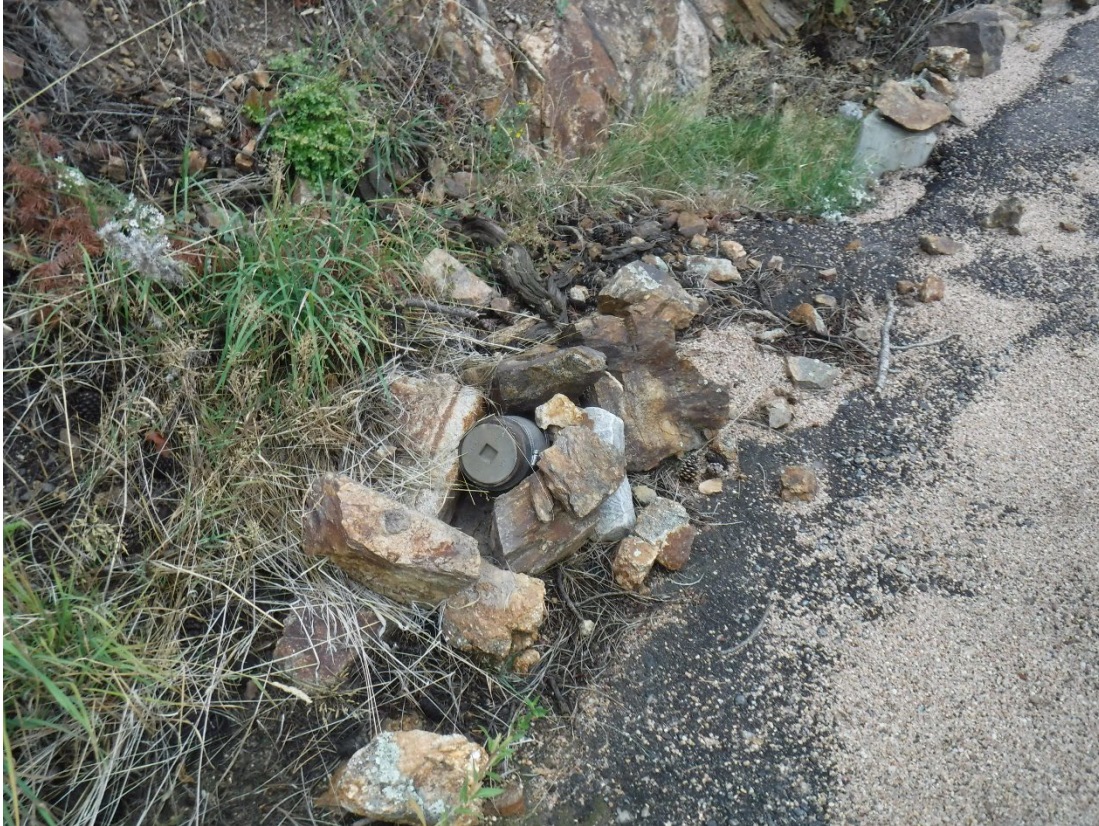
**Photo 17:** Pipe chase at culvert

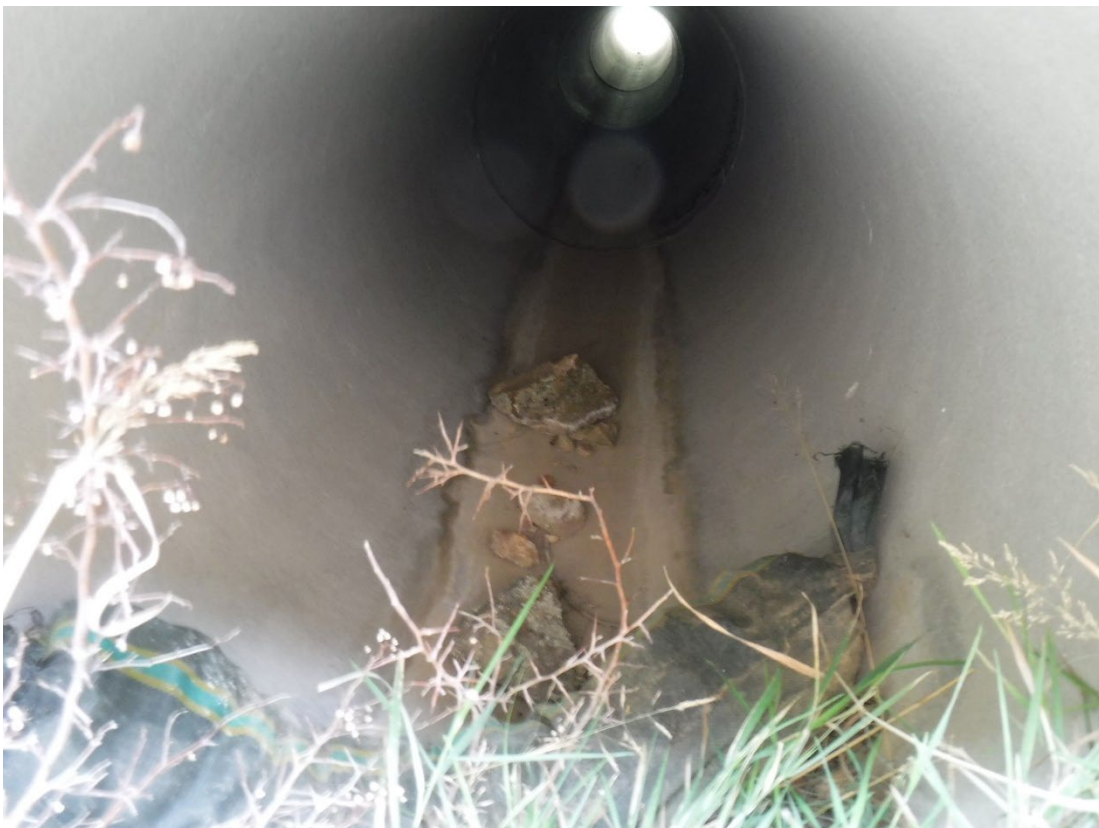
**Photo 18:** Dry culvert inlet

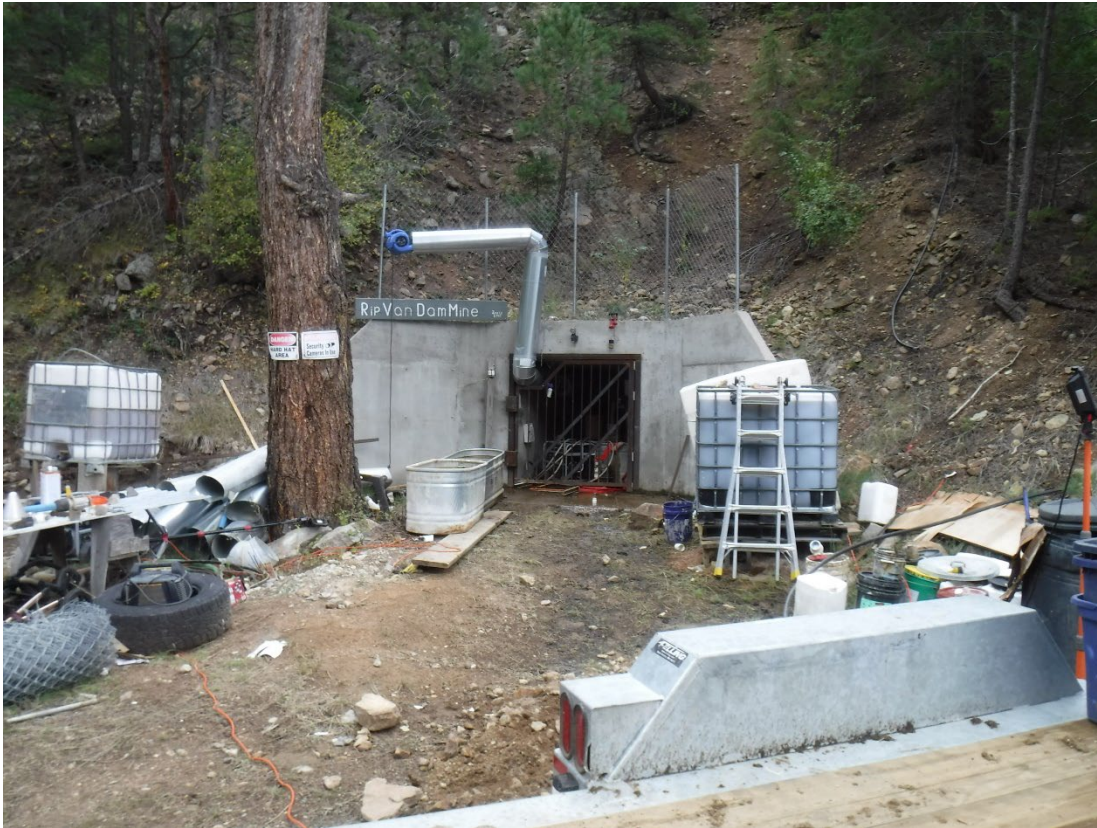
**Photo 19:** Conditions at the Rip Van Dam portal

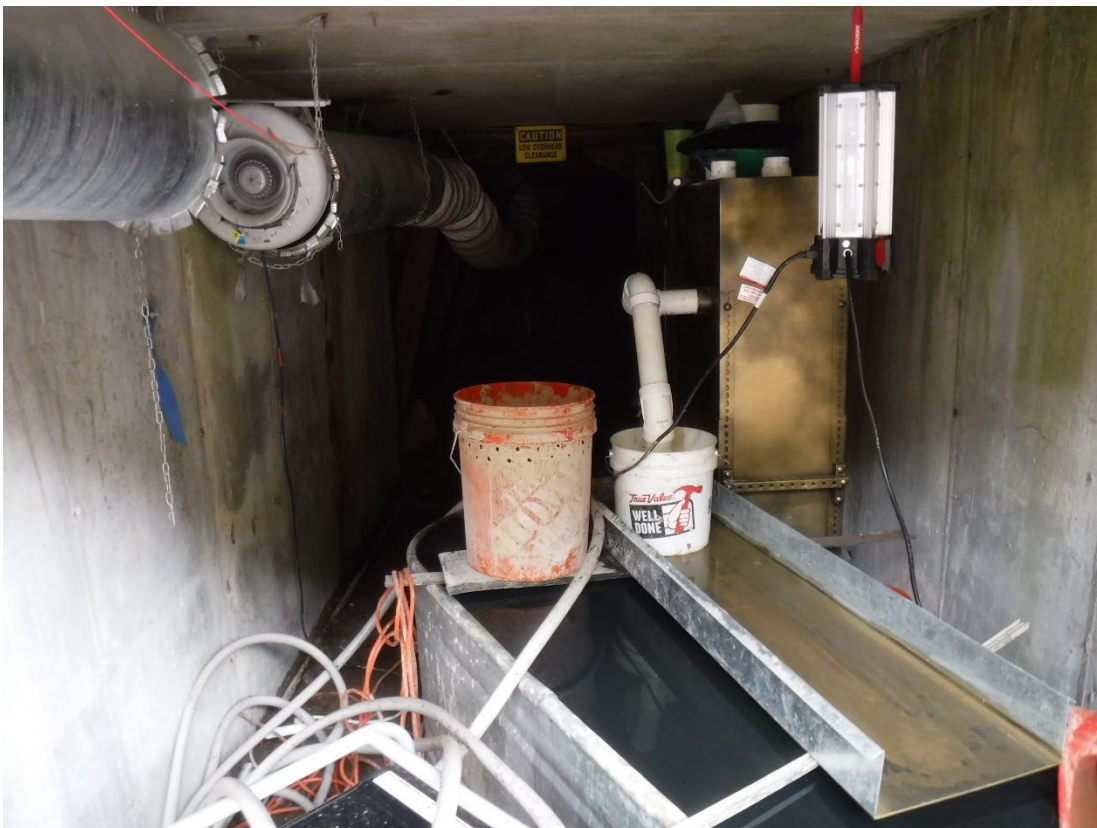
**Photo 20:** Equipment in the Rip Van Dam portal

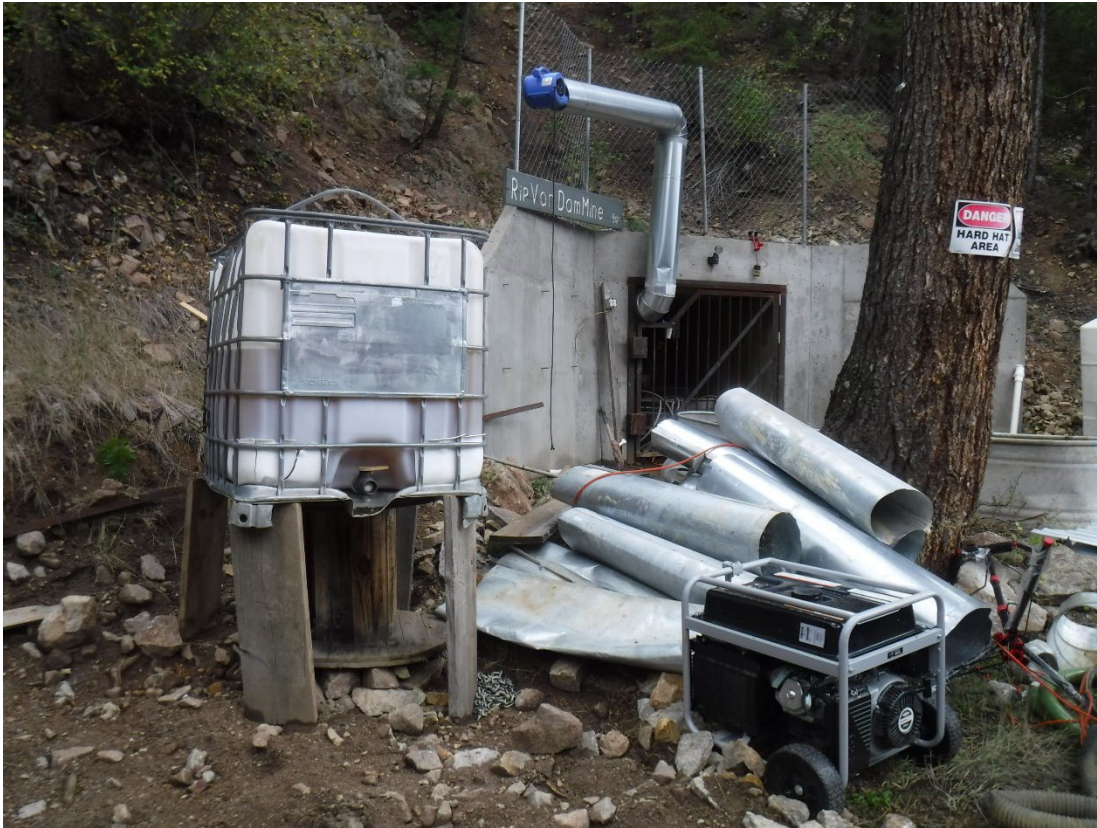
**Photo 21:** Equipment at the Rip Van Dam portal

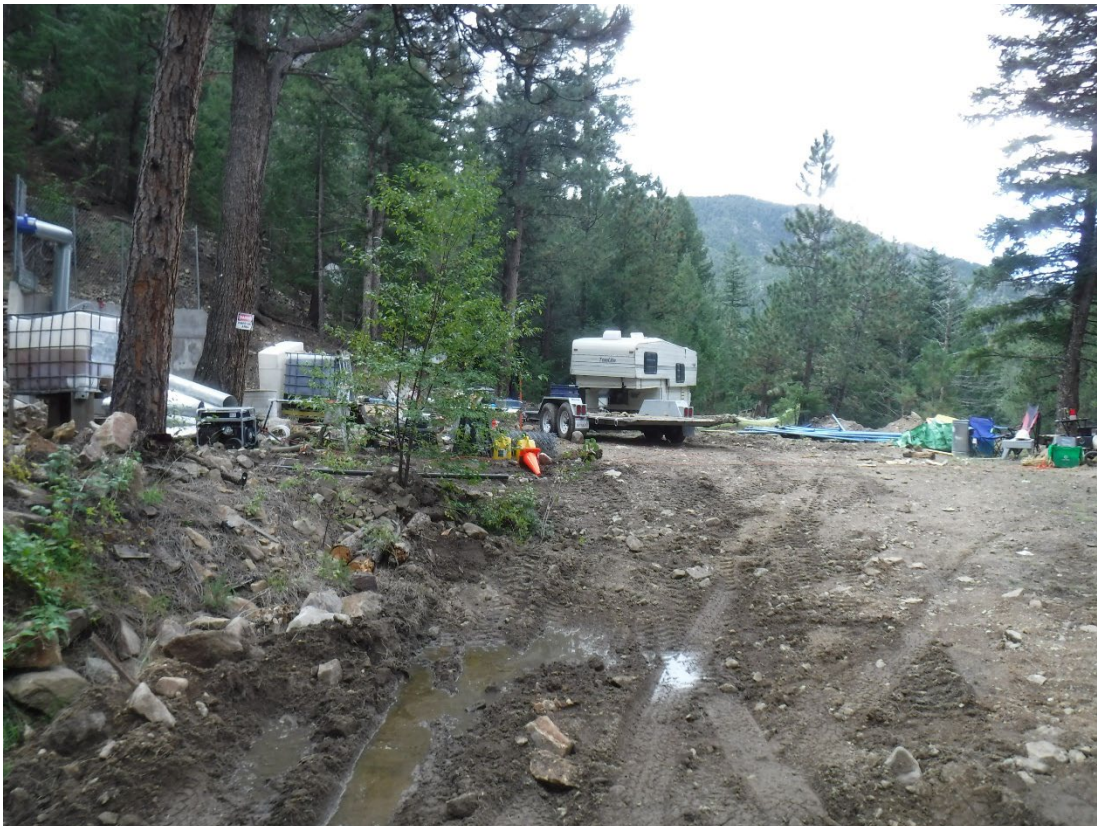
**Photo 22:** Equipment laydown area adjacent to the Rip Van Dam portal to the right of the picture is where the shed is located

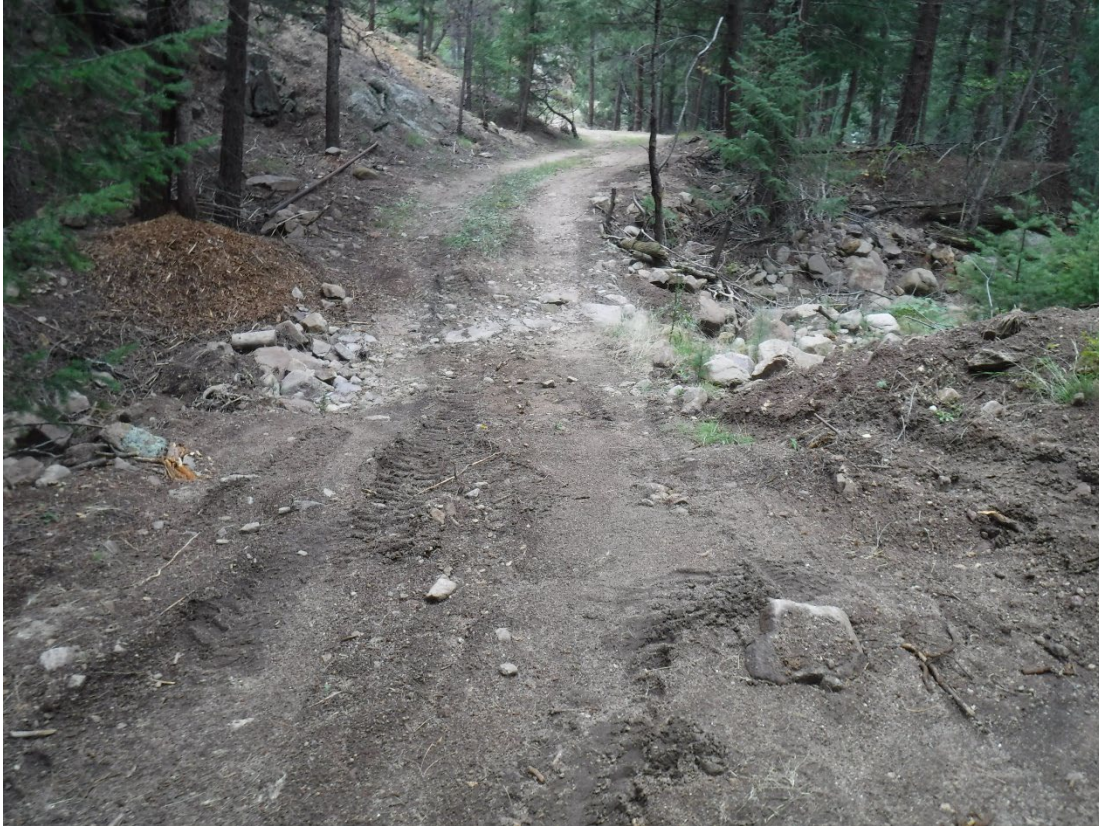
**Photo 23:** Low water crossing

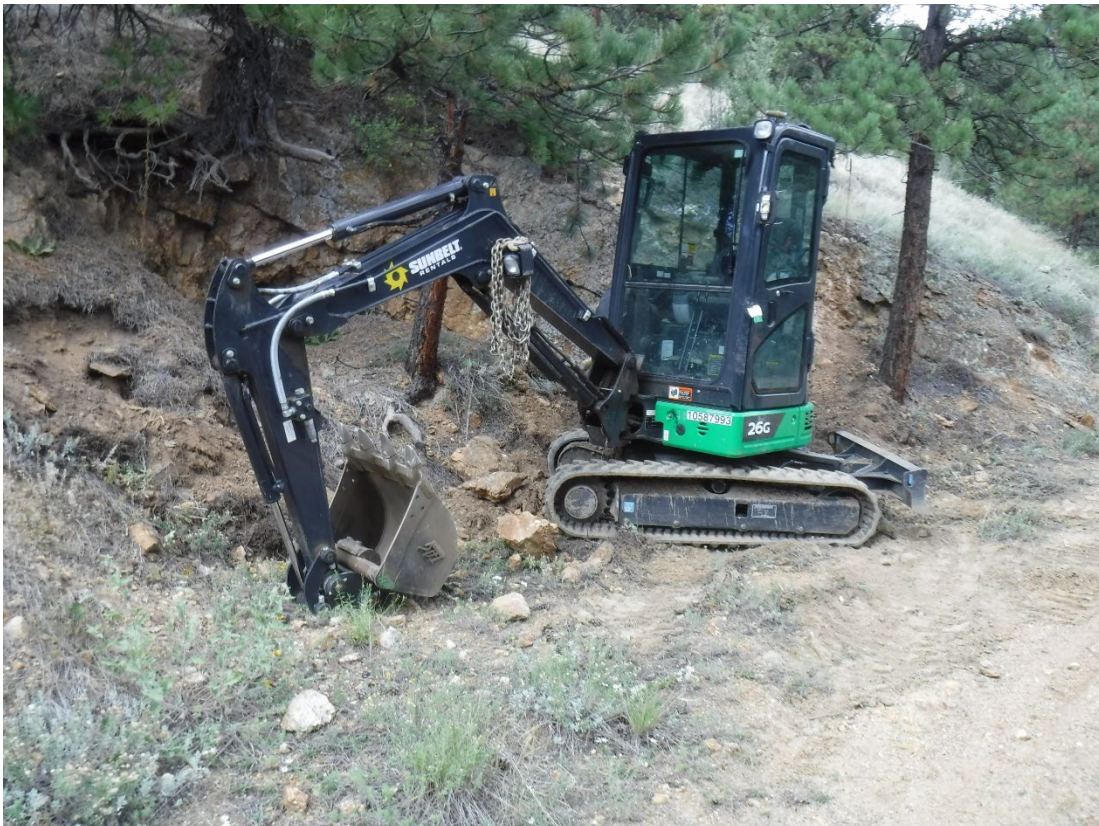
Lastly, the Division performed an inspection of the NOI P-2013-019. JL Mining indicated the only activity they had performed was collecting and running samples through a wash plant at the Rip Van Dam adit, marked Portal #2 on Map 2. The Division noted a temporary shed and converted trailer used for shelter at the entrance to the portal. There was a variety of equipment located at the adit entrance including two water tanks, a couple of troughs, and other assorted equipment. The Division also hiked to locate the mini-excavator. The excavator was found along the road leading to the King Wilhelm claim. The excavator was

**Photo 24:** Mini-excavator used on-site
