## MINERALS PROGRAM INSPECTION REPORT

<b>MINE NAME:</b> Boettcher Sandstone Quarry	<b>MINE/PROSPECTING ID#:</b> M-1977-345	<b>MINERAL:</b> Sandstone (silica, stone, quartzite)	<b>COUNTY:</b> Larimer
<b>INSPECTION TYPE:</b> Monitoring	<b>INSPECTOR(S):</b> Amy Eschberger	<b>INSP. DATE:</b> August 31, 2022	<b>INSP. TIME:</b> 10:45
<b>OPERATOR:</b> Holcim (US) Inc.	<b>OPERATOR REPRESENTATIVE:</b> Mike Toelle	<b>TYPE OF OPERATION:</b> 110c - Construction Limited Impact

# M-1977-345 / Boettcher Sandstone Quarry / Holcim (US) Inc.

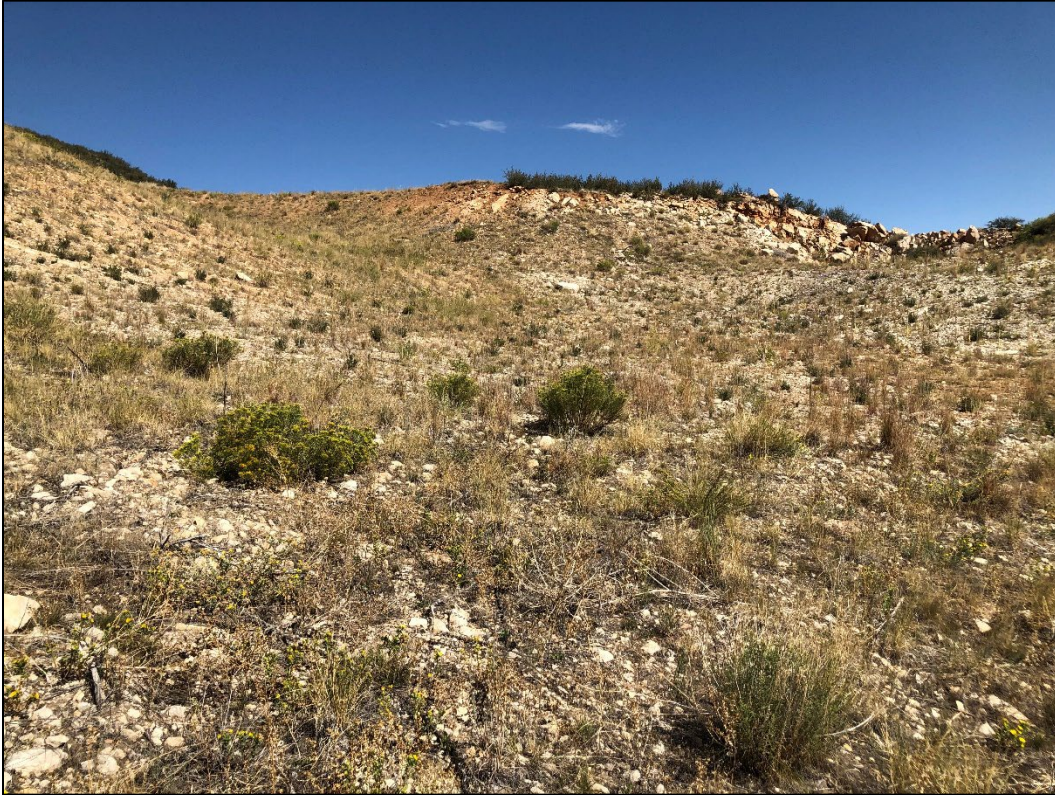
**Photo 1.** View looking north across northern edge of quarry, showing site reclaimed with stable slopes and vegetative cover consisting of grasses and shrubs.

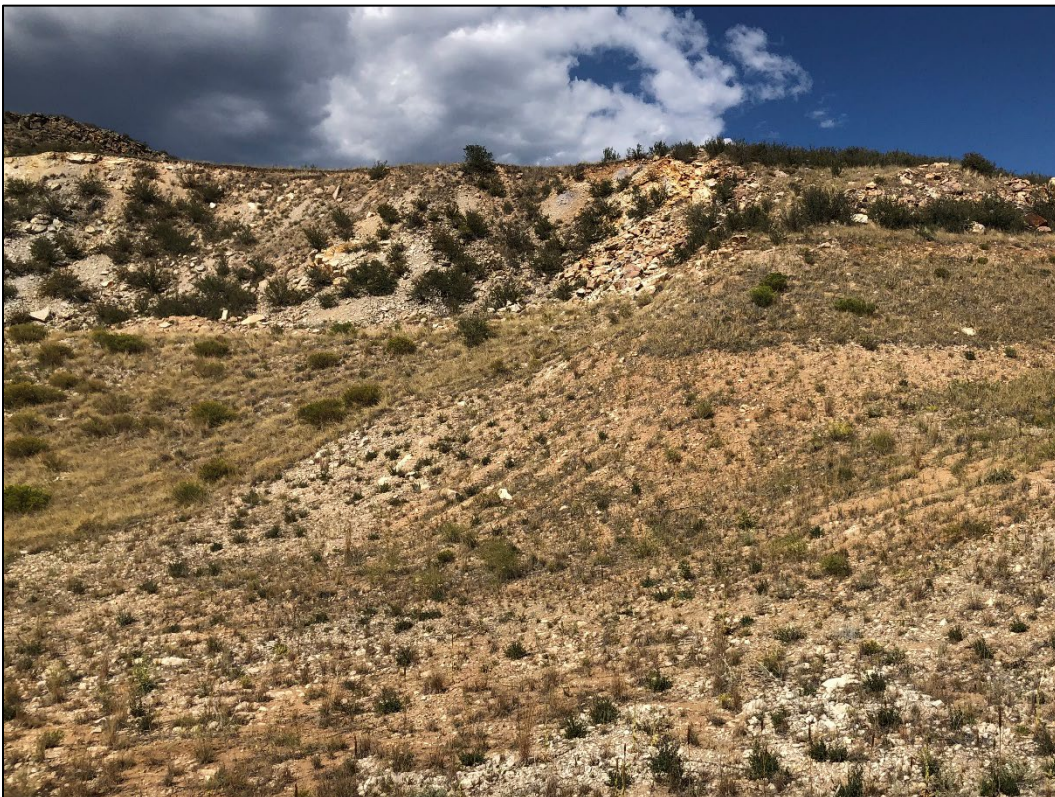
**Photo 2.** View looking west across western edge of quarry, showing site reclaimed with stable slopes and vegetative cover consisting of grasses and shrubs.

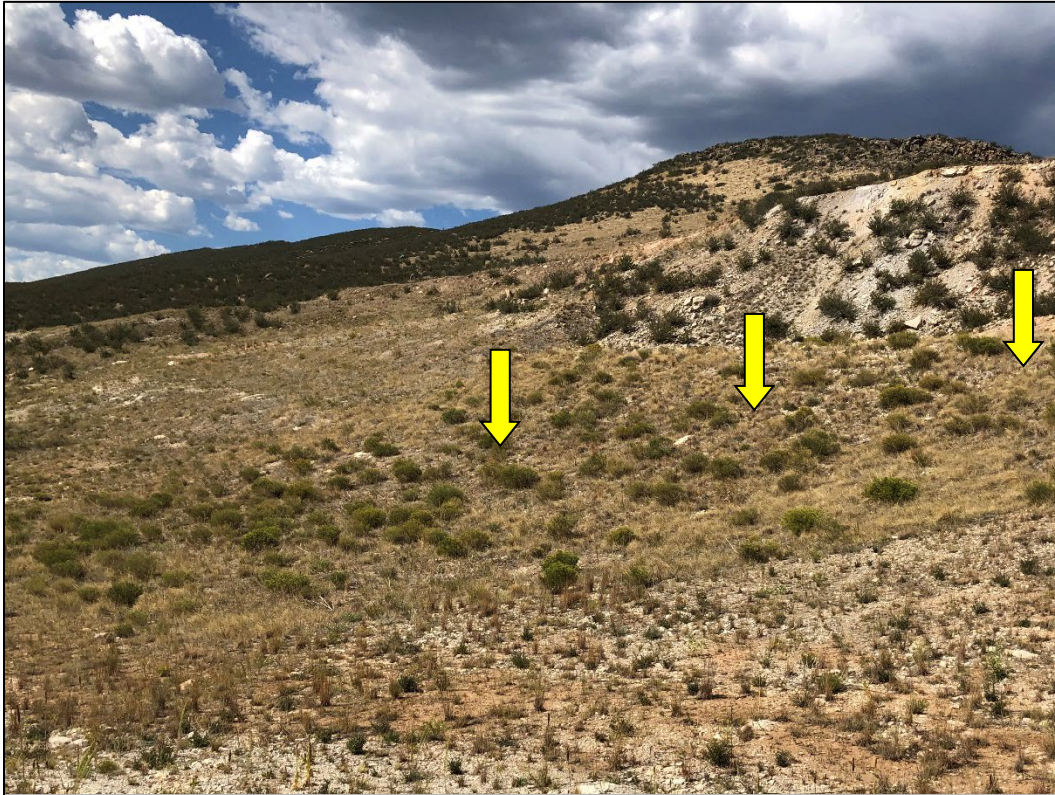
**Photo 3.** View looking southwest across portion of western highwall backfilled in 2016 (indicated), showing site reclaimed with stable slopes and vegetative cover consisting of grasses and shrubs.

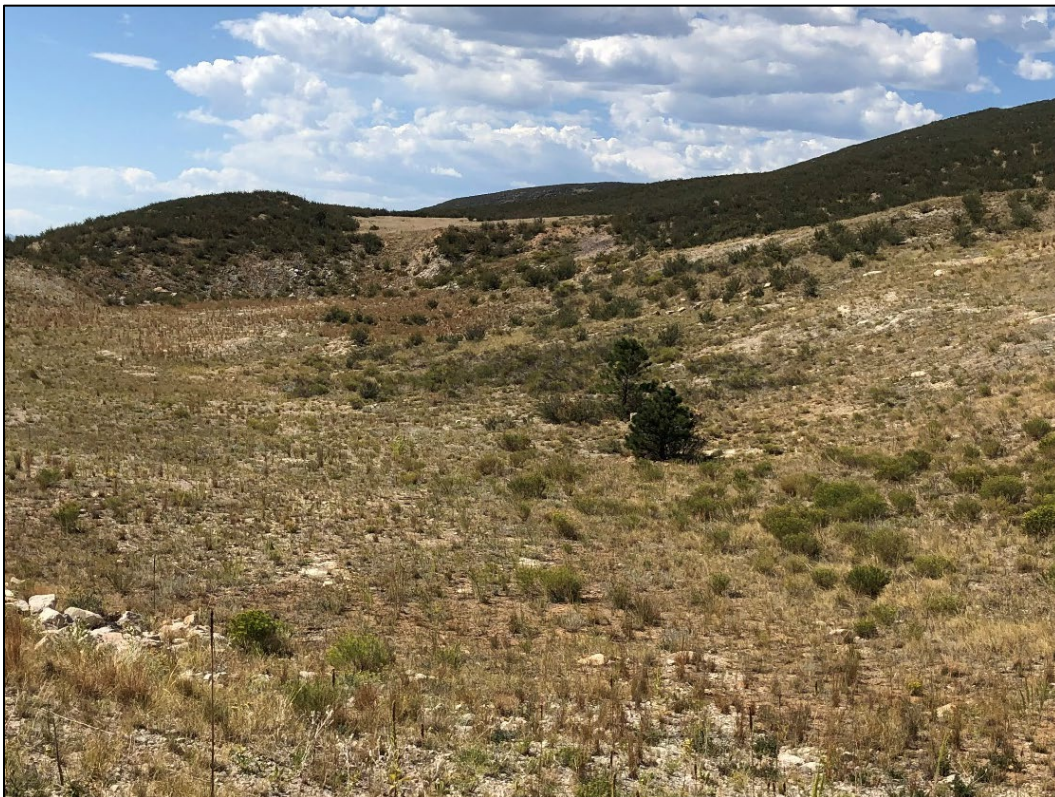
**Photo 4.** View looking south across central portion of quarry, showing site reclaimed with stable slopes and vegetative cover consisting of grasses and shrubs (and a few volunteer pine trees).

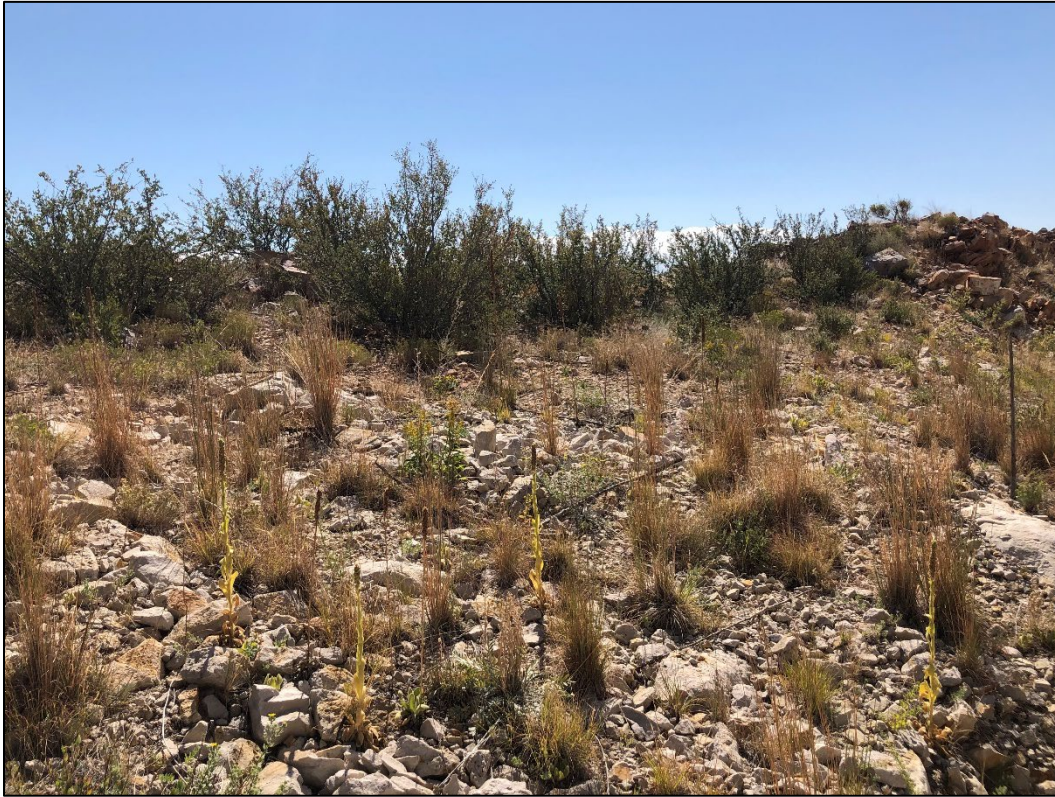
While there were some weeds observed growing in reclaimed areas, it is clear the weeds are being managed regularly. Also, the weeds did not appear to be hindering the growth of the desired vegetation. According to the operator, the county continues to manage the weeds at the site, generally visiting the site twice per year (once in the spring and again in the fall). Per the Colorado Department of Agriculture (CDA), the noxious weeds observed at the site, leafy spurge and common mullein, are considered List B and List C species, respectively. According to the CDA, List B species require the development and implementation of a noxious weed management plan designed to stop the continued spread of these species. List C species require the development and implementation of a noxious weed management plan designed to support the efforts of local governing bodies to facilitate more effective integrated weed management on the lands. For this site, a noxious weed management plan has been developed in coordination with the local government (Larimer County) and is implemented at the site every year.

**Photo 5.** View looking east across eastern edge of quarry, showing slopes stabilized with grasses and shrubs. Common mullein in this area was treated earlier this year and will continue to be managed.

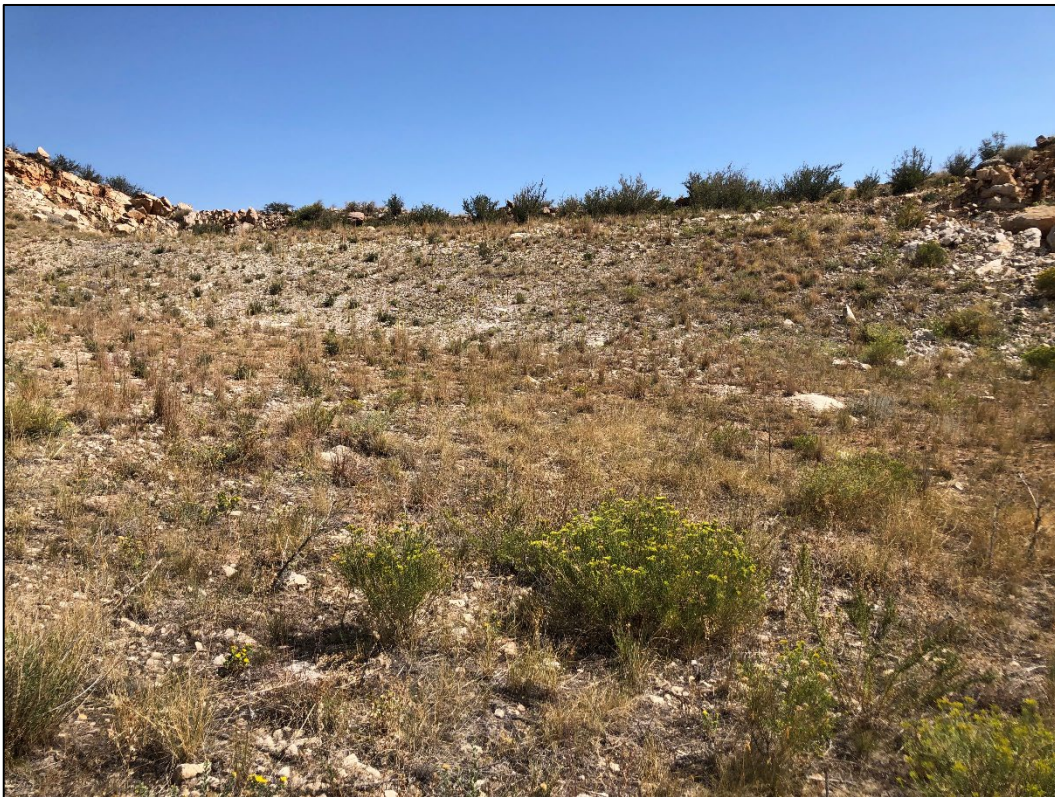
**Photo 6.** View looking east across eastern edge of quarry, showing site reclaimed with stable slopes and vegetative cover consisting of grasses and shrubs.

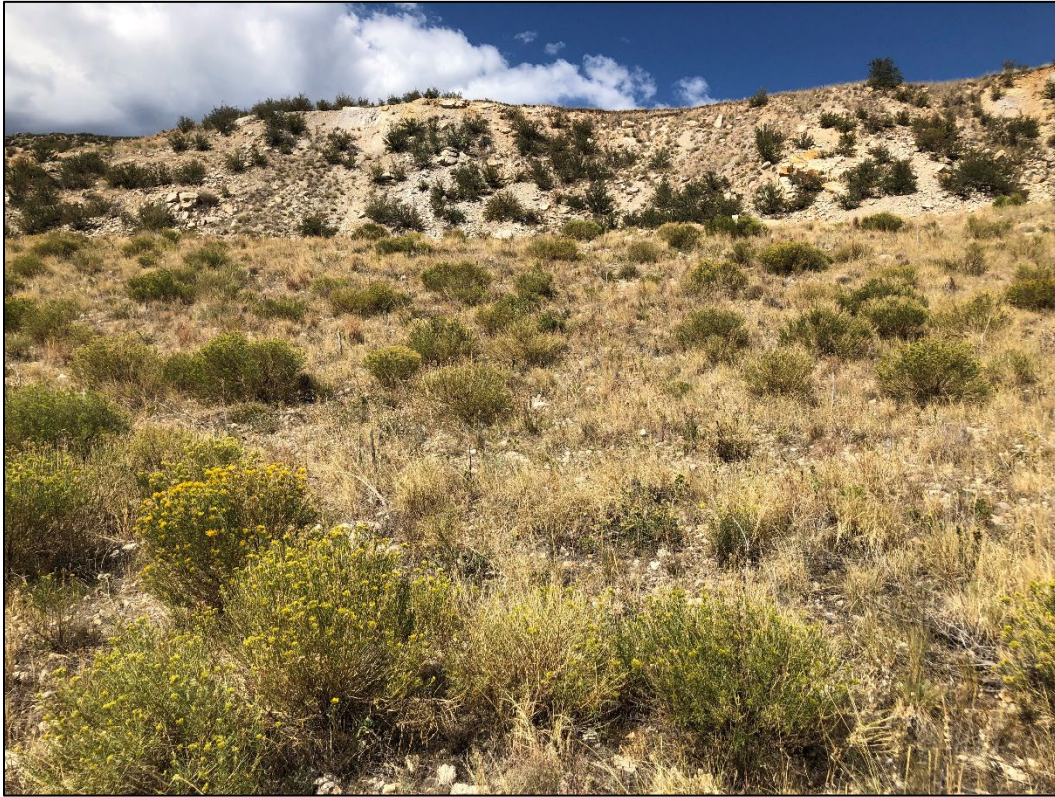
**Photo 7.** View looking west across western edge of quarry, showing site reclaimed with stable slopes and vegetative cover consisting of grasses and shrubs.

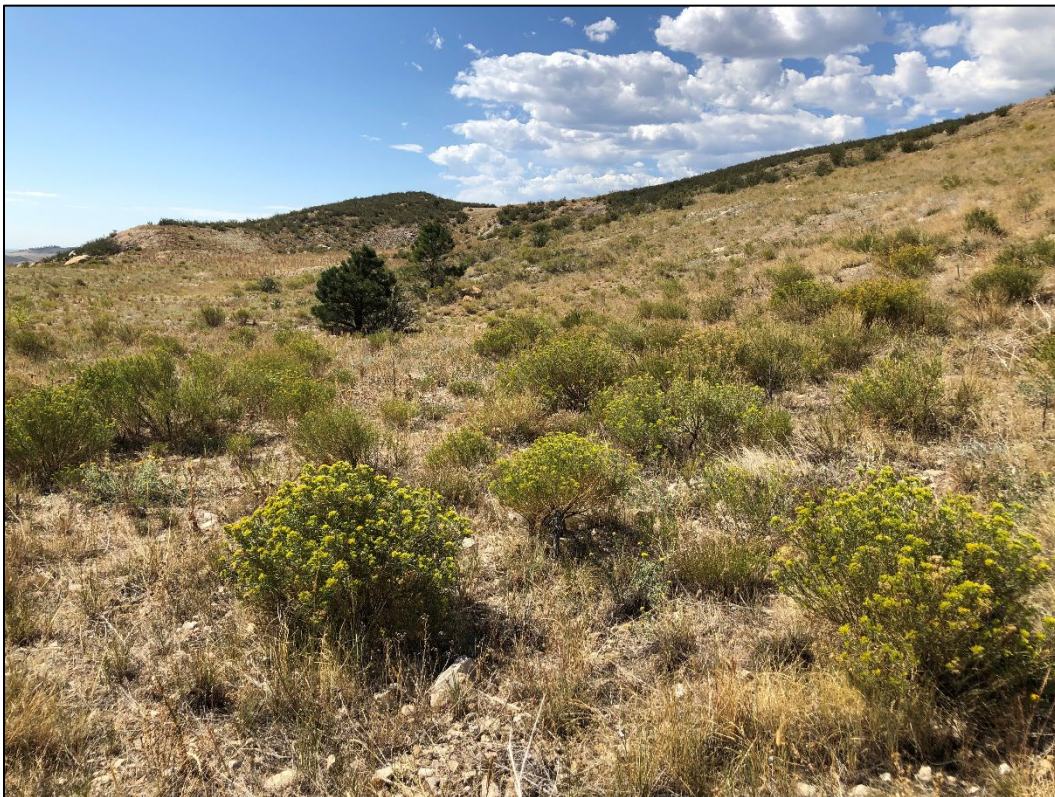
**Photo 8.** View looking south across western edge of quarry, showing site reclaimed with stable slopes and vegetative cover consisting of grasses and shrubs (and a few volunteer pine trees).

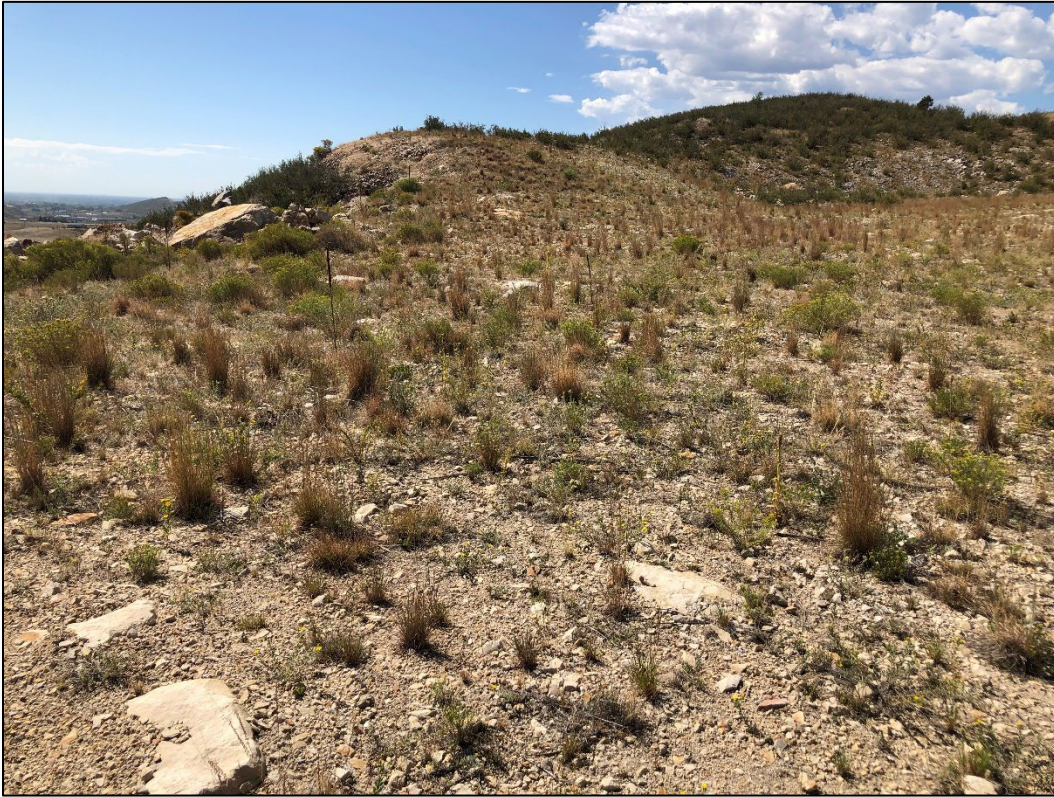
**Photo 9.** View looking south across previously reclaimed southern edge of quarry. Note reclaimed surface left rocky per approved plan, with good establishment of grasses and shrubs.

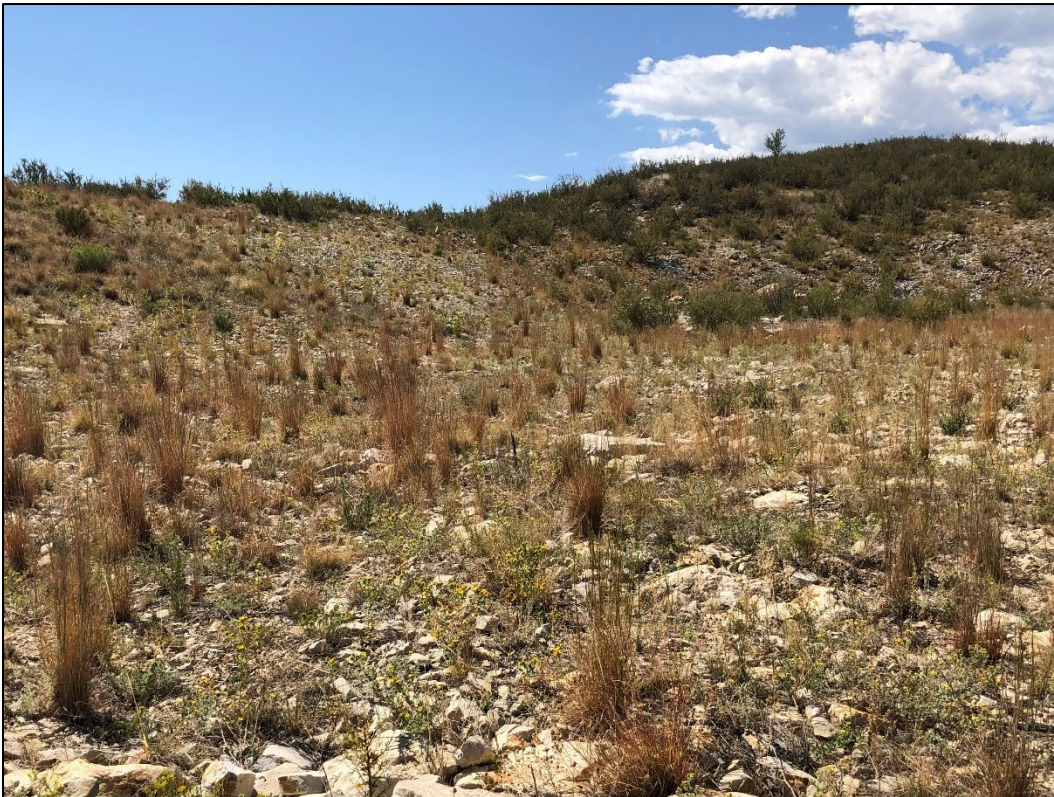
**Photo 10.** View looking southwest across previously reclaimed southern edge of quarry. Note reclaimed surface left rocky per approved plan, with good establishment of grasses and shrubs.
