MINERALS PROGRAM INSPECTION REPORT

MINE NAME: West Equity Project	MINE/PROSPECTING ID#: P-2010-015	MINERAL: Zinc, lead, gold and silver	COUNTY: Mineral
INSPECTION TYPE: Monitoring	INSPECTOR(S): Lucas West	INSP. DATE: August 31, 2022	INSP. TIME: 09:50
OPERATOR: Rio Grande Silver, Inc.	OPERATOR REPRESENTATIVE: Randy McClure	TYPE OF OPERATION: MP - Mineral Prospecting	
REASON FOR INSPECTION: Normal I&E Program	BOND CALCULATION TYPE: None	BOND AMOUNT: \$34,500.00	
DATE OF COMPLAINT: NA	POST INSP. CONTACTS: None	JOINT INSP. AGENCY: None	
WEATHER: Clear	INSPECTOR'S SIGNATURE:

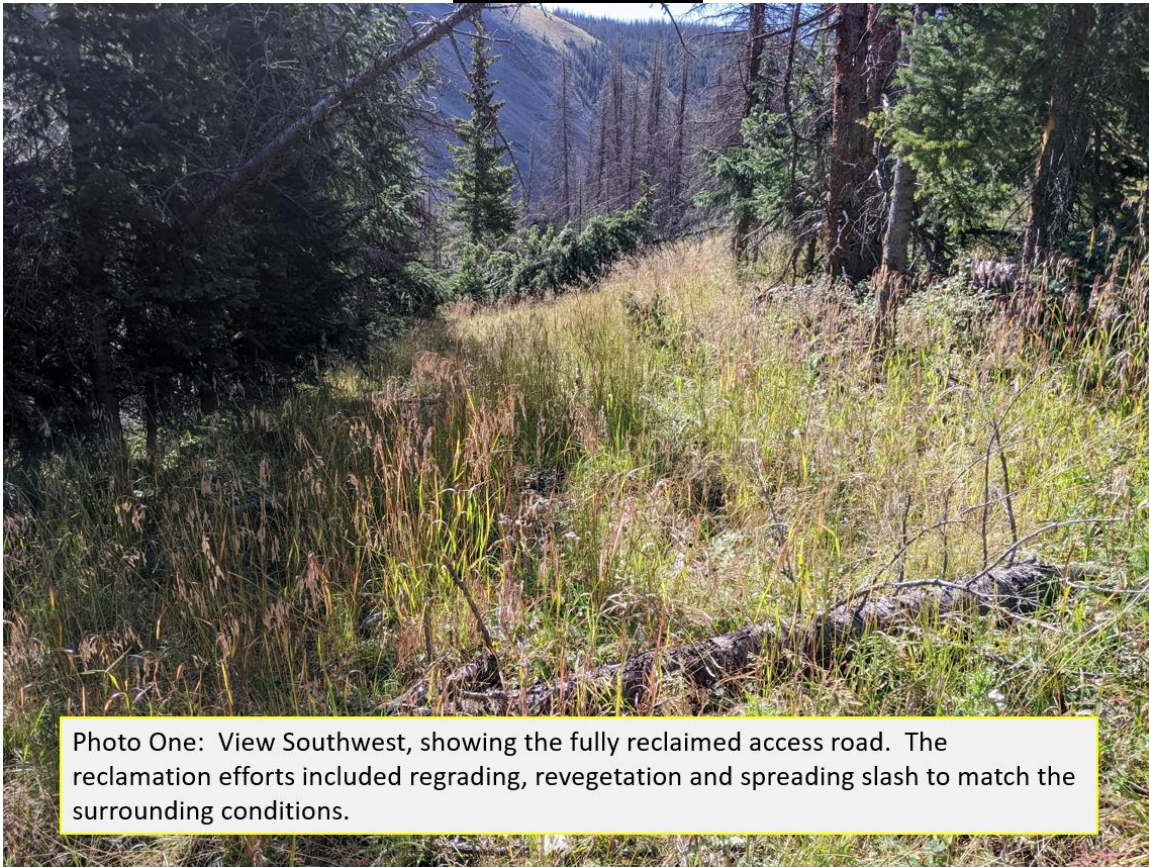
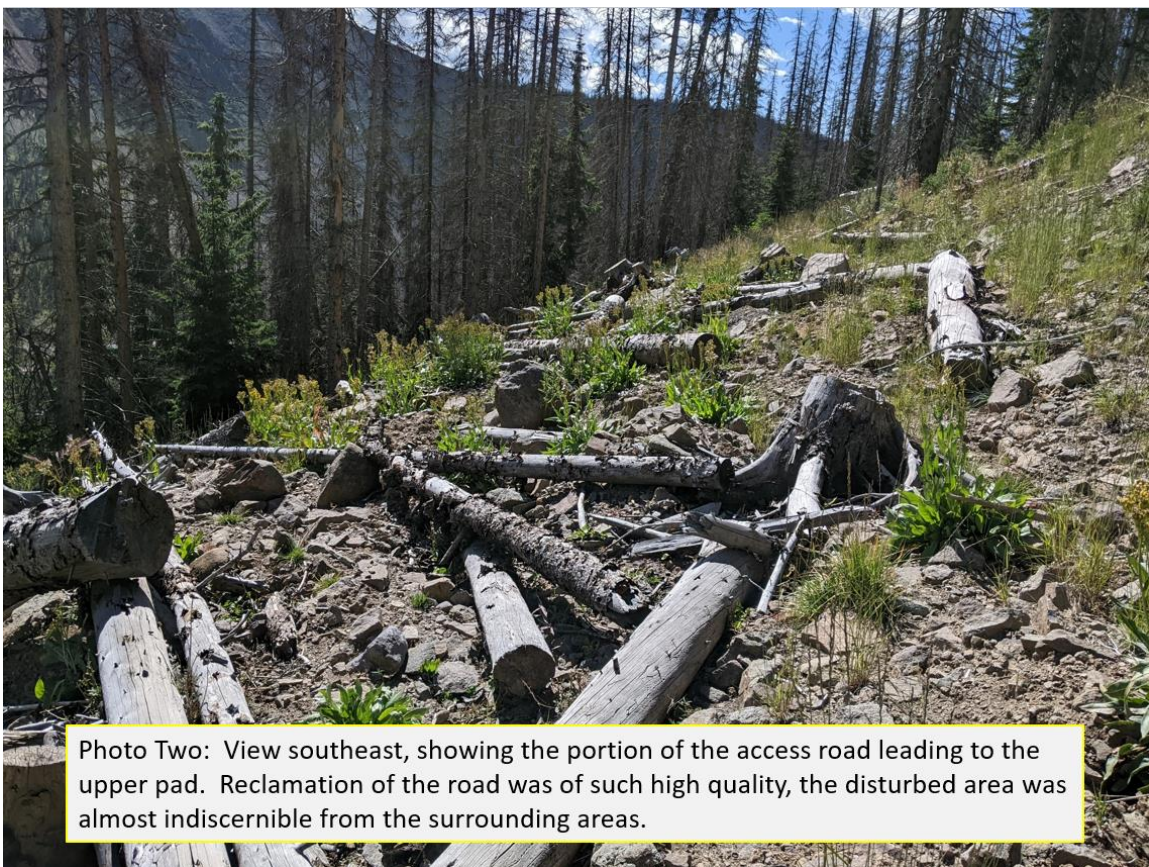
Development and exploration activities conducted at the site was the construction of approximately 2,500 linear feet of access road and two drill pads for surface drilling operations. The entire length of the access road and drill pads were observed during the inspection. All disturbances have been fully reclaimed. The access road has been regraded to match the surrounding topography. No evidence of settling, slumping or erosion was noted along the access road. The road has also been revegetated through a combination of seeding and weed control efforts by the Operator as well as volunteer vegetation from the surrounding areas. Examples of the access road can be seen in Photos One and Two.

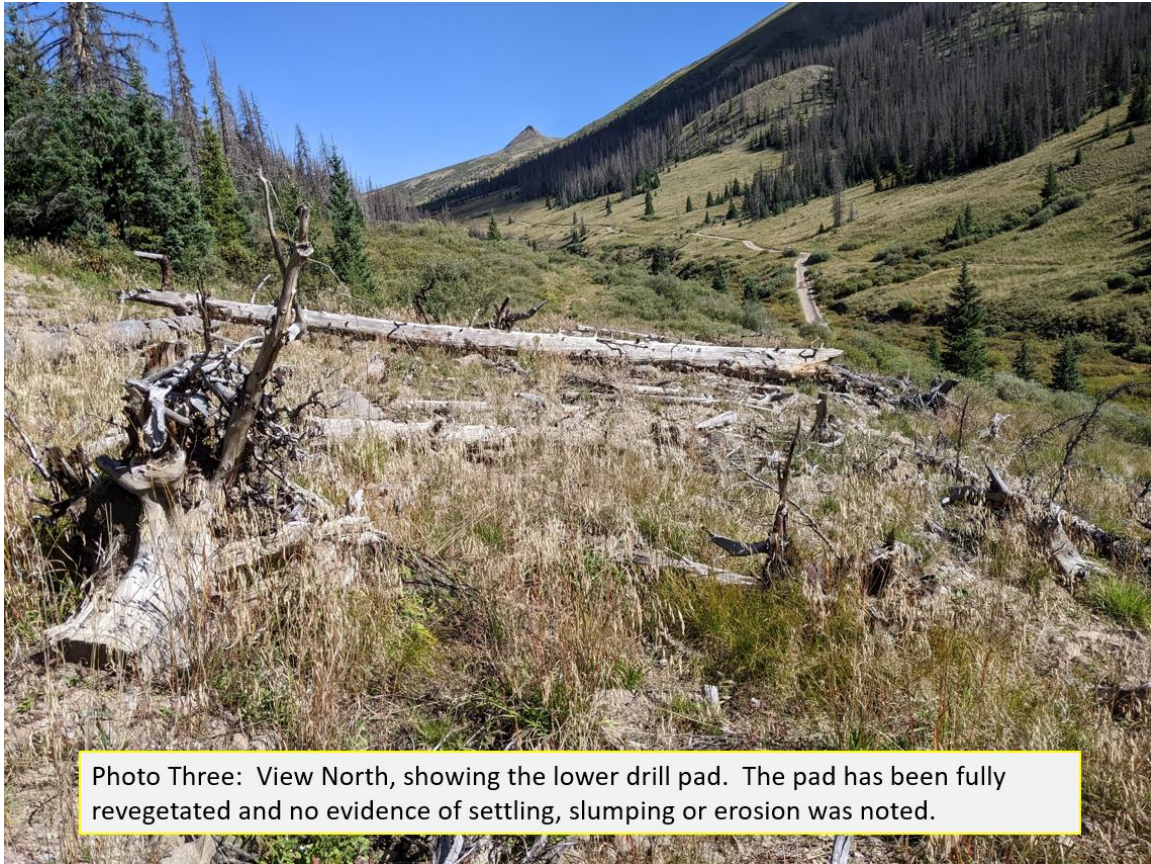
Both pads have also been regraded, and seeded. The pads were stable at the time of the inspection and no evidence of settling, slumping or erosion was noted. The vegetative cover on the pads is dense, diverse and shows multiple year's biomass indicating the cover is capable of self-regeneration. No State Listed Noxious Weeds were noted on the pads nor the access road. On site discussions with the Operator indicated that weed management had been aggressive to achieve the high quality of reclamation that was observed. Examples of the pads can be seen in Photos Three and Four. No exploration related trash or debris was observed on site.

Photo Three: View North, showing the lower drill pad. The pad has been fully revegetated and no evidence of settling, slumping or erosion was noted.

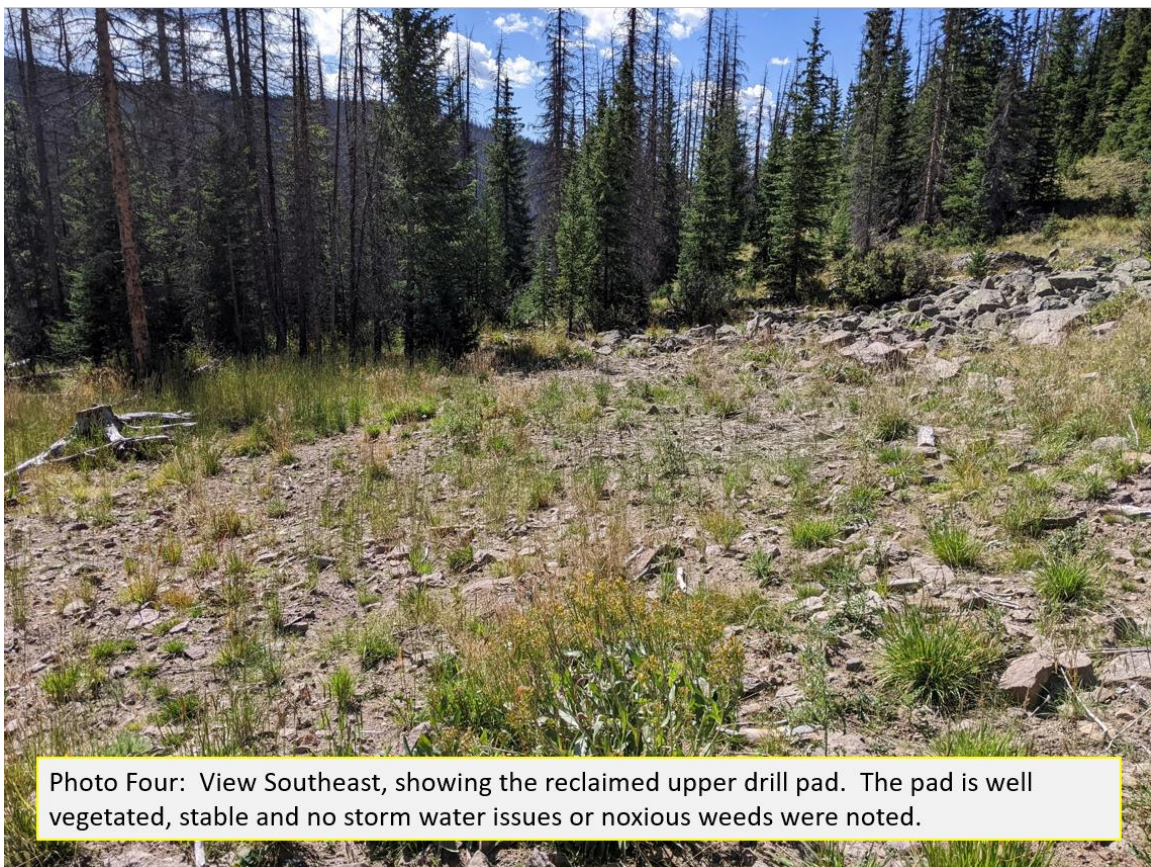
Photo Four: View Southeast, showing the reclaimed upper drill pad. The pad is well vegetated, stable and no storm water issues or noxious weeds were noted.
