MINERALS PROGRAM INSPECTION REPORT

MINE NAME: Equity Exploration Project	MINE/PROSPECTING ID#: P-2011-010	MINERAL: Silver, gold, lead and	COUNTY: Mineral
INSPECTION TYPE: Monitoring	INSPECTOR(S): Lucas West	INSP. DATE: August 31, 2022	INSP. TIME: 11:10
OPERATOR: Rio Grande Silver, Inc.	OPERATOR REPRESENTATIVE: Randy McClure	TYPE OF OPERATION: MP - Mineral Prospecting

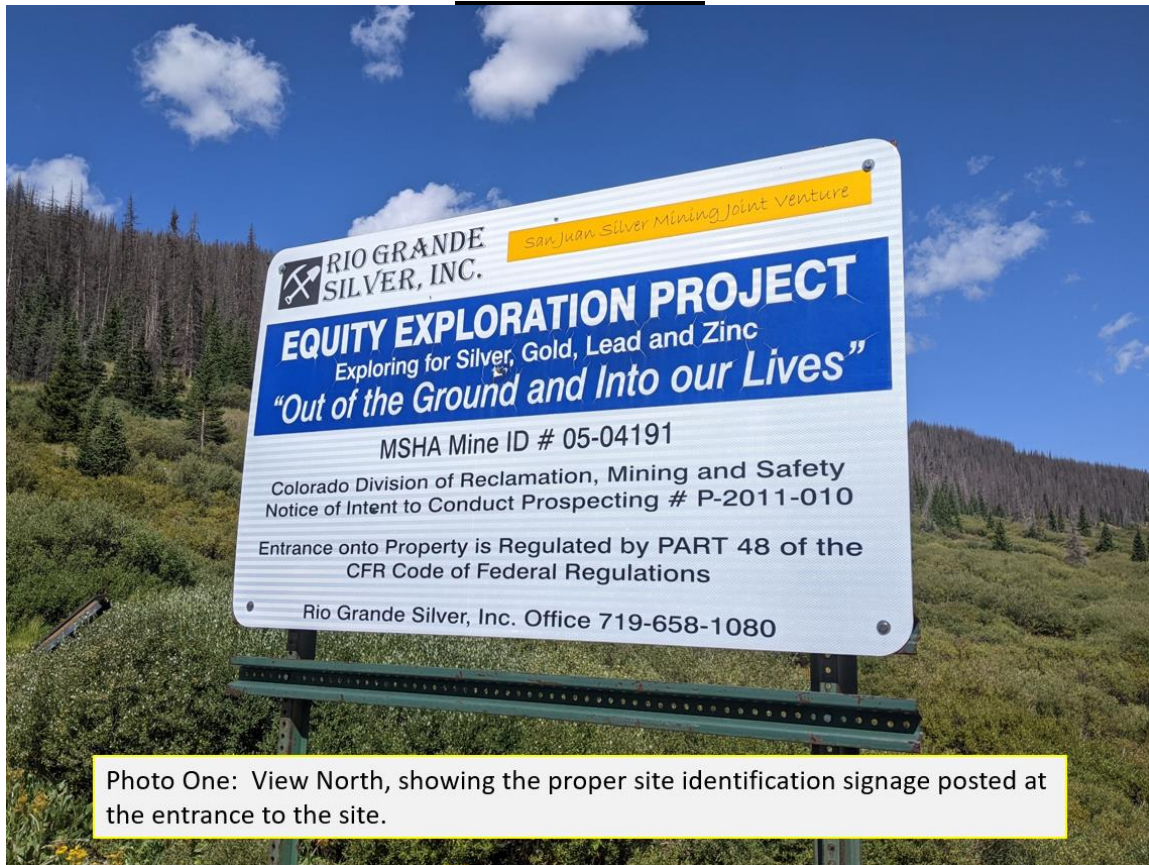
The site was not active the day of the inspection and no exploration equipment was located on site. The Proper NOI Identification sign was posted at the entrance to the site and can be seen in Photo One. The permit boundaries were clearly identifiable by prominent landmarks around the site. Public access to the site is controlled by a locked gate along the access road. The site consists of 3.8 acres, containing a main access portal, ventilation adit and various support facilities located on the portal pad. The portal pad contains various support structures for the exploration project including a shop facility, storage containers and fuel storage building. The various structures can be seen in Photo Two. Since the Division's previous inspection the soft cover over the shop facility had fallen into disrepair and needed to be removed. The frame of the shop building still remains and will likely be reused with a new cover. The storage container was verified to be secure. Various above ground water storage tanks are located adjacent to the shop and verified to be empty. During active exploration the tanks are used for drilling water underground. On site fuel storage is located just north of the shop building and consists of two large double walled fuel tanks stored within a secure building. The tanks are also stored in a lined secondary containment structure within the building providing for extra spill prevention. The fuel storage building can be seen in Photo Three. The tanks and secondary containment structures are in excellent condition.

Photo One: View North, showing the proper site identification signage posted at the entrance to the site.

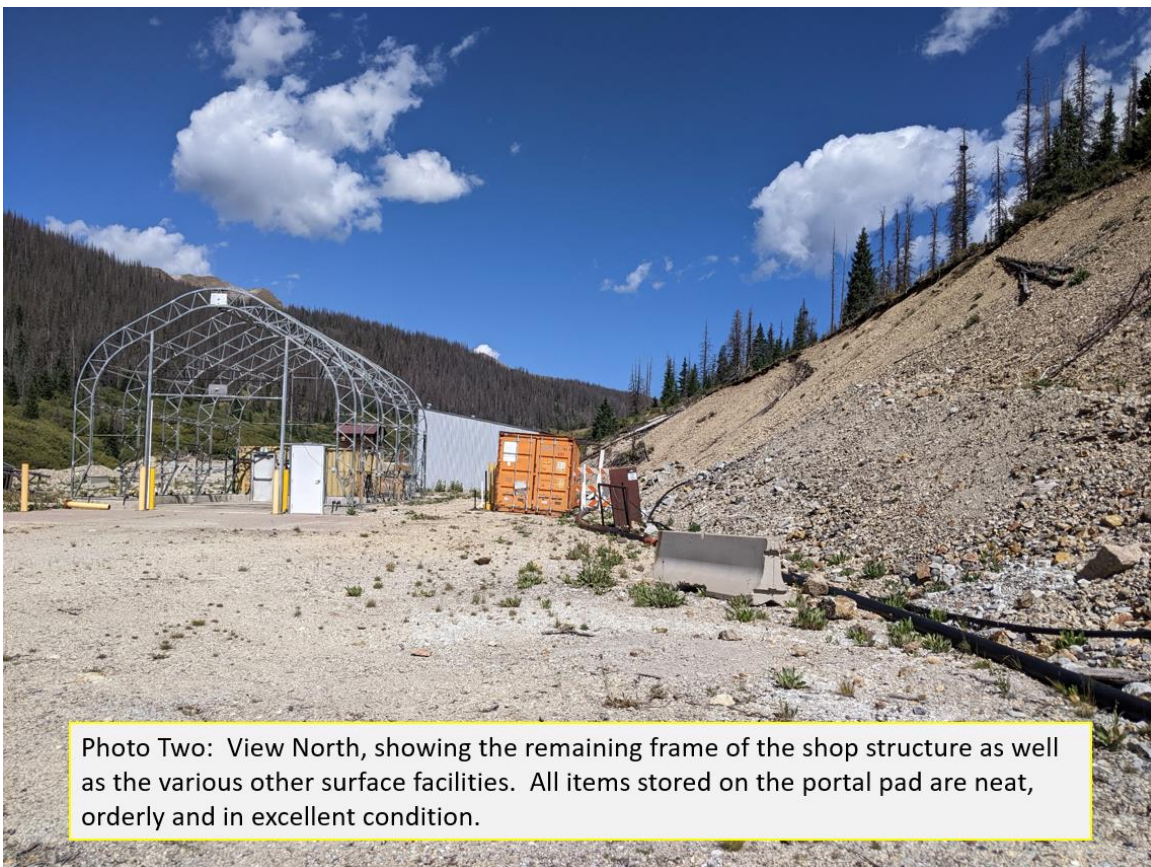
Photo Two: View North, showing the remaining frame of the shop structure as well as the various other surface facilities. All items stored on the portal pad are neat, orderly and in excellent condition.

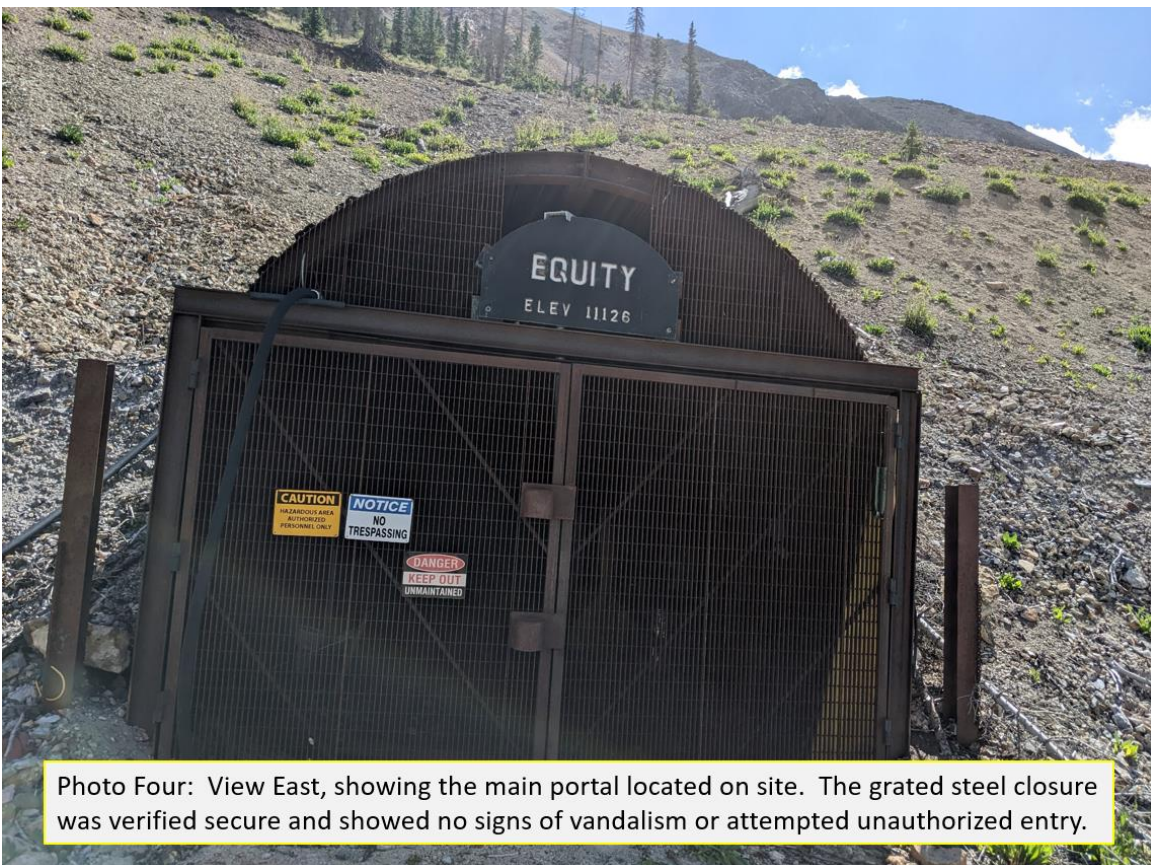
The main portal was observed with a locking metal gate closure that was verified secure at the time of the inspection. The portal can be seen in Photo Four. The closure is in excellent condition and no evidence of vandalism or attempted unauthorized entry was observed. The portal does not have an associated discharge or water management facilities. The ventilation adit, shown in Photo Five was also observed to be in excellent condition. It is closed off and secured with a locking metal gate closure and similar to the main portal, showed no signs of damage or vandalism.
