MINERALS PROGRAM INSPECTION REPORT

MINE NAME: Bulldog Mine Operation	MINE/PROSPECTING ID#: M-1977-215	MINERAL: Lead and silver	COUNTY: Mineral
INSPECTION TYPE: Monitoring	INSPECTOR(S): Lucas West	INSP. DATE: August 31, 2022	INSP. TIME: 12:23
OPERATOR: Rio Grande Silver, Inc.	OPERATOR REPRESENTATIVE: Randy McClure	TYPE OF OPERATION: 112d-2 - Designated Mining Operation	
REASON FOR INSPECTION: Normal I&E Program	BOND CALCULATION TYPE: Complete Bond	BOND AMOUNT: \$163,228.13	
DATE OF COMPLAINT: NA	POST INSP. CONTACTS: None	JOINT INSP. AGENCY: None	
WEATHER: Clear	INSPECTOR'S SIGNATURE:

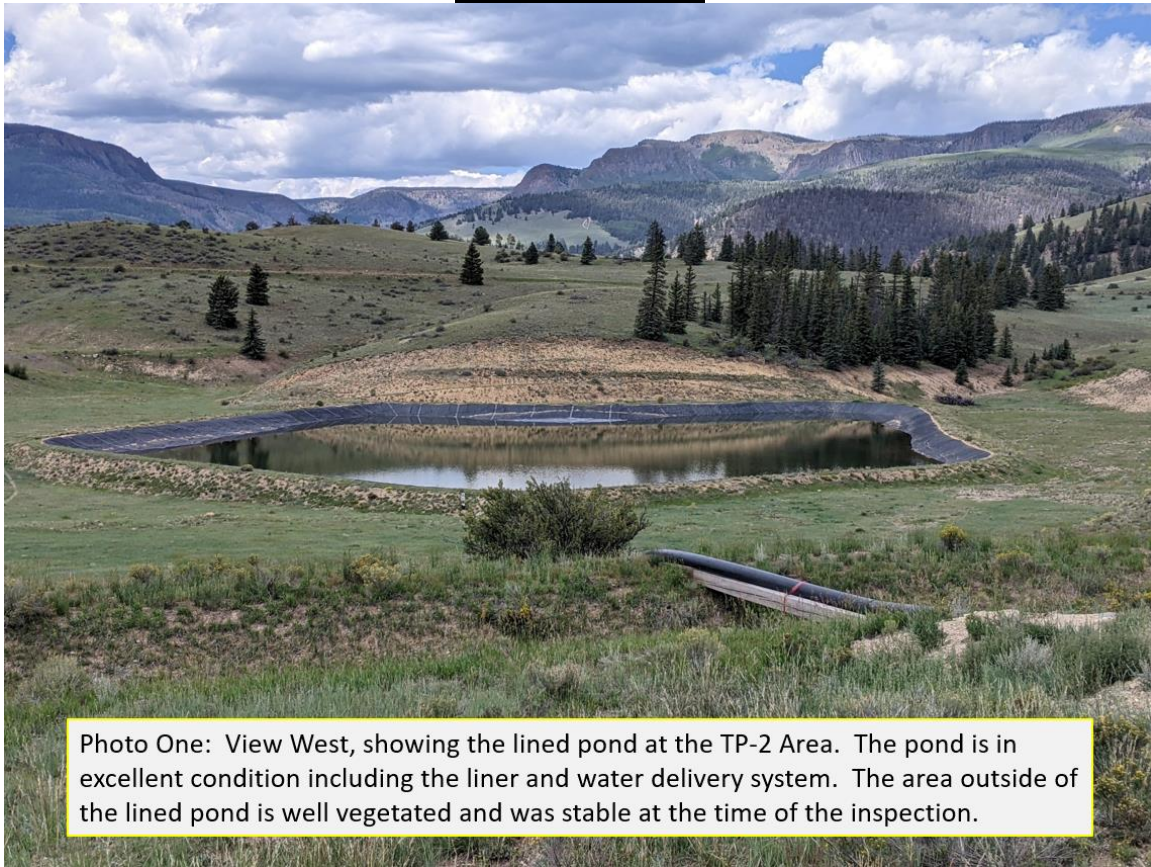
The Tailings Pond 2 area lies approximately 1.5 miles to the south of the main facilities and office area. This area consists of the lined Tailings Storage Facility (TSF) that was utilized during active mining operations. Active tailings deposition in this facility has not occurred in recent years. Within the lined TP-2 facility lies a lined contact water pond. The pond is lined with an HDPE liner, within the confines of the lined Tailings Storage Facility. The liner appeared to be in excellent condition and the pond contained sufficient freeboard to allow for inputs from precipitation and snowmelt. Conversations with the Operator indicate that evaporators are in-route and will be installed to assist in evaporating more water from the pond. The Tailings Storage Facility and interior pond can be seen in Photo One. Adjacent to the TSF is a cleared pad utilized to store drill core samples from recent drilling projects as well as an equipment storage container. The container, pad and stacked drill core samples are in excellent condition and were stable at the time of inspection. The pad, at its construction, had topsoil salvaged and stockpiled. The topsoil stockpiles are well vegetated and showed no signs of erosion.

Photo One: View West, showing the lined pond at the TP-2 Area. The pond is in excellent condition including the liner and water delivery system. The area outside of the lined pond is well vegetated and was stable at the time of the inspection.

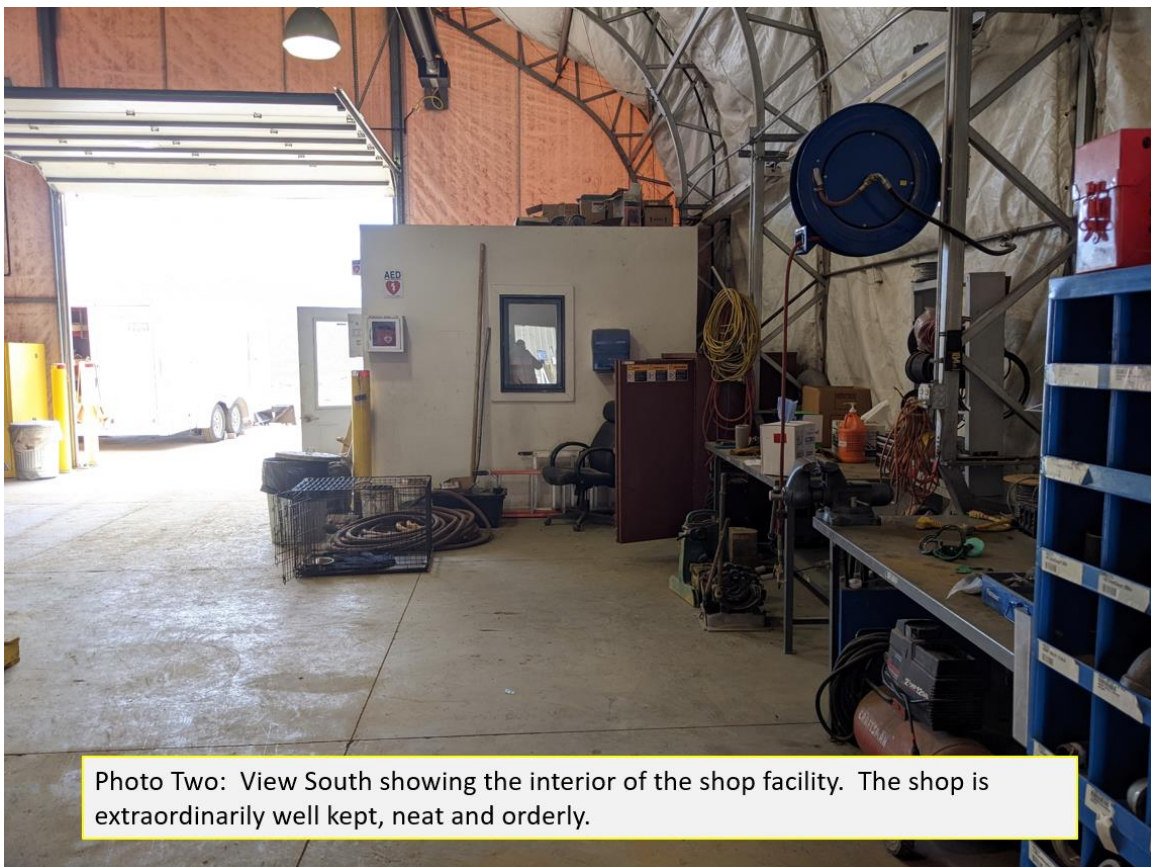
The main facilities adjacent to the office area contains the maintenance shop, shotcrete batch plant building, fuel storage building and materials storage. The shop is a semi-permanent Quonset style building. The building itself is in excellent condition. The interior of the shop is in excellent condition and very well kept and can be seen in Photo Two. The shotcrete batch plant is also being used as an equipment and storage area to keep items out of the elements. The building, similar to the shop is in excellent condition and very well kept. On site fuel storage is contained within an enclosed building near the maintenance shop. Within the fuel storage building is a single above ground diesel tank. The tank is double walled, and set within a lined containment structure providing tertiary spill containment. A spill pad has been installed in the front of the building to prevent spills during refilling of the tank. The tank and containment structure were in excellent condition, the storage building and external spill pad can be seen in Photo Three. Various areas around the facilities area are being utilized for mining related materials storage. Materials stored in these areas are well

Photo Two: View South showing the interior of the shop facility. The shop is extraordinarily well kept, neat and orderly.

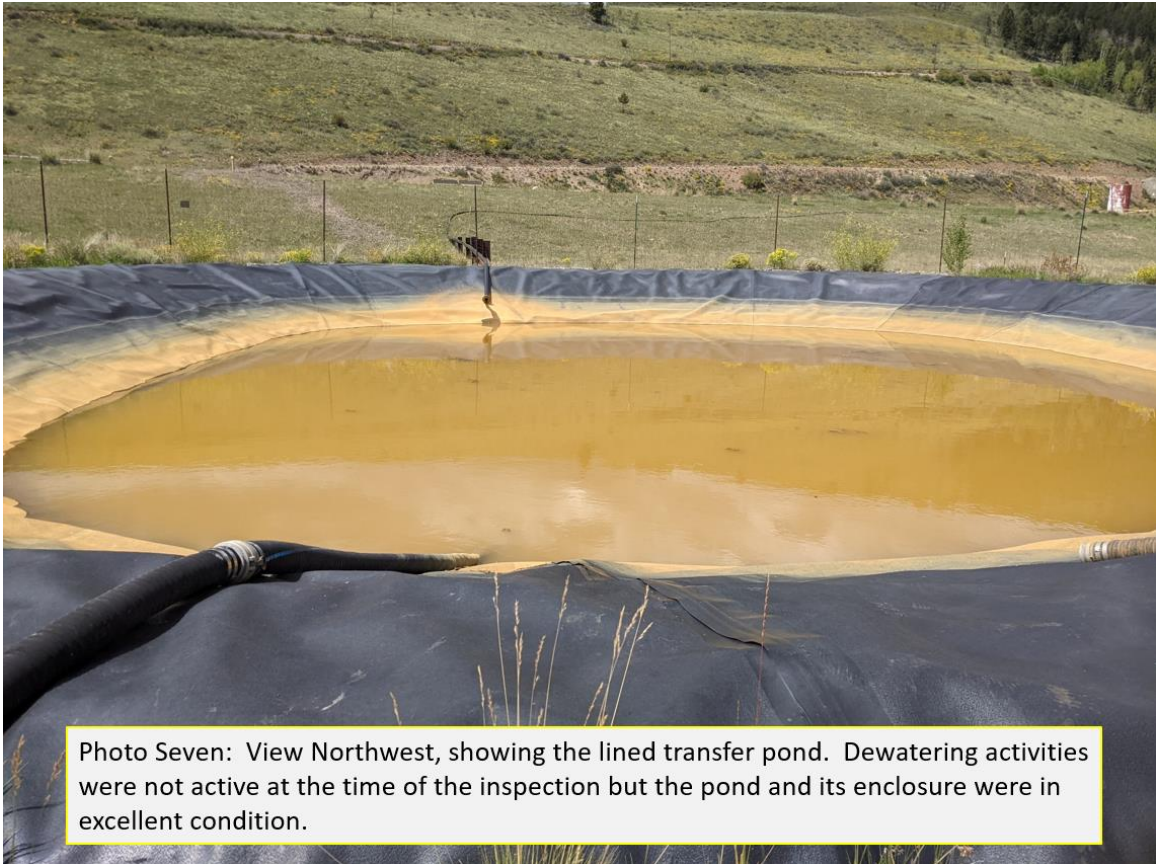
The dewatering infrastructure including pipes, tanks and onsite lined transfer pond were observed. All elements of the dewatering system were in good working order. At the time of the inspection no transfer of water was taking place. The gravity feed tank can be seen in Photo Five. The onsite transfer pond and pump station were found to be in excellent condition as seen in Photos Six and Seven. The pump has been set inside a temporary secondary containment structure to prevent spills of any fuels or oils. The pond liner shows no signs of compromise.

Photo Seven: View Northwest, showing the lined transfer pond. Dewatering activities were not active at the time of the inspection but the pond and its enclosure were in excellent condition.
