QUARTERLY SEDIMENTATION POND INSPECTION REPORT

Mine: New Elk

Inspection Period: Third Quarter 2022

QUARTERLY SEDIMENTATION POND INSPECTION REPORT
New Elk Mine- August 10, 2022

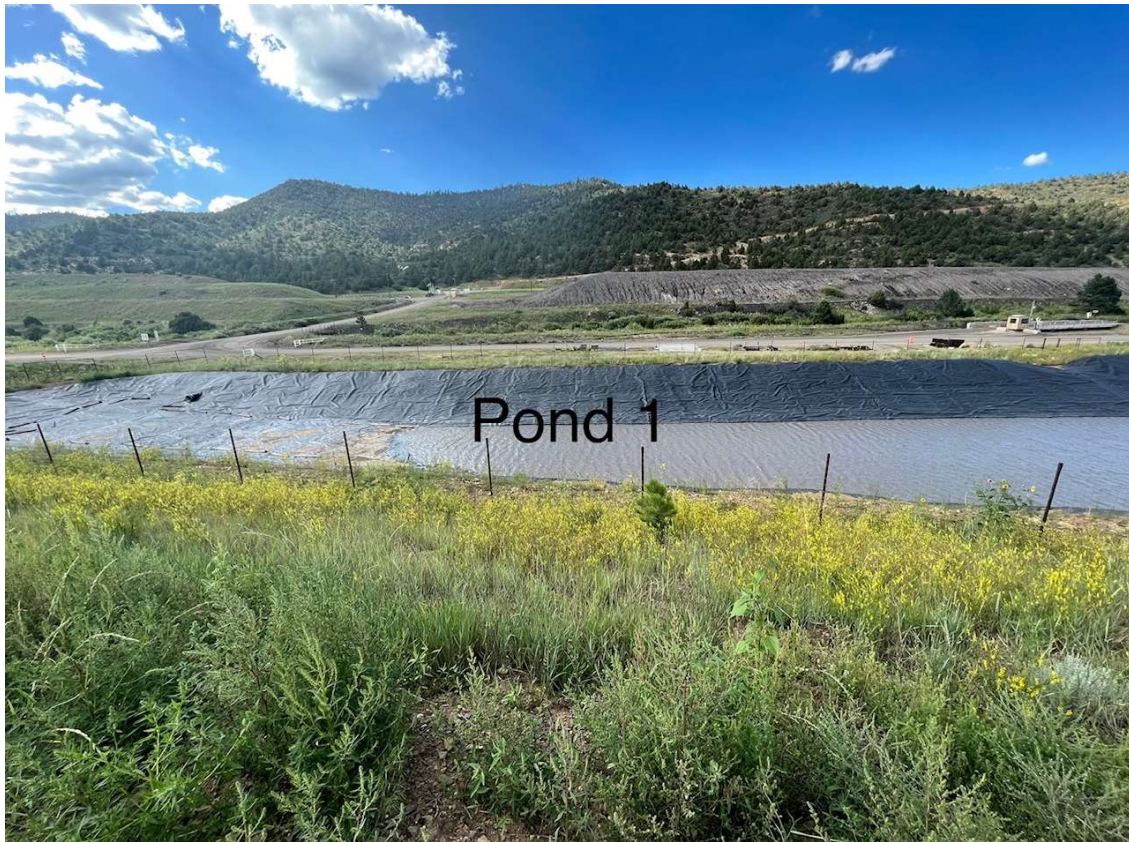
Pond 1

Pond liner is in good working condition at time of inspection. Pond was holding water at time of
Inspection. No issues

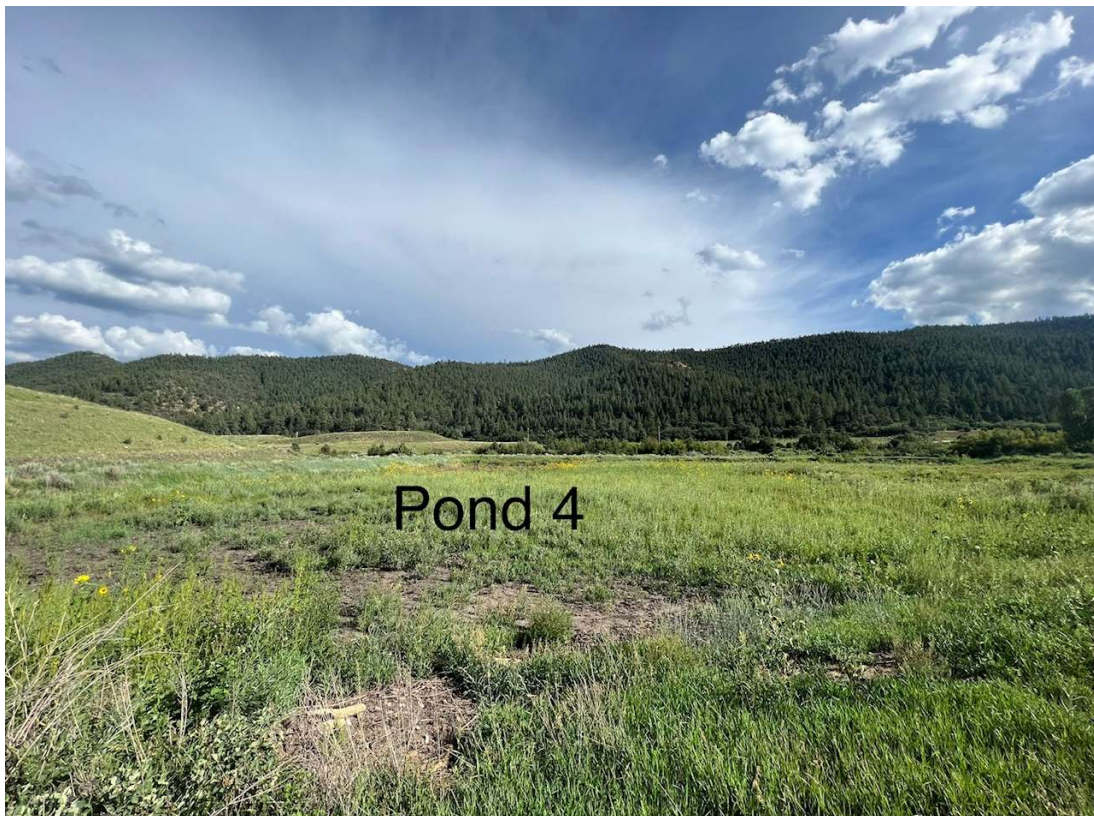
Pond 4

Pond was holding very little water at the time of inspection. No issues

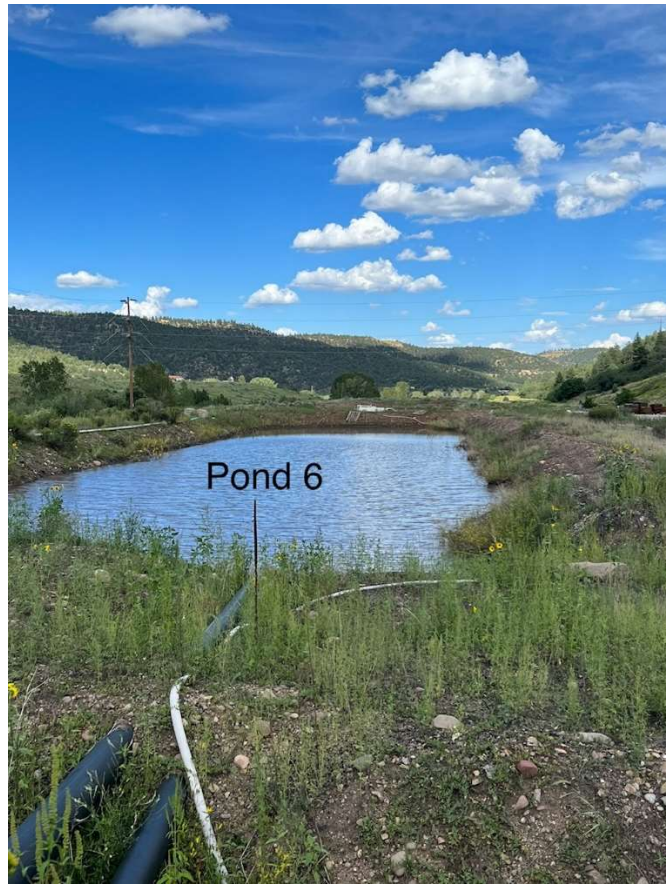
Pond 6

Pond had water in it at time of inspection, almost full. No issues

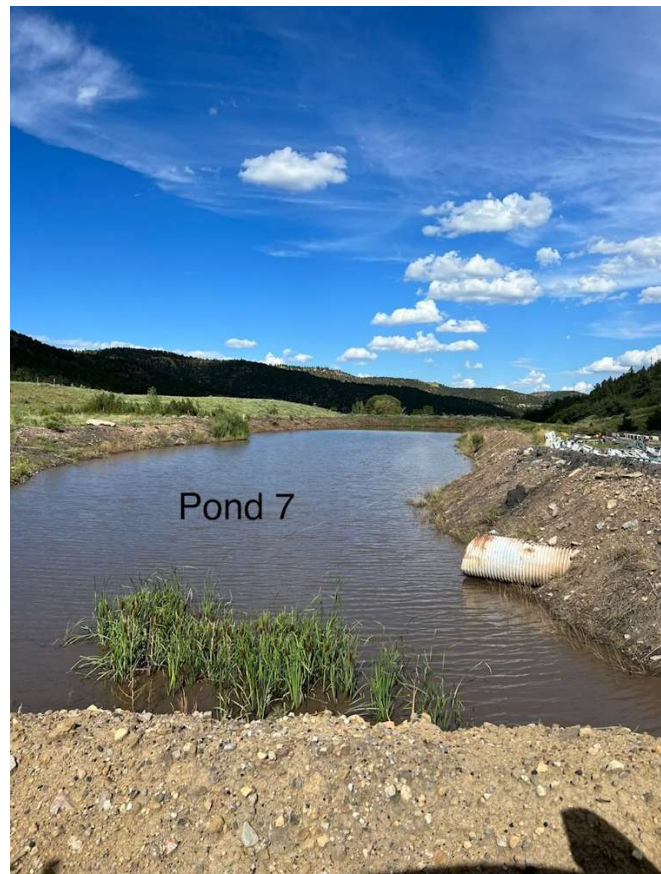
Pond 7

Pond is holding water at time of inspection. Not discharging, but is almost up to decant level.

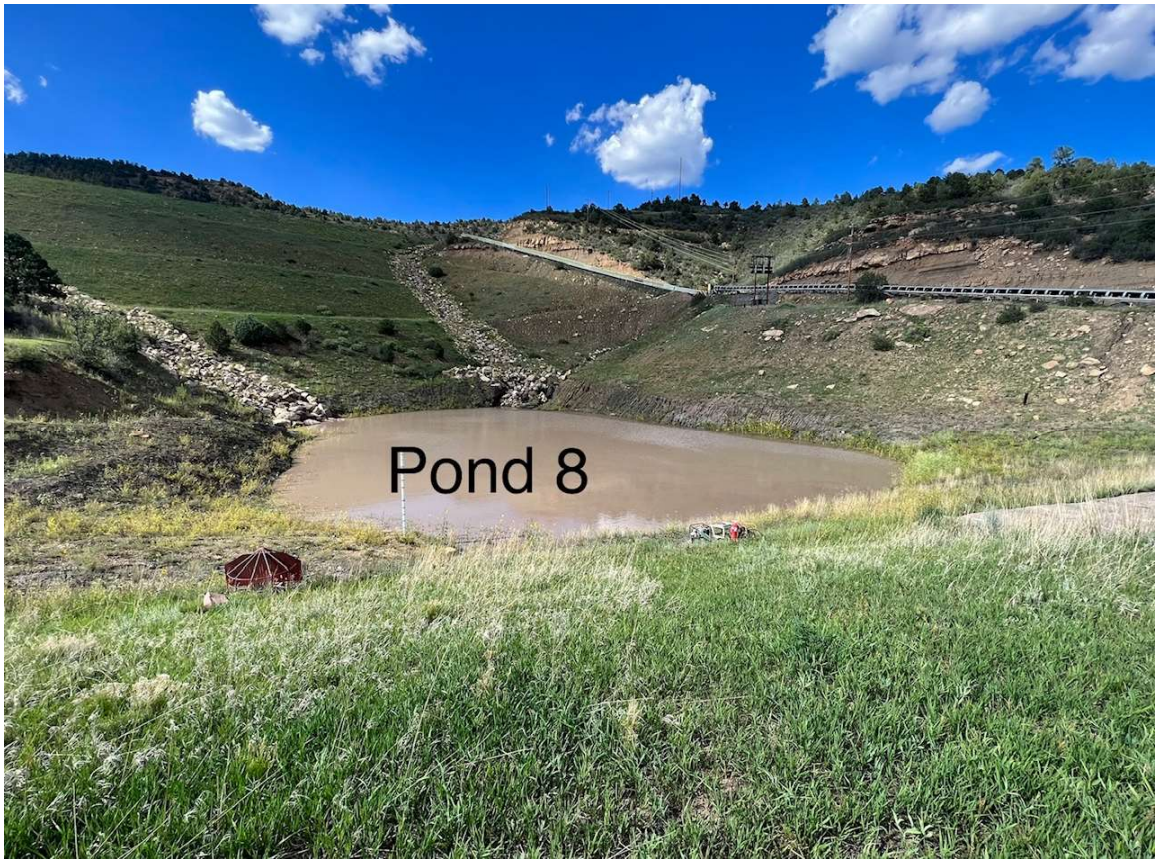
Pond 8

Pond is holding water at time of inspection. Not discharging and no issues.

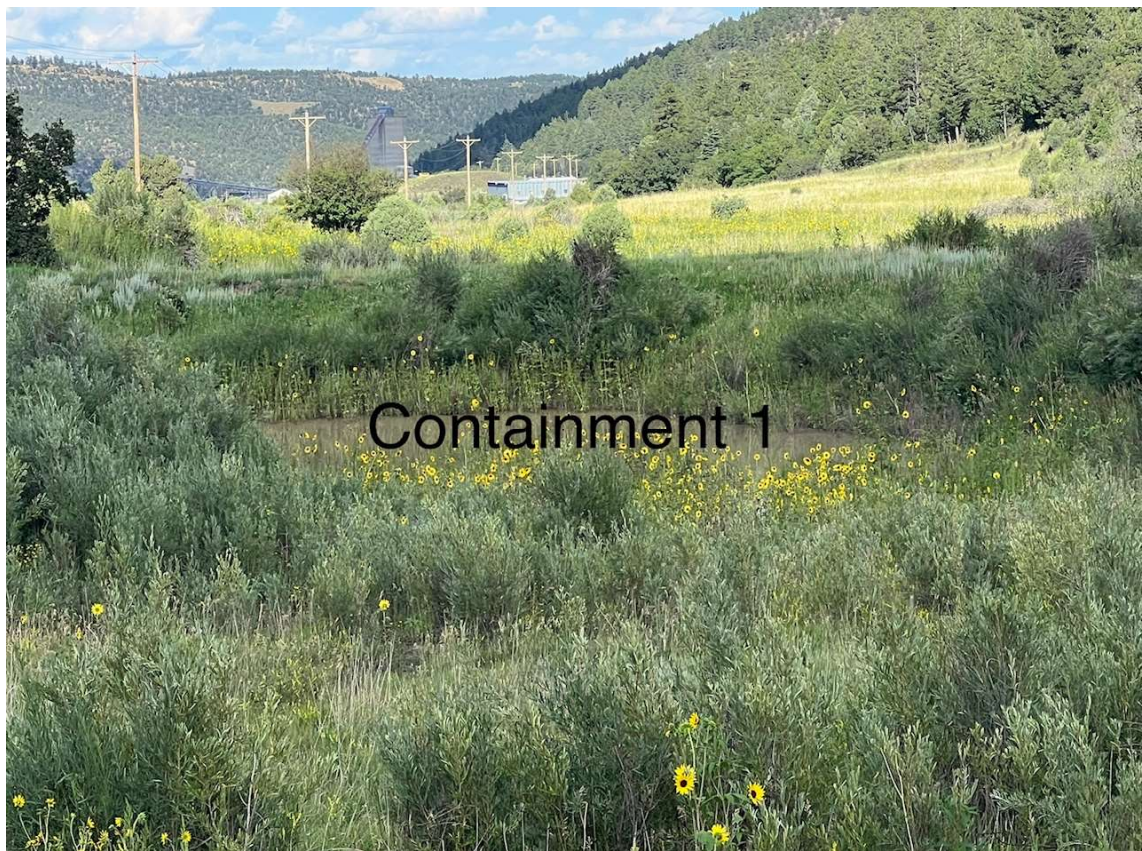
Containment Area #1

Containment was holding water at time of inspection. No issues

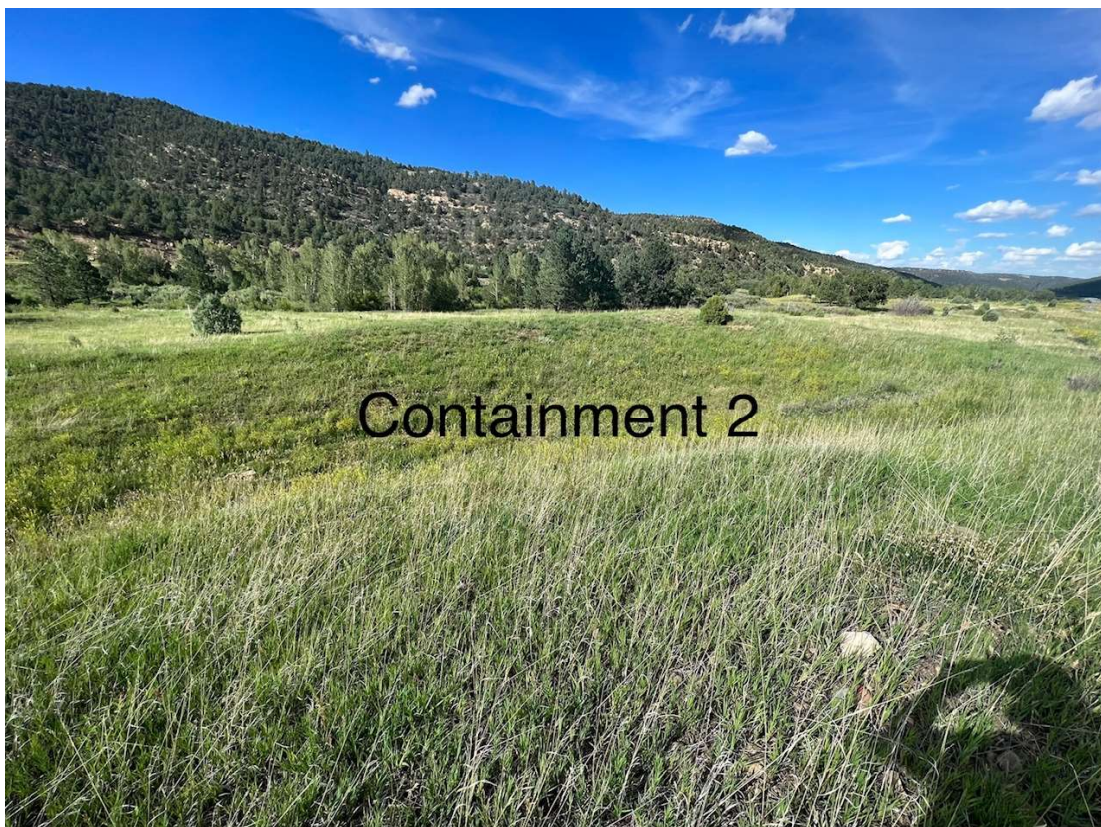
Containment Area #2

Containment was empty at time of inspection. No issues

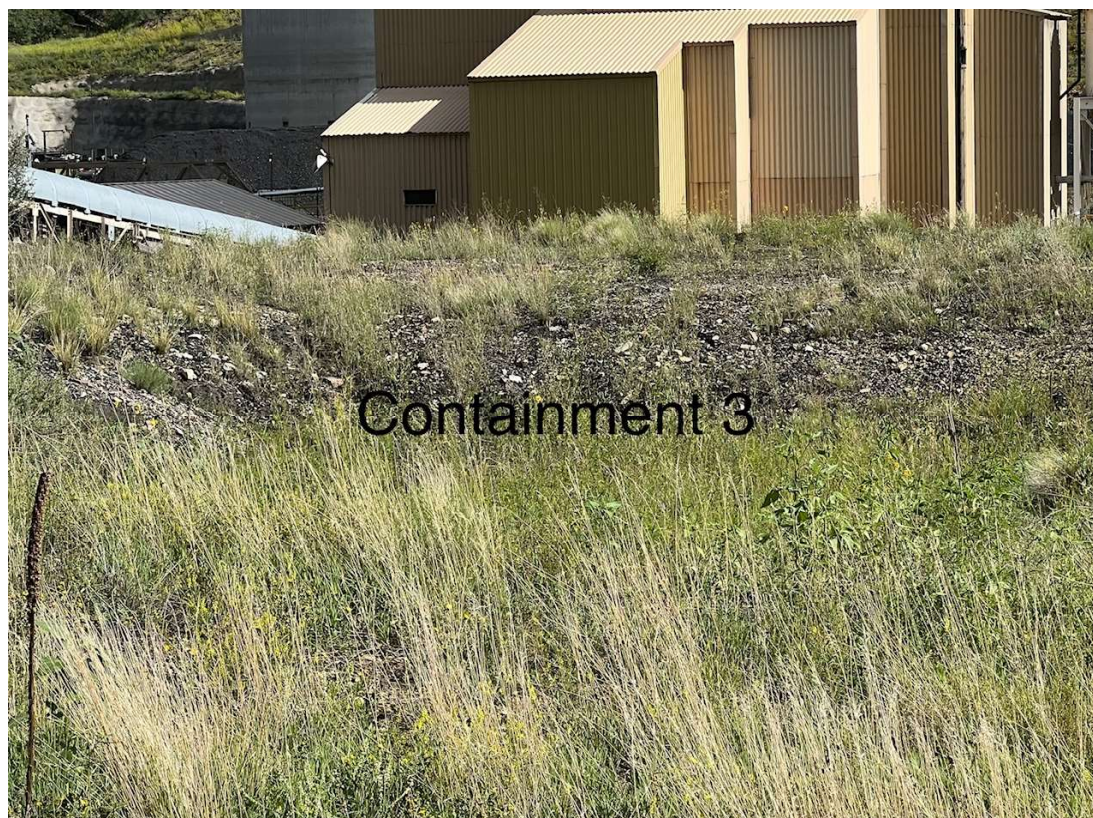
Containment Area #3

Containment Area was dry at time of inspection. No issues

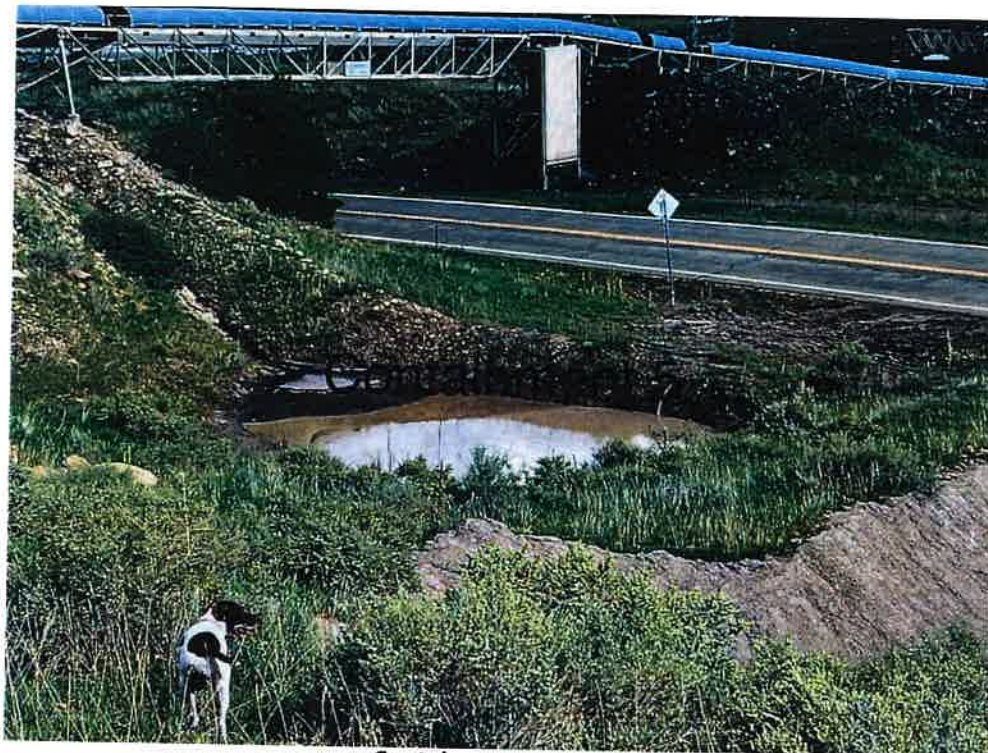
Containment Area #5

Containment Area was holding water at time of inspection. Looks to have been recently pumped.
