**NEW ELK MINE**  
**Permit No. C-1981-012**

**QUARTERLY COAL WASTE BANK INSPECTION REPORT**  
**August 10, 2022**

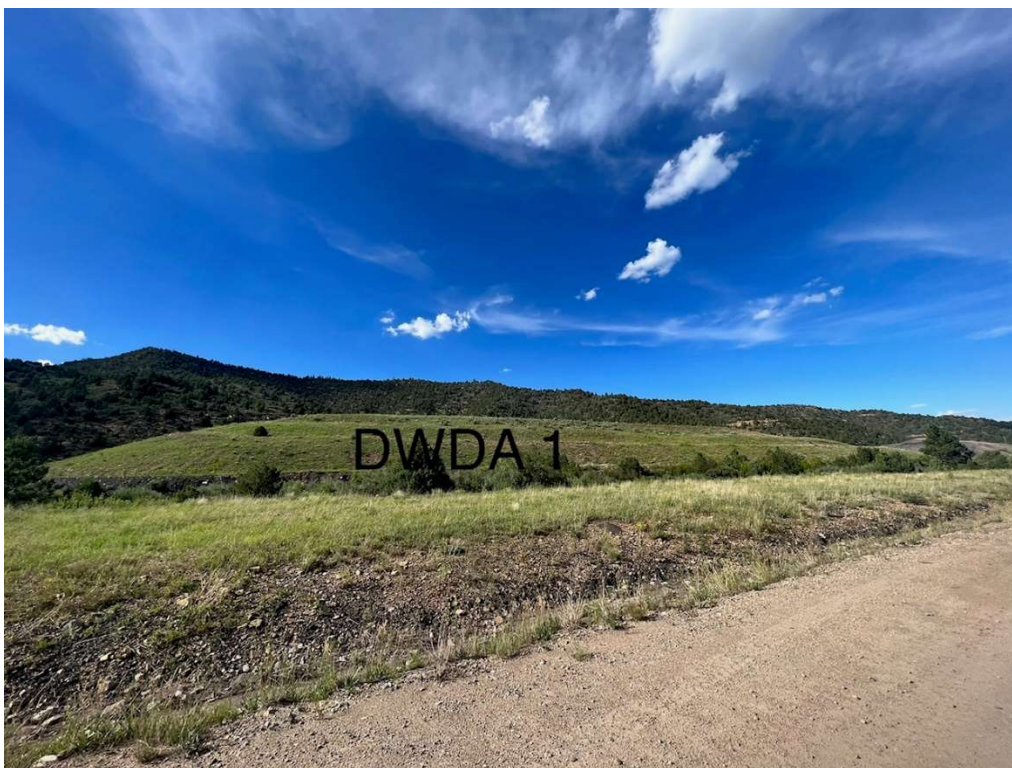
**DWDA #1**

Surface and out slopes of the pile were inspected for visible signs of potential failure or instability. None were observed.

Overall the disposal area is in good condition.

None at this time.

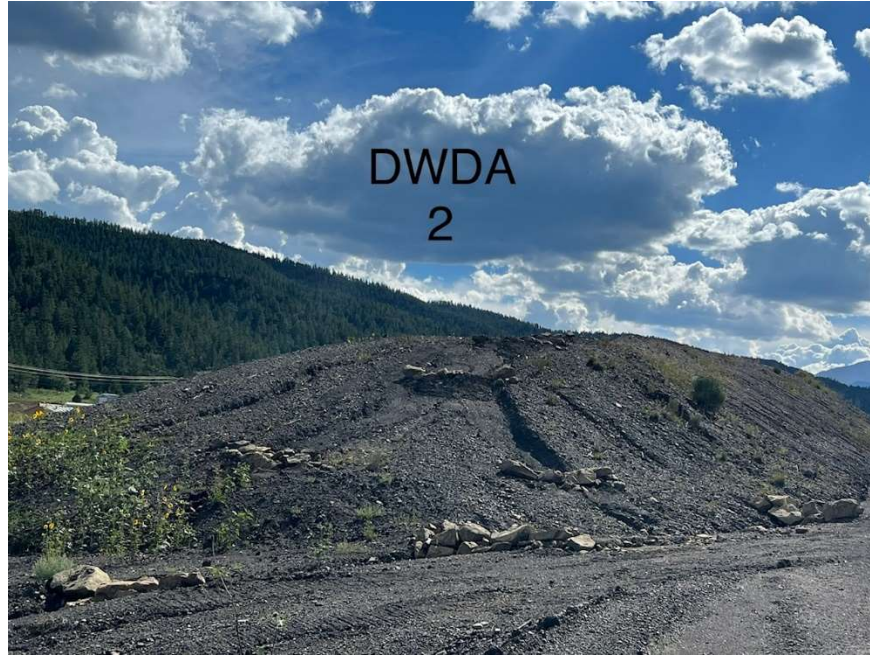
**DWDA #2**

Positive Drainage is maintained on the surface of the DWDA. Sump on East end of pile was being cleaned at time of inspection. Rills on the disposal area are being monitored. No evidence of springs nor seeps were observed.

Surface and out slopes of the pile were inspected for visible signs of potential failure or instability. There was some surface erosion but not enough to make the area unstable. In all no signs of failure or instability were observed.

Overall the disposal area is in good condition.

A rill has formed on the east end of the waste pile. Rill should be filled in and check dams put in place to prevent this rill developing again. Operator is evaluating either reclamation of the area or permitting alternative uses of the land north of the Purgatoire River and south of Highway 12.

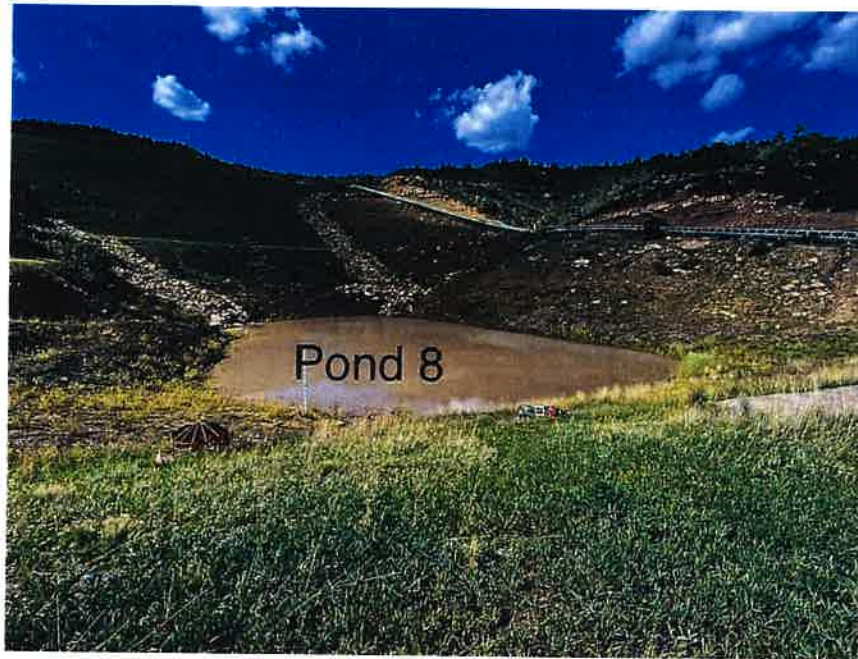
**Pond at base of Refuse Disposal Area**

Overall the site is in good condition. Compaction test from this quarter is attached. Compaction tests came back at 97 and 96 percent which complies with specifications.

None required at this time.
