**LORENCITO CANYON MINE**  
**Permit No. C-1996-084**

**INSPECTION OF EXCESS SPOIL-FILLS 7, 8, & 9**  
**August 10, 2022**

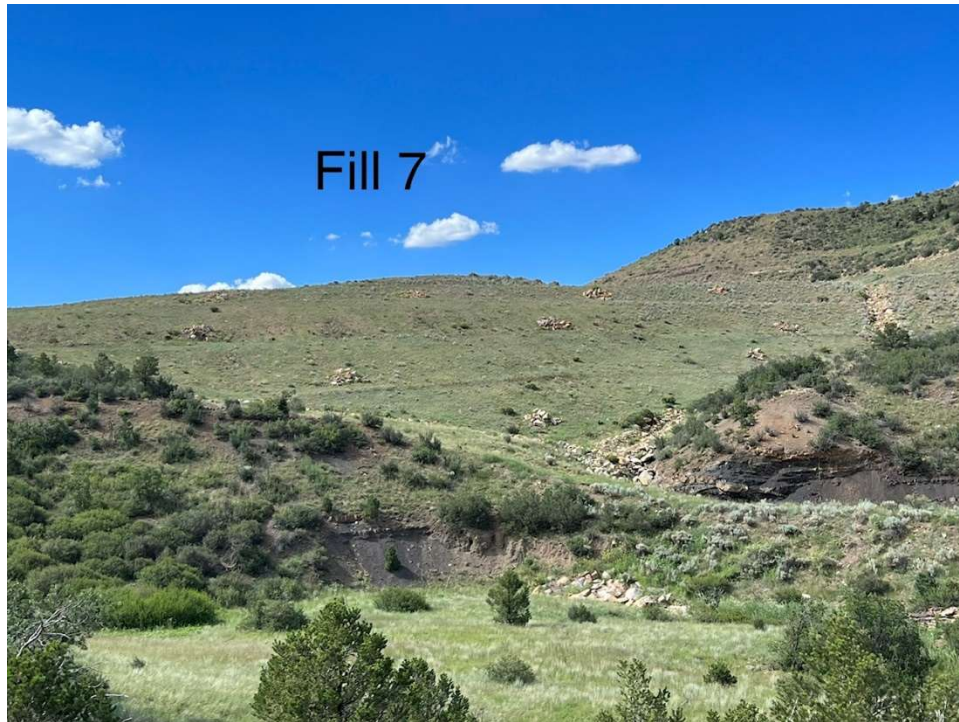
**Fill #7**

The entire excess spoil fill facility was examined for signs of failure and instability such as tension cracks, ground movement, springs and seeps, and standing water. There was no indication of potential instability at time of inspection.

Overall the site is in good condition. The vegetation on the fill is encouraging.

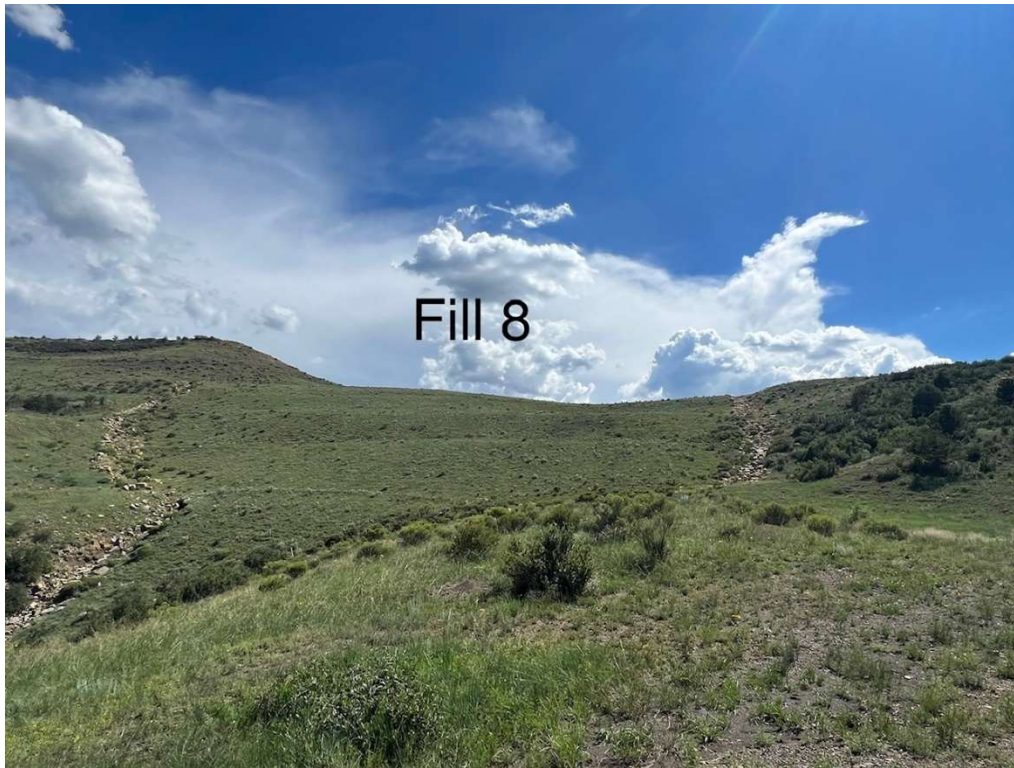
**Fill #8**

The entire excess spoil fill facility was examined for signs of failure and instability such as tension cracks, ground movement, springs and seeps, and standing water. There was no indication of potential instability at time of inspection.

Overall the site is in good condition. Vegetation is very good on the fill.

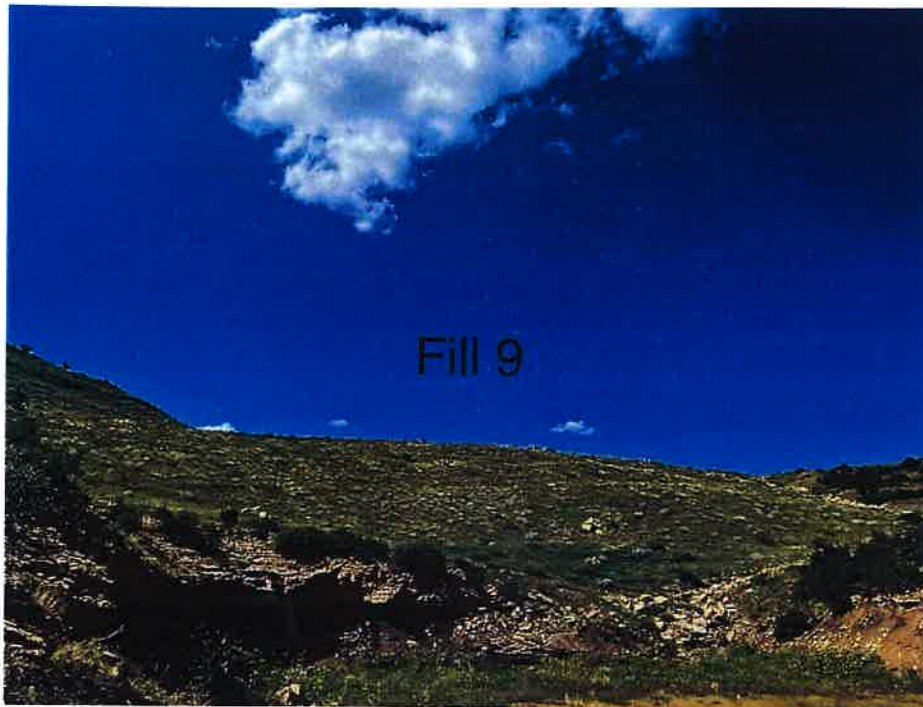
Fill #9

The entire excess spoil fill facility was examined for signs of failure and instability such as tension cracks, ground movement, springs and seeps, and standing water. There was no indication of potential instability at time of inspection.

Overall the site is in good condition.
