QUARTERLY SEDIMENTATION POND INSPECTION REPORT

Mine: Lorencito

Inspection Period: Third Quarter 2022

QUARTERLY SEDIMENTATION POND INSPECTION REPORT
Lorencito Canyon Mine- August 10, 2022

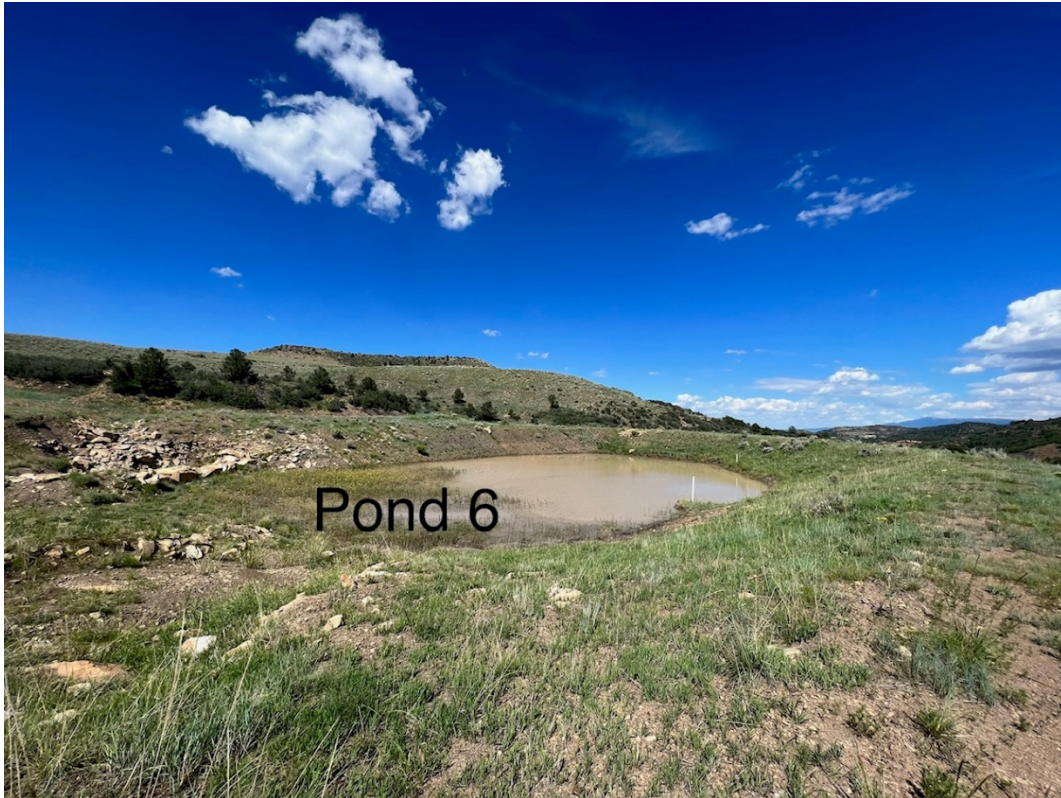
Pond 6

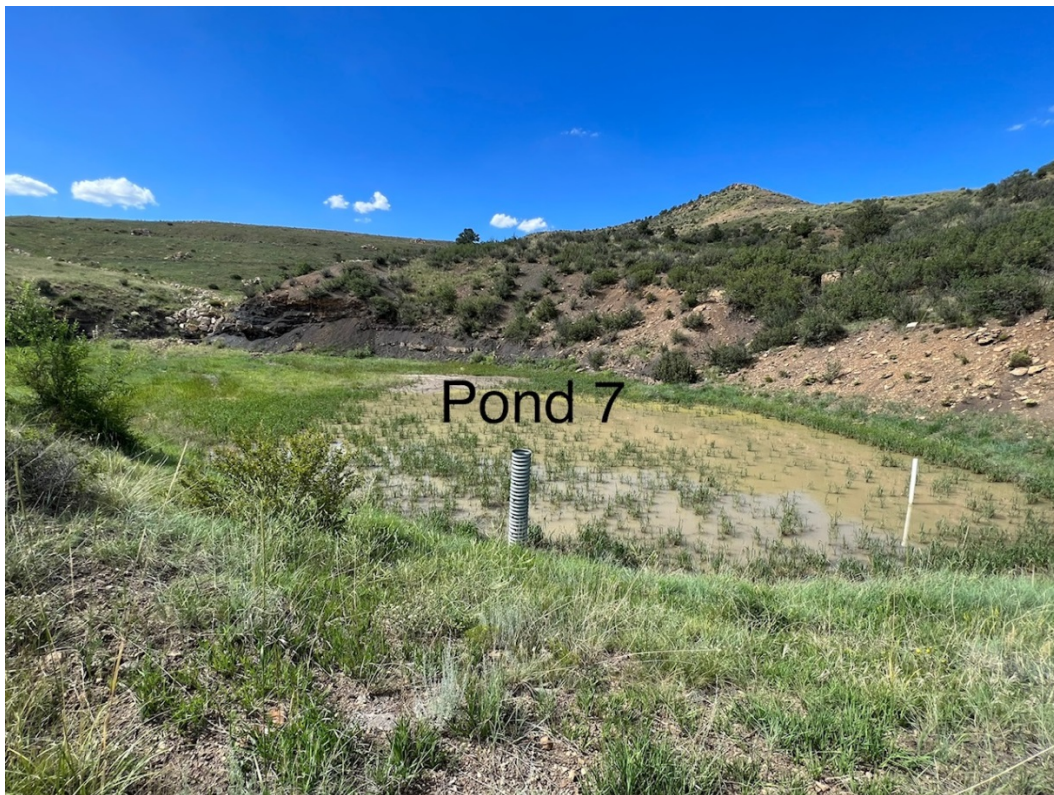
Pond 7

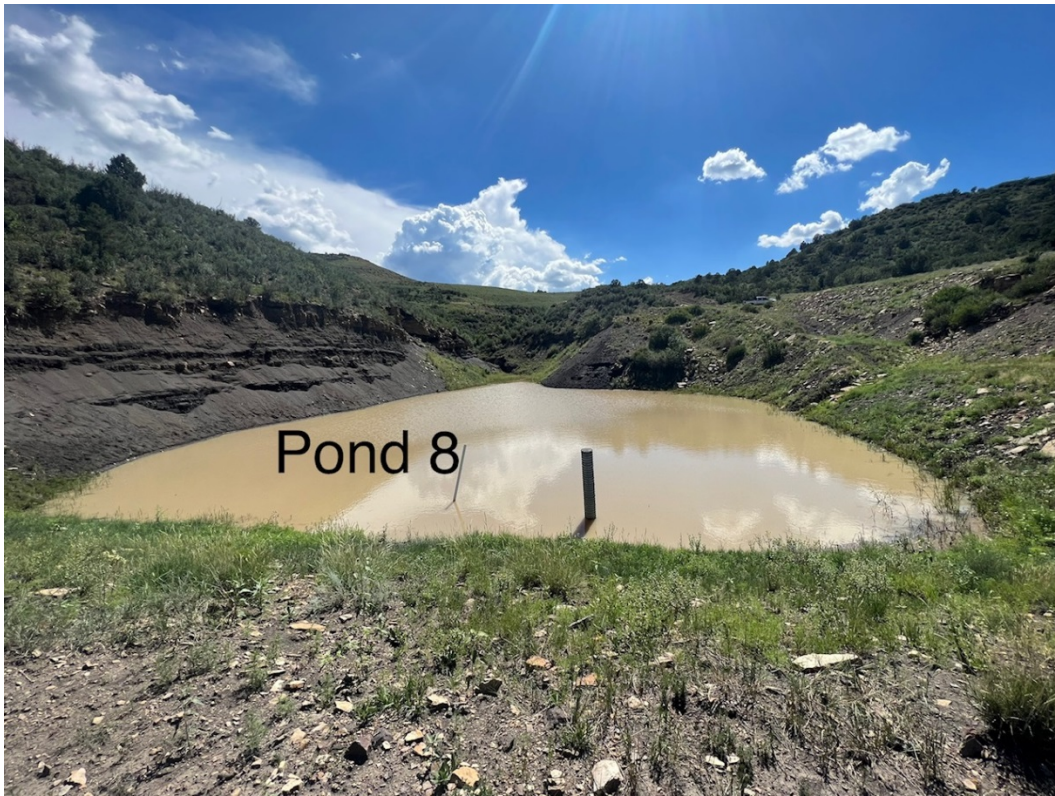
Pond 8

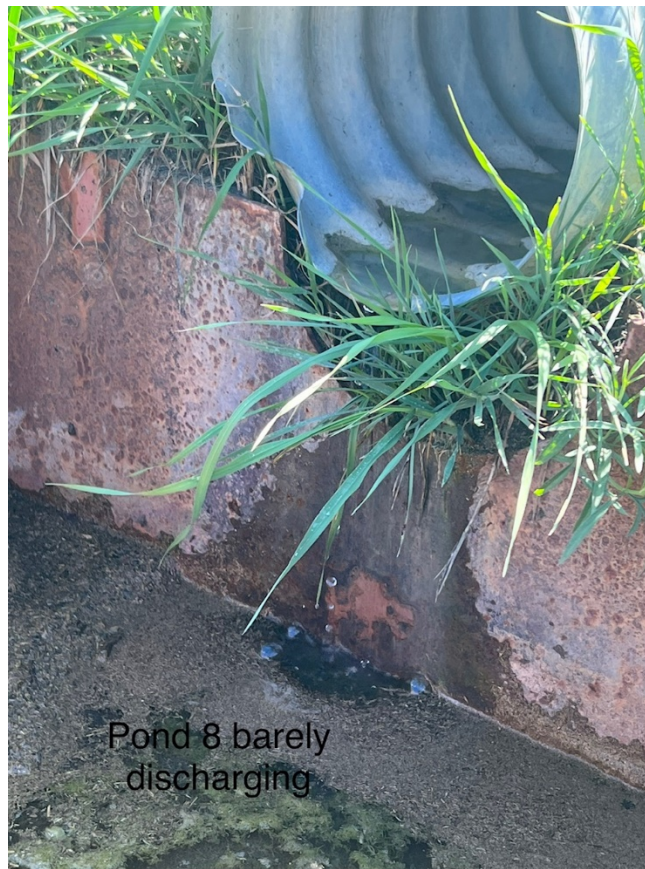
Pond 8 Discharging

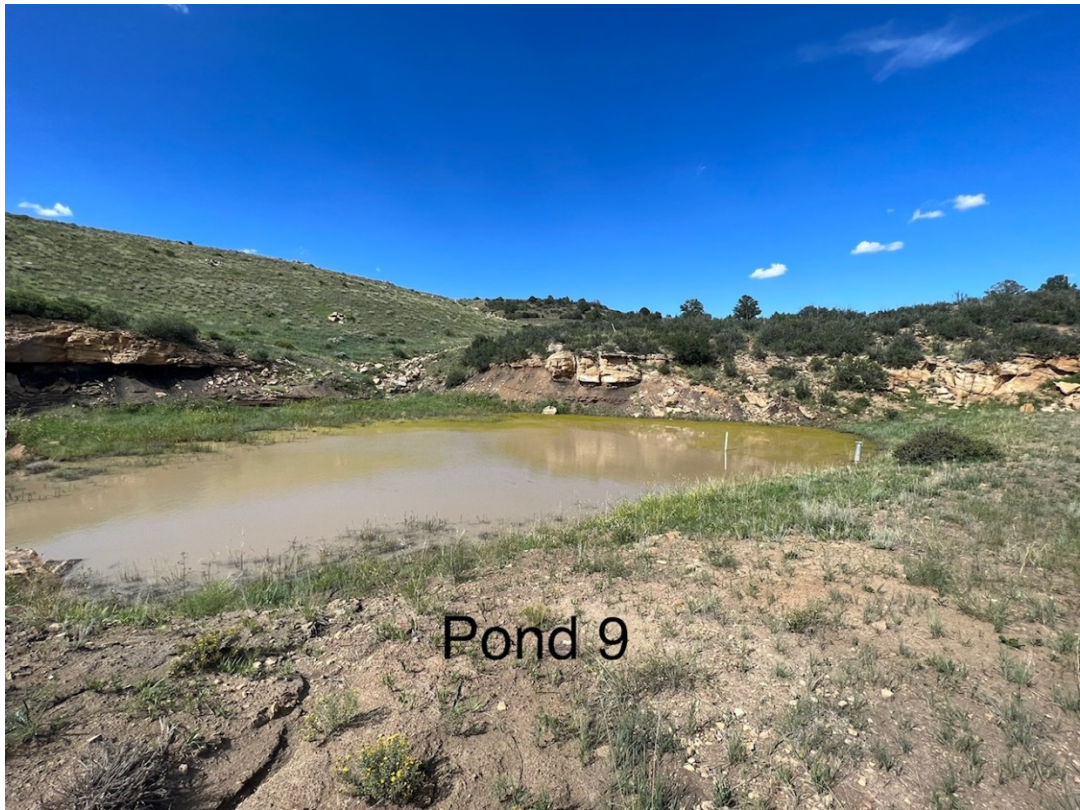
Pond 9

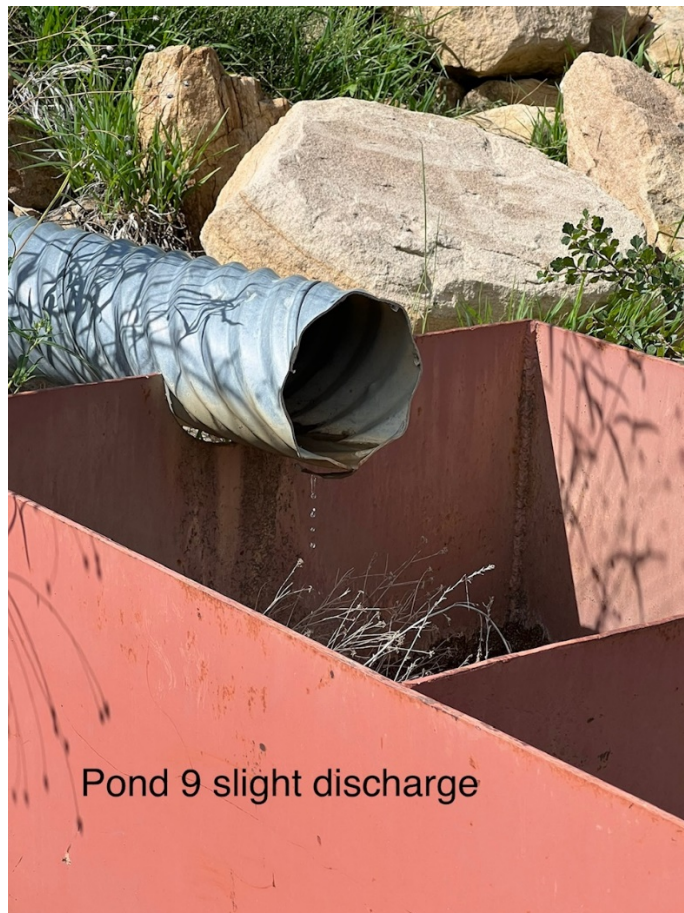
Pond 9 Discharging

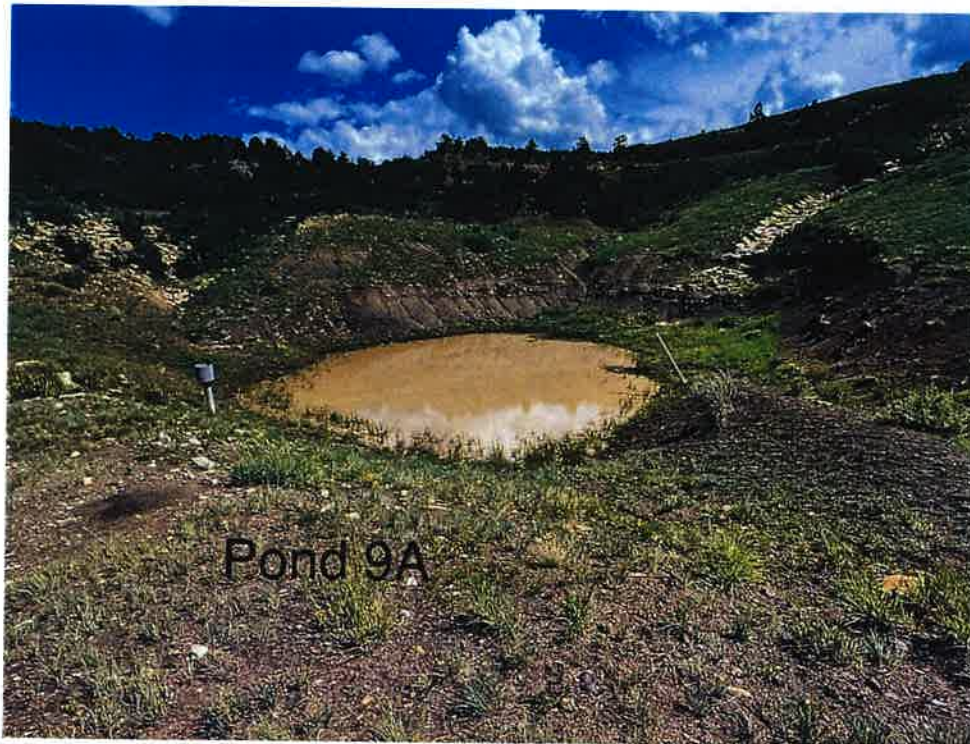
Pond 9A
