## MINERALS PROGRAM INSPECTION REPORT

<b>MINE NAME:</b> Boettcher Gypsum Quarry	<b>MINE/PROSPECTING ID#:</b> M-1977-346	<b>MINERAL:</b> Anhydrite, gypsum	<b>COUNTY:</b> Larimer
<b>INSPECTION TYPE:</b> Monitoring	<b>INSPECTOR(S):</b> Amy Eschberger	<b>INSP. DATE:</b> August 31, 2022	<b>INSP. TIME:</b> 13:15
<b>OPERATOR:</b> Holcim (US) Inc.	<b>OPERATOR REPRESENTATIVE:</b> Mike Toelle, Tom Newman	<b>TYPE OF OPERATION:</b> 112c - Construction Regular Operation	
<b>REASON FOR INSPECTION:</b> Normal I&E Program	<b>BOND CALCULATION TYPE:</b> None	<b>BOND AMOUNT:</b> \$38,000.00	
<b>DATE OF COMPLAINT:</b> NA	<b>POST INSP. CONTACTS:</b> None	<b>JOINT INSP. AGENCY:</b> None	
<b>WEATHER:</b> Clear	<b>INSPECTOR'S SIGNATURE:</b>

# M-1977-346 / Boettcher Gypsum Quarry / Holcim (US) Inc.

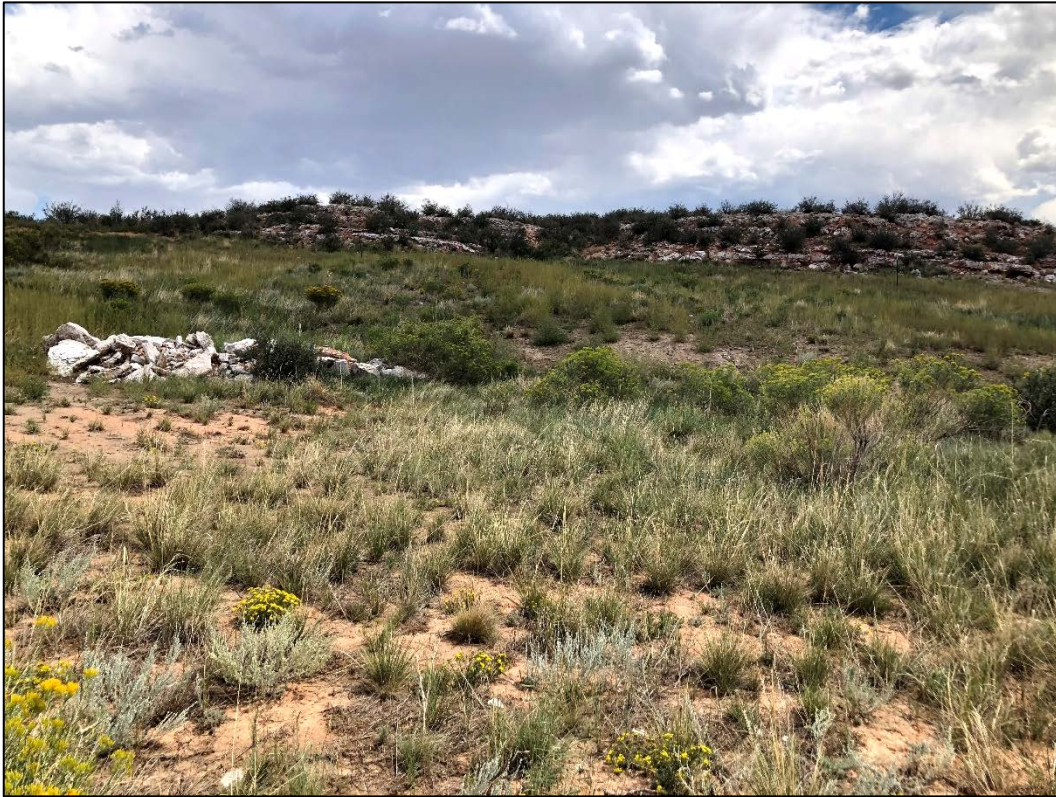
During the current inspection, the Division inspected the west permit area first. The previously reclaimed western portion of disturbance in this area remains stable with a good grass and shrub cover. The eastern portion of disturbance looked very different than it did during the 2017 inspection, as a good stand of grasses are now present in this area, mixed with shrubs. Per the Division's recommendation, the operator had installed livestock fencing around this area after reseeding it in the fall of 2017. This fencing was still in place during the inspection. All reclaimed slopes in the west permit area appeared to be stable with no erosion issues observed.

**Photo 1.** View looking east across eastern portion of disturbance in west permit area, showing site reclaimed with stable slopes and vegetative cover consisting of grasses and shrubs.

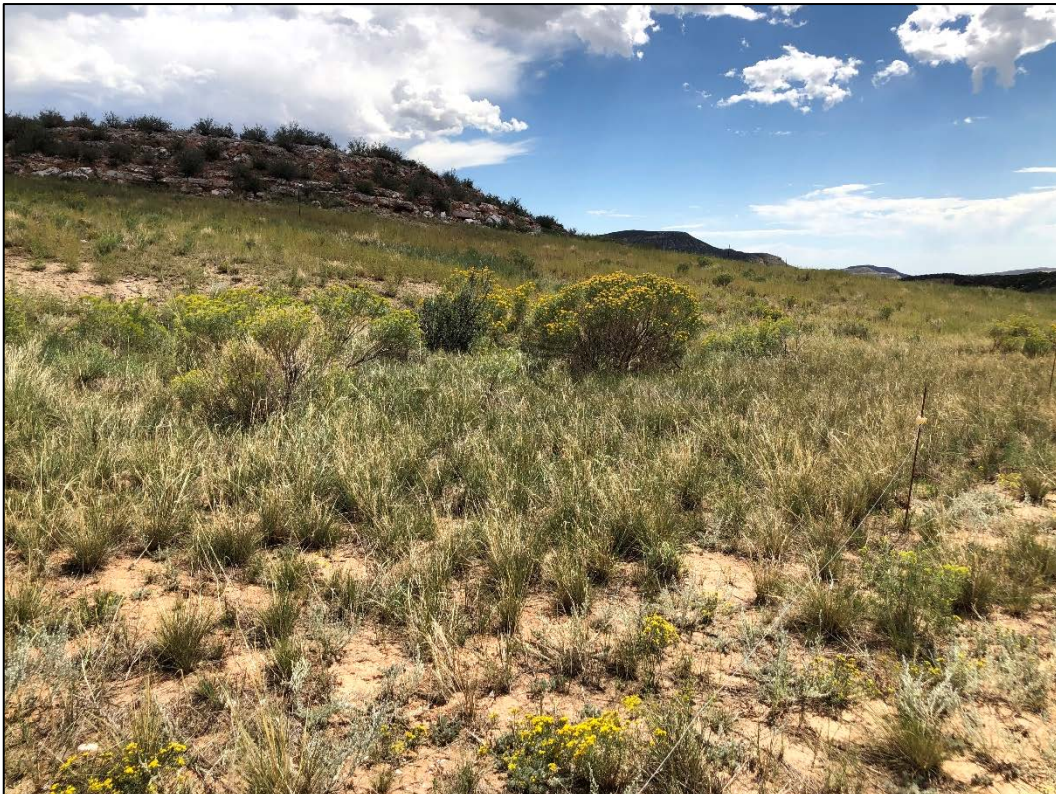
**Photo 2.** View looking southeast across eastern portion of disturbance in west permit area, showing site reclaimed with stable slopes and vegetative cover consisting of grasses and shrubs. Note livestock fencing (at bottom right) installed to protect area undergoing revegetation.

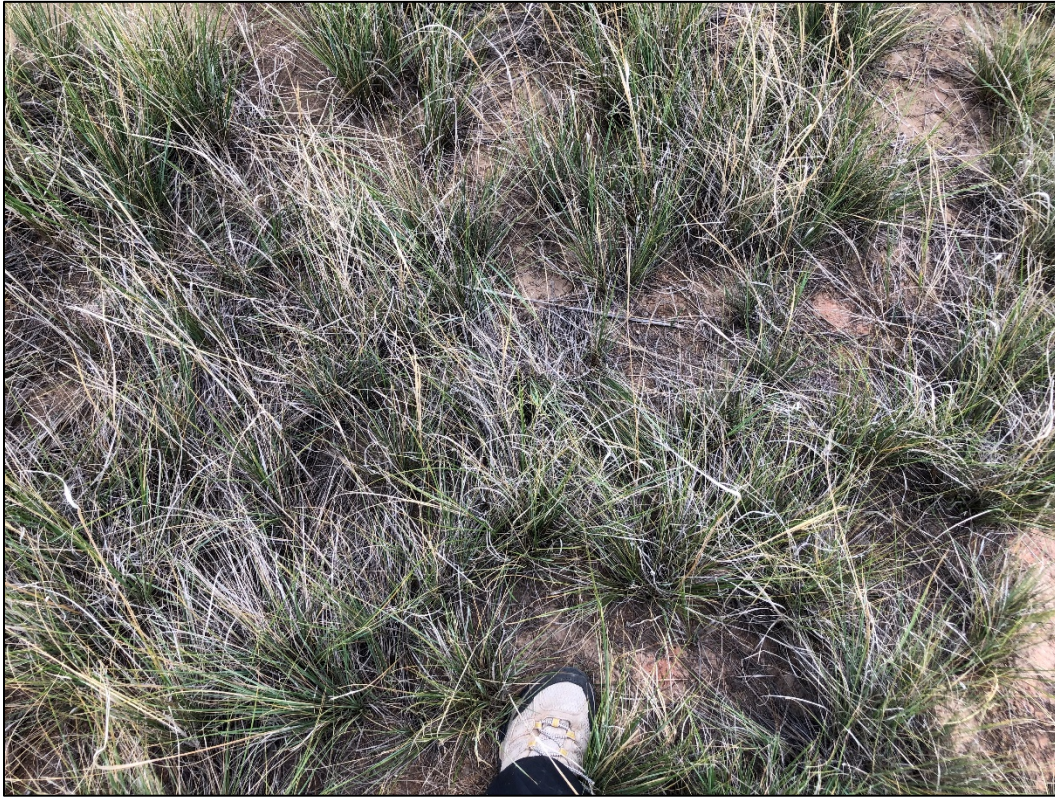
**Photo 3.** Ground view in eastern portion of disturbance in west permit area, showing established grasses in this area.

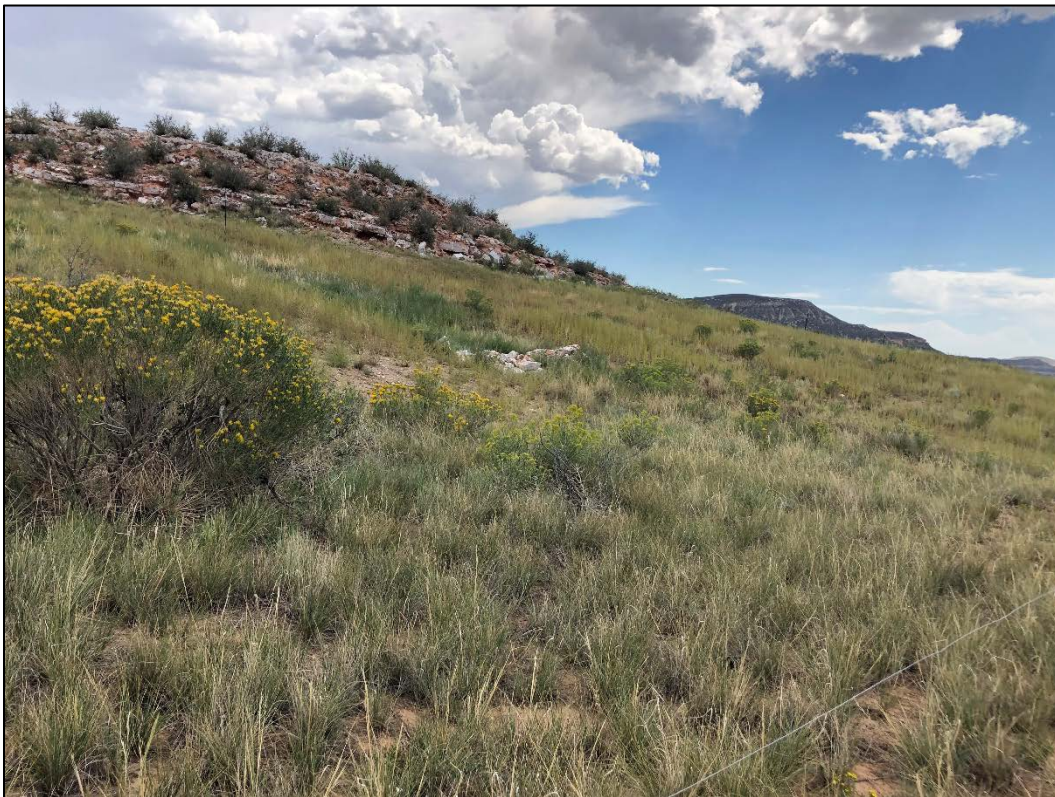
**Photo 4.** View looking southeast across eastern portion of disturbance in west permit area, showing site reclaimed with stable slopes and vegetative cover consisting of grasses and shrubs.

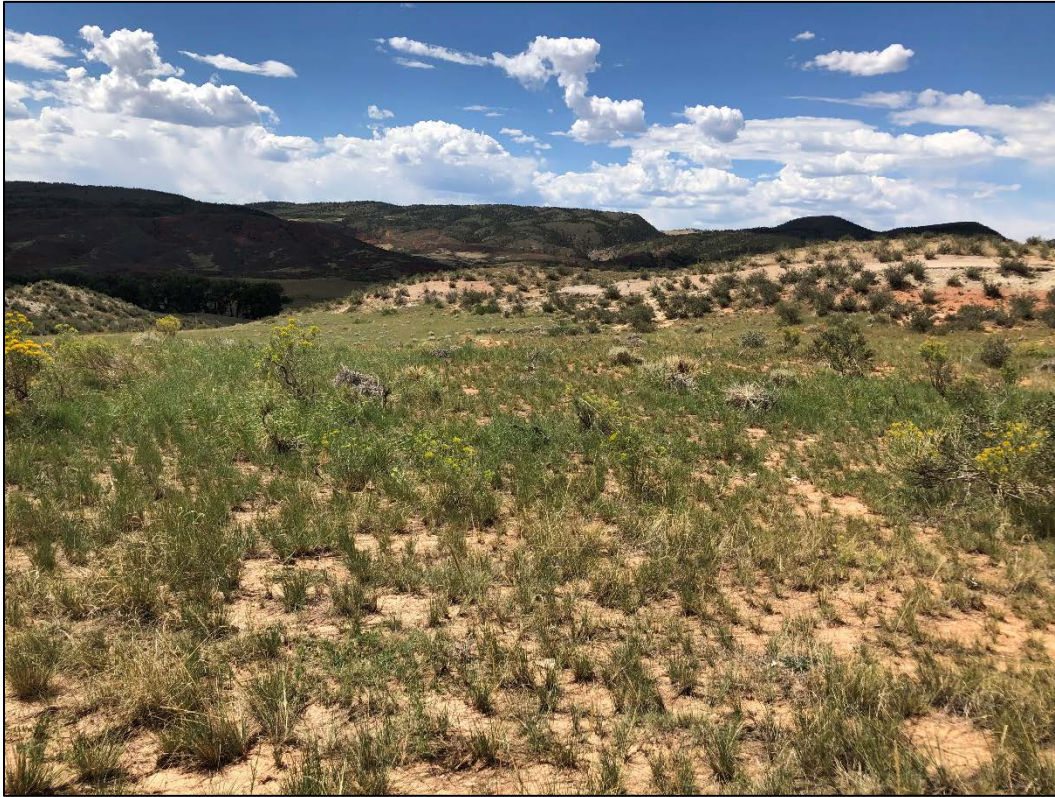
**Photo 5.** View looking southwest across previously reclaimed western portion of disturbance in west permit area, which remains stable with vegetative cover consisting of grasses and shrubs.

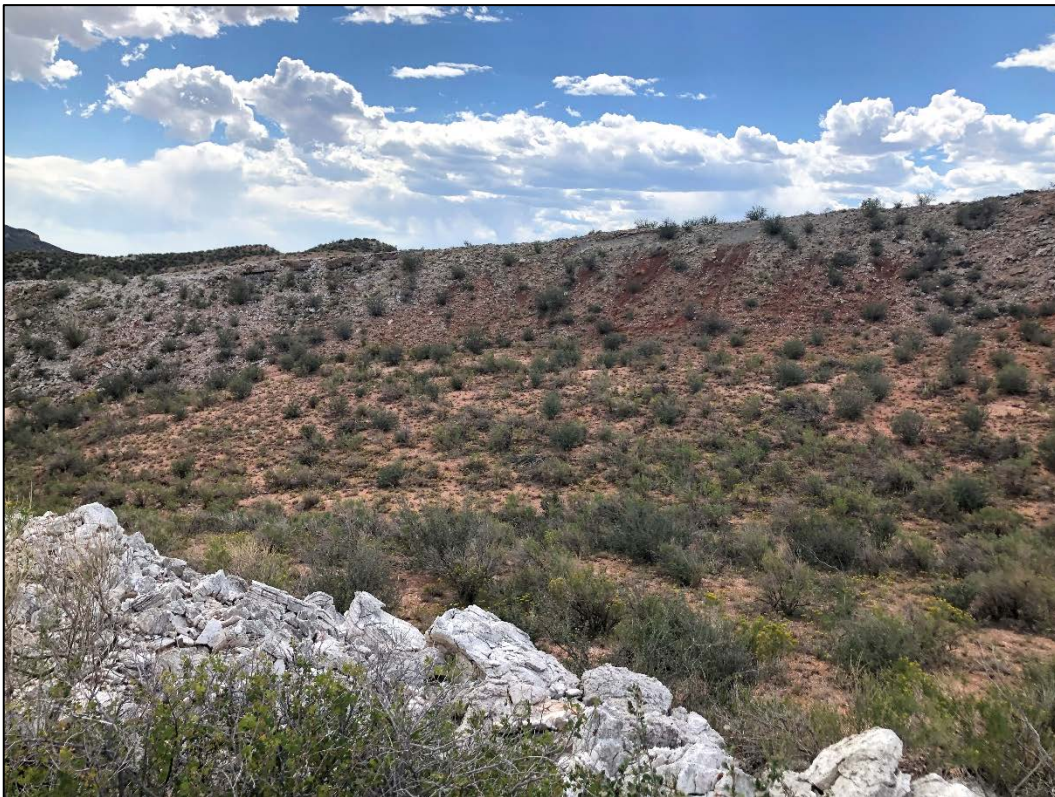
**Photo 6.** View looking south across previously reclaimed portion of disturbance in east permit area, which remains stable with vegetative cover consisting of grasses and shrubs.

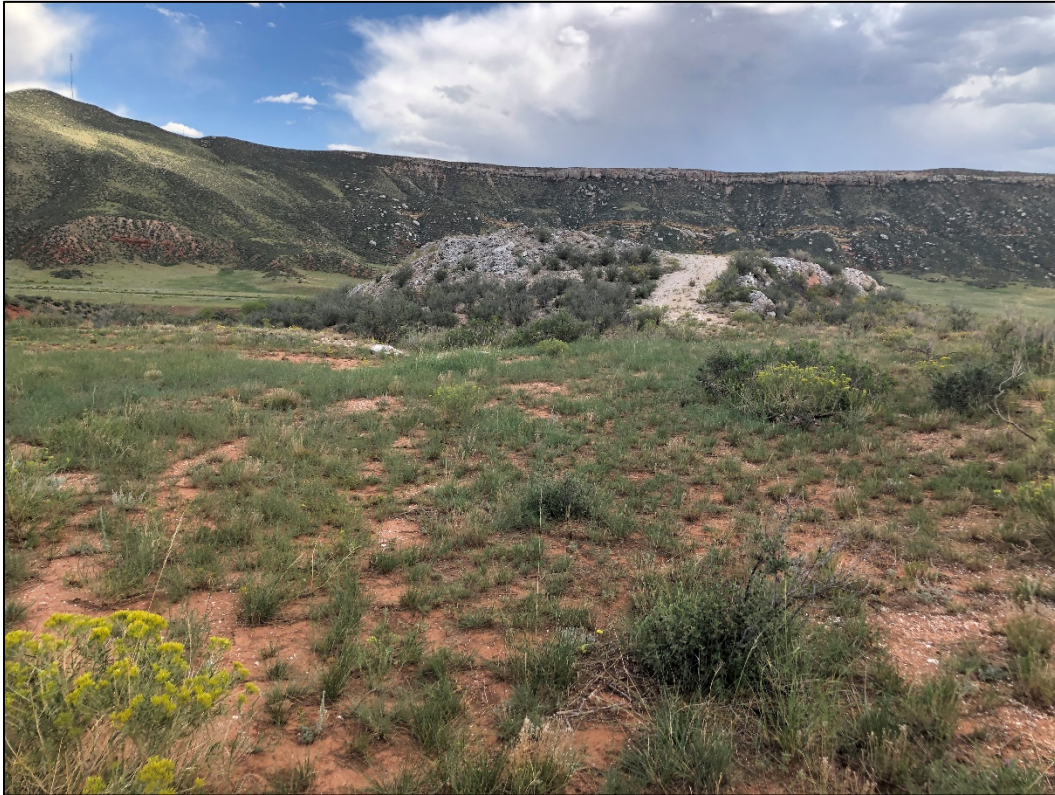
**Photo 7.** View looking northeast across previously reclaimed portion of disturbance in east permit area, which remains stable with vegetative cover consisting of grasses and shrubs.

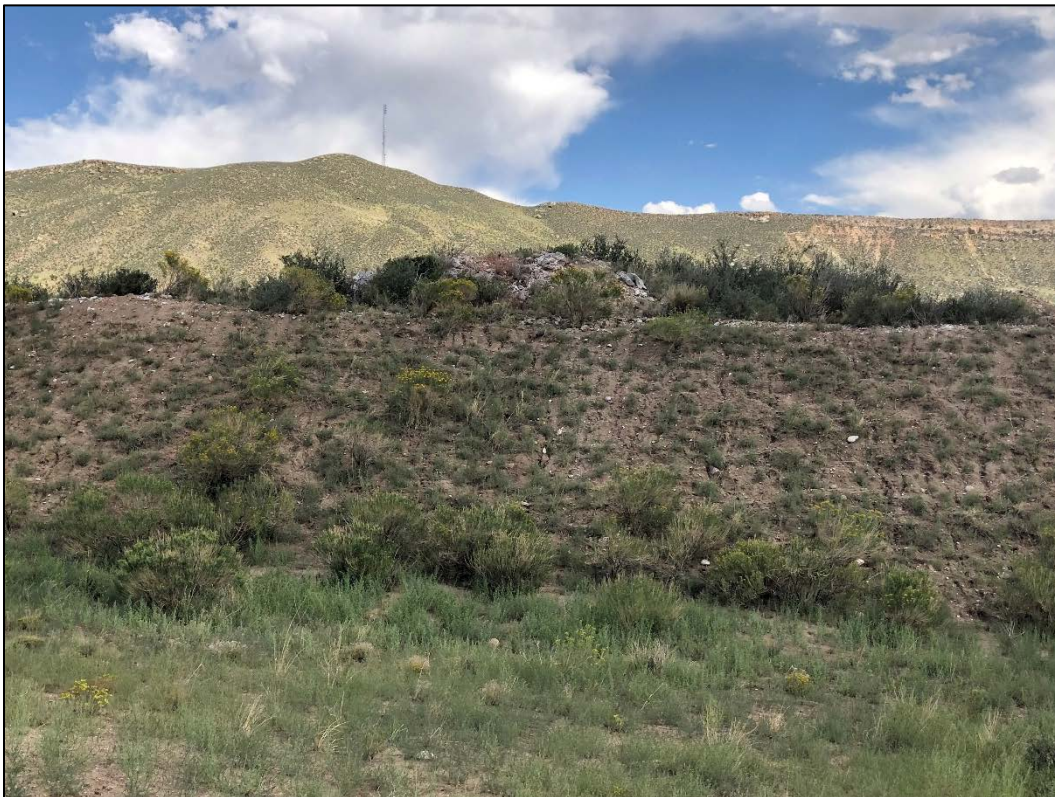
In the east permit area, the previously reclaimed disturbance remains stable with a good grass and shrub cover. The hillside that was reseeded in the fall of 2017 appeared to be stable with a good grass and shrub cover. While some minor erosional rilling was present along this slope, no significant erosion issues were observed (e.g., gullies, washouts).

**Photo 8.** View looking north across disturbed slope in east permit area that was reseeded in 2017, showing slope now stabilized with grasses and shrubs.
