Pikeview monitoring report

Reference: August 2022 Geotechnical Monitoring Summary Pikeview Quarry

Client/Project
**CONTINENTAL MATERIALS
CORP.
PIKEVIEW QUARRY SLOPE
MONITORING**

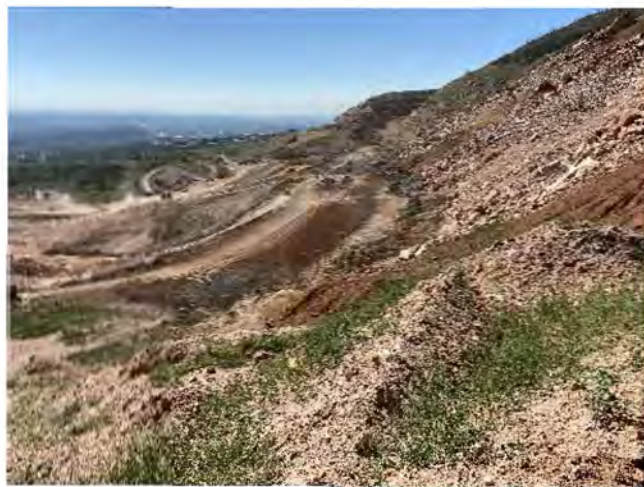
6. View to the south of the pit floor.

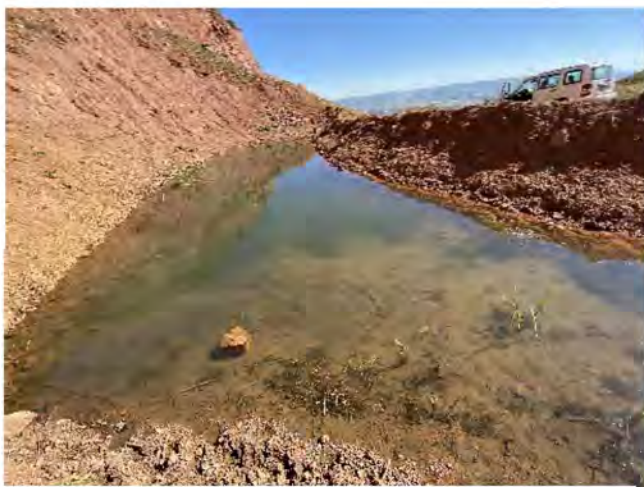
5. Wildlife water sump along top of haul road.

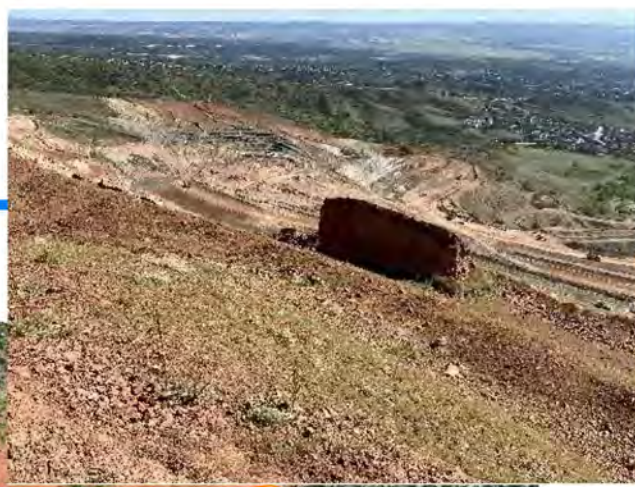
4. Rock formation on the slopes of the landslide.

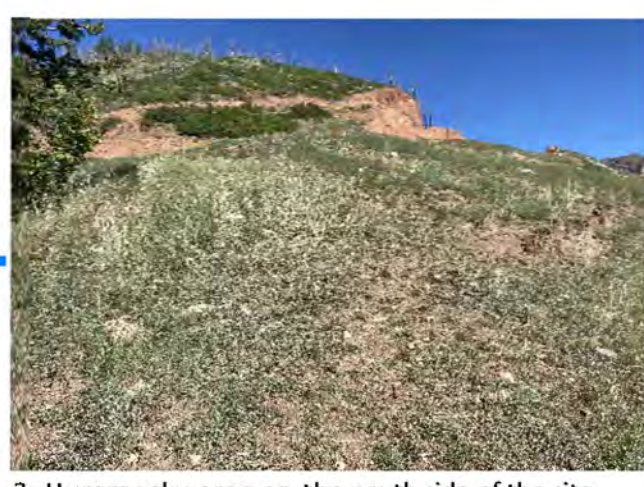
- No cracking was observed on the native granite slopes above the extents of the disturbed area. (Photo 3)
- Offsite fill was placed near the reclamation benches. The material was spread by dozers and compacted in one-foot lifts in accordance with the project specifications. (Photo 8)

3. Hummocky area on the south side of the site remains stable without new cracks.

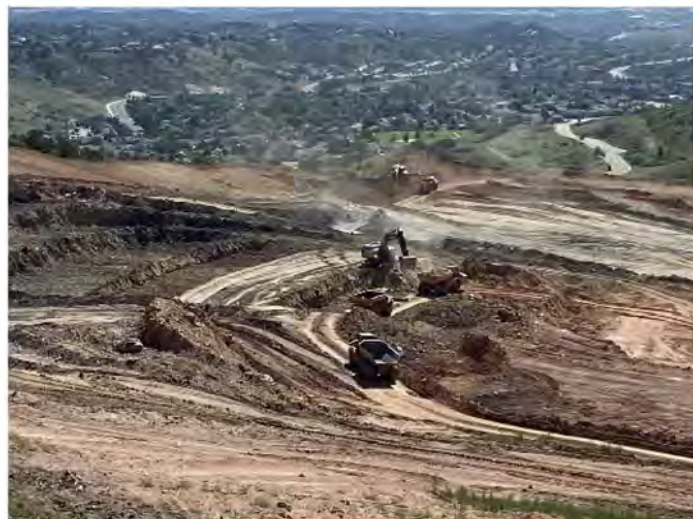
7. Excavator loads haul trucks at north borrow area.

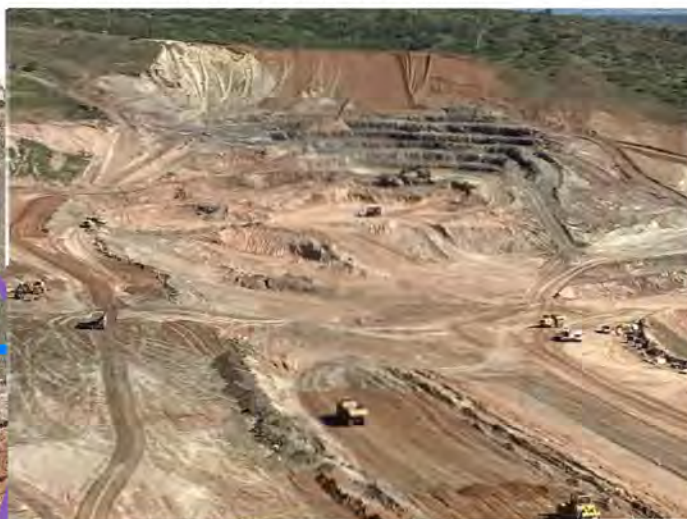
2. North borrow area on the north end of the site.

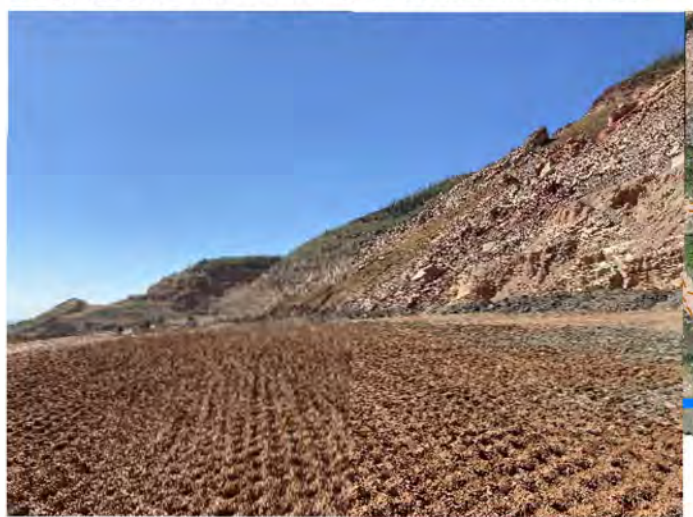
8. Recently compacted lift on the pit floor.

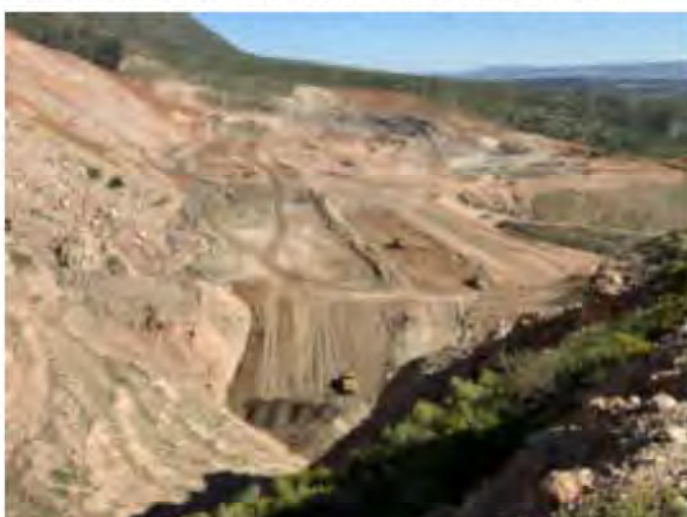
1. View north of compaction area and borrow area.

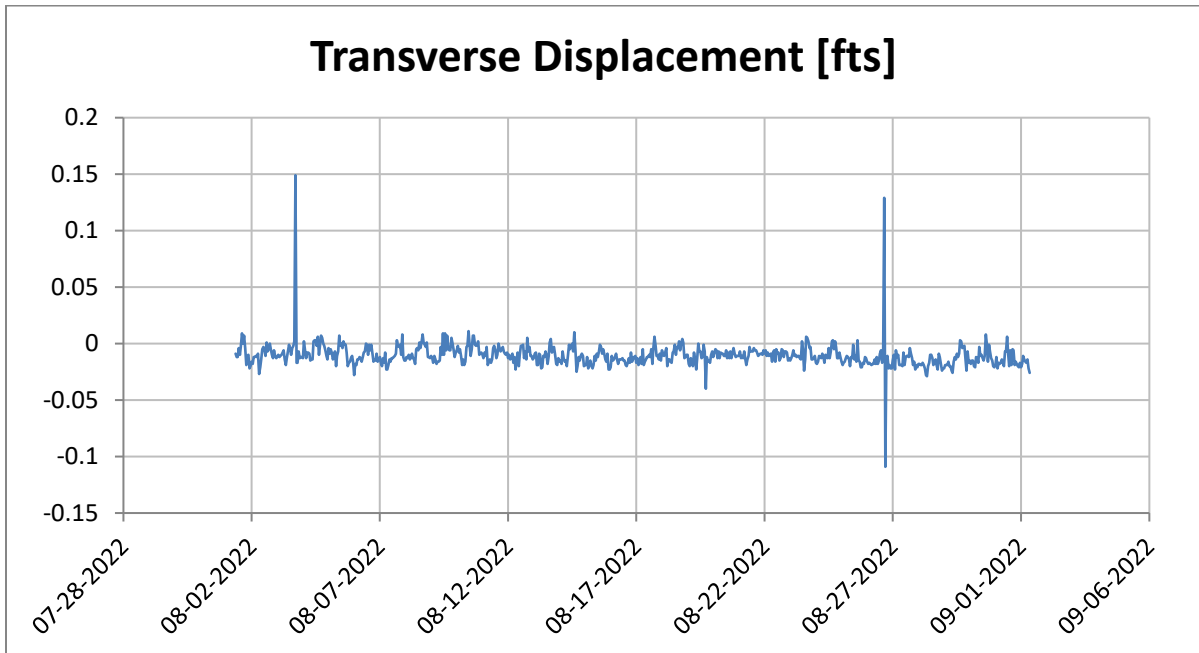
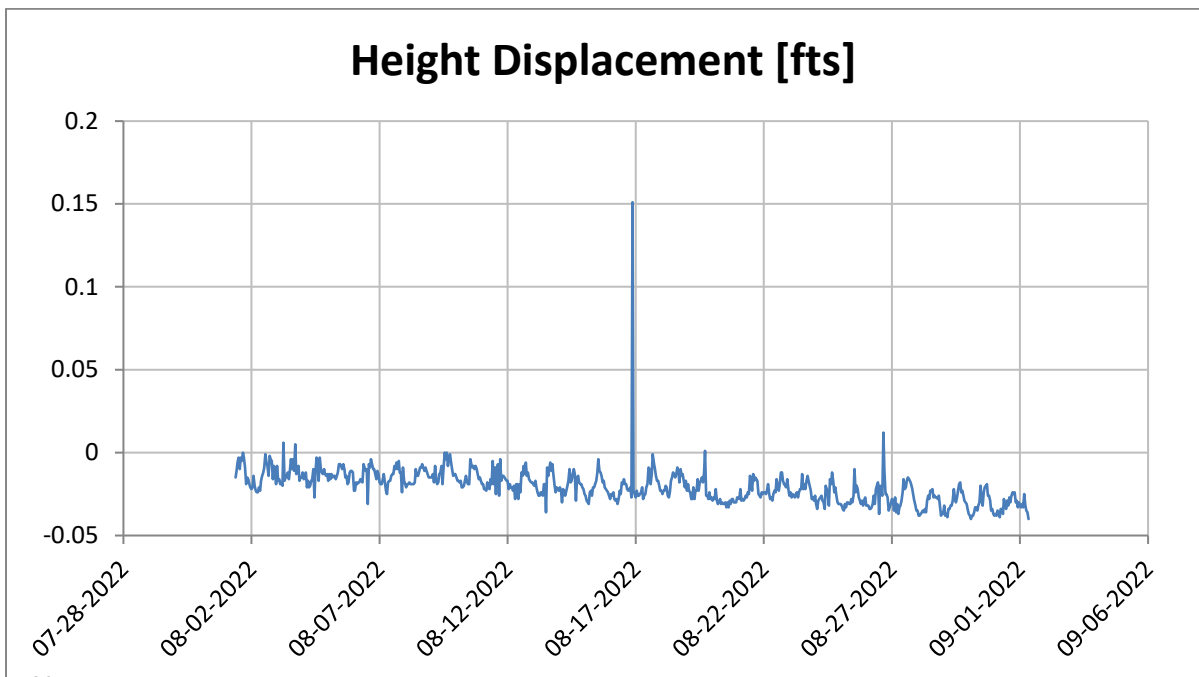
Prism BR1

1. Survey accuracy is +/-0.016 feet.
2. Alarm threshold is +/-0.35 feet.
3. Transverse displacement is in the horizontal direction. Positive direction means closer to the robotic station.
4. Height displacement is in the vertical direction. Positive direction means higher in elevation.
5. Prism records slope creep movements with slow velocity.

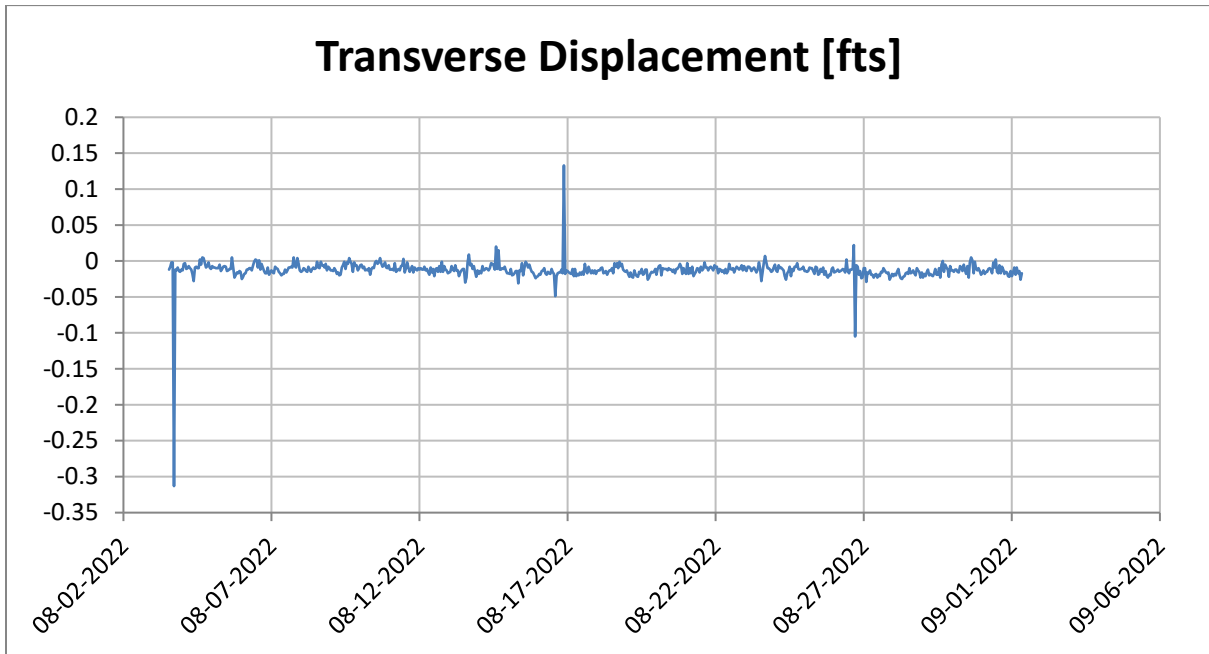
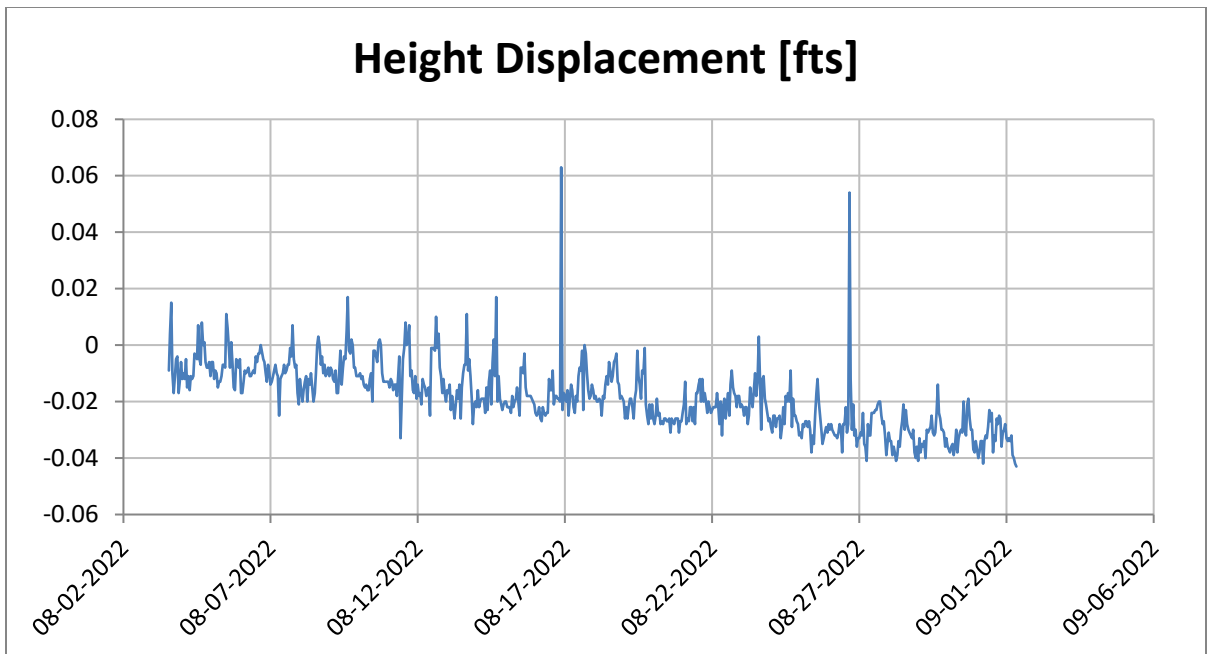
Prism BR2

1. Survey accuracy is +/-0.016 feet.
2. Alarm threshold is +/-0.35 feet.
3. Transverse displacement is in the horizontal direction. Positive direction means closer to the robotic station.
4. Height displacement is in the vertical direction. Positive direction means higher in elevation.
5. Prism records slope creep movements with slow velocity.

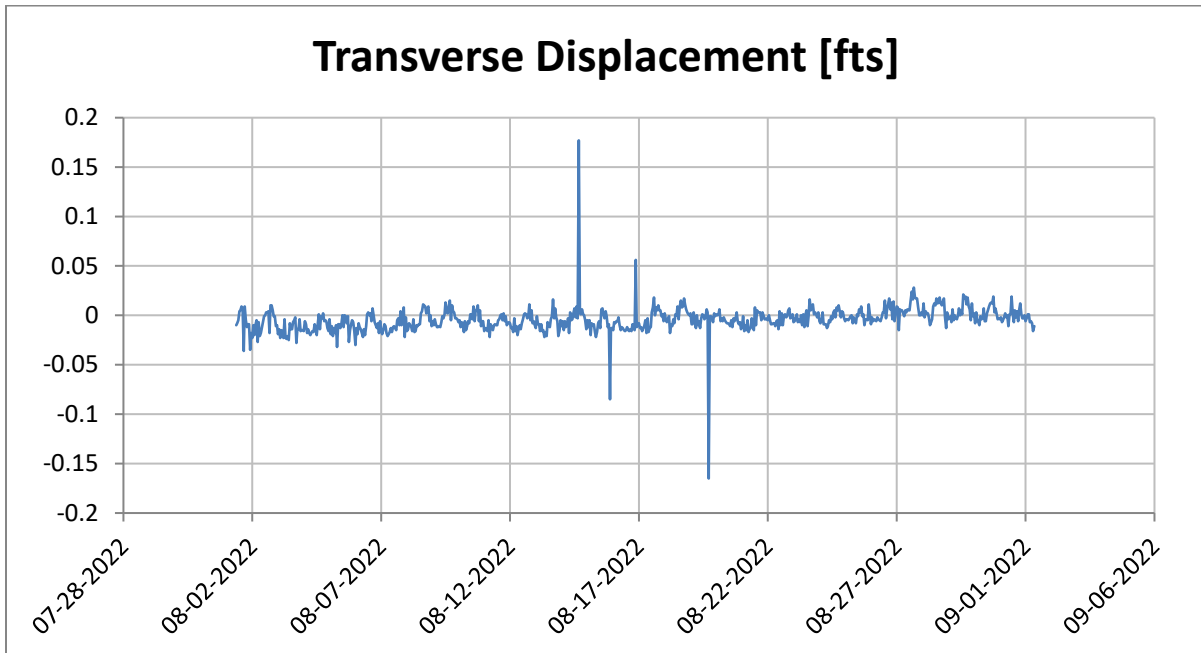
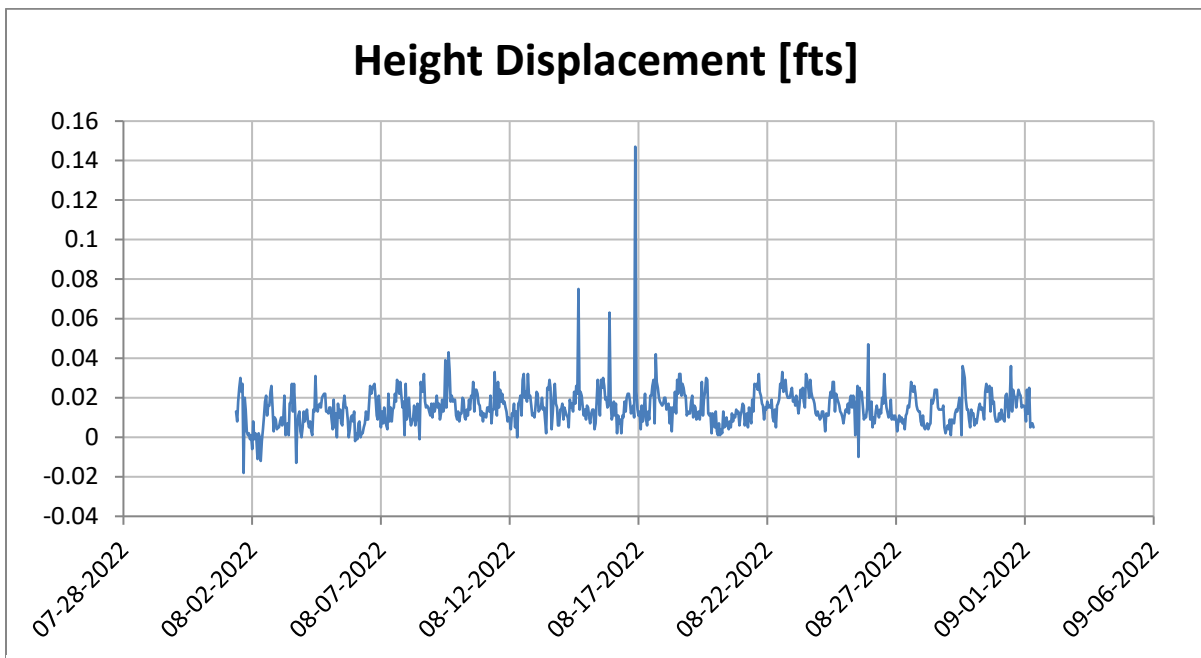
Prism NP2

1. Survey accuracy is ± 0.016 feet.
2. Alarm threshold is ± 0.35 feet.
3. Transverse displacement is in the horizontal direction. Positive direction means closer to the robotic station.
4. Height displacement is in the vertical direction. Positive direction means higher in elevation.
5. Exceedance alerts were received on 8/14, 8/15, 8/16, 8/17, and 8/19.

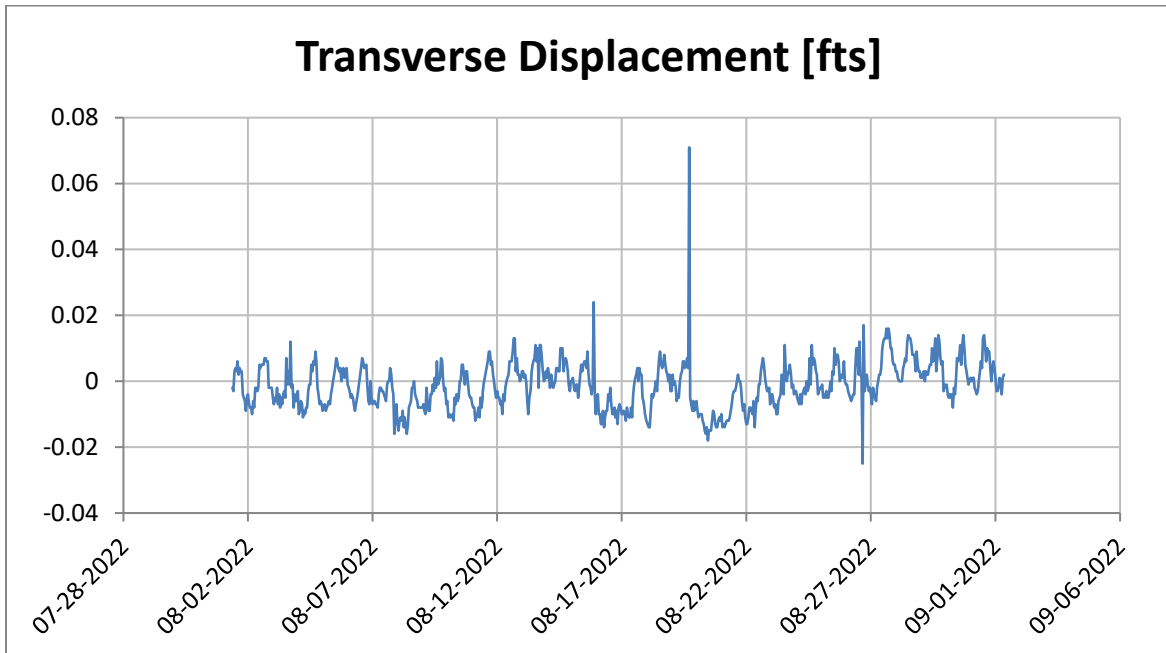
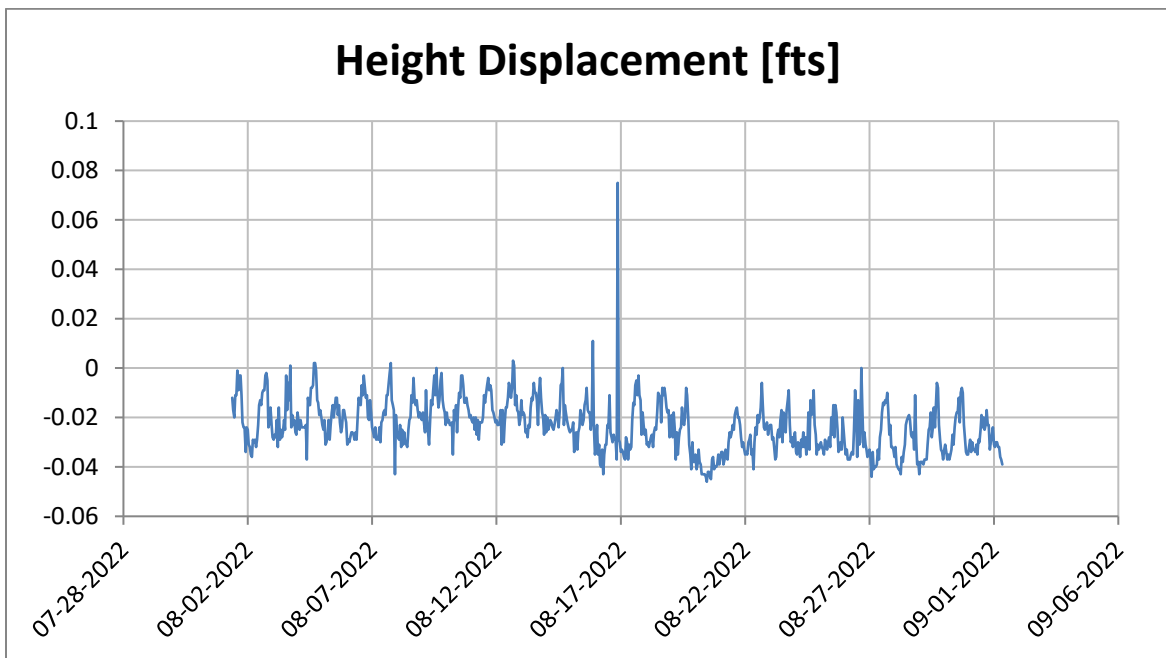
Prism NP66

1. Survey accuracy is ± 0.016 feet.
2. Alarm threshold is ± 0.35 feet.
3. Transverse displacement is in the horizontal direction. Positive direction means closer to the robotic station.
4. Height displacement is in the vertical direction. Positive direction means higher in elevation.
5. Prism records slope creep movements with slow velocity.
6. Exceedance alerts were received on 8/15, 8/17, 8/19, and 8/26.

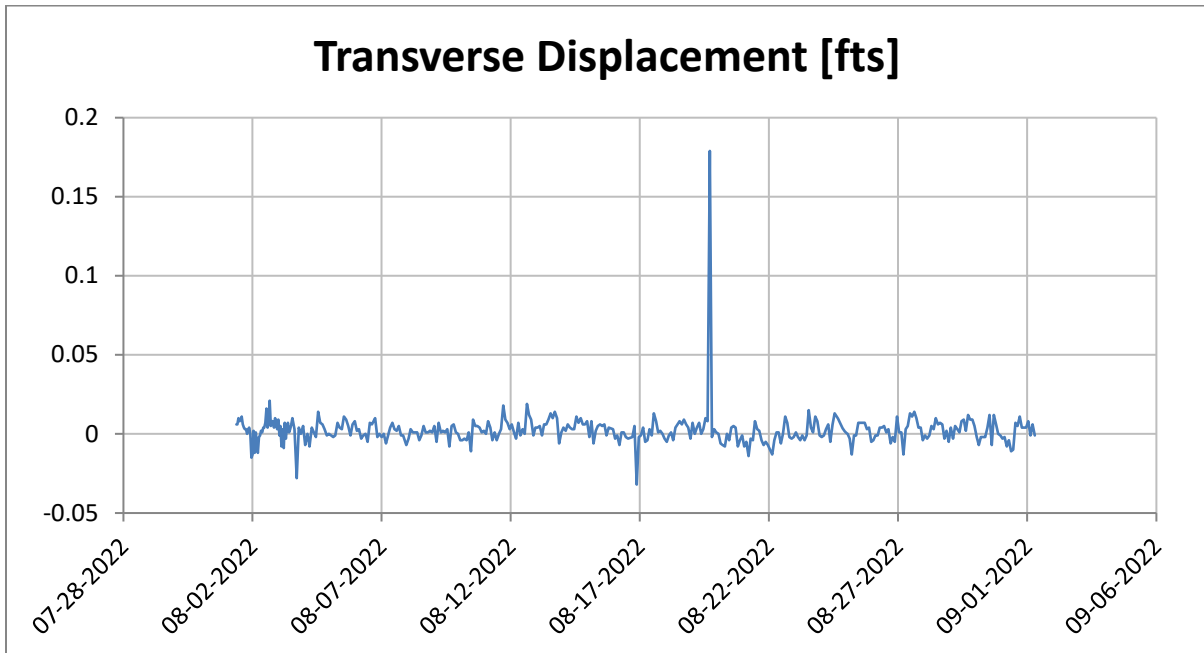
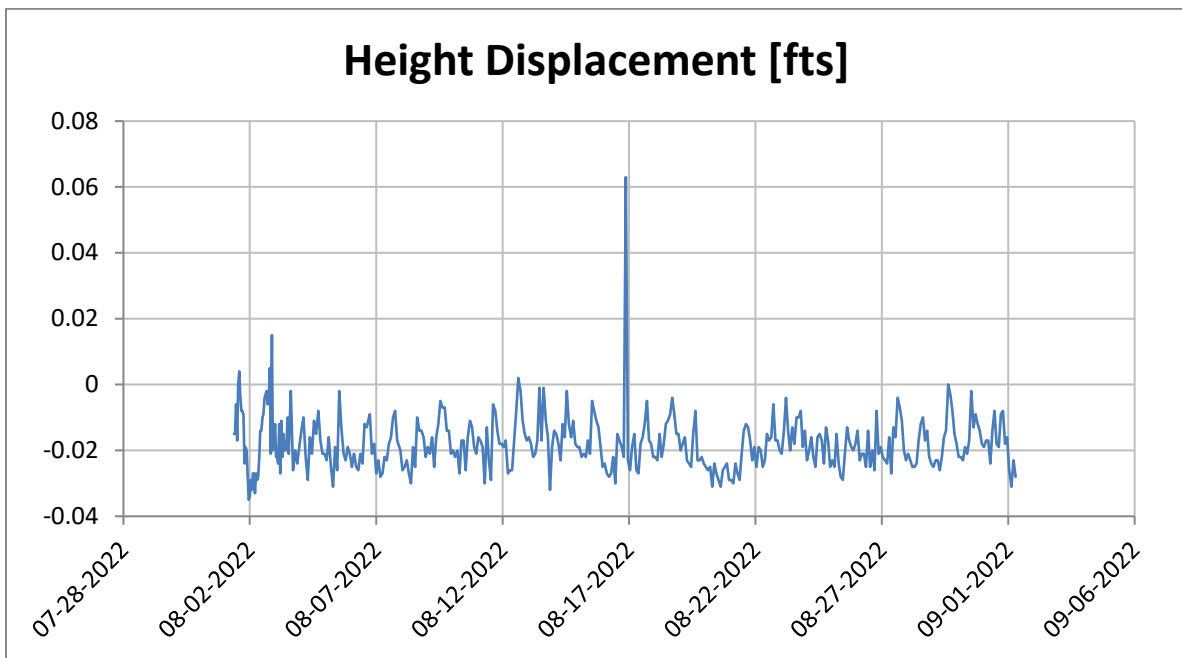
Prism P1

1. Survey accuracy is ± 0.016 feet.
2. Alarm threshold is ± 0.35 feet.
3. Transverse displacement is in the horizontal direction. Positive direction means closer to the robotic station.
4. Height displacement is in the vertical direction. Positive direction means higher in elevation.
5. Exceedance alerts were received on 8/19 and 8/26.

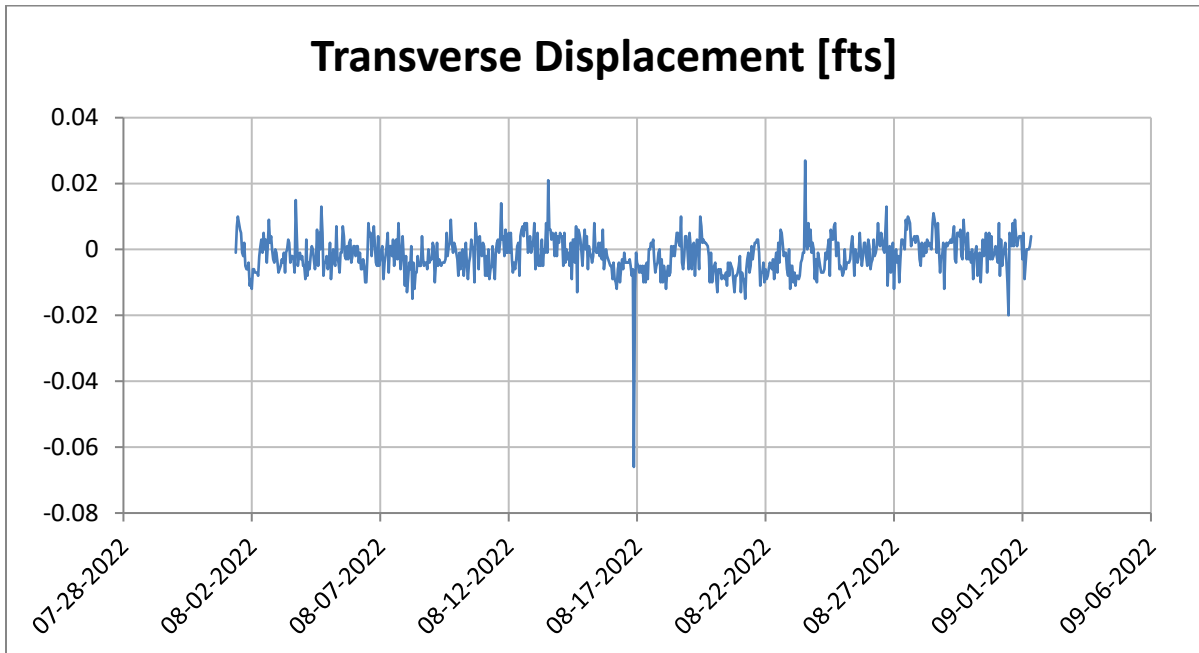
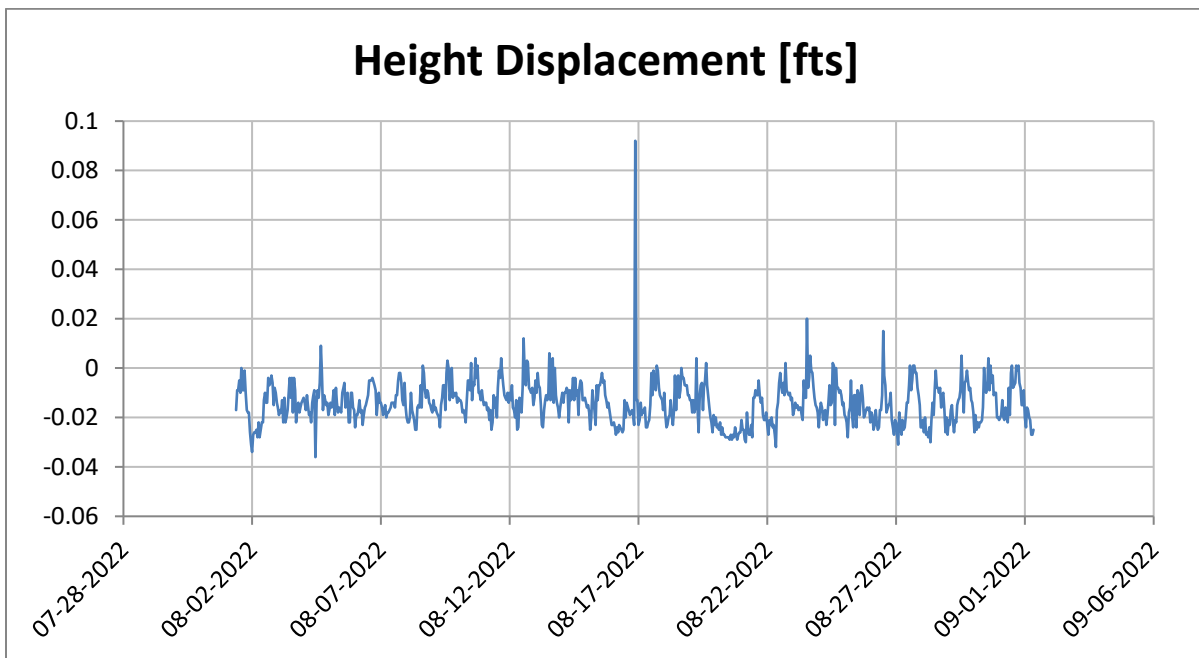
Prism P2

1. Survey accuracy is +/-0.016 feet.
2. Alarm threshold is +/-0.35 feet.
3. Transverse displacement is in the horizontal direction. Positive direction means closer to the robotic station.
4. Height displacement is in the vertical direction. Positive direction means higher in elevation.
5. Exceedance alerts were received on 8/15 and 8/17.

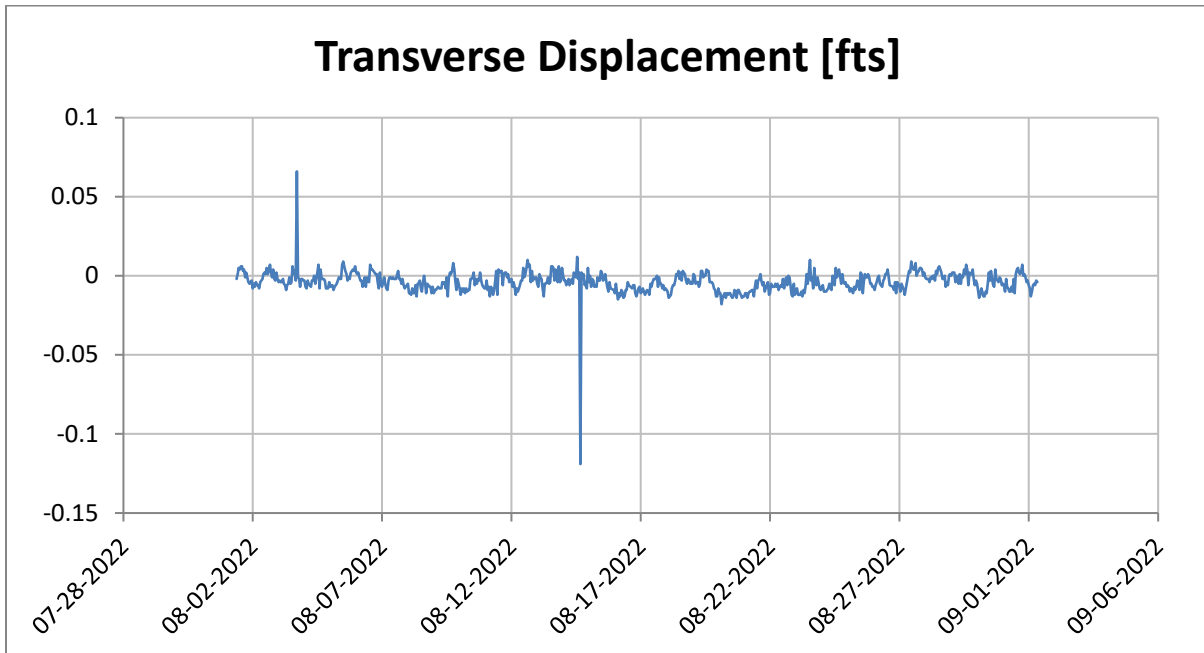
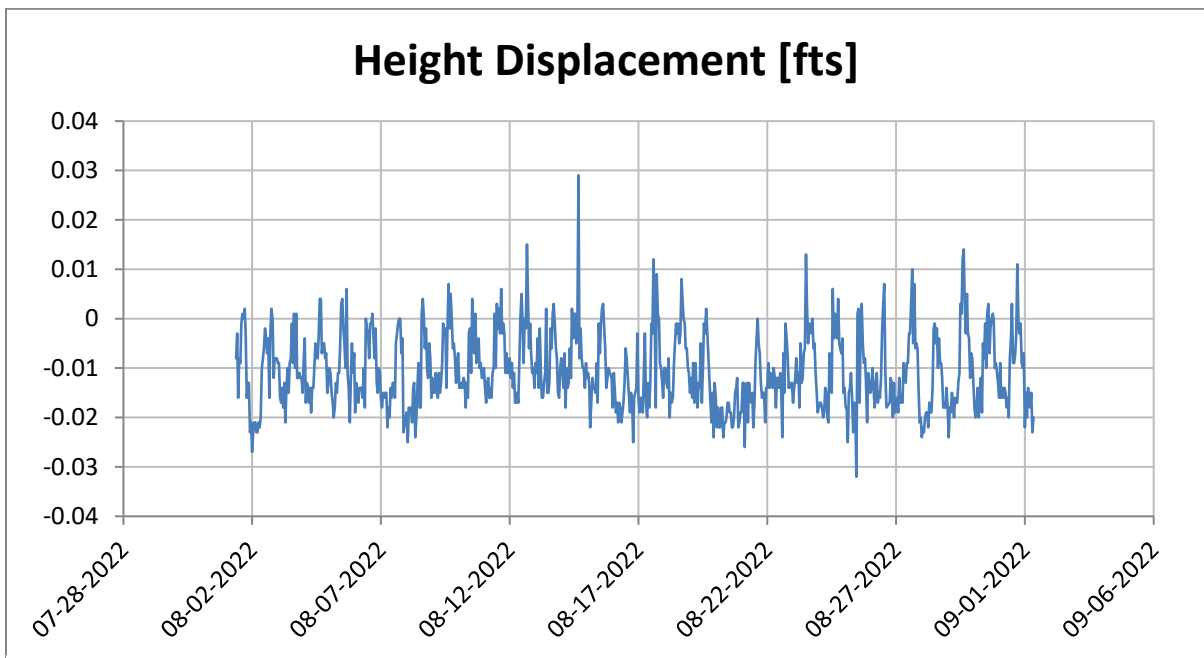
Prism P5

1. Survey accuracy is +/-0.016 feet.
2. Alarm threshold is +/-0.35 feet.
3. Transverse displacement is in the horizontal direction. Positive direction means closer to the robotic station.
4. Height displacement is in the vertical direction. Positive direction means higher in elevation.
5. Exceedance alerts were received on 8/3 and 8/14.

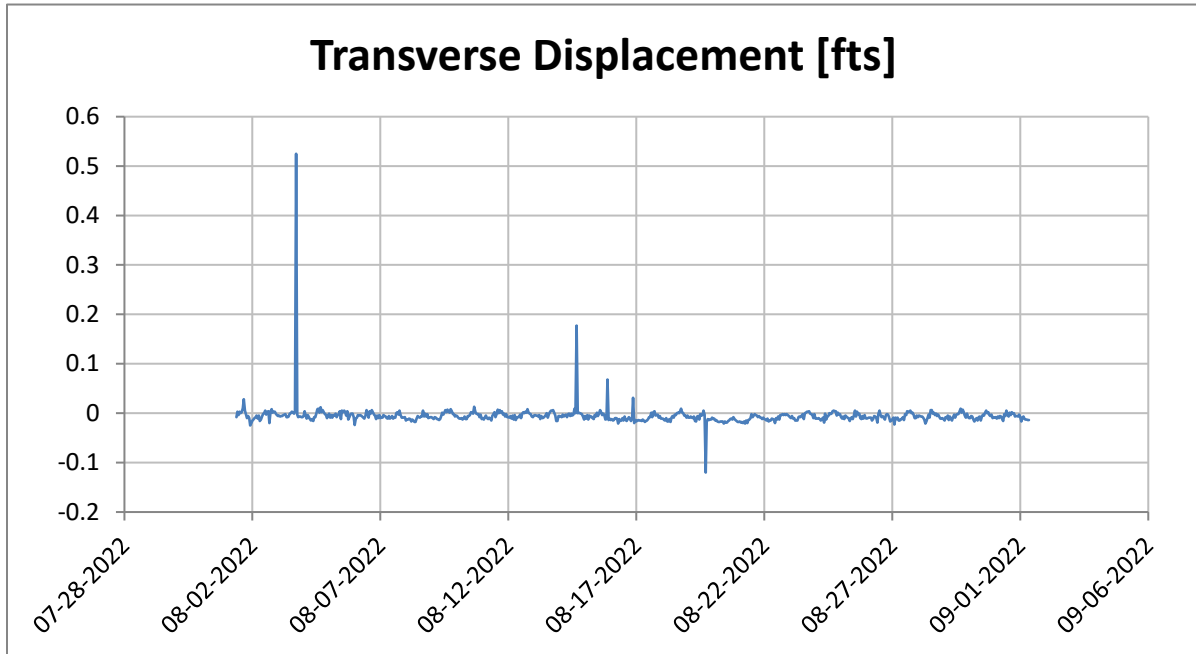
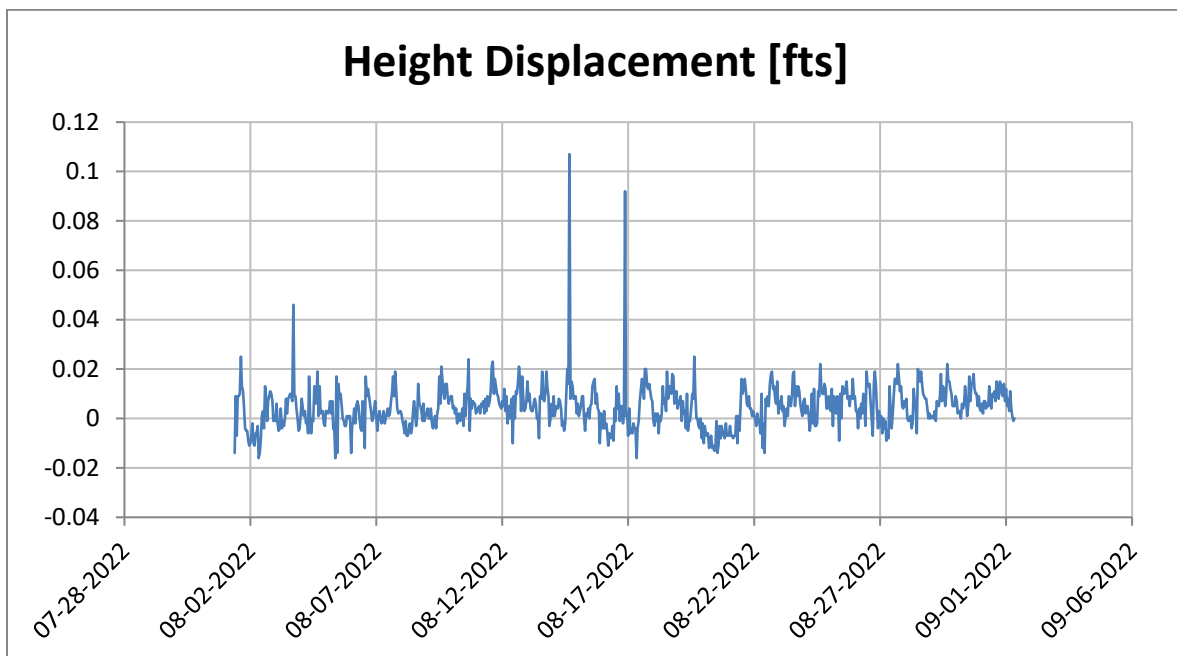
Prism P25

1. Survey accuracy is +/-0.016 feet.
2. Alarm threshold is +/-0.35 feet.
3. Transverse displacement is in the horizontal direction. Positive direction means closer to the robotic station.
4. Height displacement is in the vertical direction. Positive direction means higher in elevation.
5. Exceedance alerts were received on 8/3, 8/14, 8/15, 8/16, 8/17, and 8/19.

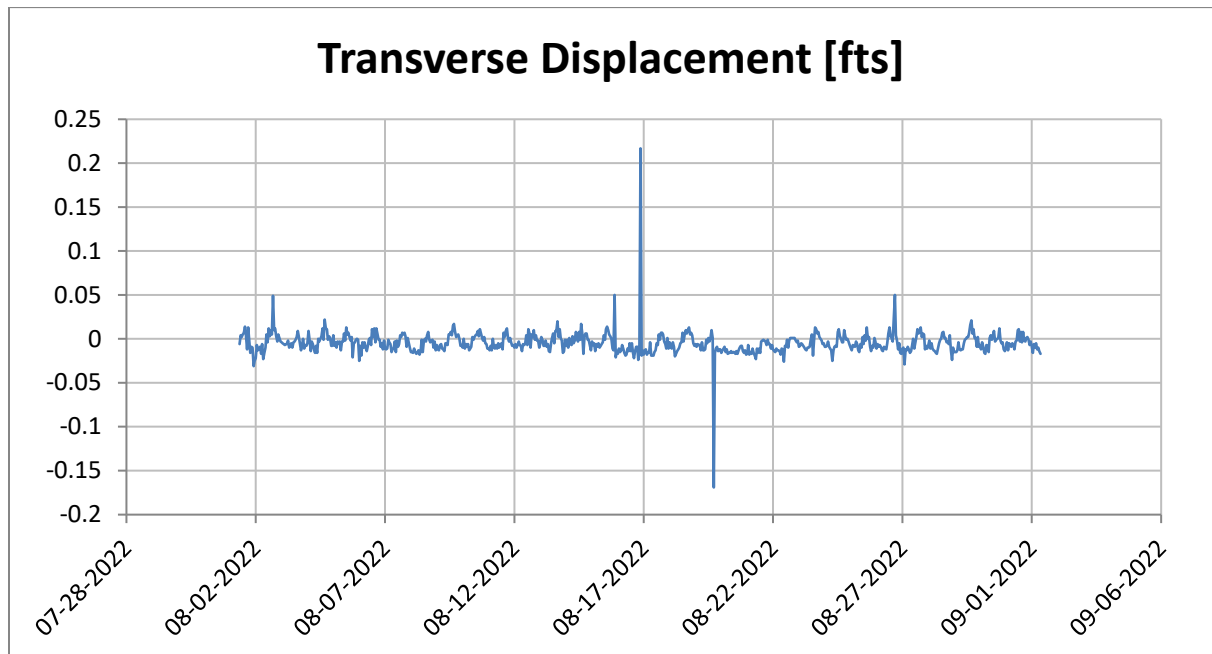
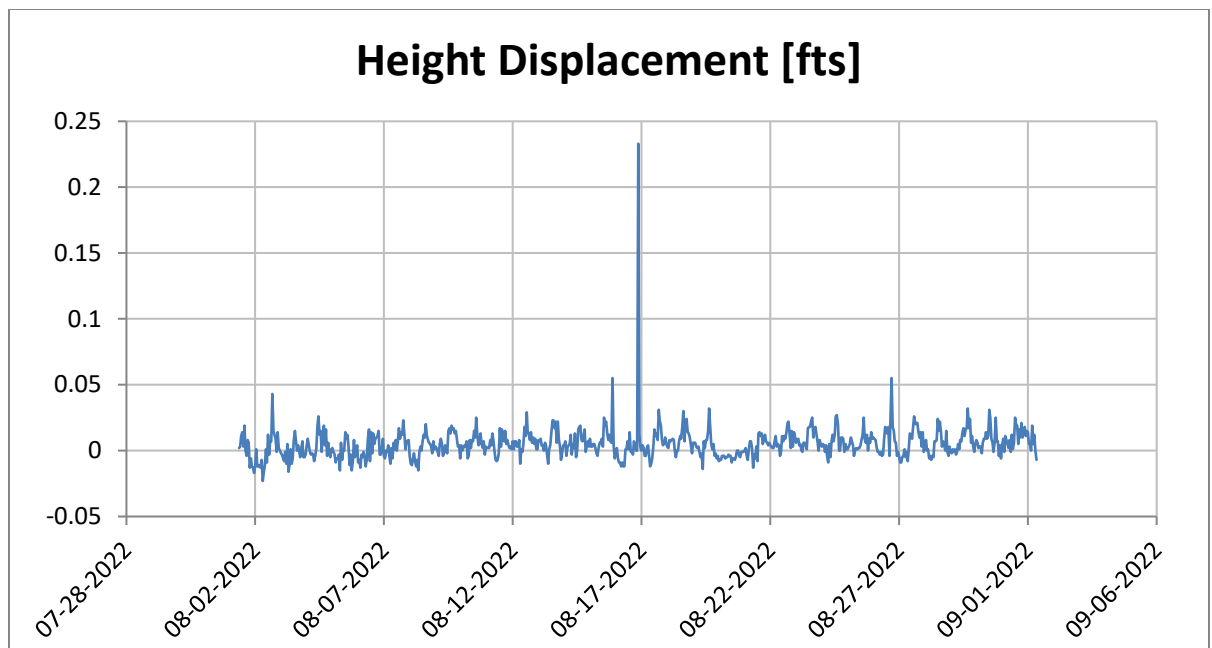
Prism P32

1. Survey accuracy is +/-0.016 feet.
2. Alarm threshold is +/-0.35 feet.
3. Transverse displacement is in the horizontal direction. Positive direction means closer to the robotic station.
4. Height displacement is in the vertical direction. Positive direction means higher in elevation.
5. Exceedance alerts were received on 8/2, 8/15, 8/16, 8/17, 8/19, and 8/26.

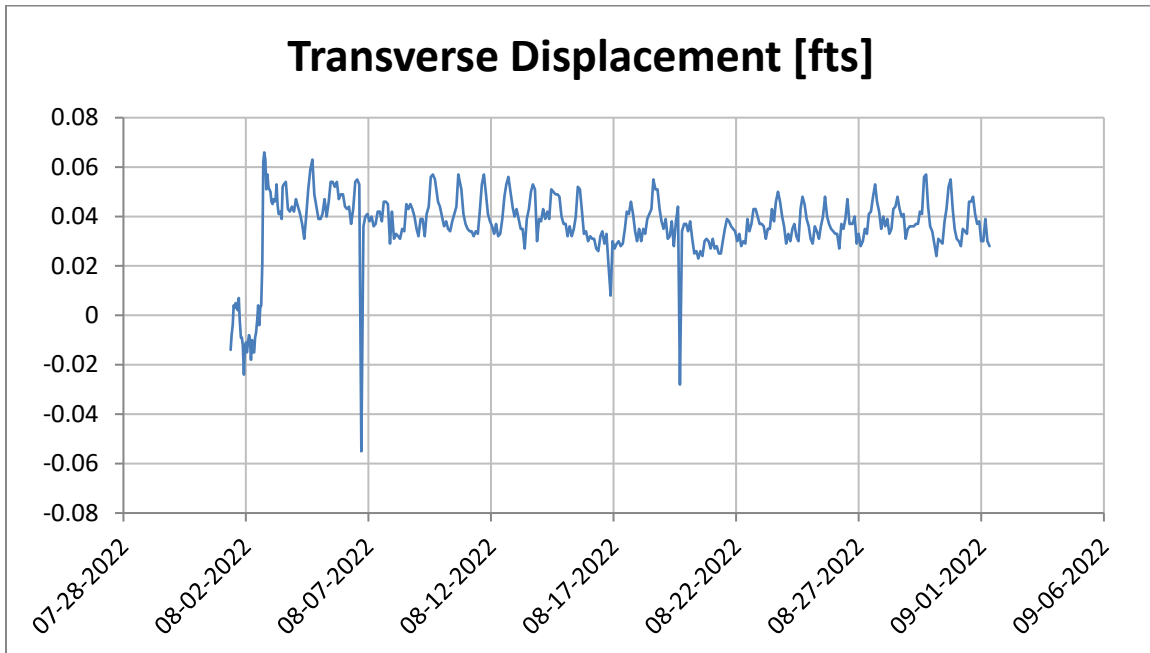
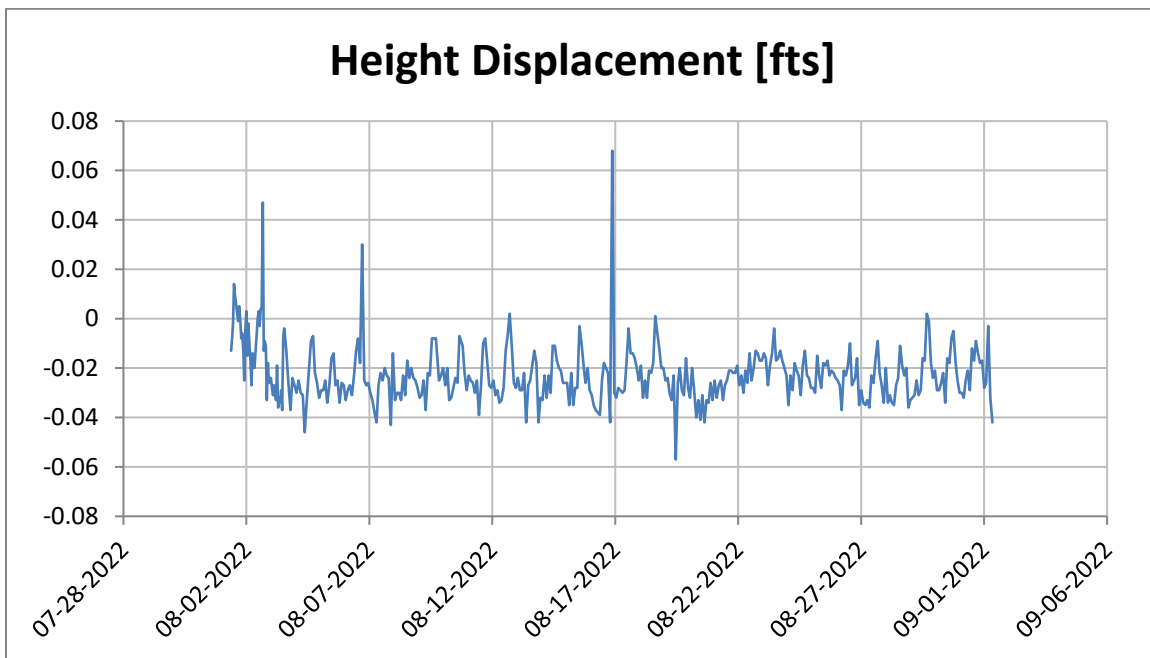
Prism P33

1. Survey accuracy is +/-0.016 feet.
2. Alarm threshold is +/-0.35 feet.
3. Transverse displacement is in the horizontal direction. Positive direction means closer to the robotic station.
4. Height displacement is in the vertical direction. Positive direction means higher in elevation.
5. Prism recorded a data shift on August 2. No signs of movement were identified at location. Believed to be caused by animals.
6. Exceedance alerts were received on 8/2, 8/6, 8/7, 8/8, 8/16, 8/17, and 8/19.

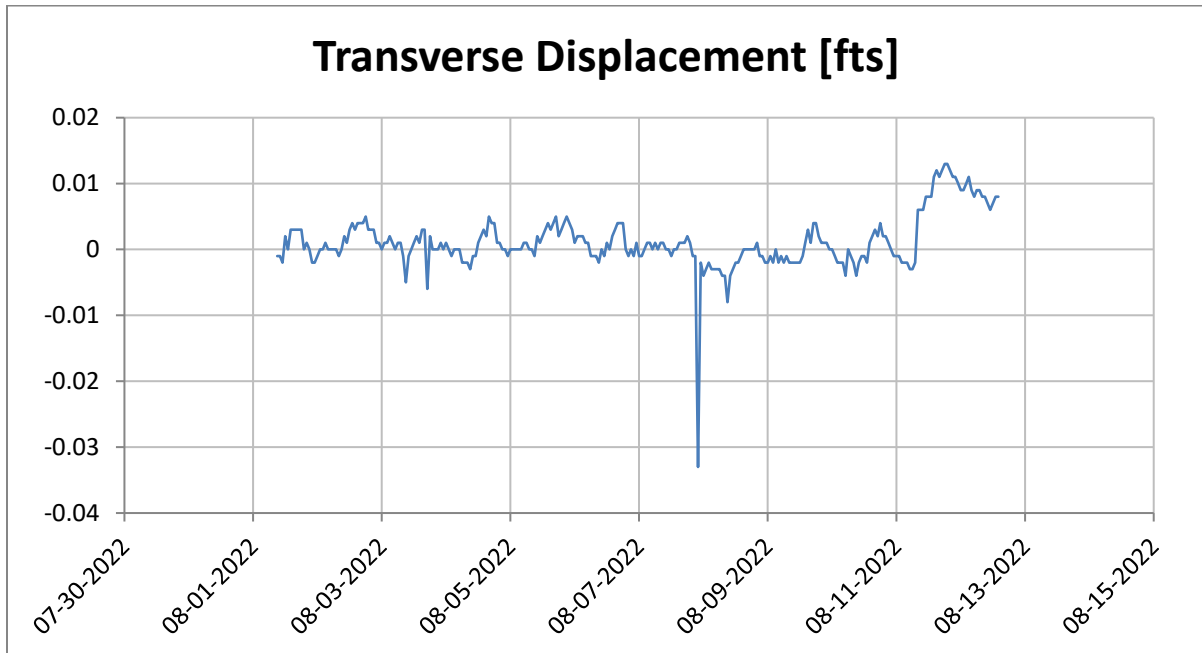
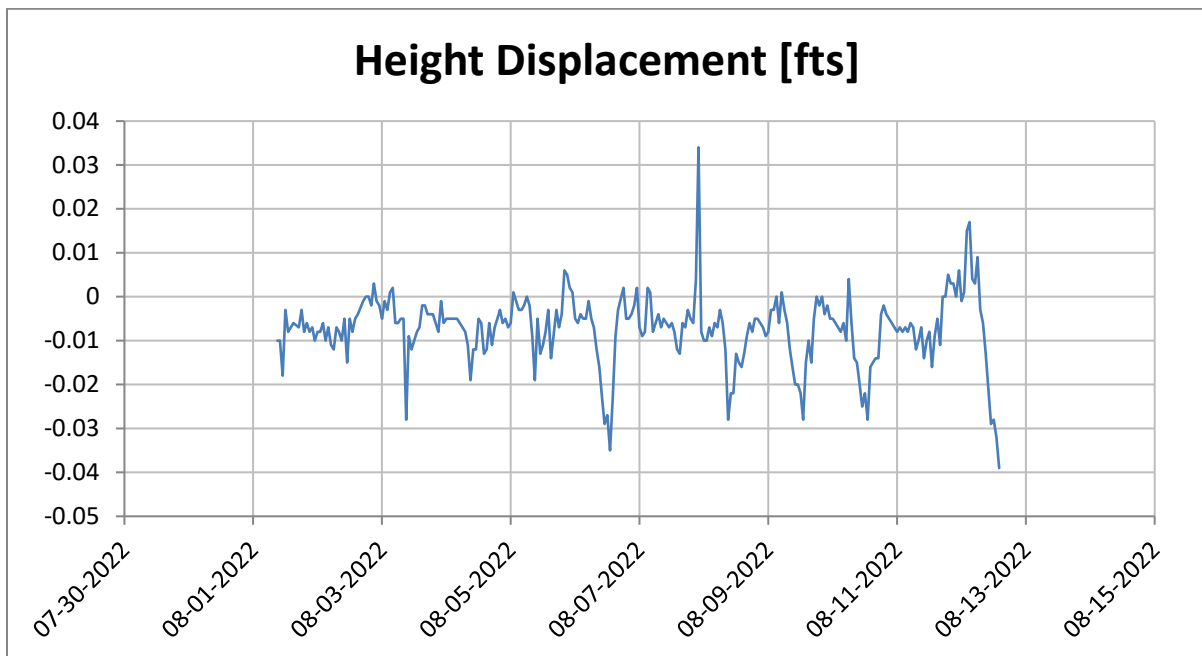
Prism P63

1. Survey accuracy is +/-0.016 feet.
2. Alarm threshold is +/-0.35 feet.
3. Transverse displacement is in the horizontal direction. Positive direction means closer to the robotic station.
4. Height displacement is in the vertical direction. Positive direction means higher in elevation.
5. Prism removed on August 15.
6. Exceedance alerts were received on 8/7 and 8/8.

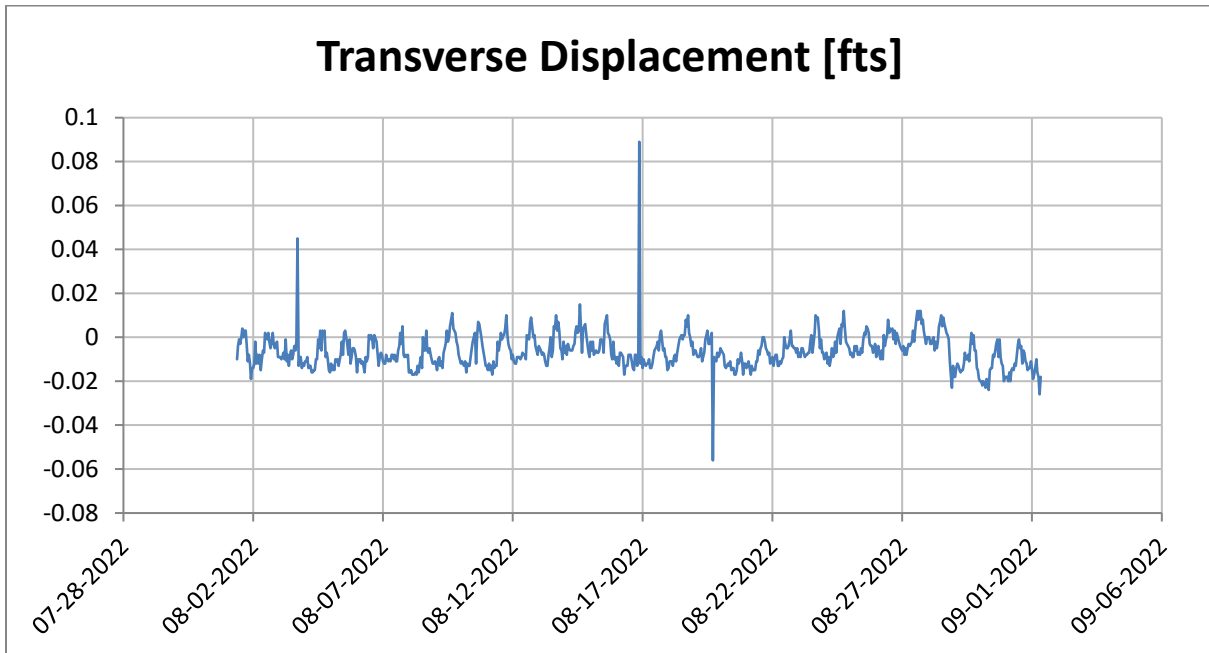
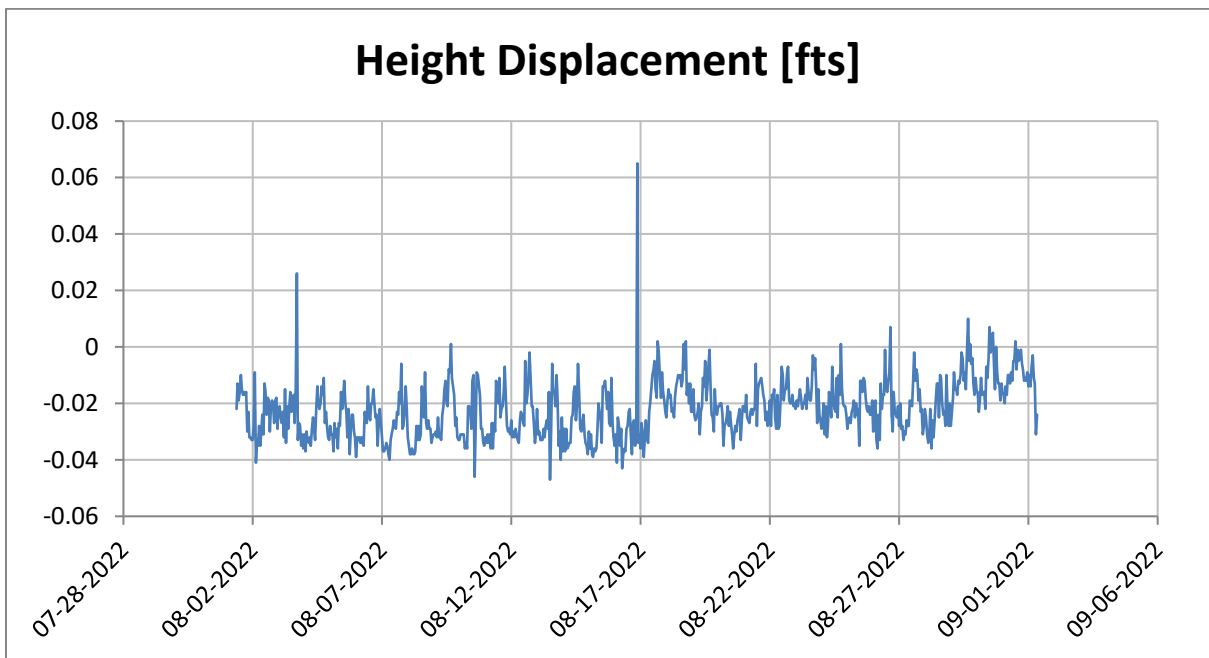
Prism P69A

1. Survey accuracy is +/-0.016 feet.
2. Alarm threshold is +/-0.35 feet.
3. Transverse displacement is in the horizontal direction. Positive direction means closer to the robotic station.
4. Height displacement is in the vertical direction. Positive direction means higher in elevation.
5. Prism previously recorded slope creep movements.
6. Exceedance alerts were received on 8/3, 8/16, and 8/17.
