Pikeview monitoring report

Reference: August 2022 Geotechnical Monitoring Summary Pikeview Quarry

Client/Project
**CONTINENTAL MATERIALS
CORP.
PIKEVIEW QUARRY SLOPE
MONITORING**

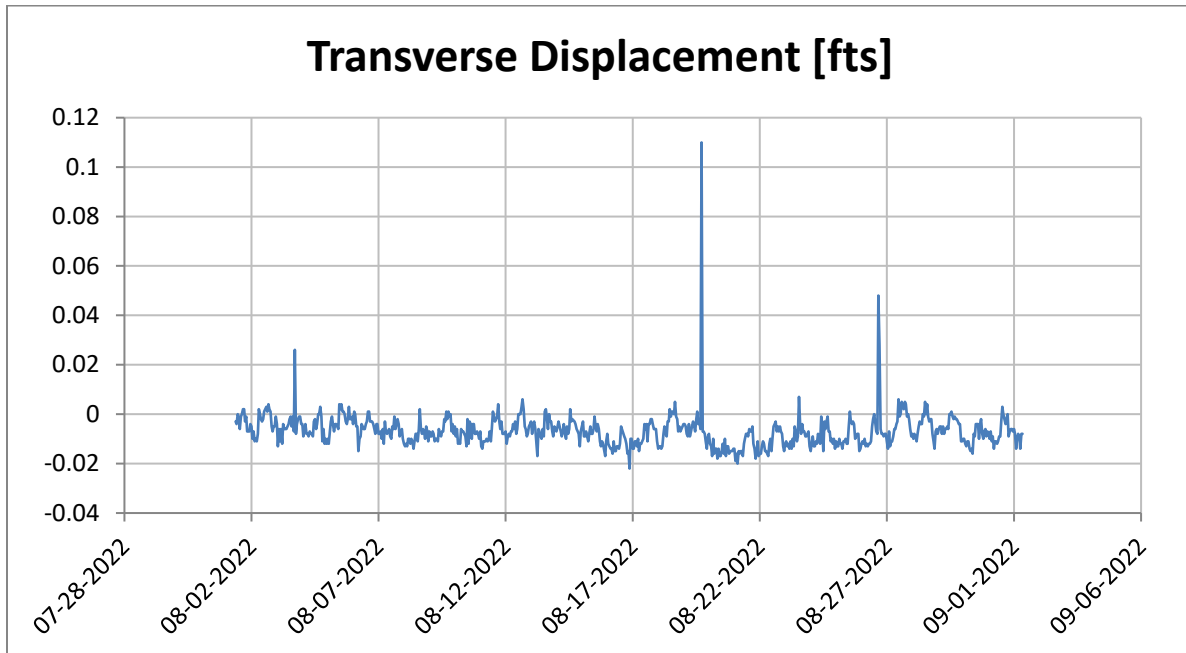
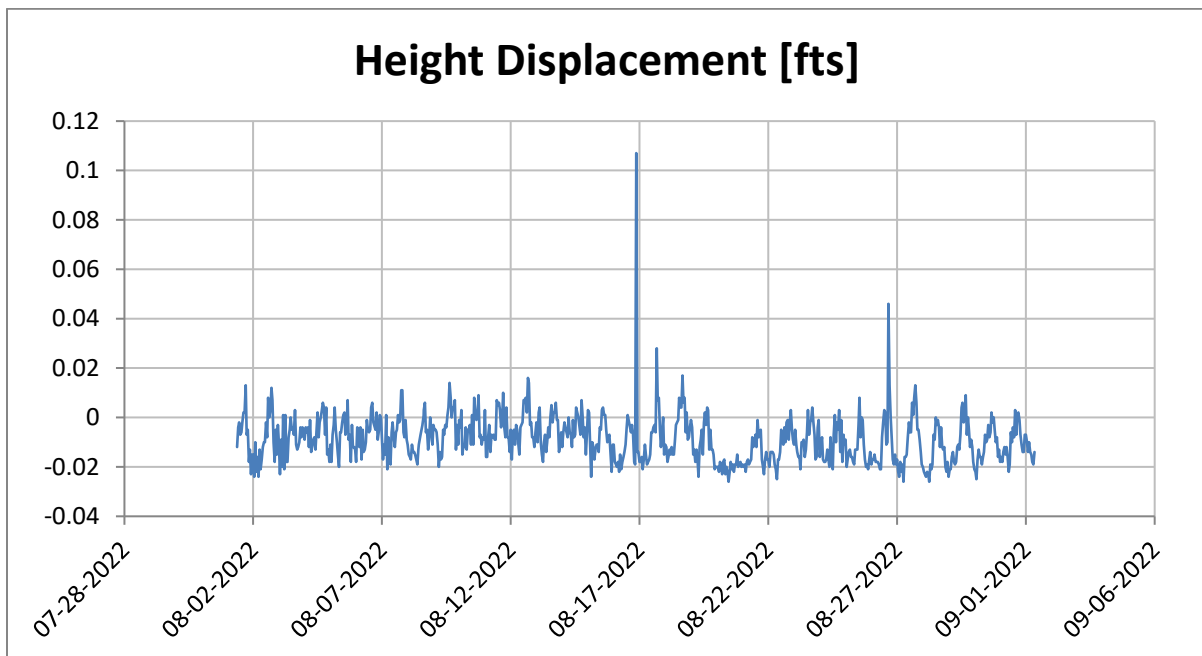
Prism P70

1. Survey accuracy is ± 0.016 feet.
2. Alarm threshold is ± 0.35 feet.
3. Transverse displacement is in the horizontal direction. Positive direction means closer to the robotic station.
4. Height displacement is in the vertical direction. Positive direction means higher in elevation.
5. Exceedance alerts were received on 8/3, 8/17, 8/19, and 8/26.
