**MINERALS PROGRAM INSPECTION REPORT**  
**PHONE: (303) 866-3567**

<b>MINE NAME:</b> Red Mountain Exploration Drilling	<b>MINE/PROSPECTING ID#:</b> P-2011-014	<b>MINERAL:</b> Molybdenum	<b>COUNTY:</b> Clear Creek
<b>INSPECTION TYPE:</b> Surety Release Inspection	<b>INSPECTOR(S):</b> Brock Bowles	<b>INSP. DATE:</b> September 15, 2022	<b>INSP. TIME:</b> 08:00
<b>OPERATOR:</b> Climax Molybdenum Company	<b>OPERATOR REPRESENTATIVE:</b> Geoff Niggeler	<b>TYPE OF OPERATION:</b> MP - Mineral Prospecting

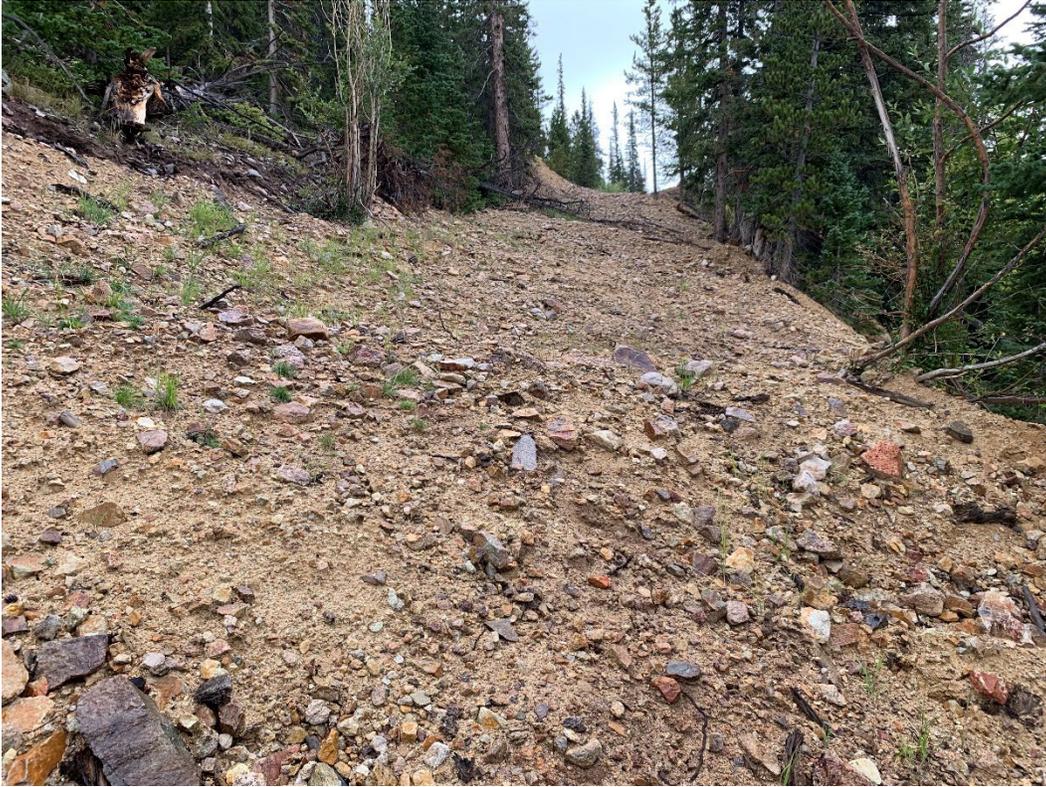
Photo 1 – Access road before Pad 1

The access road between all the drill pads (see attached map) was graded to blend in with the surrounding landscape (photos 1-4). A few check dams/basins were installed to control runoff. No significant erosion gullies were seen and the road appeared to be stable.

The access road was seeded in 2020 according to the 2022 Annual Report Map (attached). The vegetation on the access road was inconsistent in success. Some areas were very good (photo 2) while other areas were very sparse (photo 4). Most of the access road had a moderate amount of vegetation as seen in photos 1 and 3. Very few flowers and seed heads were seen on the vegetation. This is an indication that the vegetation is not very mature and not capable of self-regeneration as required by Rule 3.1.10. No noxious weeds were noted on the access road.

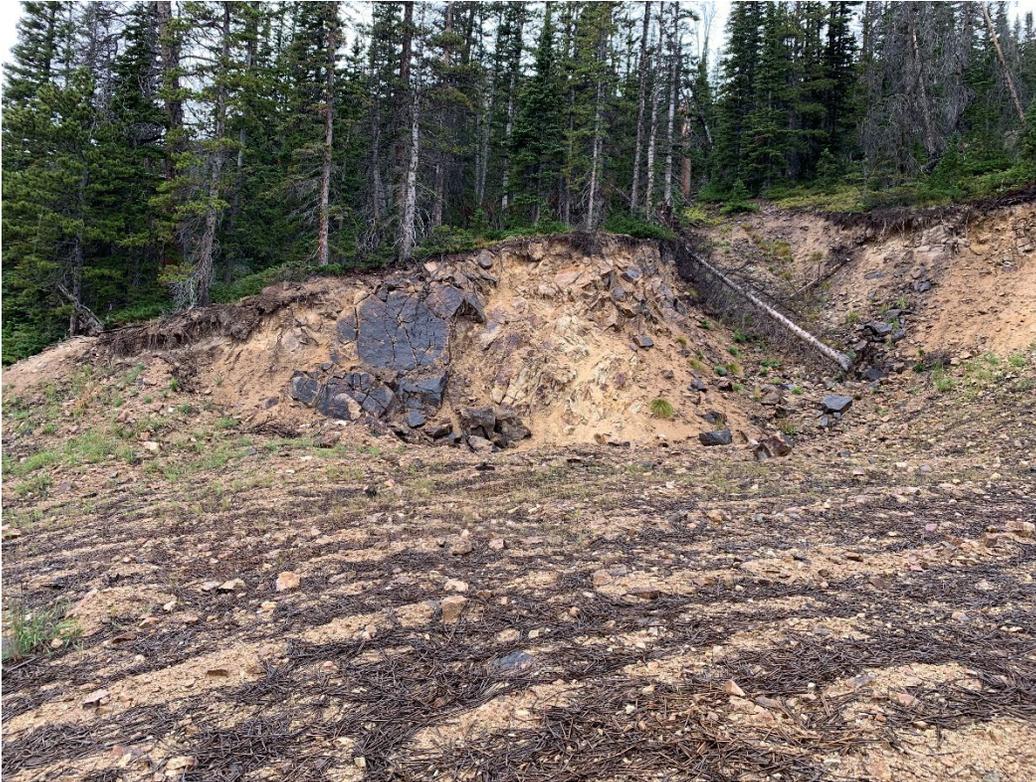
The drill pads 1, 3 and 4 were backfilled and graded to blend in with the surrounding landscape. The cut on drill pad 2 was not backfilled up to the original contour (photo 5), but the slopes appeared to be stable. All the drill pads (1-4) were mulched with wood straw and seeded in 2020. The wood straw mulch was very effective at controlling erosion. There were no signs of soil erosion. The vegetation on the drill pads was very thin and not well established (photos 6-9). Very few seed heads or flowers were seen on the vegetation. Just like the road, this is an indication that the vegetation is not very mature and not capable of self-regeneration as required by Rule 3.1.10. No noxious weeds were noted on any of the drill pads.

Photo 5 – Drill pad 2 partially filled cut area

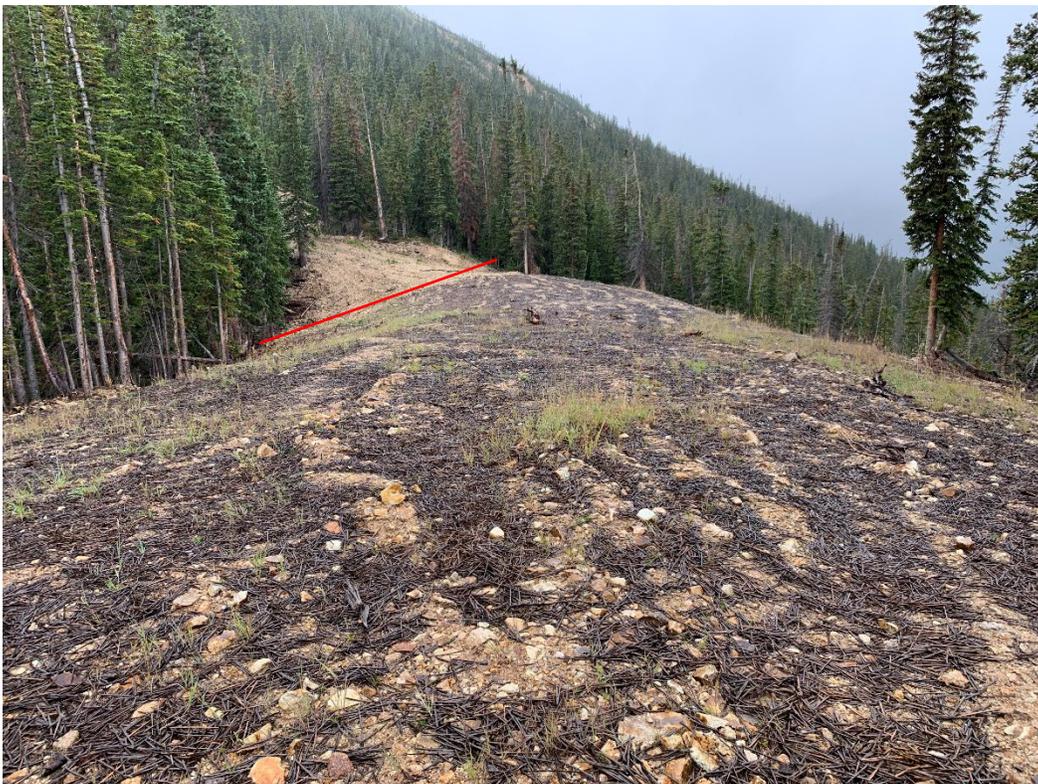
Photo 8 – Drill pad 3, area above red line not in surety release request
