MINERALS PROGRAM INSPECTION REPORT

MINE NAME: Kay Claims	MINE/PROSPECTING ID#: P-2008-045	MINERAL: Gold	COUNTY: Lake
INSPECTION TYPE: Surety Release Inspection	INSPECTOR(S): Lucas West	INSP. DATE: September 7, 2022	INSP. TIME: 09:33
OPERATOR: Mt. Elbert Mining Co., L.L.C.	OPERATOR REPRESENTATIVE: Dennis Sonnenschein	TYPE OF OPERATION: MP - Mineral Prospecting

REASON FOR INSPECTION: Surety Release Requested	BOND CALCULATION TYPE: None	BOND AMOUNT: \$12,100.00
DATE OF COMPLAINT: NA	POST INSP. CONTACTS: None	JOINT INSP. AGENCY: None
WEATHER: Clear	INSPECTOR'S SIGNATURE:

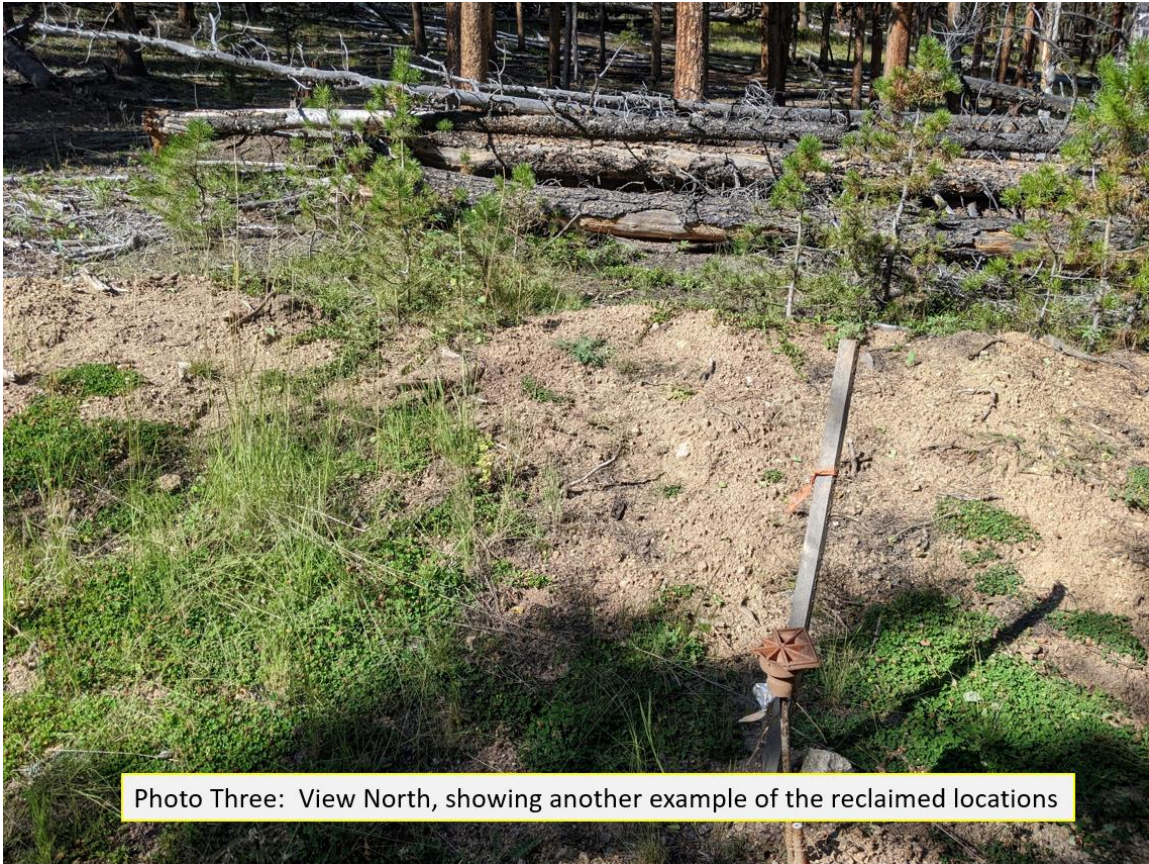
Photo Three: View North, showing another example of the reclaimed locations
