MINERALS PROGRAM INSPECTION REPORT
PHONE: (303) 866-3567

MINE NAME: S & H Mine	MINE/PROSPECTING ID#: M-2000-158	MINERAL: Sand and gravel	COUNTY: Weld
INSPECTION TYPE: Monitoring	INSPECTOR(S): Robert Zuber, P.E.	INSP. DATE: September 1, 2022	INSP. TIME: 08:50
OPERATOR: Scout Investments, L.L.C.	OPERATOR REPRESENTATIVE: Jason VonLembke	TYPE OF OPERATION: 112c - Construction Regular Operation

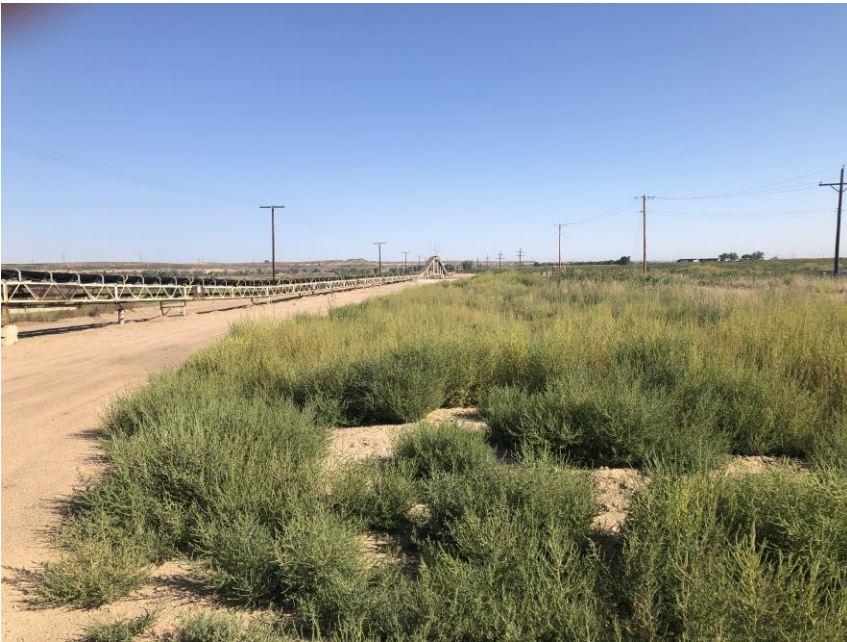
Conveyor, facing north

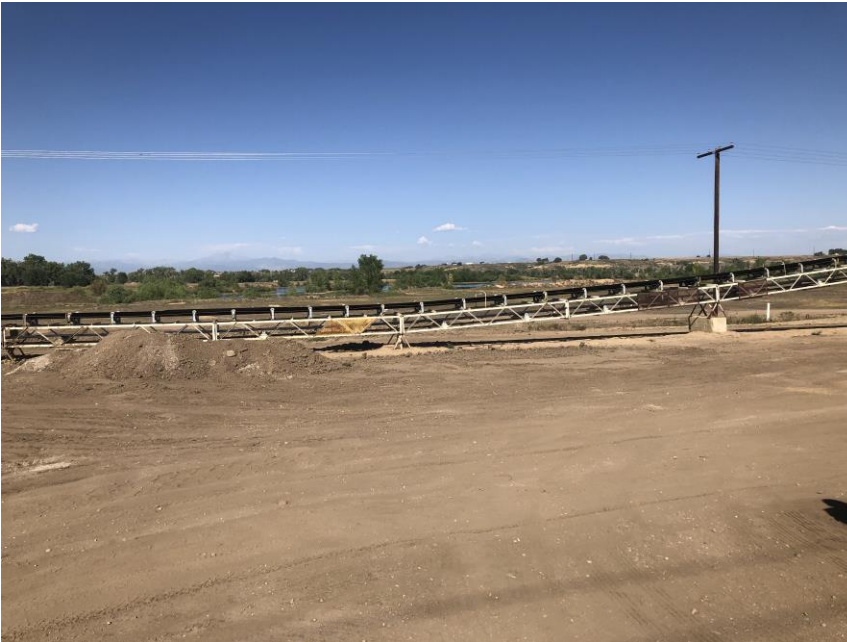
Conveyor, facing west, with Cell C2 in background

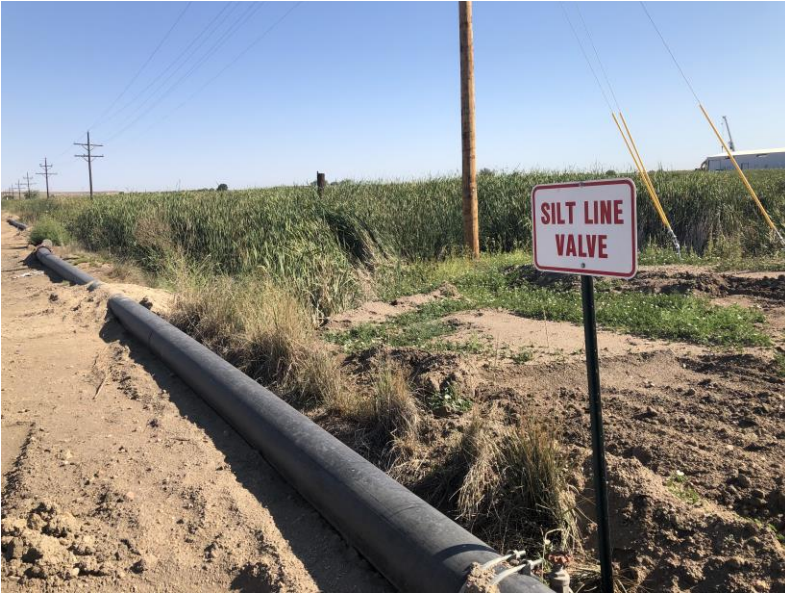
Pipeline to silt pond

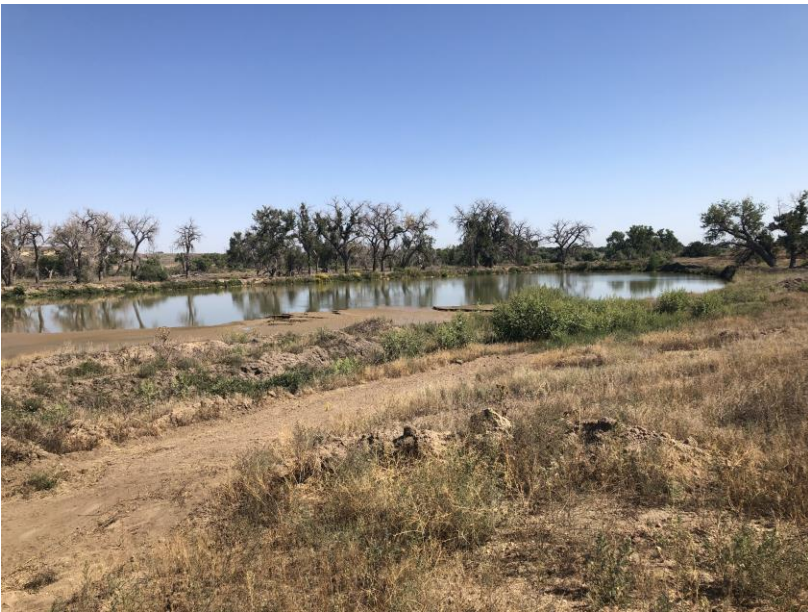
East cell of silt pond ("dirty" water)

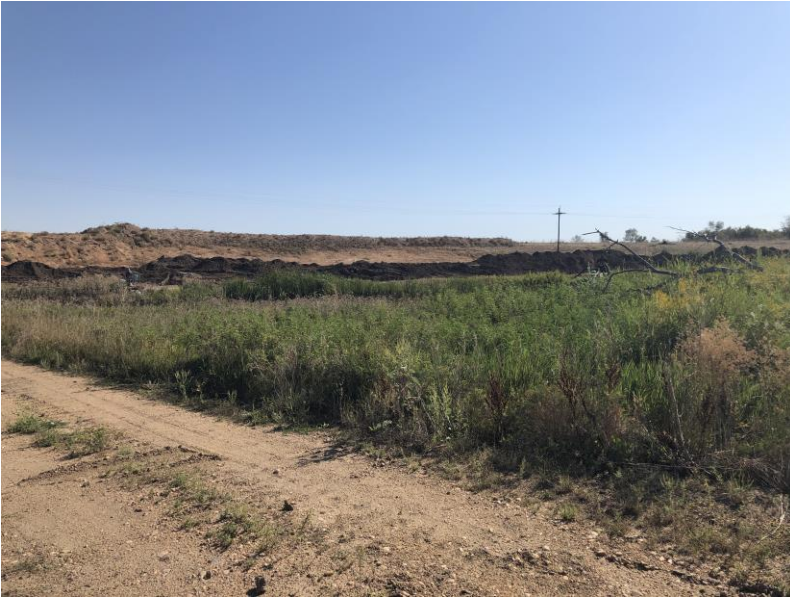
Slurry wall construction for D Cell

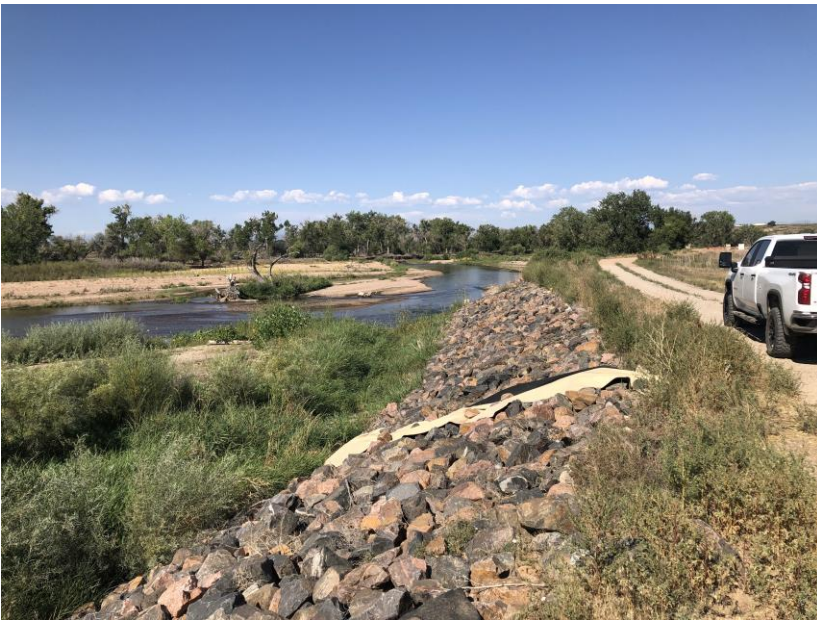
South Platte River near Cell C1

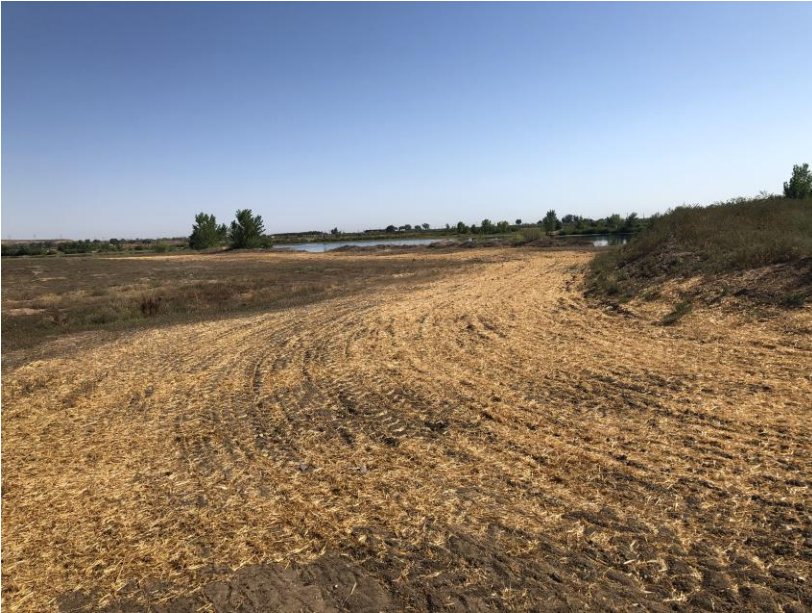
Cell C1 with Sharkey Lake in background (disturbance in foreground from oil and gas operation)

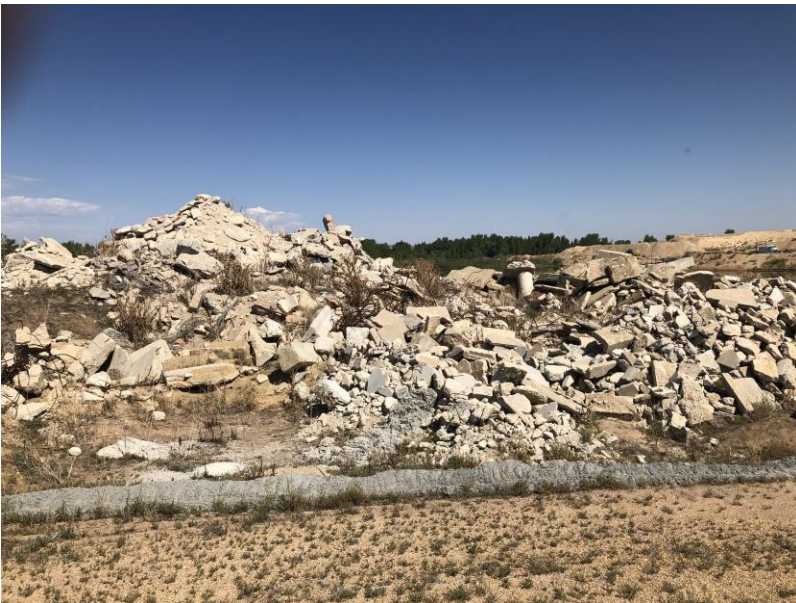
PROBLEM/POSSIBLE VIOLATION: Problem: The current reclamation plan needs to be updated and clarified pursuant to C.R.S. 34-32.5-116 (1). The large pile of concrete and rebar on the south side of the site must be accounted for in the Reclamation Plan.

A large pile of concrete and rebar was seen at the south end of the site (waste from demolition). This material should be disposed of soon or the removal of it added to the reclamation plan and cost estimate.

Concrete and rebar on south side

CORRECTIVE ACTIONS: The operator shall submit a Technical Revision by the corrective action date, with the required \$216 revision fee, to update and clarify the current approved Reclamation Plan to reflect future removal of the concrete and rebar. Alternatively, the material can be moved offsite, and proof (e.g., photographs) provided to the Division.
