MINERALS PROGRAM INSPECTION REPORT
PHONE: (303) 866-3567

| MINE NAME: Climax Mine | MINE/PROSPECTING ID#: M-1977-493 | MINERAL: Molybdenum | COUNTY: Lake, Summit |
| INSPECTION TYPE: Monitoring | INSPECTOR(S): Dustin Czapla | INSP. DATE: September 22, 2022 | INSP. TIME: 13:00 |

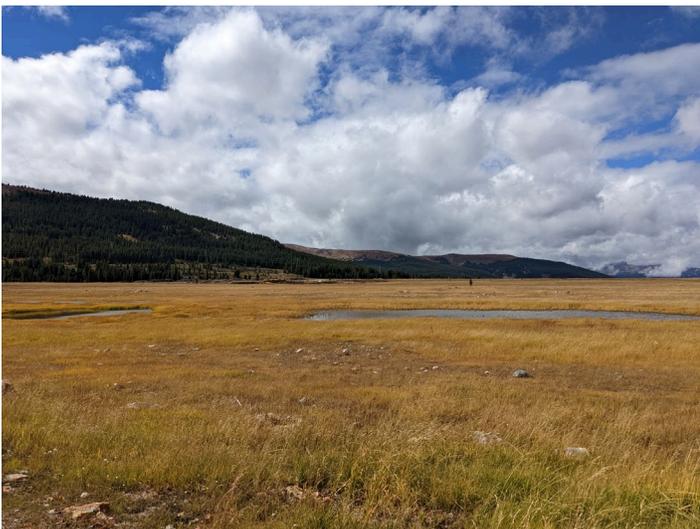
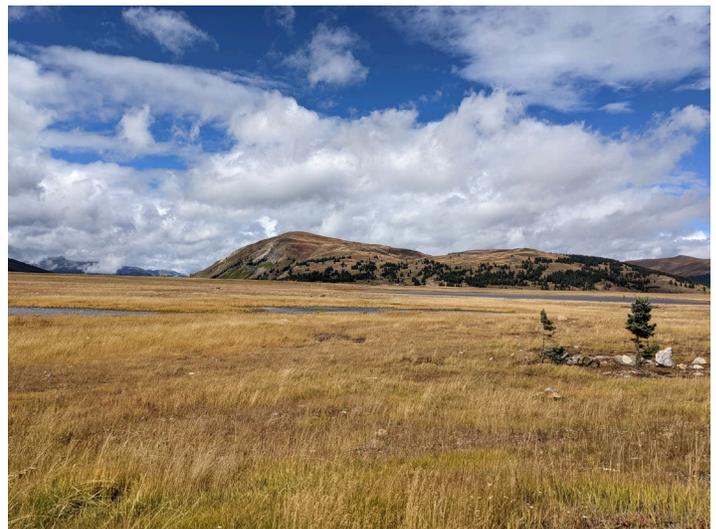
The Robinson TSF and pond are an EPF and function as the primary process water storage facility for the site. The reservoir stores process water that is collected from the Tenmile and Mayflower TSFs and delivered through the Tenmile Tunnel. Water collected from the Tenmile TSF is decanted through the Tenmile Decant to the Tenmile Tunnel and water collected from the Mayflower TSF is pumped by the Mayflower barge system to the Tenmile Tunnel. Robinson Pond also collects seepwater and toe drain discharge from 1 Dam as well as seepwater pumped from the Robinson Dam and 4 Dam seepage collection systems. The reservoir primarily contains industrial process water, TSF seepwater and 4 Dam seepwater, along with unintercepted storm water from the surrounding area and overflow from Chalk Mountain Reservoir. 2 Dam is partially inundated by the upstream portion of the Tenmile TSF in the Tenmile Creek drainage. The dam is well vegetated and appears stable. The Robinson TSF has been capped with a rock cover and most of the surface reclaimed. Vegetation is becoming well established. No problems were noted in this area.

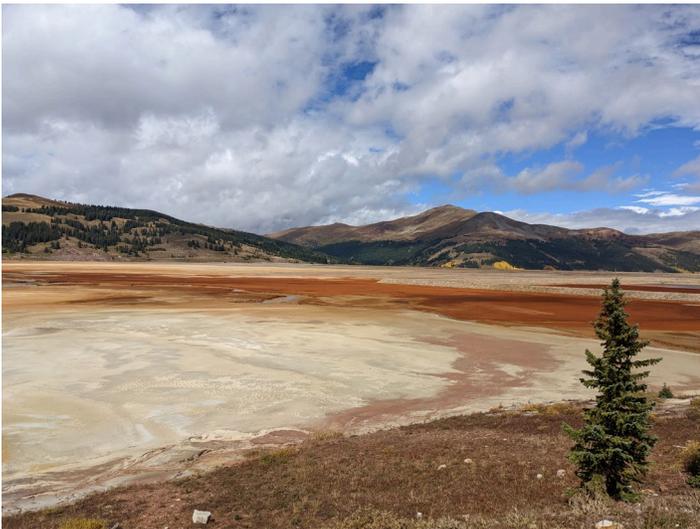
The Tenmile TSF and 3 Dam are an EPF. The TSF contains acid-generating material. Mill tailing is delivered to the TSF through the tailings delivery line. A water pool is maintained at the upstream end of the Tenmile TSF for process water storage, storm water management, and as the first stage in the water treatment system. Seepage from 3 Dam is routed to a collection pond and pumped back by vertical turbine pumps to the Sludge Densification Plant or diverted to the water pool on the Mayflower TSF. The pumping system is located within the 3 Dam Pump Station below the Tenmile TSF. No problems were noted in this area.

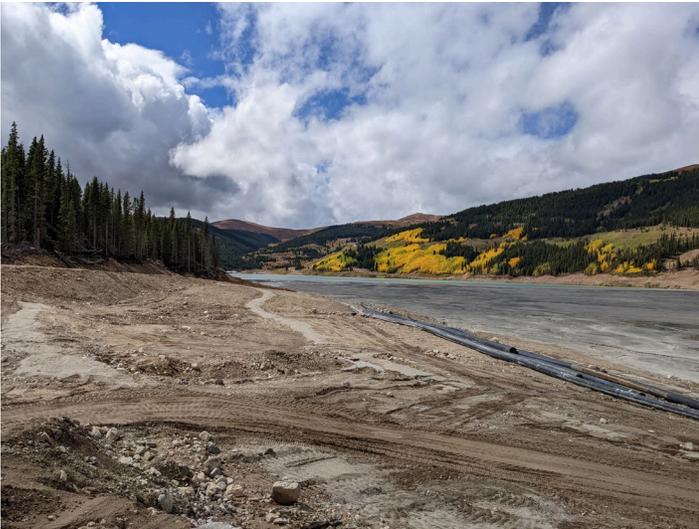
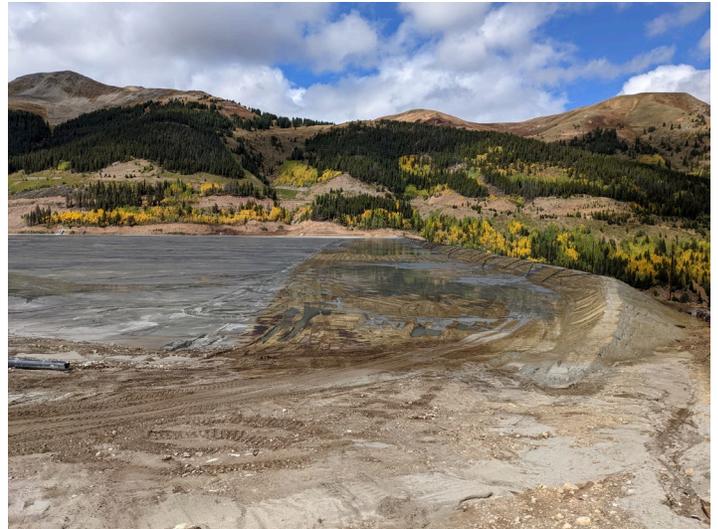
The Mayflower TSF and 5 Dam are the last downstream TSF in the Tenmile Creek Watershed. The TSF contains acid-generating material. To prevent dam failure, the Mayflower TSF includes an emergency flood bypass tunnel. Along with tailings storage, the Mayflower TSF also provides containment of contaminated materials or designated chemicals that might be accidentally released up-gradient of the TSF. Seepage from 5 Dam is routed to concrete ponds. Collected seepage is pumped back by vertical turbine pumps to the 3 Dam Pump Station or the water pool on the Mayflower TSF. The 5 Dam seepwater pumping system is located within the Mayflower Pump Station below the TSF. No problems were noted in this area.

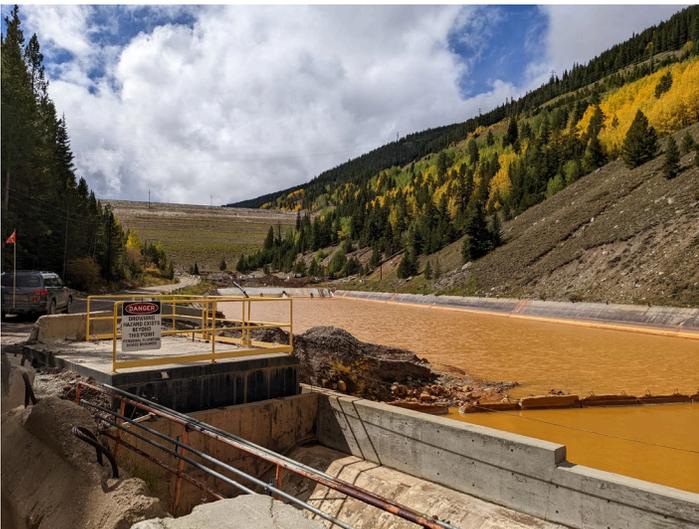
Concreted pond below 5 Dam

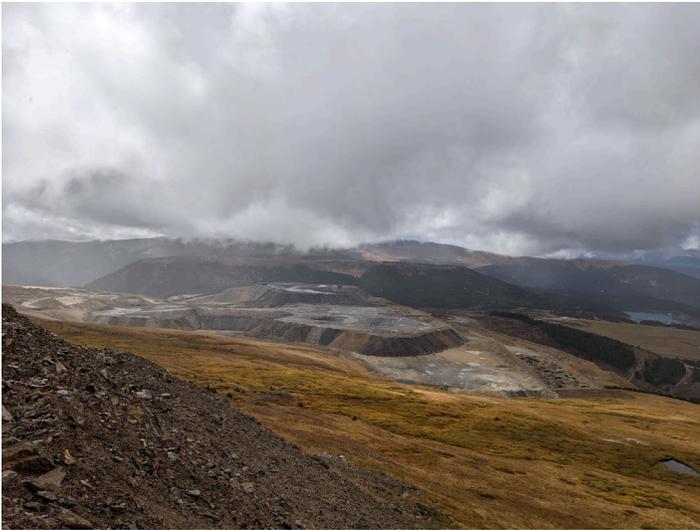
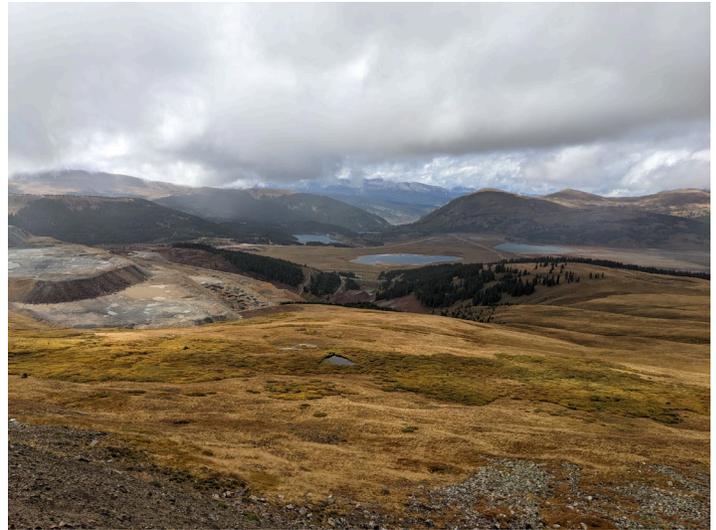
The North 40 is located on the south side of the McNulty OSF. The overburden materials excavated from the pit are trucked to the OSFs. The overburden consists mostly of igneous and metamorphic rock, which is either unmineralized or contains uneconomical mineralization. Sedimentary rock from the Minturn Formation makes up a lesser part of the overburden. Low grade ore is stockpiled on top of the south portion of the North 40 for processing near the end of mine operations. Overburden placement on the McNulty OSF is currently active. During mining OSF overall slopes are not to exceed 2.4H:1V. Work was occurring in the McNulty expansion area. Topsoil is being salvaged and stockpiled at the base of the OSF area. Underdrains were being installed. No problems were noted in this area.

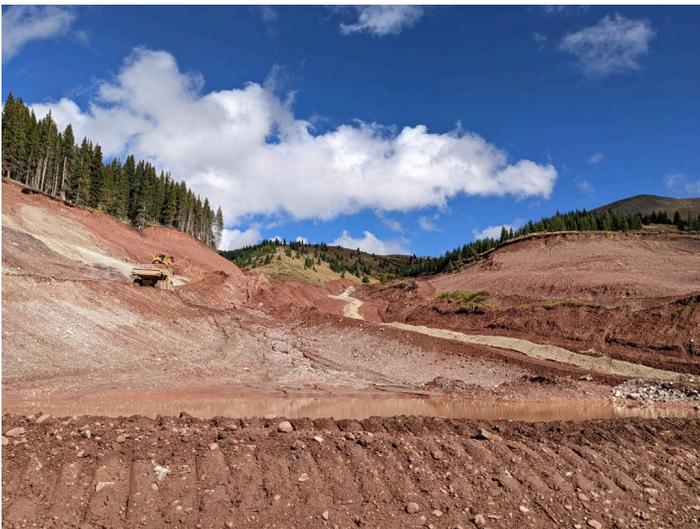
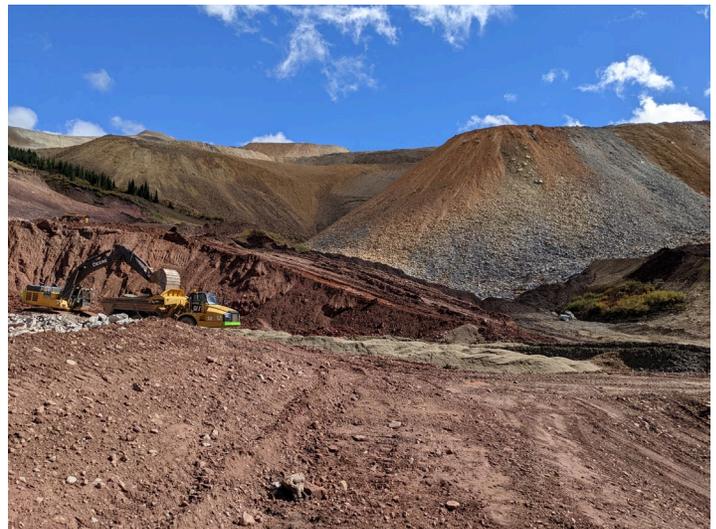
Underdrains being installed in McNulty expansion area

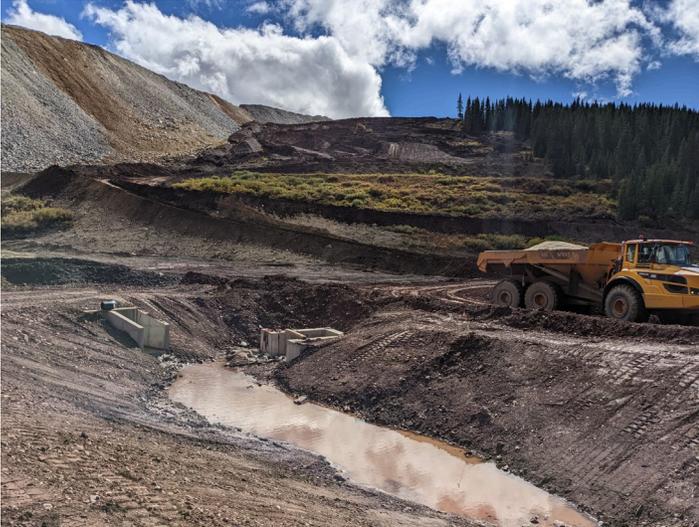
Topsoil being salvaged from the slope in the McNulty expansion area

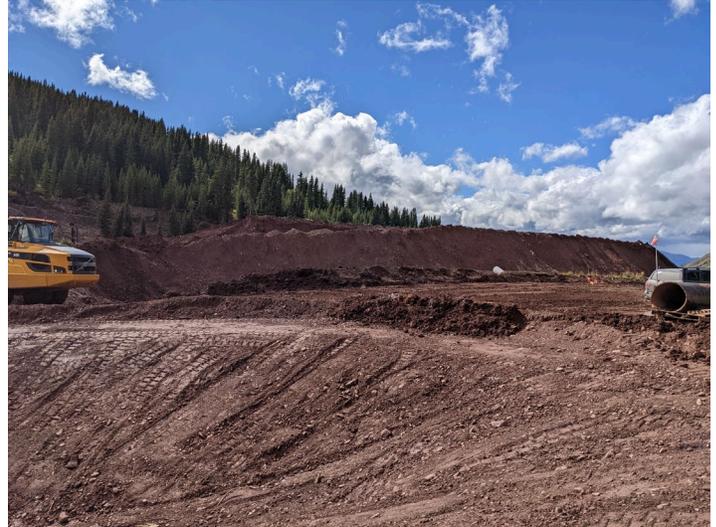
Topsoil stockpiled at base of McNulty expansion area

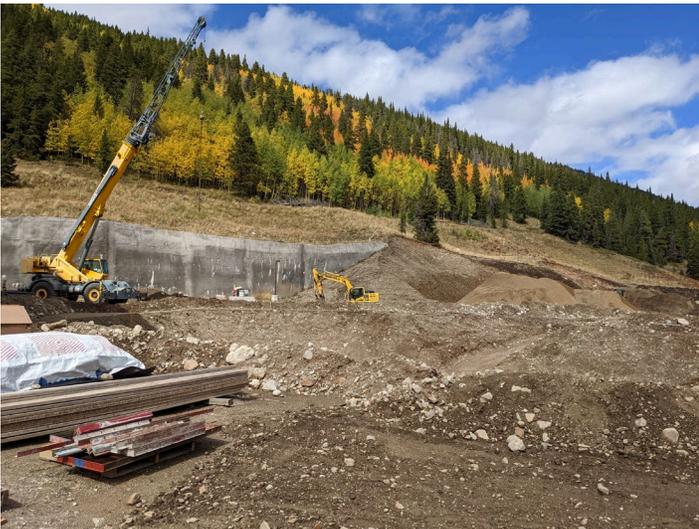
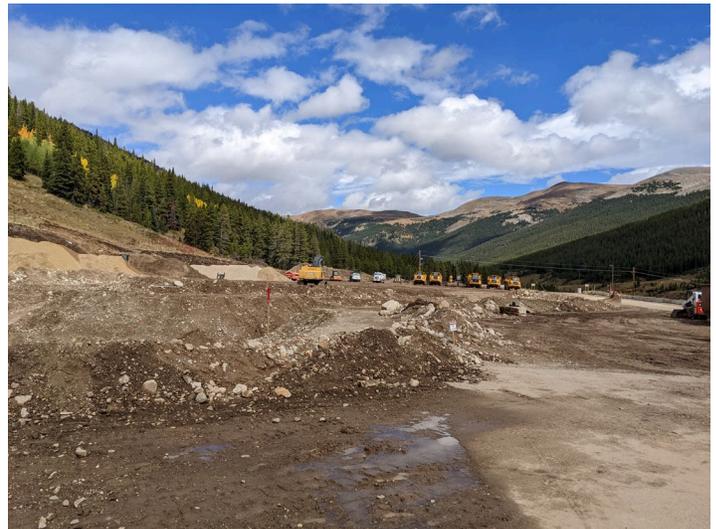
MRWTP area

Plans to construct the Molybdenum Removal Water Treatment Plant were approved through TR34 in May 2022. The Operator's contractor has broken ground on the project, preparing the site for laying the foundation. No problems were noted in this area.
