MINERALS PROGRAM INSPECTION REPORT
PHONE: (303) 866-3567

MINE NAME: Willow Creek Mine	MINE/PROSPECTING ID#: M-1983-011	MINERAL: Gold	COUNTY: Lake
INSPECTION TYPE: Multi Person Inspection	INSPECTOR(S): Lucas West	INSP. DATE: September 7, 2022	INSP. TIME: 09:33
OPERATOR: Mt. Elbert Mining Co., L.L.C.	OPERATOR REPRESENTATIVE: Dennis Sonnenschein	TYPE OF OPERATION: 112 - Hard Rock Regular Operation	
REASON FOR INSPECTION: Normal I&E Program	BOND CALCULATION TYPE: None	BOND AMOUNT: \$190,000.00	
DATE OF COMPLAINT: NA	POST INSP. CONTACTS: None	JOINT INSP. AGENCY: None	
WEATHER: Clear	INSPECTOR'S SIGNATURE:

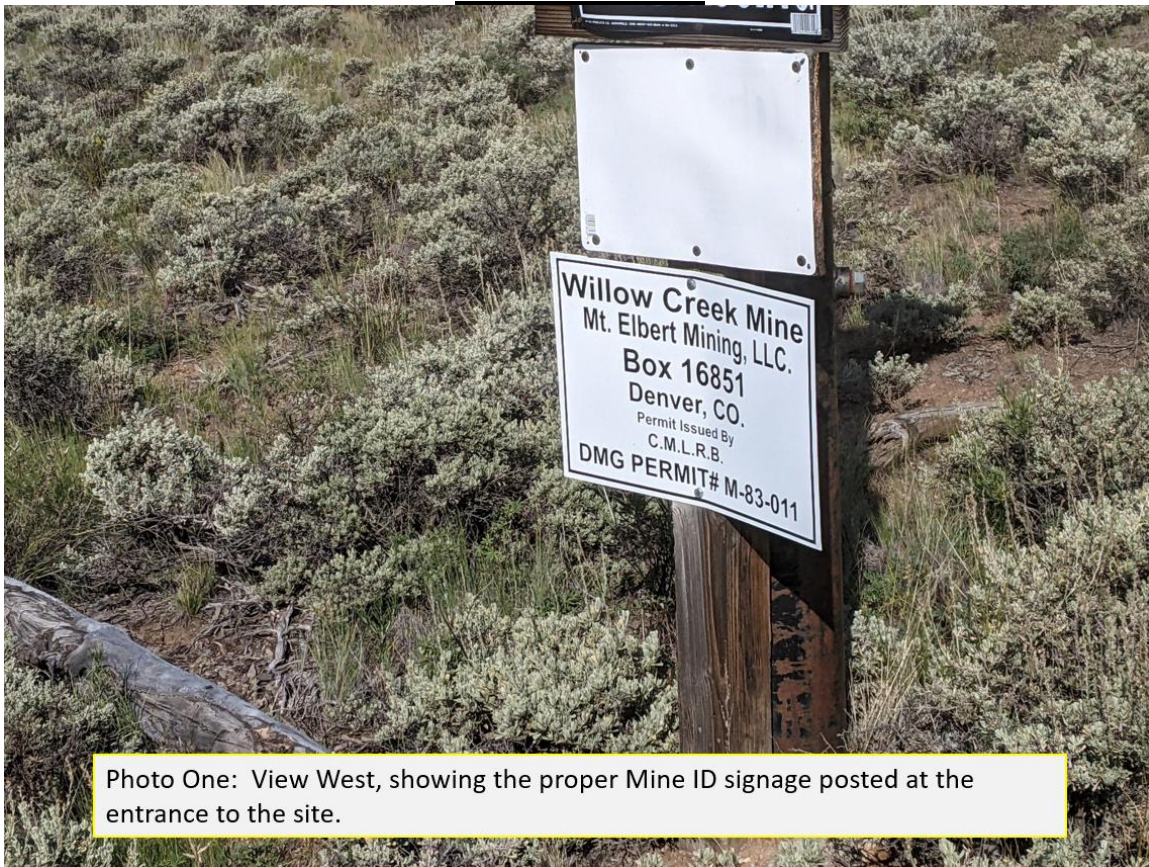
The operation involves the excavation of glacial till material that is processed in pursuit of placer gold deposits. Material is excavated by way of excavators and loaders, then processed through a trommel machine and run through a series of ponds and other separation equipment to recover gold. The process involved in the processing and separation are purely mechanical and no chemical extraction or flotation is involved in the operation. The site was not active at the time of the inspection however mining and processing equipment was present on site. The proper Mine Identification signage is posted at the entrance to the site and can be seen in Photo One. Public access to the site is controlled by a gate just outside of the encampment area.

Photo One: View West, showing the proper Mine ID signage posted at the entrance to the site.

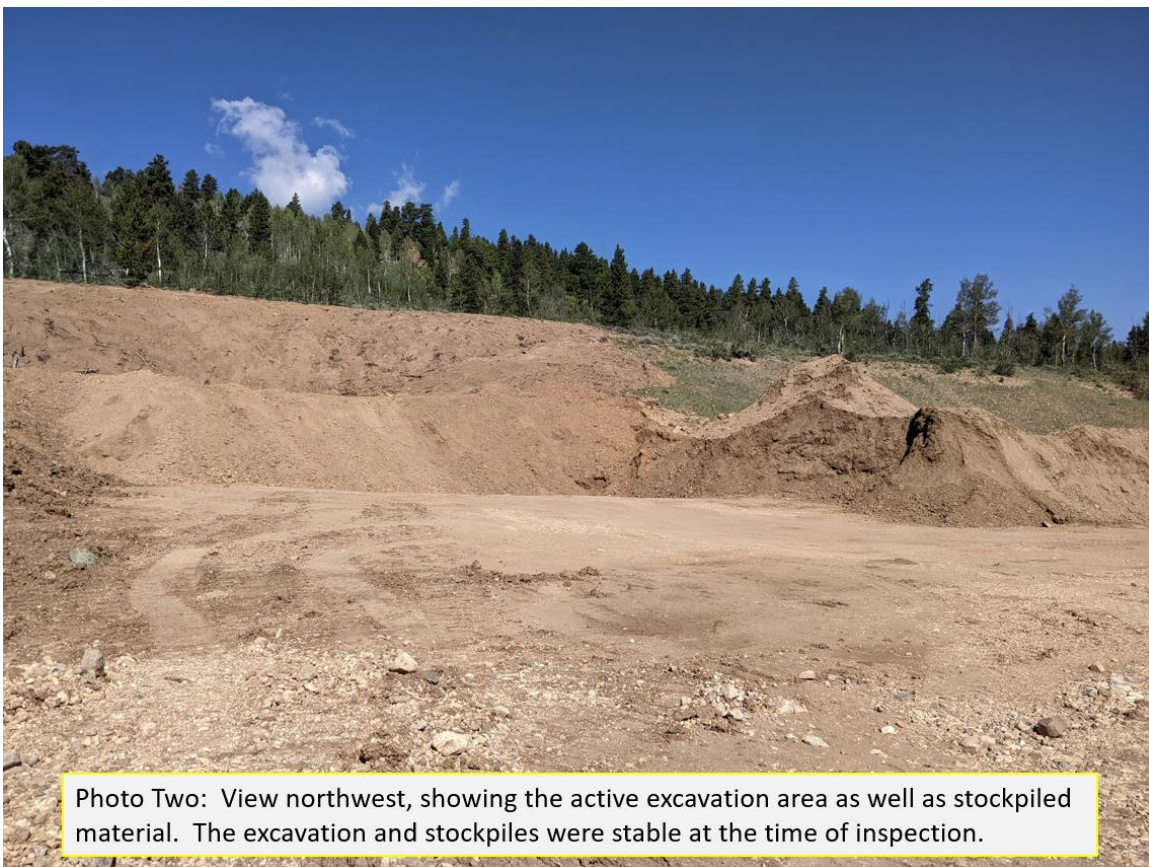
The active excavation area, shown in Photo Two was observed to be in good condition and stable. Material has been removed from the hillside proceeding northwest from the processing area. The excavation showed no signs of sloughage or erosion and was in good condition. Throughout the site several stockpiles of virgin material as well as mid processed material were observed. All observed stockpiles were stable at the time of the inspection and examples of them can be seen in Photos Three and Four. At various locations throughout the site, topsoil stockpiles were observed. The stockpiles are well vegetated and stable. On site equipment observed included the large main trommel, with associated stackers and conveyors, diesel generators, small test trommels and various excavation equipment. All equipment appeared to be in good working order and examples of the equipment can be seen in Photos Five and Six. The series of processing ponds involved in the operation were observed to be in good condition and all contained standing water. The banks of the ponds appeared stable and no evidence of significant sloughage was noted. The water in the ponds appeared murky but no visual evidence of impaired water quality was observed. An aerial view of the site with the ponds can be seen in Photo Seven.

Photo Two: View northwest, showing the active excavation area as well as stockpiled material. The excavation and stockpiles were stable at the time of inspection.

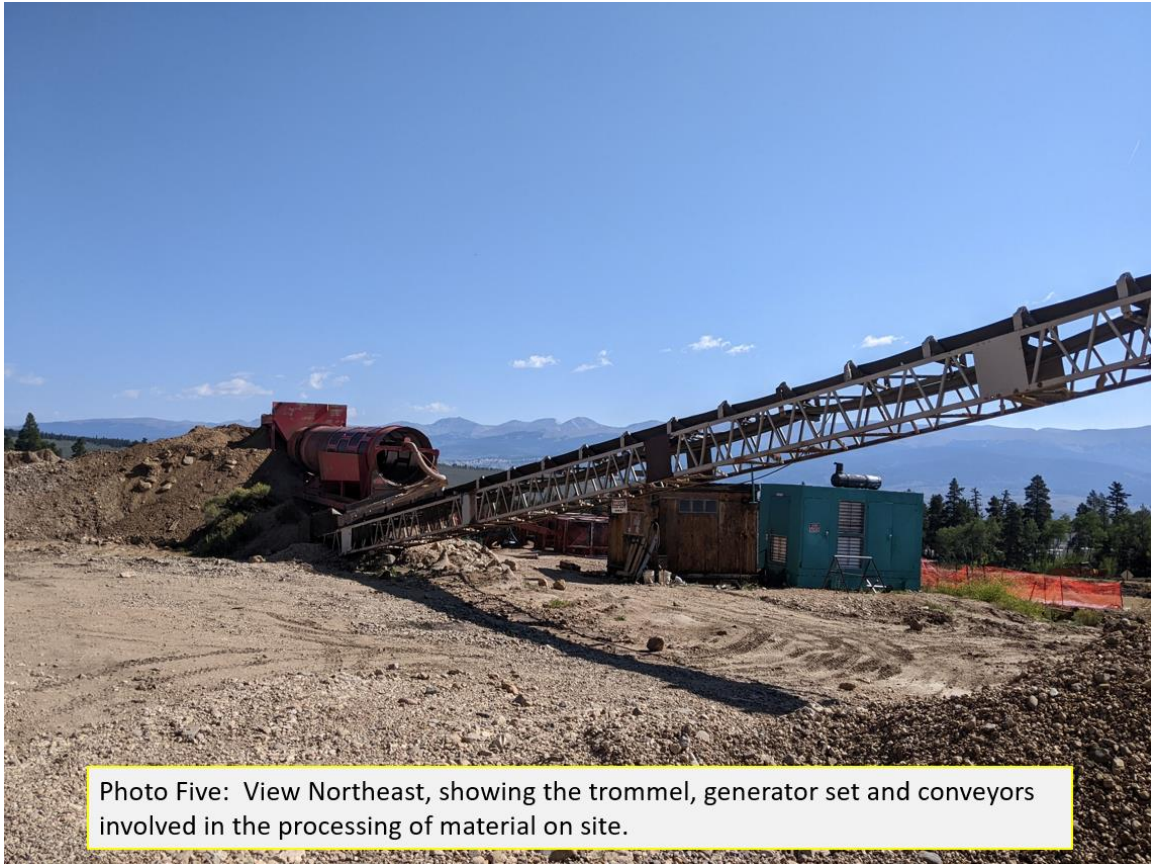
Photo Five: View Northeast, showing the trommel, generator set and conveyors involved in the processing of material on site.

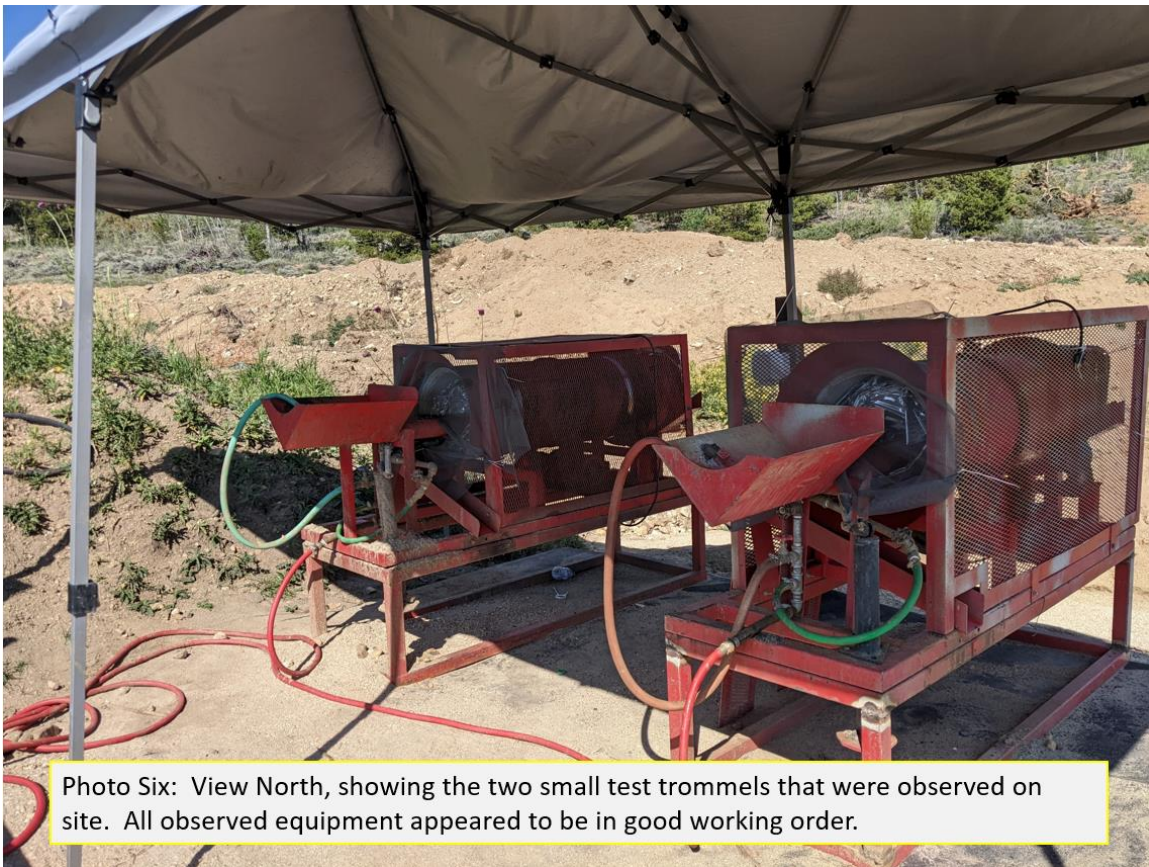
Photo Six: View North, showing the two small test trommels that were observed on site. All observed equipment appeared to be in good working order.
