PERMIT INFORMATION

Permit Number: C-1981-038 Mine Name: Bowie No. 1 Mine Operator: Bowie Resources, LLC Operator Address: Mr. Basil R Bear P.O. Box 1488 Paonia, CO 81428	County: Delta Operation Type: Underground Permit Status: Active Ownership: Private
	Operator Representative Present: None
Operator Representative Signature: (Field Issuance Only)

INSPECTION INFORMATION

Inspection Start Date: September 29, 2022 Inspection Start Time: 08:30 Inspection End Date: September 29, 2022 Inspection End Time: 10:50		Inspection Type: Coal Partial Inspection Inspection Reason: Normal I&E Program Weather: Clear	
Joint Inspection Agency: None		Joint Inspection Contacts: 	
Post Inspection Agency: None		Post Inspection Contacts: 	
Inspector(s): Robert Zuber, P.E.	Inspector's Signature: <i>Robert D. Zuber</i>		Signature Date: September 30, 2022

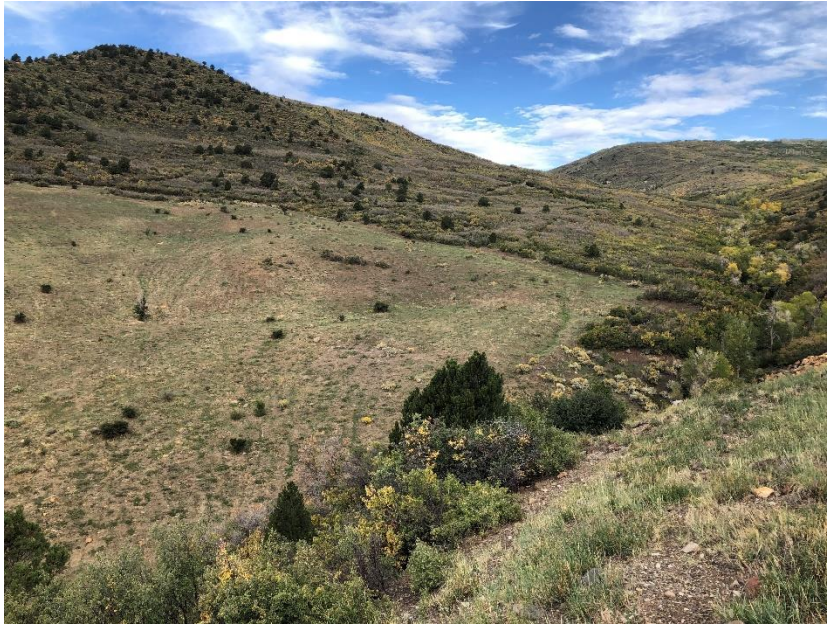
West Mine, northern portion

The northeastern corner of the West Mine was walked, and no yellow starthistle were observed. Knapweed was seen on the embankment of the lower pond at the West Mine. Many dead thistle and knapweed were seen along the haul road below Johnson Road, indicating that BRL has been spraying to control them.

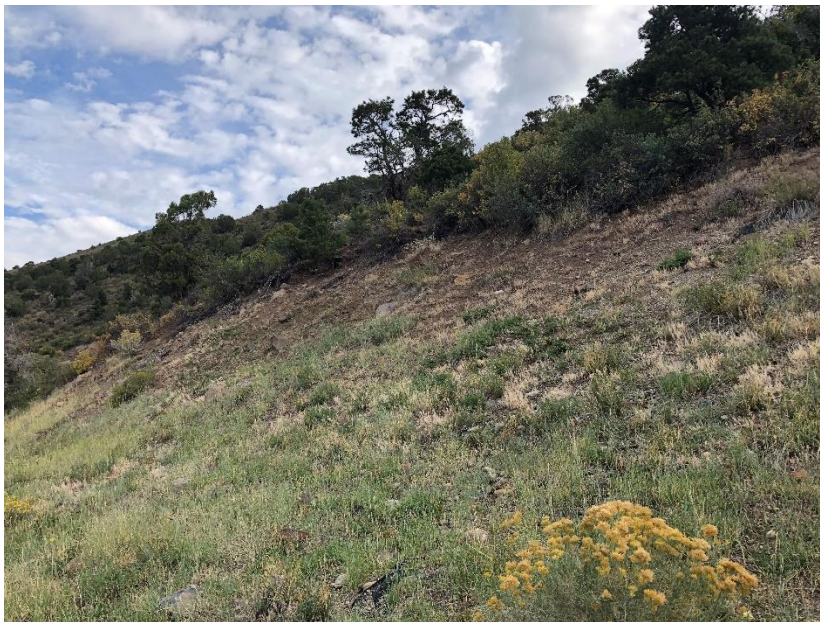
West Mine, slope below Johnson Road

The West Mine was in good shape (no erosion or other problems), including the steep hill below Johnson Road.

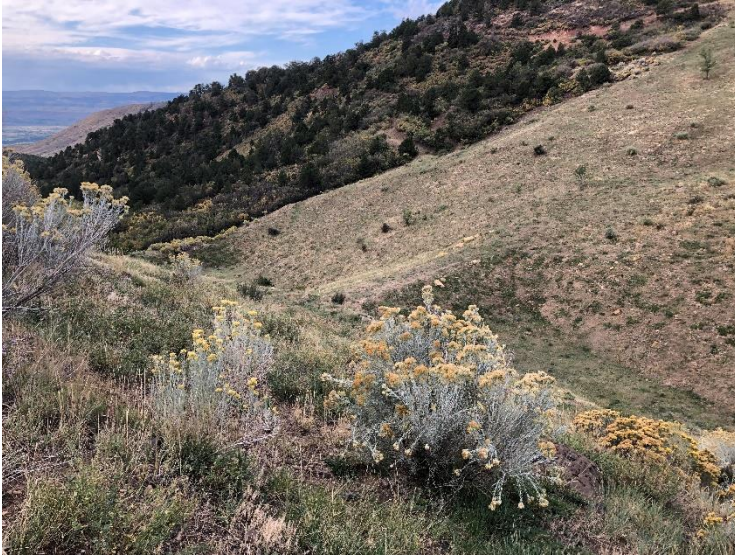
West Mine ponds

The ponds at the West Mine were dry, and no problems were identified with these ponds (other than knapweed on the embankment for the lower pond). The lower end of the long culvert was inspected, and it was clear of debris.

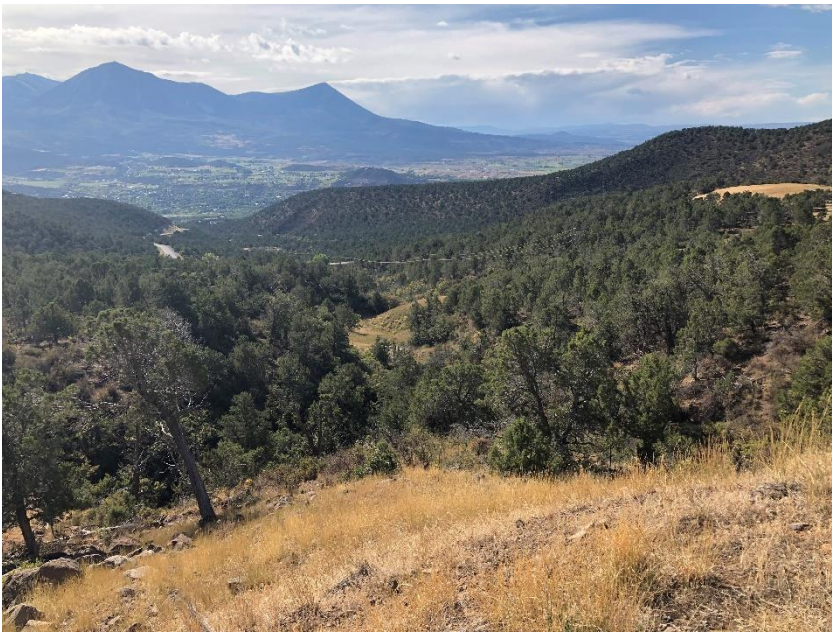
East Mine, drainage below Old Waste Disposal Area

No erosion was seen at the reclaimed areas of the East Mine, including:

- The main area along the haul road and around the old portals
- The RDA
- The Old Waste Disposal Area
- The drainage where the reclaimed ponds (Ponds 1 – 4) are located.

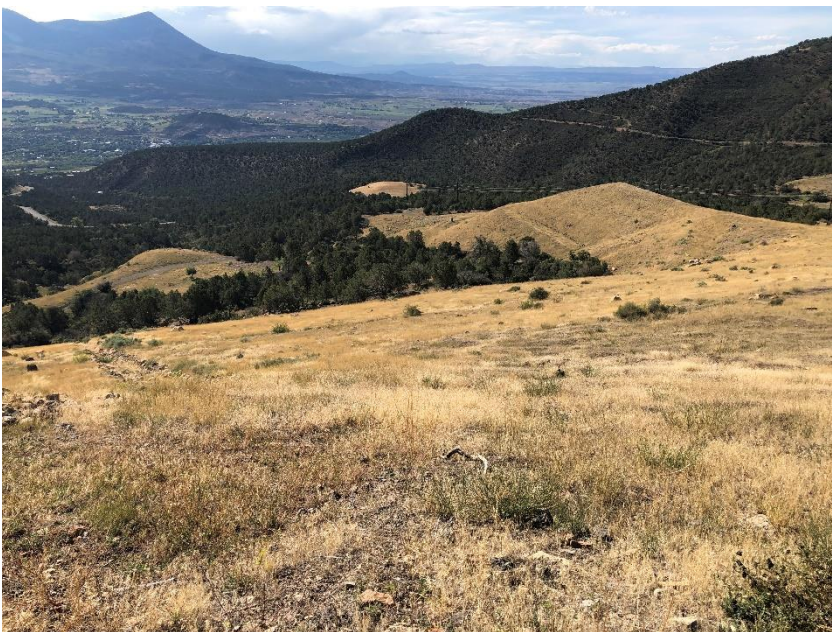
East Mine, lower portion with RDA

Riprap ditches at the East Mine are stable. The sediment control practices (straw bales) southeast of the RDA were functioning.

At the first switchback in the haul road west of the RDA, the slope below the road was inspected. No erosion control practices are in place here, but the slope is generally stable.

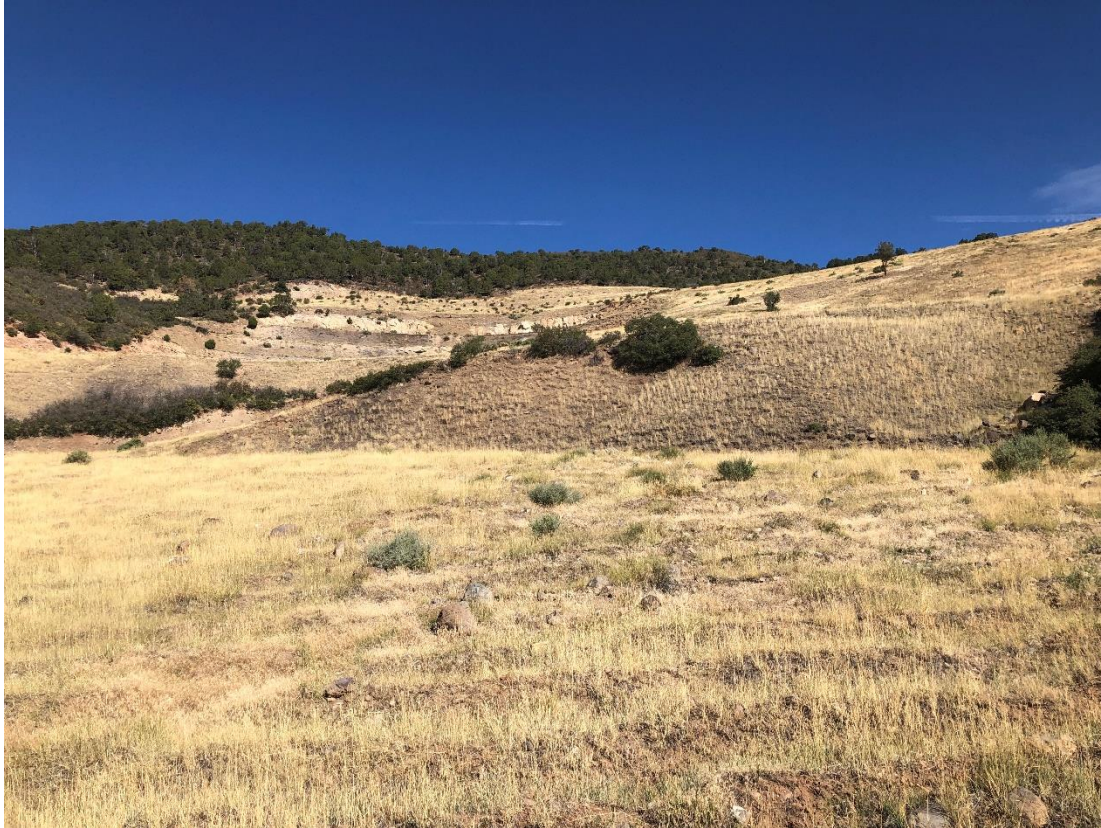
East Mine, upper portion

The slope around the fallen fence at the upper part of the East Mine was stable.
