MINERALS PROGRAM INSPECTION REPORT

MINE NAME: Kunau Site	MINE/PROSPECTING ID#: M-2008-025	MINERAL: Gravel	COUNTY: El Paso
INSPECTION TYPE: Monitoring	WEATHER: Cloudy	INSP. DATE: May 4, 2022	INSP. TIME: 11:50
OPERATOR: Tim Kunau	OPERATOR REPRESENTATIVE: Red Kunau	TYPE OF OPERATION: 110c - Construction Limited Impact

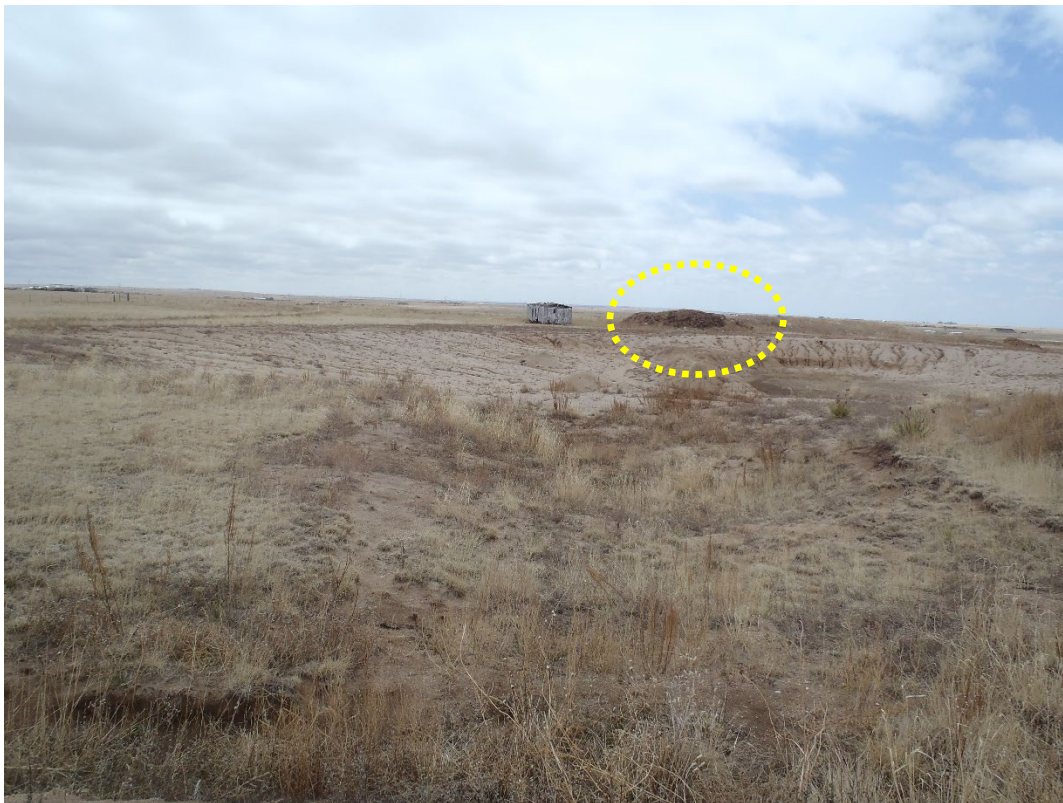
Backfilling and Grading: Slopes are variable within the pit. The east (see **Photo 1**) and north (see **Photo 2**) highwalls are sloped at approximately 4H:1V. The South highwall is slightly steeper (see **Photo 3**).

Photo 1. East highwall (looking south, note circled mulch stockpile).

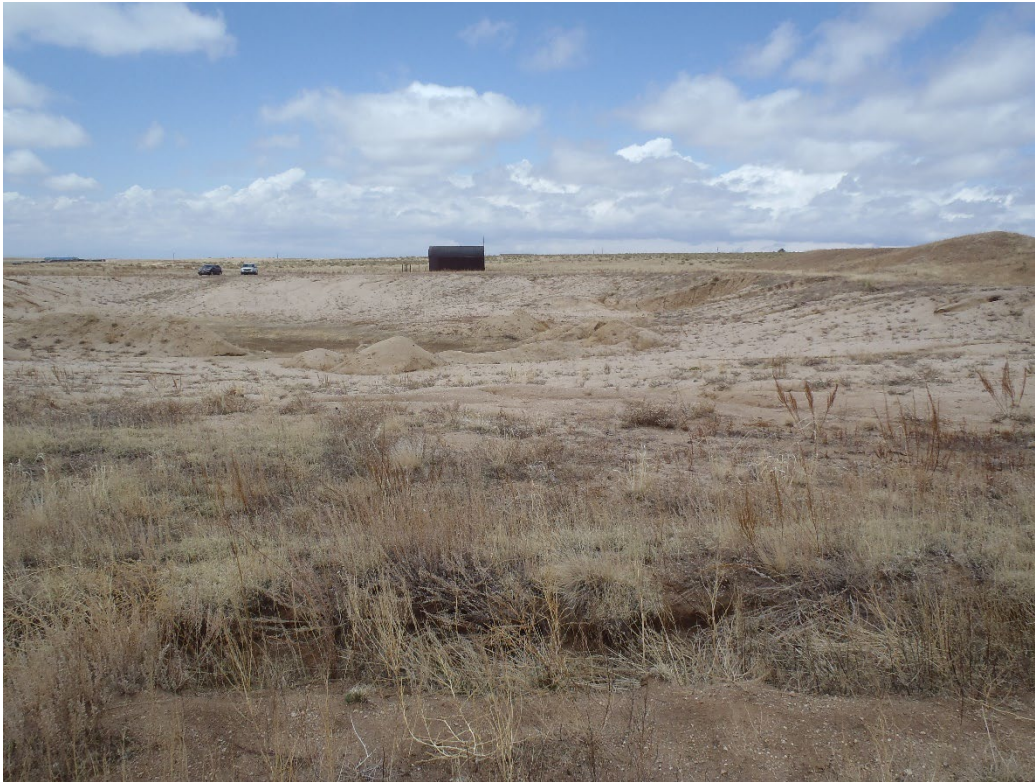
Topsoil: A topsoil stockpile is in the north side of the pit and appeared stable (see **Photo 6**).

Photo 2. North highwall and south side of topsoil stockpile (looking west).

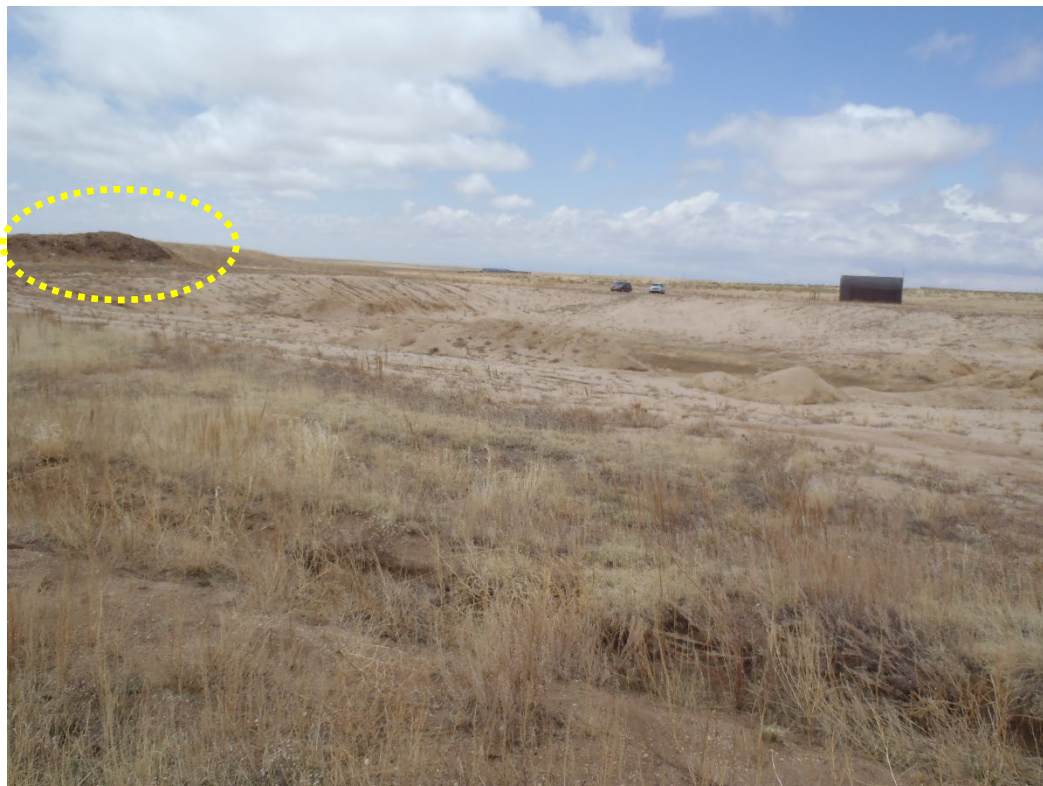
Photo 3. South highwall (looking west, note circled mulch stockpile).

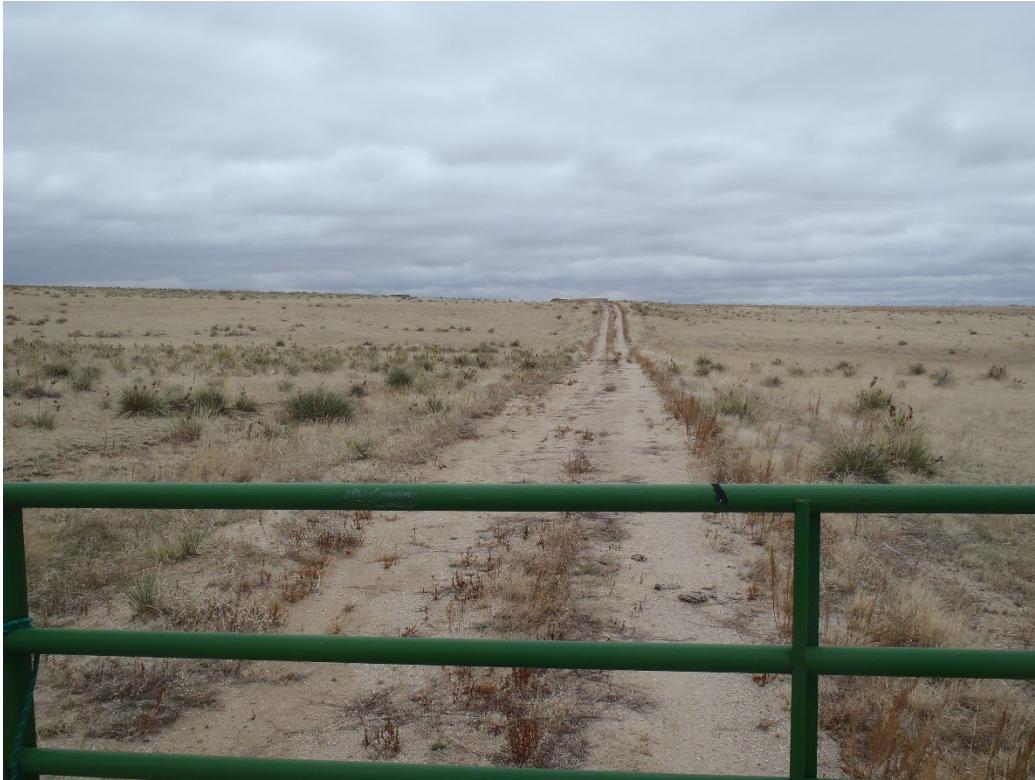
Roads: The two-track access road did not appear to be a source of sediment that could be tracked offsite (see **Photo 4**).

Photo 4. Two track access road (from gate, looking east).

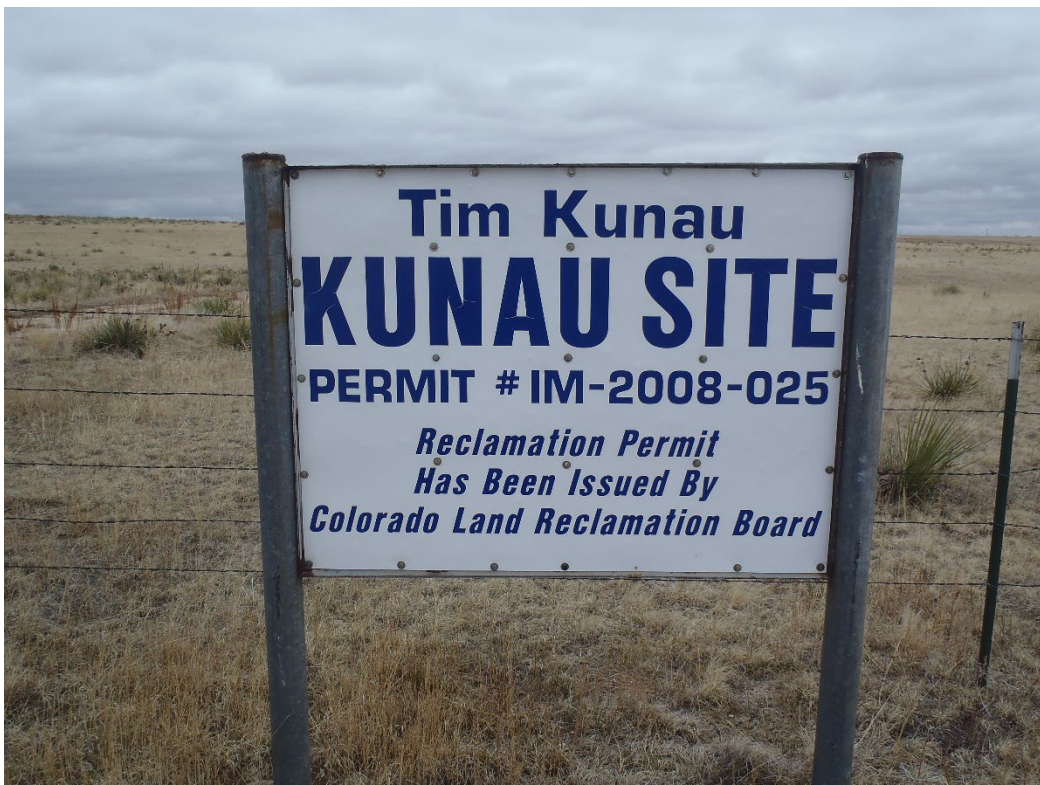
Signs and Markers: The permit sign was properly posted (see **Photo 5**) and boundary markers were observed to delineate the four corners of permit boundary (see **Photo 6**).

Photo 5. Permit sign at gate ~750 feet east of Yoder Road.

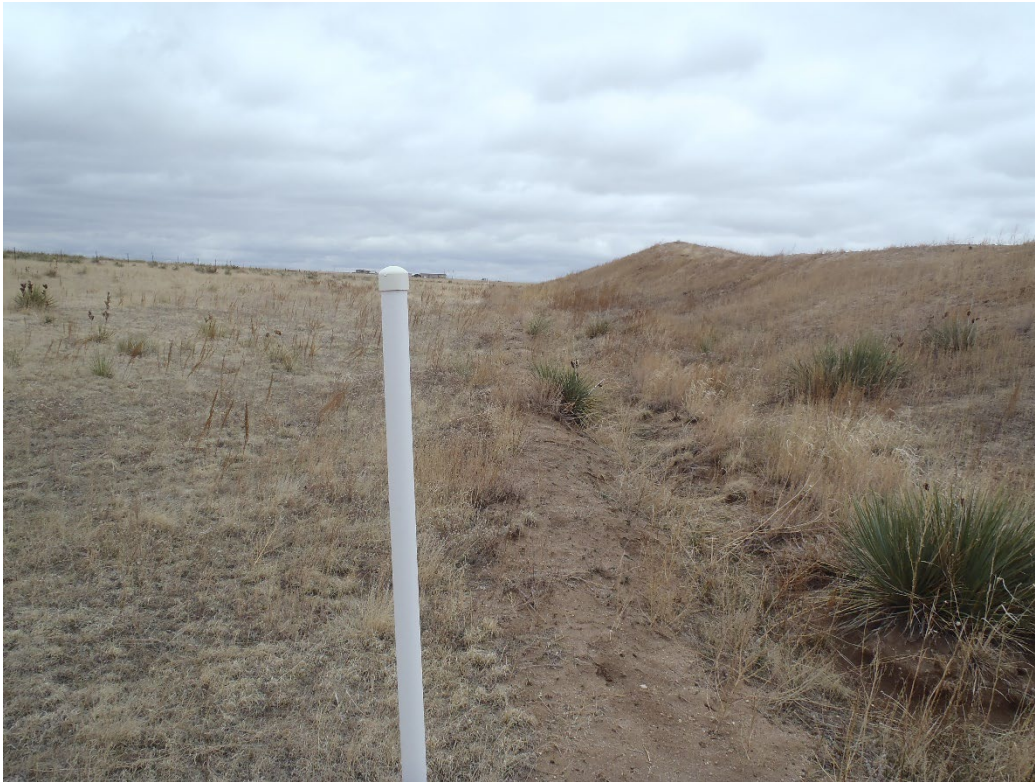
Photo 6. Typical boundary marker (NW corner, looking east; note stormwater trench and topsoil stockpile).

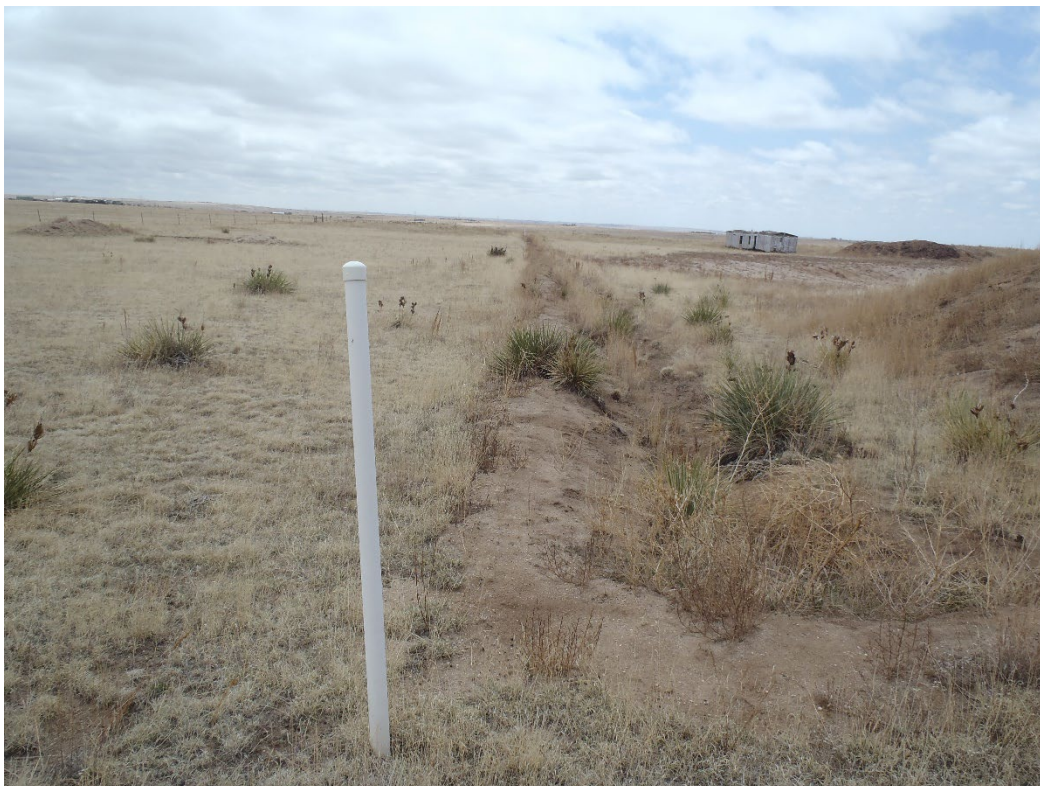
Storm Water MGT Plan: No oil or fuel spills observed. Trenches (see **Photo 7**) are dug around the perimeter of the pit to prevent stormwater runoff. Stormwater drains to the pit and infiltrates.

Photo 7. Typical stormwater trench and boundary marker (NE corner, looking south).

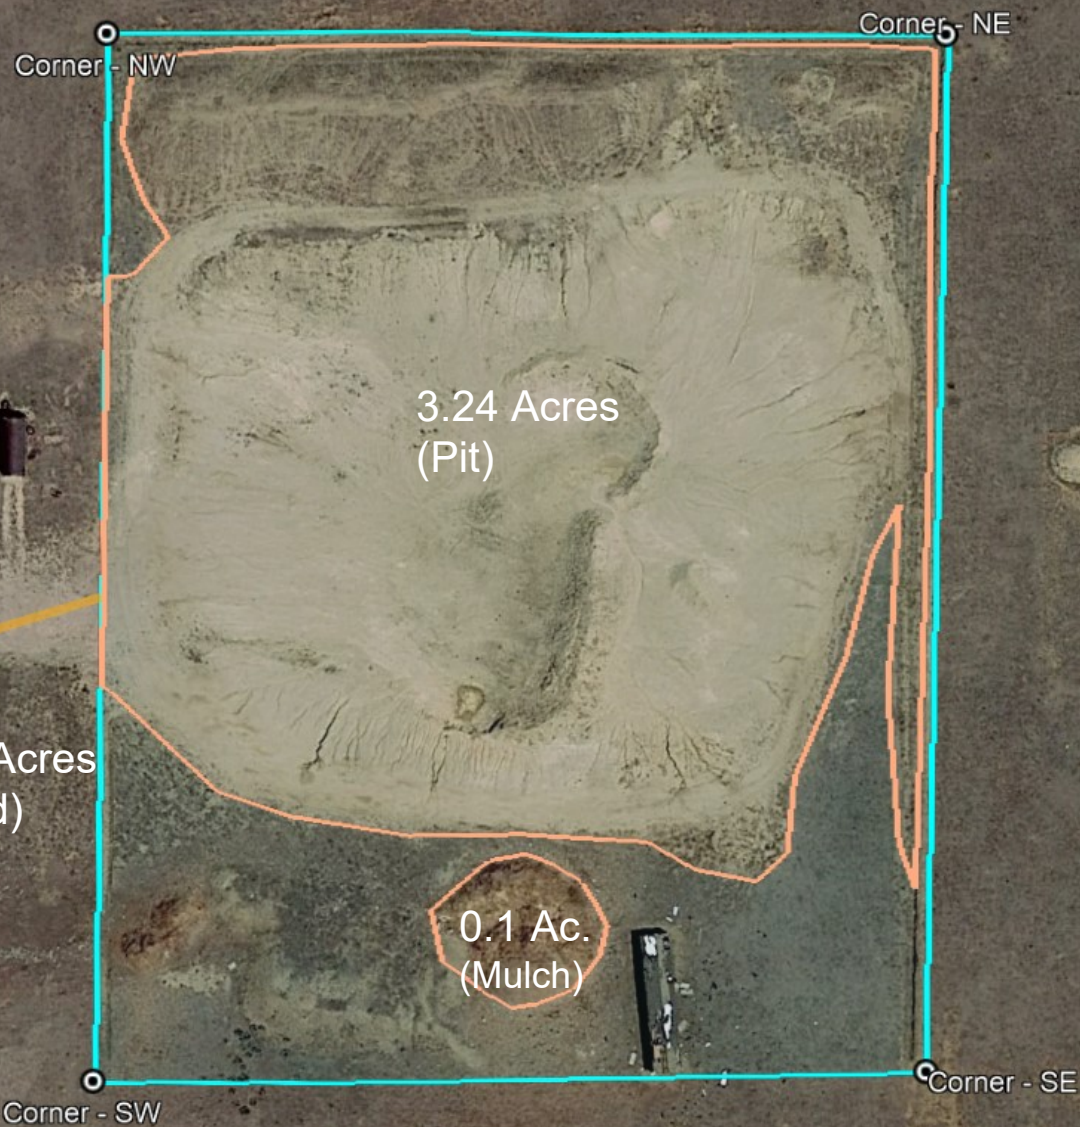
M-2008-025 Kunau Site Post 2022 Inspection Map

PROBLEM/POSSIBLE VIOLATION No. 1: Problem: Disturbed area is under reported on the annual report as 2.2 acres. 2018 satellite imagery indicates the disturbed area is 3.96 acres.

Gen. Compliance with Mine Plan: The operation appeared to be in compliance with the approved mine plan. The maximum allowed disturbed area is 4.59 acres (one of the two non-contiguous designated affected areas in this permit). Google Earth was used to measure the disturbed area, which was approximately 3.96 acres, based on older 2018 imagery. Highwalls were estimated to be 15 feet in height and appeared stable.

CORRECTIVE ACTIONS: Provide the correct disturbed area with the 2023 annual report, due 2/17/2023.
