# Spring 2022 Subsidence and Geologic Field Observations

## Southern Panels and Sunset Trail Mining Areas

September 2022

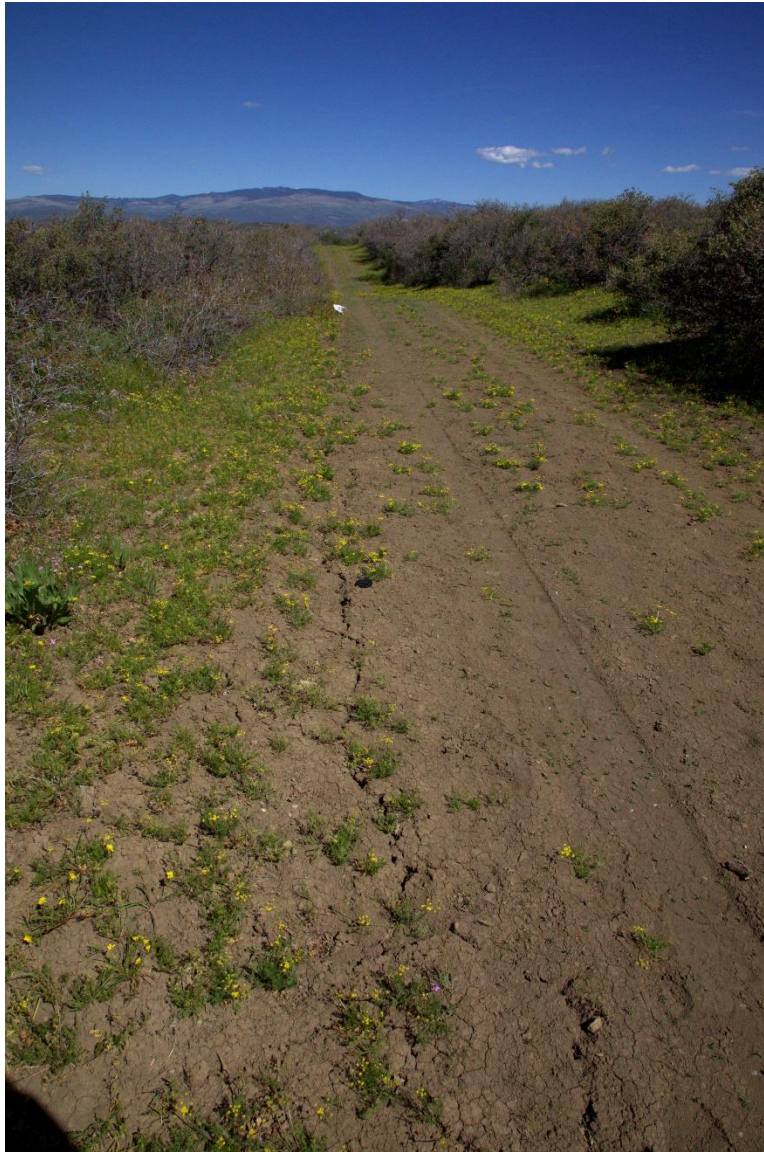
Cracks were observed along the existing road over the E14 Headgate with the initial observations occurring between Crosscuts 23 and 22. As shown in Figure 1, the cracks were generally parallel to the road with a S40°E orientation. No cracks had previously been observed along this traverse with all prior observations occurring prior to mining in Longwall Panel E14. Therefore, the cracks were deemed to be subsidence-related features. The E-seam overburden thickness at this location is approximately 650 to 700 feet.

There were multiple cracks at this location with the longest continuous crack being on the order of 10 to 20 feet. Most of the cracks with localized and only a few feet in length. The maximum observed width of the cracks was between one-half and one inch, and the maximum depth of the cracks was three to four inches.

Figure 1: Southeast view of subsidence crack parallel to road on Traverse C-C' located over the E14 Headgate, between crosscuts 23 and 22.

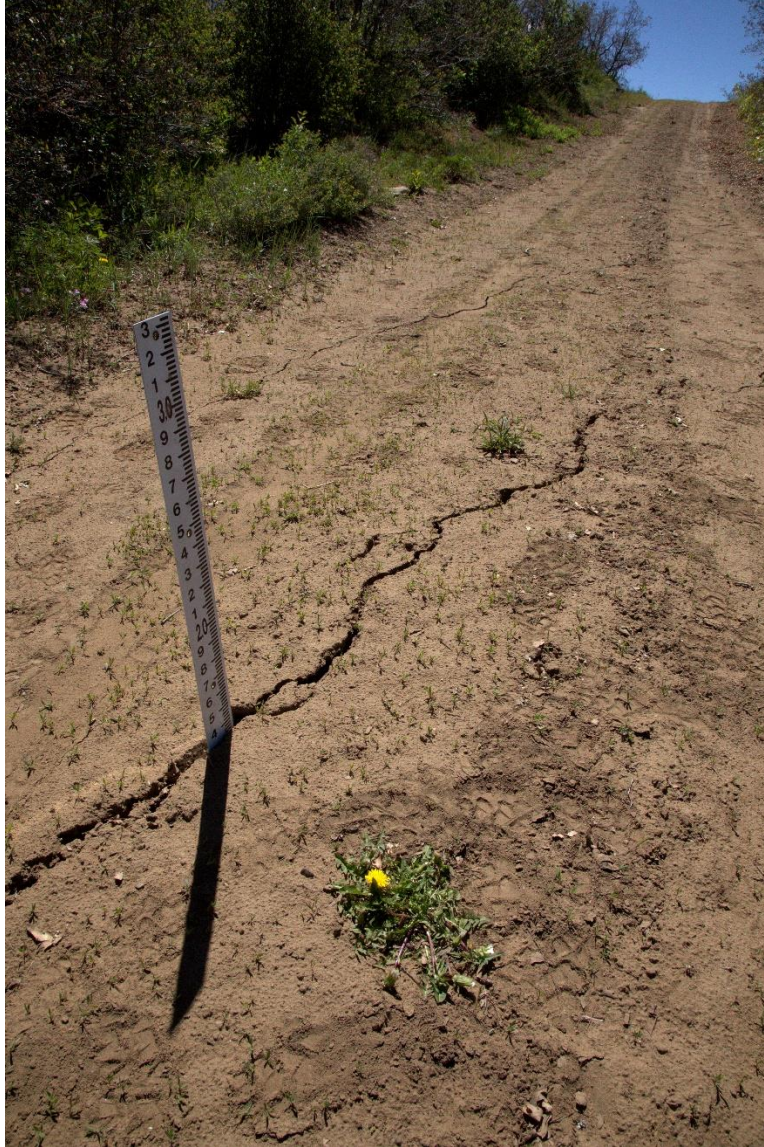
Farther to the southeast along Traverse C-C', additional cracks were observed along the road over the E14 Headgate between Crosscuts 22 and 21. As shown in Figure 2, the cracks were generally

diagonal to the road with a S30°E to S35°E orientation. At this location, the road is approximately over the edge of the longwall panel. No cracks had previously been observed along this traverse with all prior observations occurring prior to mining in Longwall Panel E14. Therefore, the cracks were also deemed to be subsidence-related features. The E-seam overburden thickness at this location is approximately 650 to 700 feet.

The cracks at Location 2 were more pronounced than those observed at Location 1. There were multiple cracks at this location with lengths on the order of 10 to 20 feet, with the maximum continuous crack being approximately 30 feet in length. The maximum observed width of the cracks was about one inch, and the maximum depth of the cracks was 1.3 feet. The cracks occurred over a reach of approximately 130 feet.

Figure 2: East-Southeast view of subsidence crack diagonal across road on Traverse C-C' located over the E14 Headgate, between Crosscuts 22 and 21.

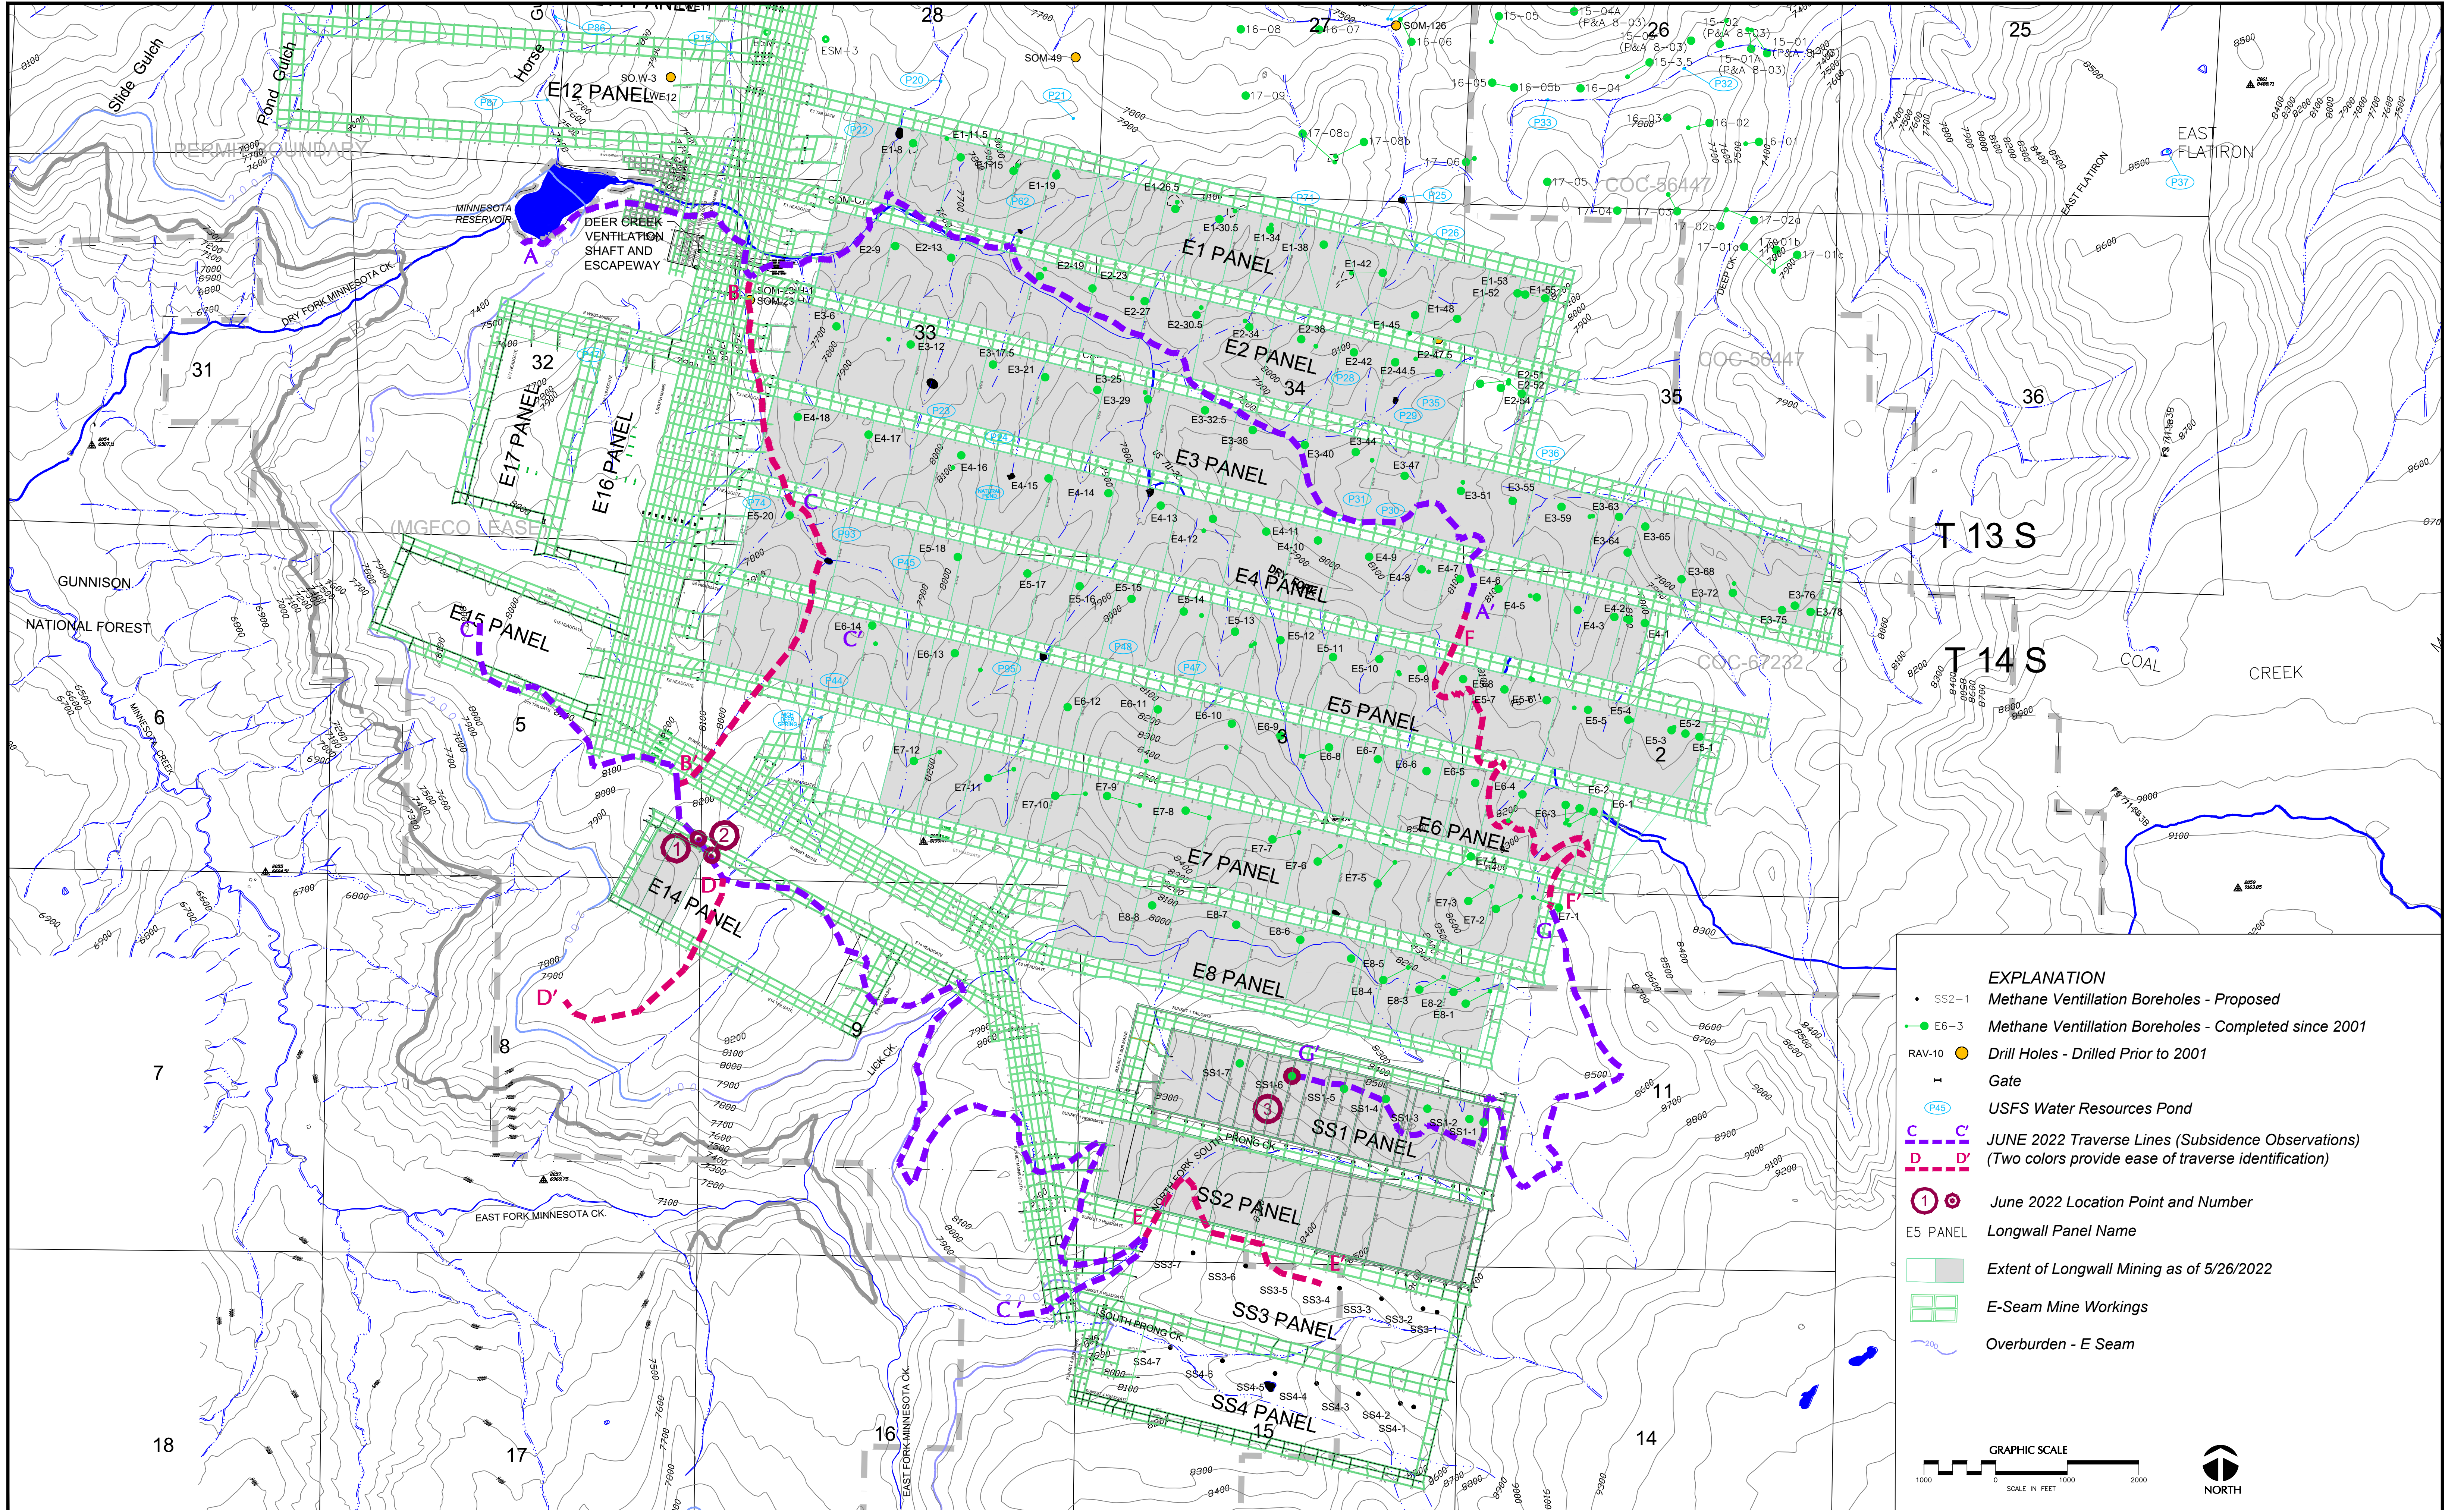
The remainder of this report provides a detailed discussion of new or recent observations associated with Traverses A-A' through G-G' (see Maps 1 and 2) as observed during the spring 2022 field visit. Details associated with these observations can be found in Sections 4.1 through 4.7 of this report. Map 1 shows the outline of E-seam mine workings along with surface topography and other surface features, including the named traverses. Map 2 shows the same area and detail as Map 1 (minus traverses) along with recently active, or potentially active, landslide and rockfall areas as delineated from aerial photo research and field observations. Also on Map 1, note that a designation such as E6-1/2/3 indicates one MVB pad containing three drill holes. The surface and
