## MINERALS PROGRAM INSPECTION REPORT

<b>MINE NAME:</b> Henderson Mine Exploration Drilling - Puzzle	<b>MINE/PROSPECTING ID#:</b> P-2022-006	<b>MINERAL:</b> Molybdenum	<b>COUNTY:</b> Clear Creek
<b>INSPECTION TYPE:</b> Monitoring	<b>INSPECTOR(S):</b> Brock Bowles	<b>INSP. DATE:</b> September 15, 2022	<b>INSP. TIME:</b> 11:30
<b>OPERATOR:</b> Climax Molybdenum Company	<b>OPERATOR REPRESENTATIVE:</b> Geoff Niggeler	<b>TYPE OF OPERATION:</b> MP - Mineral Prospecting

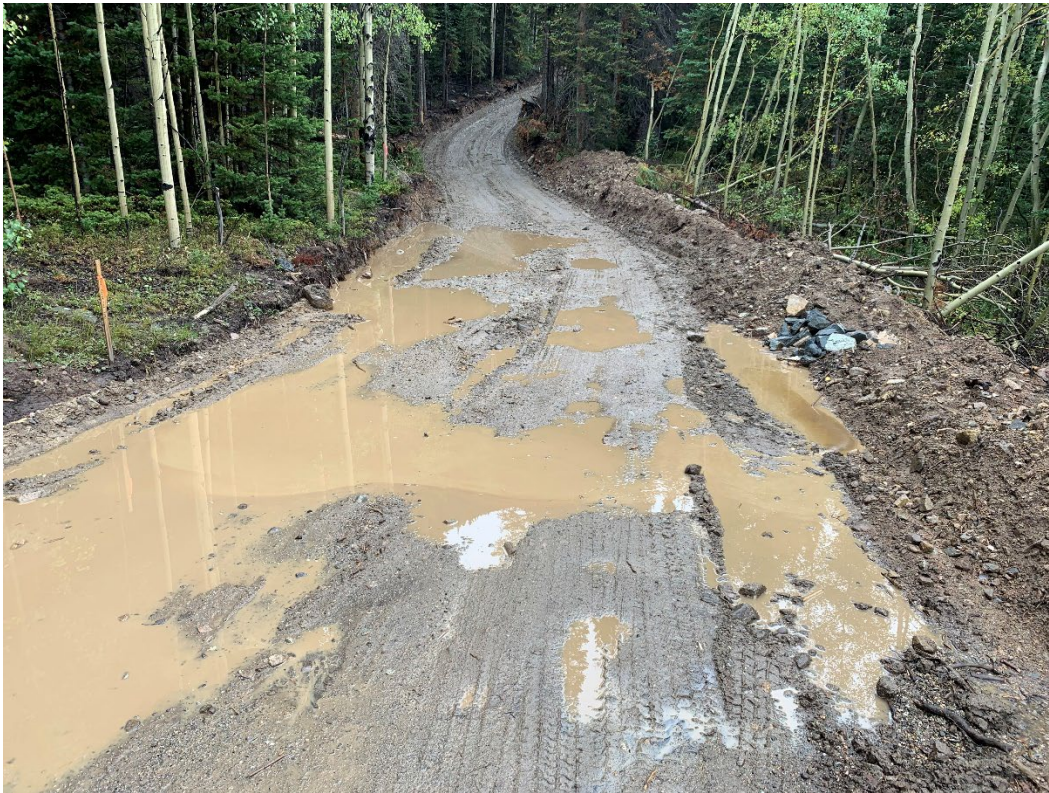
Photo 1 – Access road

The access road was very wet and muddy (photo 1). A check dam was in place controlling the flow of water off the road.

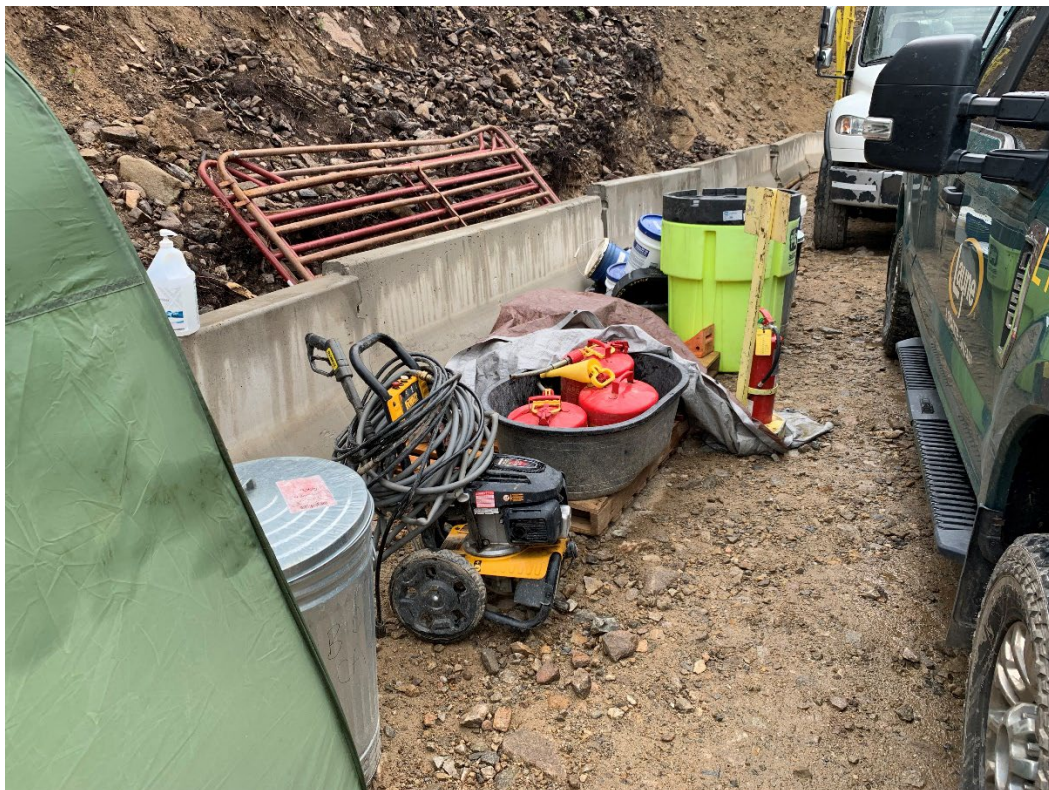
Photo 2 – Fuel storage secondary containment

Fuel containers were stored in secondary containment (photo 2). The drill rig and trailer with mixing tank had secondary spill containment under them.

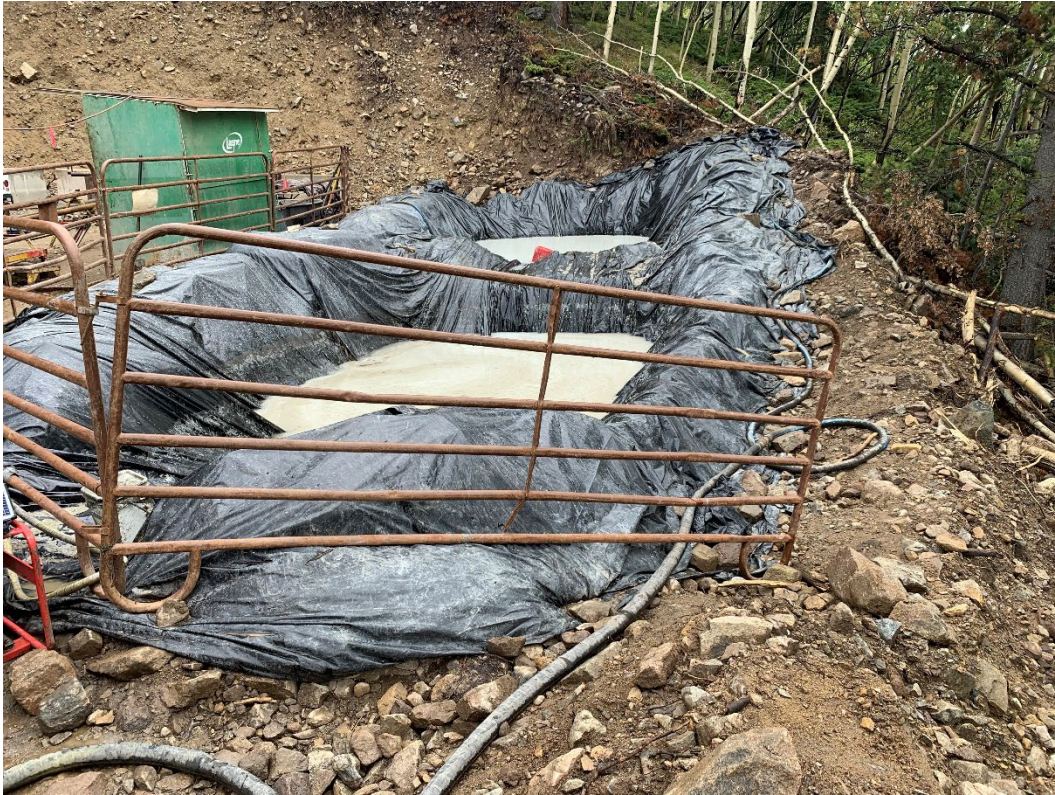
Photo 3 – Drilling fluid sumps

A water truck was hauling water to the site for the drilling fluid. Water was being pumped into the lined holding sumps (photo 3).

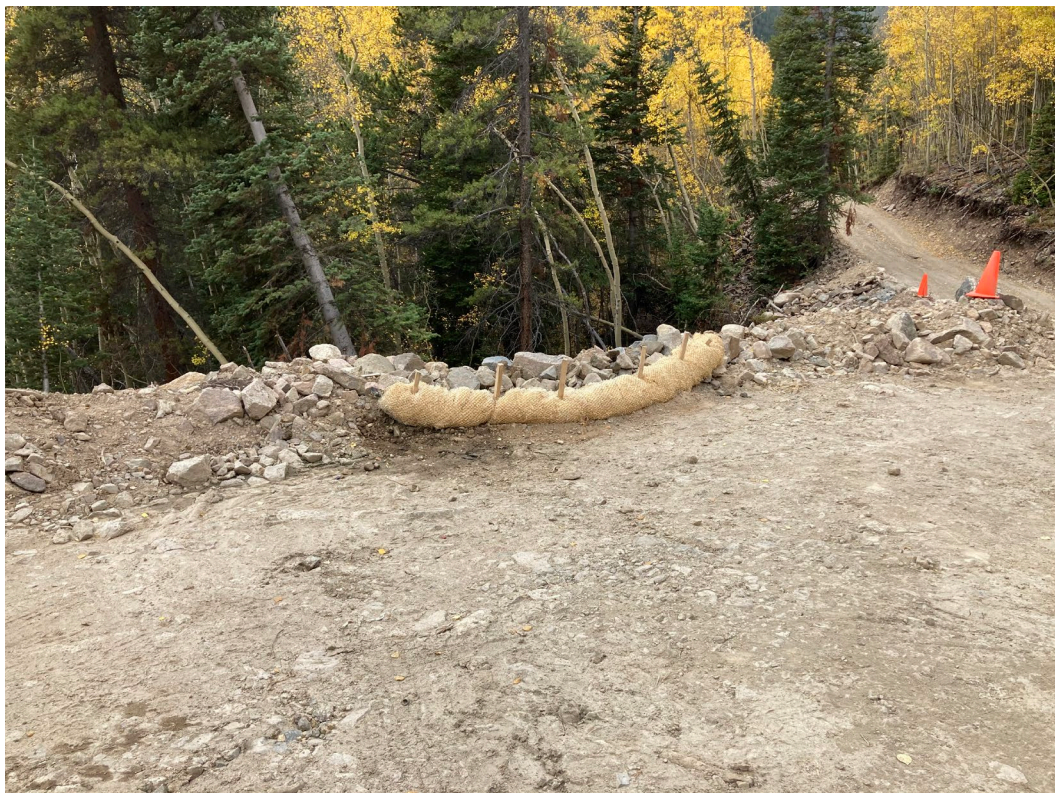
Photo 4 – Sediment control structure at pad area

A check dam controlling sediment runoff from the pad area was installed (photo 4).
