Division of Reclamation,  
Mining and Safety

### PERMIT INFORMATION

### INSPECTION INFORMATION

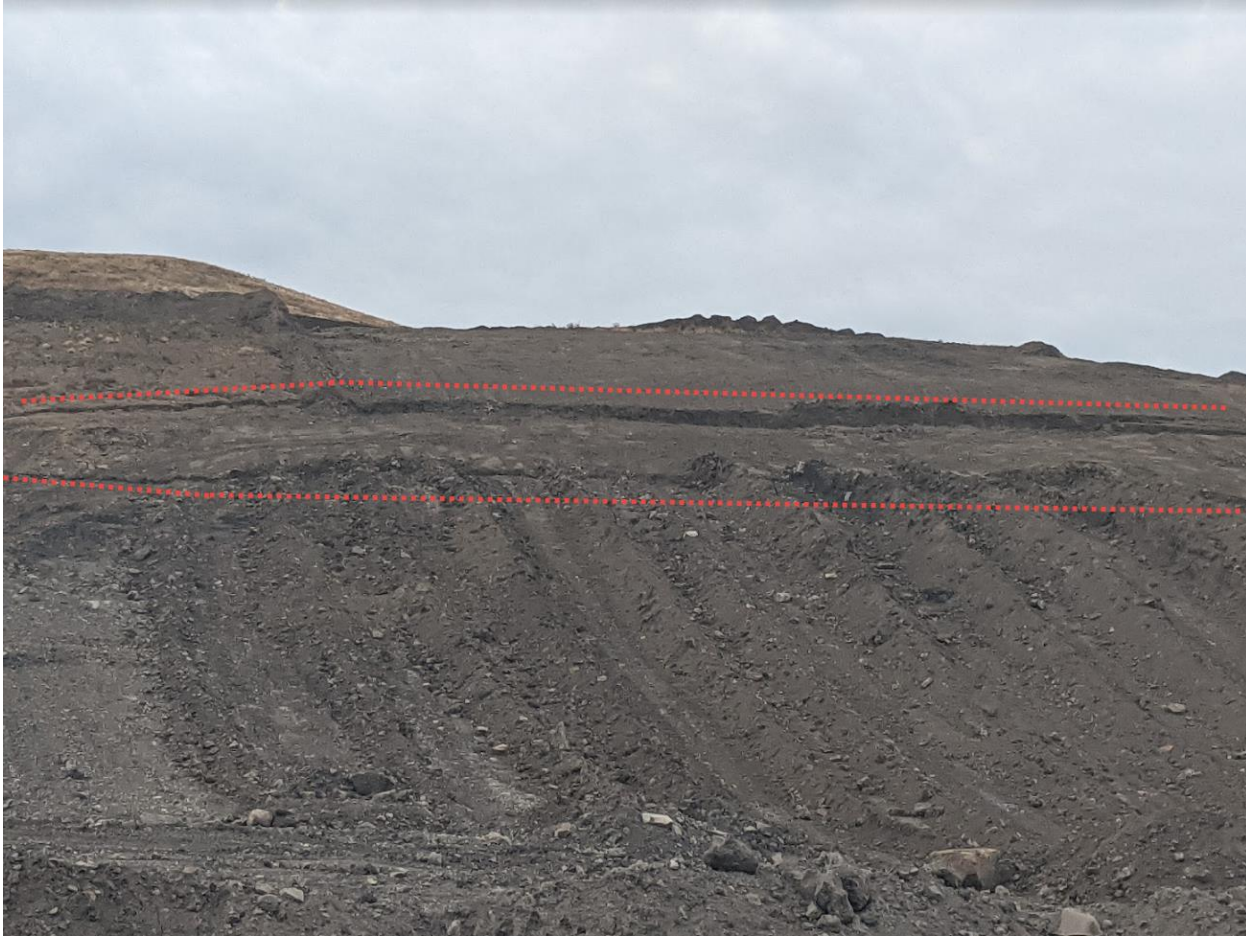
The evening of 9/28, slumping had occurred within the backfill and regrade area of the West Pit. The area is approximately midway from east to west within the West Pit highwall backfill. At the time of the inspection, Colowyo was assessing and monitoring the area before beginning work on the slope. During the remaining inspection, no additional movement had occurred.

Approximate slump outline.

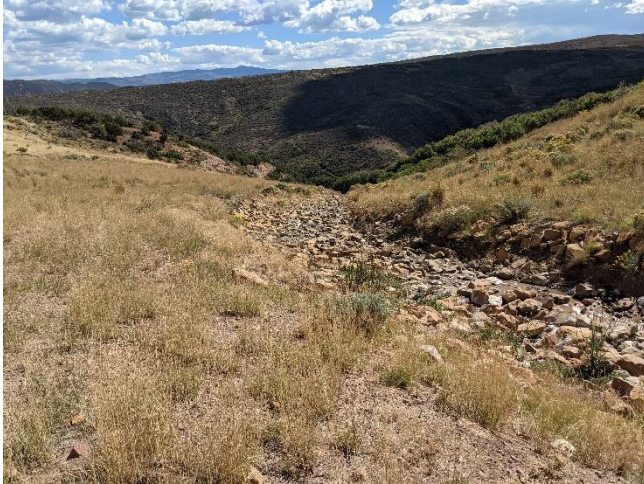
All remaining ditches within East Pit were inspected along with their associated stock tanks. This includes the Final East Pit Ditch, North Tributary, East Pit Ditch, Prospect Ditch and the Streeter Ditch. Each ditch was stable at the time of the inspection. All ditches were either well vegetated or lined with rip rap. All associated tanks held water with no discharge into their associated ditch. Collection Ditches locatedNo issues observed.

Final East Pit Ditch.

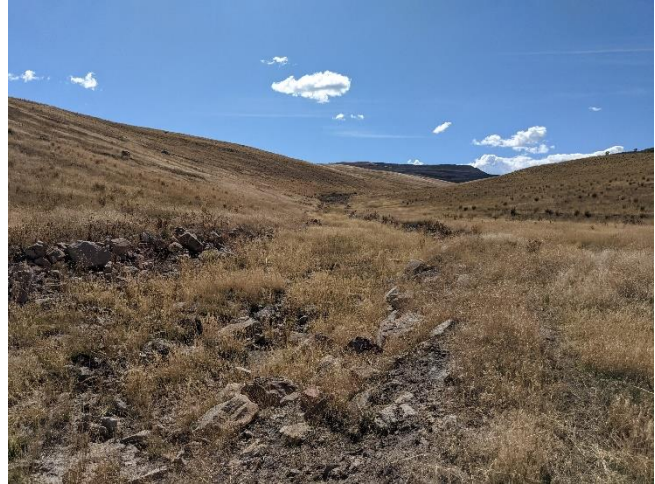
Four ditches within the West Pit were inspected along with the associated stock tanks. This included the Taylor Ditch, Taylor Tributary Ditch, East Taylor Ditch and Buckskin Ditch. The Buckskin ditch has only a portion constructed at the moment and is located in the eastern portion of the West Pit. The entirety of Taylor Ditch and East Taylor Ditch were inspected. The Taylor Ditch is lined with rip rap for its entirety and no issues were observed. The East Taylor Ditch is mostly lined with rip rap with a portion that is a vegetated channel just above stock tank ETD1. ETD1 has received maintenance in 2021 which added an additional discharge point with rip rap. No issues were observed the ditch or associated stock tank. The Taylor Tributary Ditch was inspected from below along the Taylor Tributary Ditch. The entire reach of the Taylor Trib. can be inspected and no issues were observed.

Taylor Ditch.

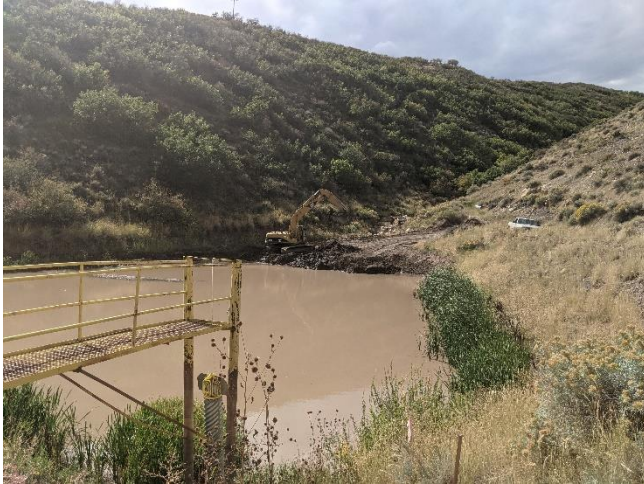
Ponds associated with the East Pit are Streeter Pond and Prospect Pond. The Streeter Pond receives runoff associated with the Streeter Ditch. The pond held water and was discharging at the time of the inspection. The embankment was stable and well vegetated. The Prospect Pond receives runoff from the Final East Pit Ditch, North Trib. East Pit Ditch and Prospect Ditch. The Prospect Pond held water but was not discharging at the time of the inspection. The pond was being cleaned at the time of the inspection. Sediment was being excavated from the pond and being transported to the South Taylor Pit. No issues were observed.

Prospect Pond.

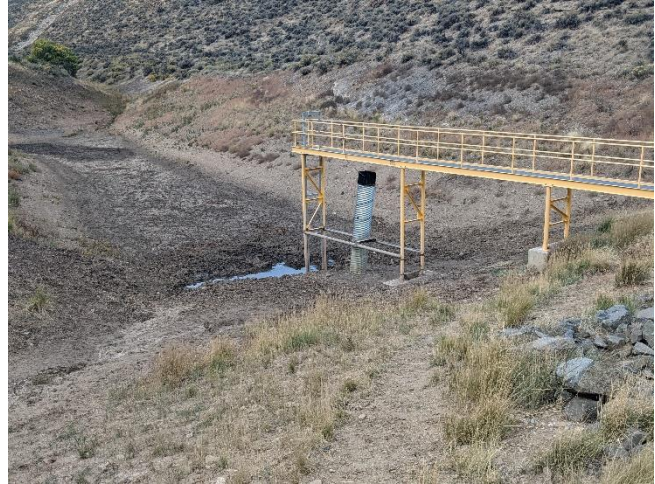
Collom ponds Section 25, Section 26, Section 36, Middle and Sidehill were inspected. Section 36, Section 25 and Middle Pond run in series with each other and collect runoff from the eastern portion of disturbance from the Collom Pit. Each of these ponds held minimal water with no discharge. Section 25 Pond has received maintenance on the primary spillway. The maintenance was completed prior to the inspection and water levels have not reached to the elevation of the spillway. The Sidehill and Section 26 ponds run in series with each other as well and receive runoff from the western portion of the Collom Pit. Both ponds held water but the Sidehill was minimal. All Collom Ponds were stable and no issues were observed.

Section 25 Pond.

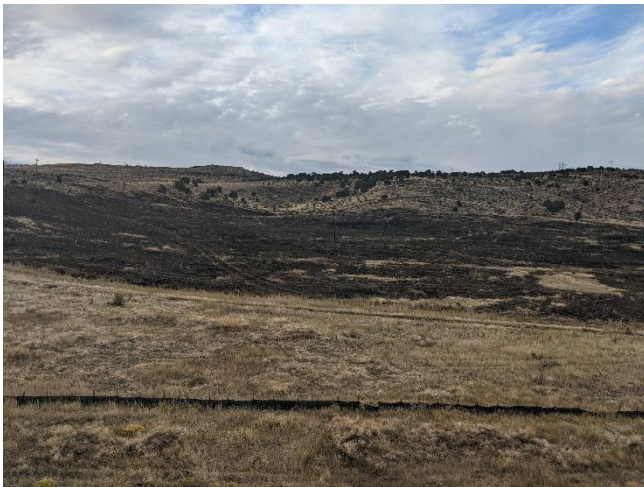
The evening of September 28th, a fire started north of the intersection of Haul Road A and the Collom Haul Road. The fire was contained with fire lines and put out. The Bureau of Land Management inspected the burn area in which the fire occurred and concluded a bird strike at the powerline started the fire and was not mine related. Colowyo stated that a revision would be provided in the future documenting the extent of the fire.

Burn area.

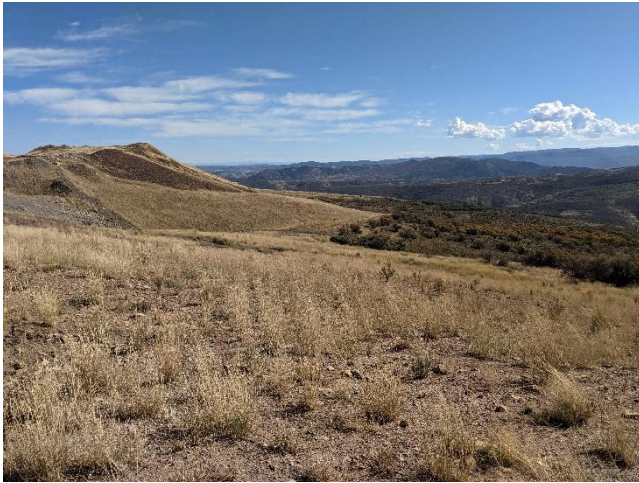
Reclamation parcel ST001 was inspected. ST001 is located just east of the South Taylor Pit and was reclaimed in 2011. This area recently received cross ripping for additional erosion control for this area. No signs of erosion was observed and the ST001 remains stable. No issues were observed.

ST001 parcel.

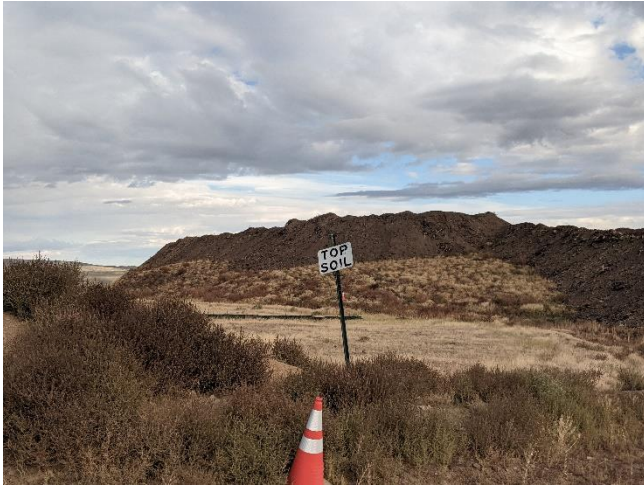
Topsoil Pile 26 A was inspected. 26A is located north of the Collom Spoil Pile. Topsoil stripping activities from the Collom Gulch has added to the pile in the previous months. The currently approved topsoil stripping activities have concluded and the pile is no longer receiving additional topsoil. At the time of the inspection, the additional topsoil to Pile 26A and is being planned to be shaped and seeded.

Pile 26A.
