MINERALS PROGRAM INSPECTION REPORT
PHONE: (303) 866-3567

MINE NAME: Witherbee Pit	MINE/PROSPECTING ID#: M-2009-070	MINERAL: Gravel and borrow in construction	COUNTY: Yuma
INSPECTION TYPE: Monitoring	INSPECTOR(S): Brock Bowles	INSP. DATE: May 18, 2022	INSP. TIME: 12:00
OPERATOR: Yuma County	OPERATOR REPRESENTATIVE: Tom Andersen	TYPE OF OPERATION: 112c - Construction Regular Operation	
REASON FOR INSPECTION: Normal I&E Program	BOND CALCULATION TYPE: None	BOND AMOUNT: \$0.00	
DATE OF COMPLAINT: NA	POST INSP. CONTACTS: None	JOINT INSP. AGENCY: None	
WEATHER: Clear	INSPECTOR'S SIGNATURE:

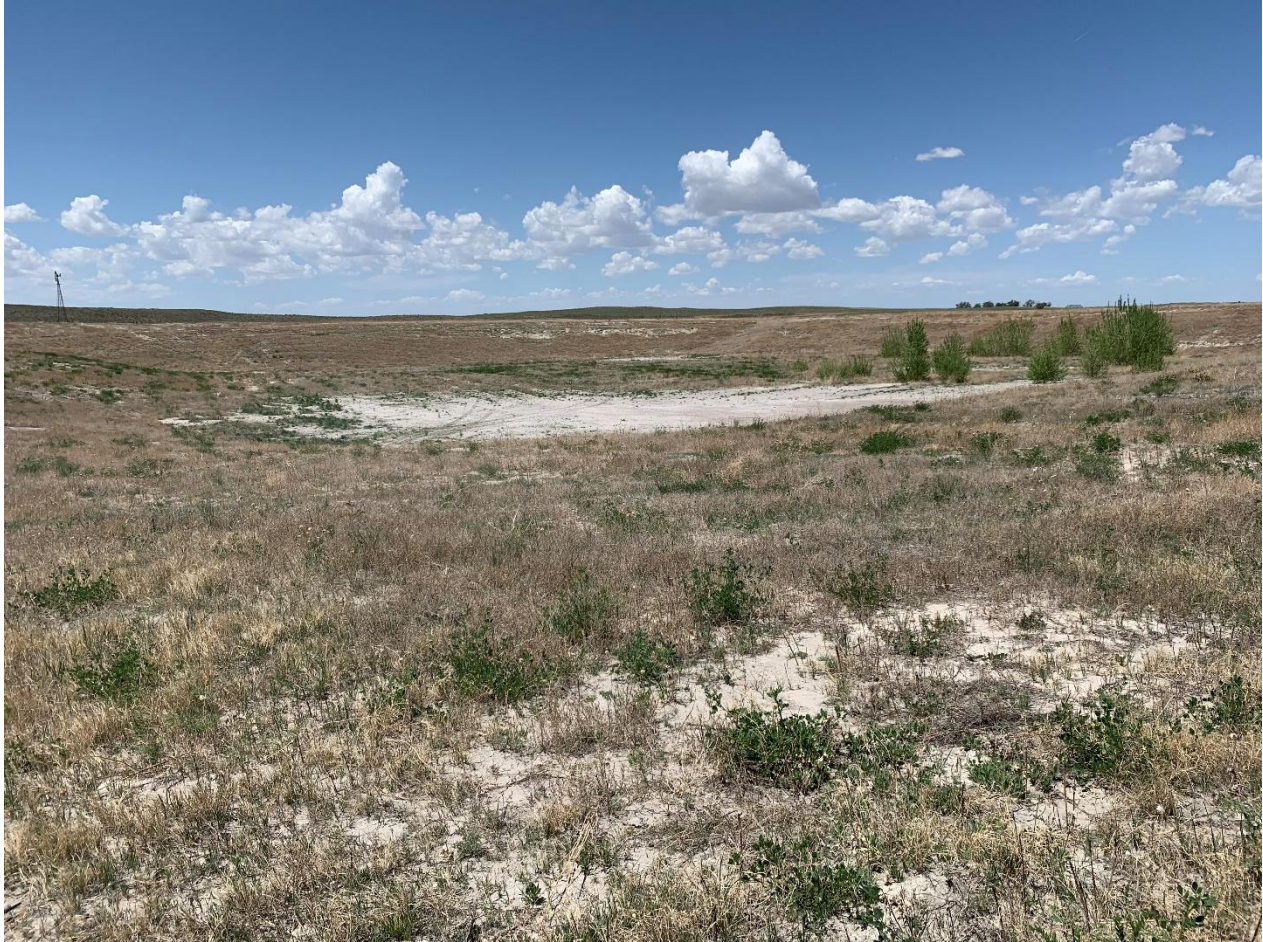
Photo 1- View of the pit facing northwest
