MINERALS PROGRAM INSPECTION REPORT
PHONE: (303) 866-3567

MINE NAME: Glass Gravel Pit	MINE/PROSPECTING ID#: M-1981-022	MINERAL: Sand and gravel	COUNTY: Larimer
INSPECTION TYPE: Monitoring	WEATHER: Clear	INSP. DATE: September 16, 2022	INSP. TIME: 11:00
OPERATOR: Connell Resources, Inc.	OPERATOR REPRESENTATIVE: Kevin Anderson	TYPE OF OPERATION: 112c - Construction Regular Operation	
REASON FOR INSPECTION: Normal I&E Program	BOND CALCULATION TYPE:	BOND AMOUNT: \$116,700.00	
DATE OF COMPLAINT: NA	POST INSP. CONTACTS: None	JOINT INSP. AGENCY: None	
INSPECTOR(S): Brock Bowles	INSPECTOR'S SIGNATURE:

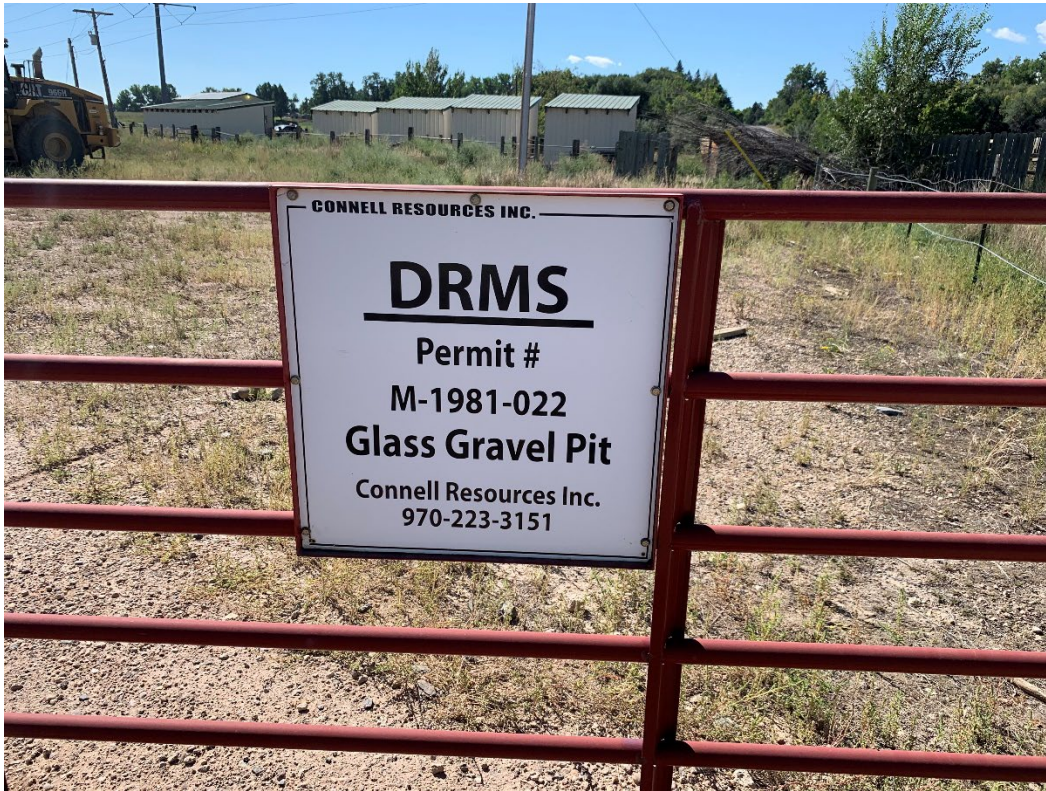
The mine entrance sign was in place facing Taft Hill Road (photo 1) and the entrance gate was locked upon arrival. The permit boundary was marked with a chain link fence on all sides of the permit boundary. A front-end loader was on site but no mining was taking place.

Photo 1 – Mine entrance sign facing Taft Hill Road

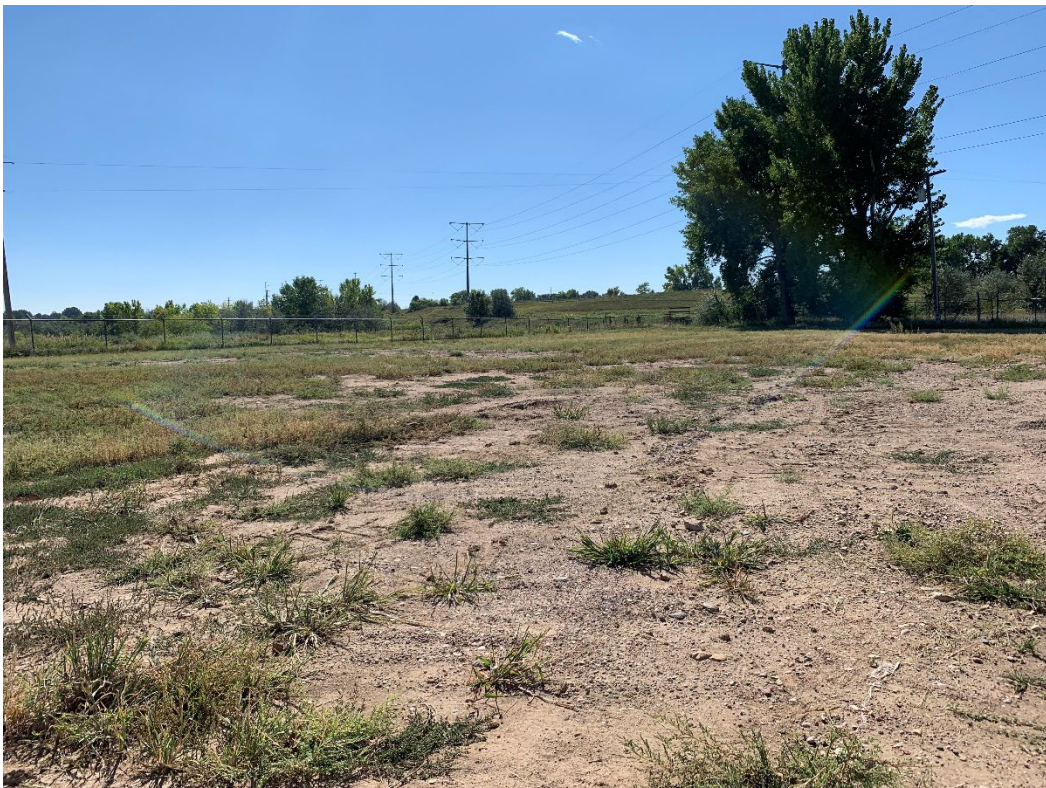
The site appears to be mostly backfilled (photo 2) and level with the surrounding landscape. There are a couple of stockpiles that need to be graded flat to blend in (photos 3 & 4). The 2015 inspection report stated that the pond contained water. No pond or exposed groundwater was seen within the permit area during this inspection.

Photo 2 – Southeast corner of former pit area

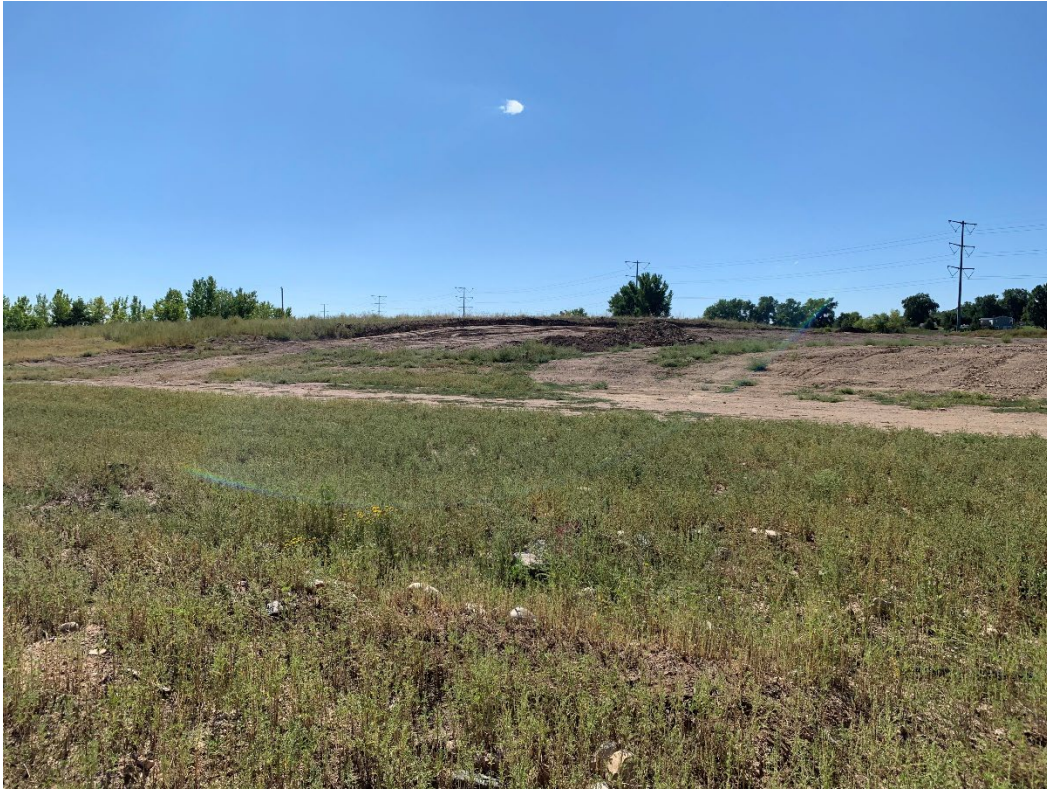
Photo 3 – Stockpile on east end of permit area.

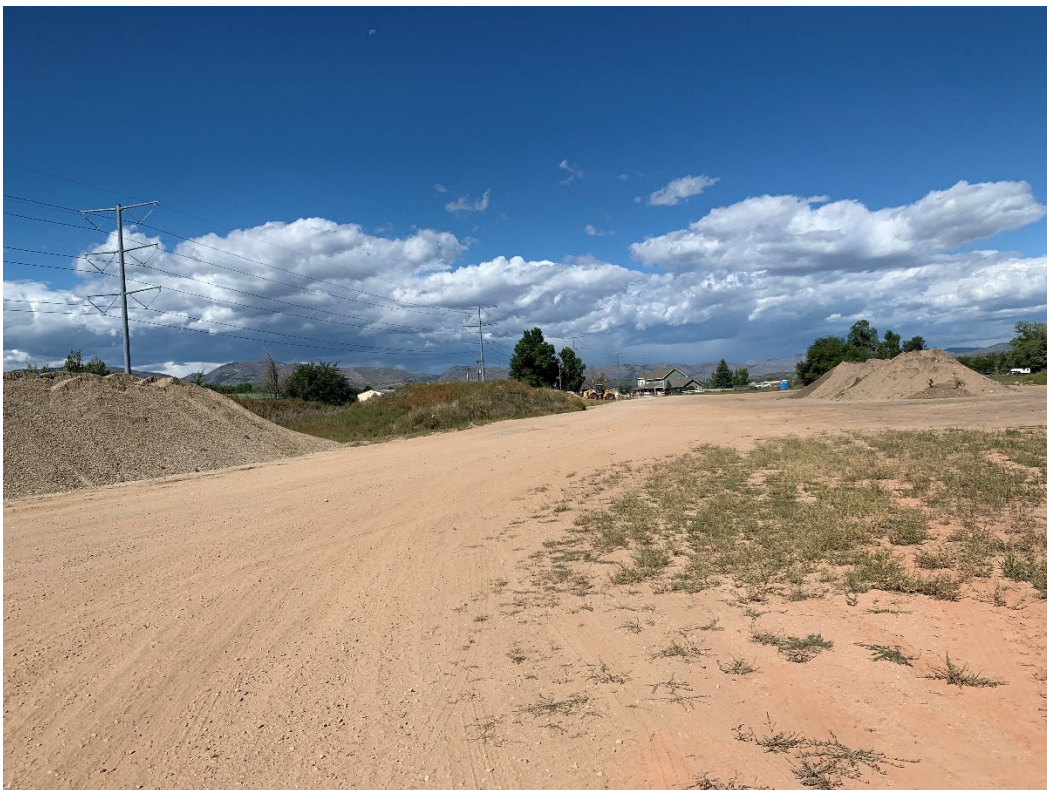
Photo 4 – Stockpiles on west side of permit area

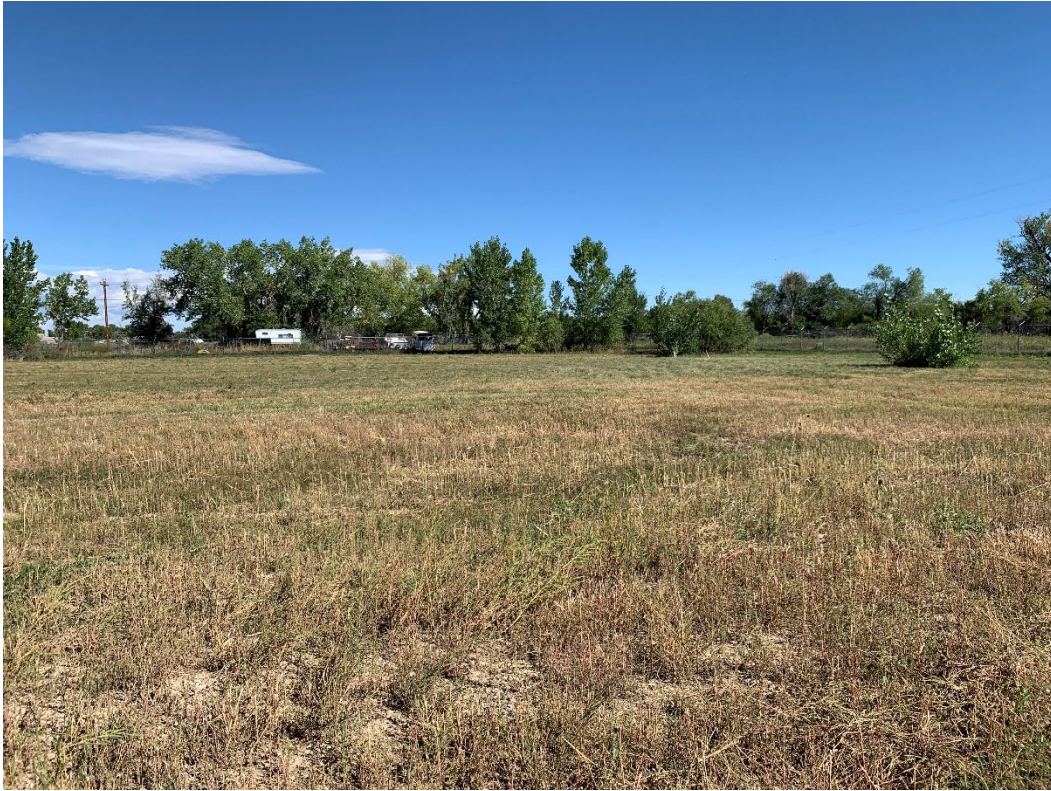
The site was recently mowed to control weeds (photo 5). The topsoil stockpiles were along the southern fence. The stockpiles were not well vegetated with desirable vegetation (photo 6). The stockpiles need to be seeded with desirable vegetation.

Photo 5 – Northeast corner of permit area has been mowed

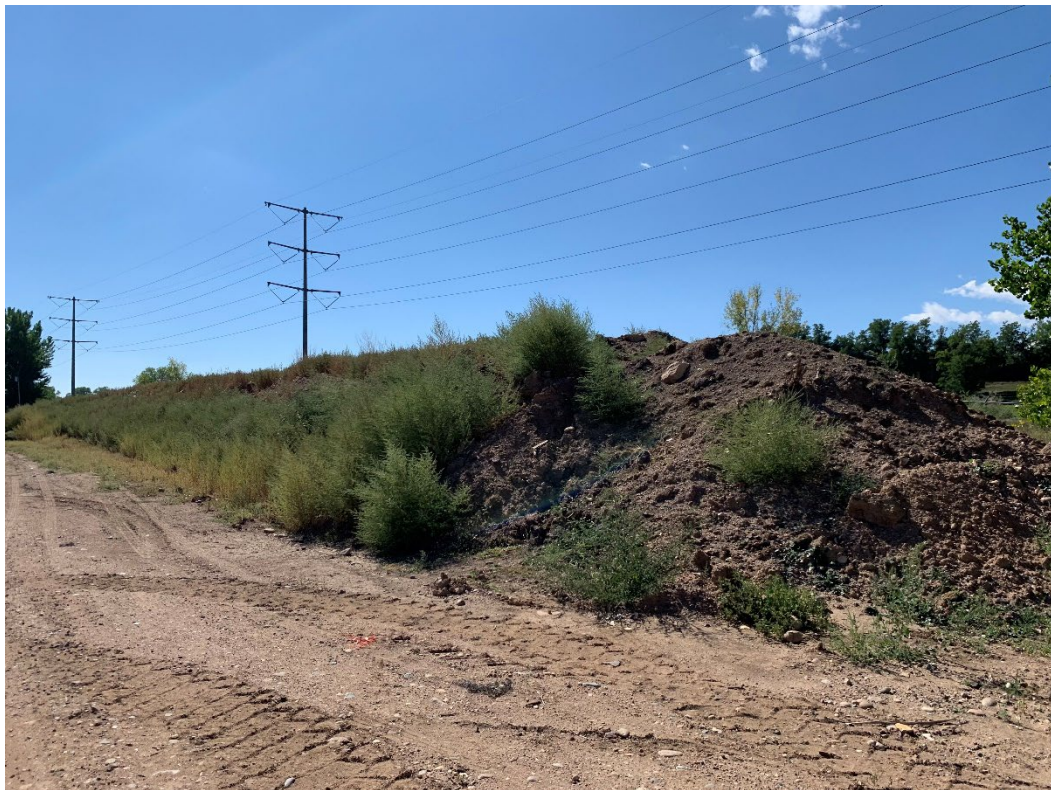
Photo 6 – Topsoil stockpile along southern fence
