PERMIT INFORMATION

Permit Number: C-1981-033 Mine Name: Bear Mine Operator: N/A Operator Address: N/A	County: Gunnison Operation Type: Underground Permit Status: Revoked Ownership: Private
	Operator Representative Present: N/A
Operator Representative Signature: (Field Issuance Only)

INSPECTION INFORMATION

Inspection Start Date: September 14, 2022 Inspection Start Time: 07:30 Inspection End Date: September 14, 2022 Inspection End Time: 09:30	Inspection Type: Coal Complete Inspection Inspection Reason: Normal I&E Program Weather: Cloudy
Joint Inspection Agency: None	Joint Inspection Contacts:
Post Inspection Agency: None	Post Inspection Contacts:
Inspector(s): Leigh Simmons	Inspector's Signature:

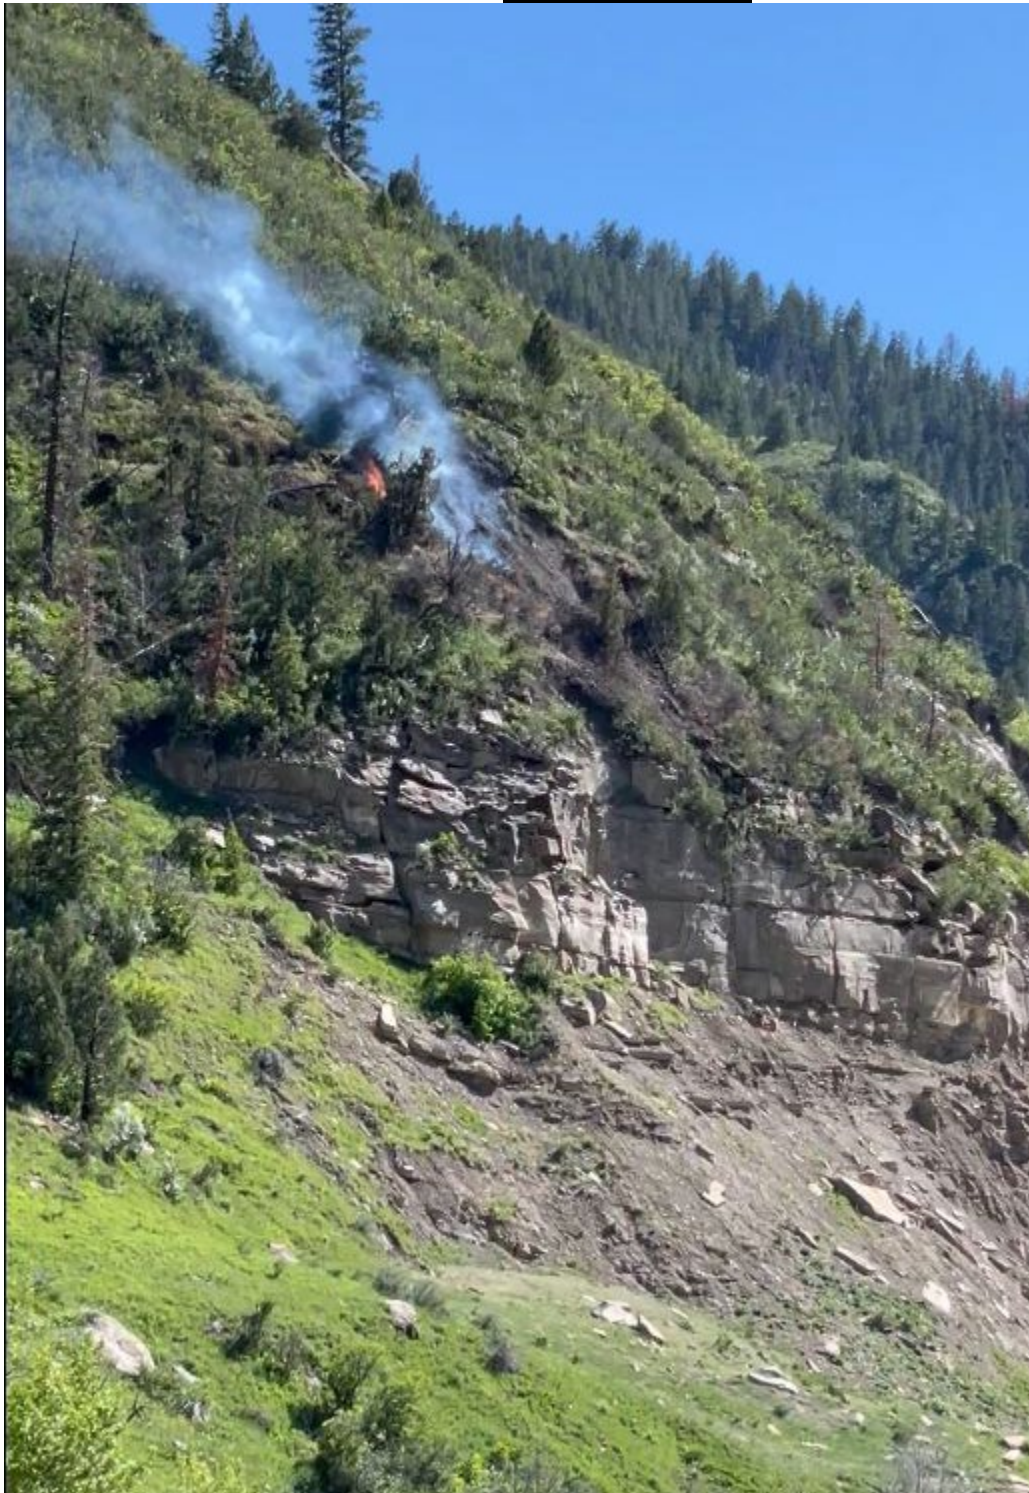
The underground coal fire flared up on May 25 and was reported to the Division by Doug Smith of Oxbow Mining, who has a view of the site from the Elk Creek mine offices across the river. Paonia Fire Department coordinated an initial response to the fire, which caught vegetation on the steep hillside above the escarpment alight. The response included helicopter drops of water collected from the North Fork of the Gunnison, as well as firefighters on the ground with wildland firefighting gear.

Figure 1: Still from a video clip of the fire taken from Hwy 133 on May 25, 2022

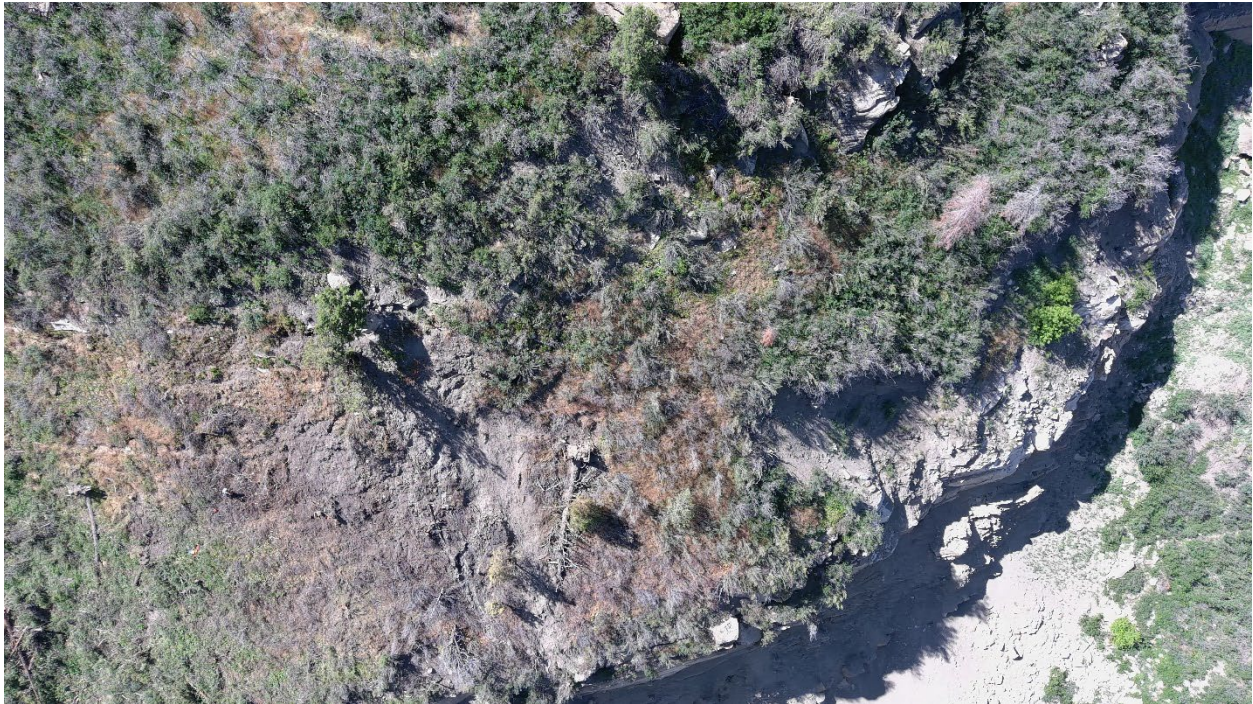
Figure 2: Aerial photo of mitigation work in progress, June 15, 2022

Mark Mikos coordinated the project and was present on-site a good deal throughout June and July. Visits to the site were made by Leigh Simmons of the Active Mines Program on June 15 and again on July 13. The first stage of the project was focused on clearing the hillside of vegetation around the vents and was accomplished by hand, with workers attached to anchors on the hillside using ropes and harnesses. The second stage was to construct a road to allow access to a bench above the escarpement, this work was subcontracted to Ryno Construction of Grand Junction, and was accomplished using a Caterpillar 328D excavator. On July 13, Ryan Crocker of Ryno Construction, reported that he had been working on the project for 8 days and hoped to finish that week.

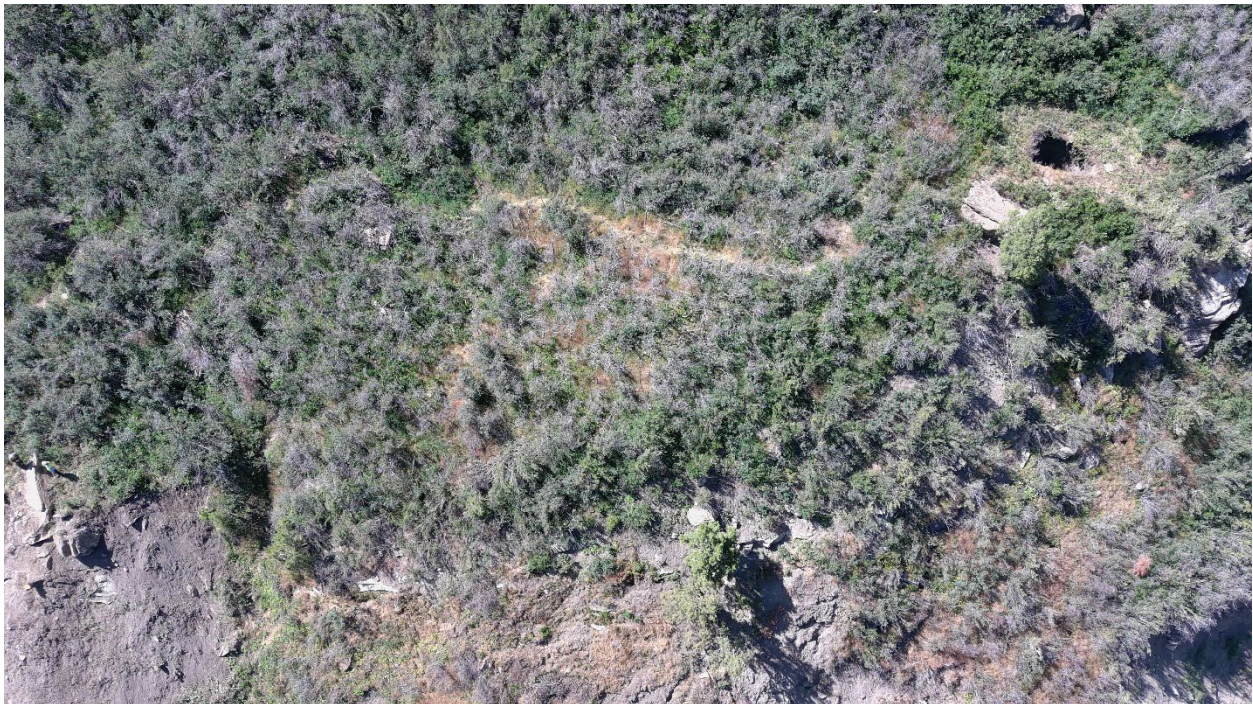
Figure 3: Aerial photo of prominent vent (upper right) and evidence of high surface temperatures to the left of the vent, June 15, 2022

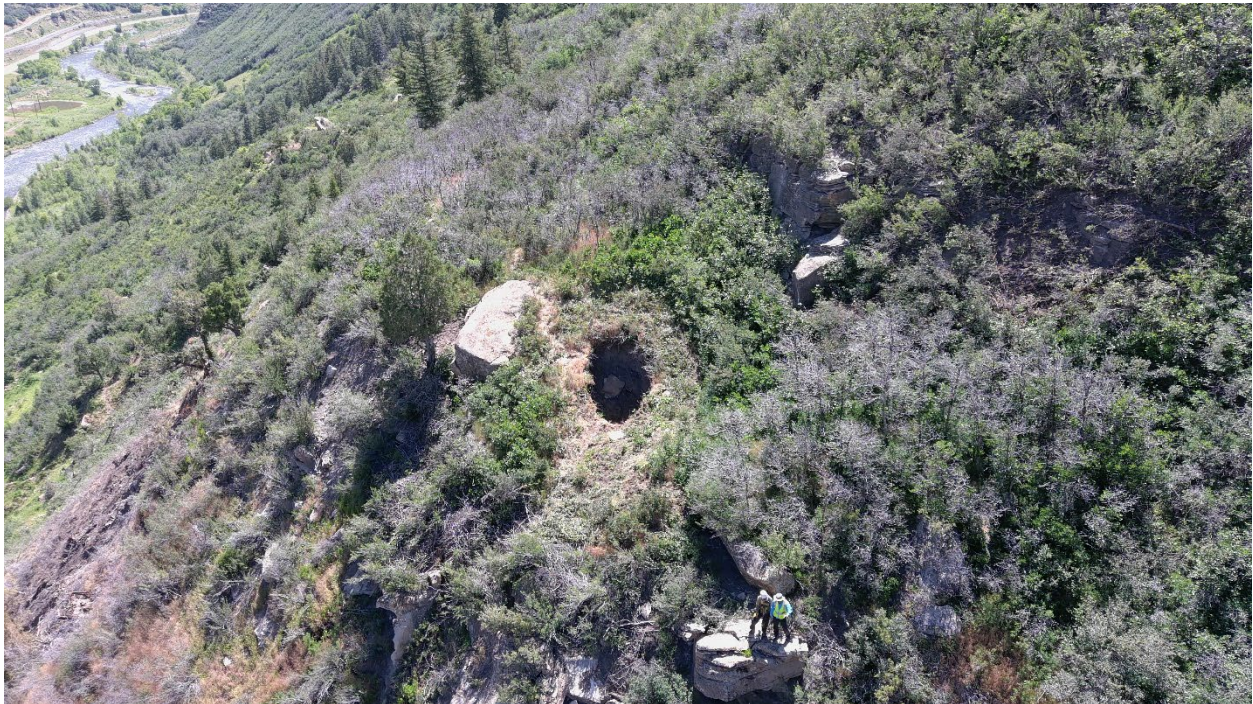
Figure 4: Prominent vent from the west, June 15, 2022

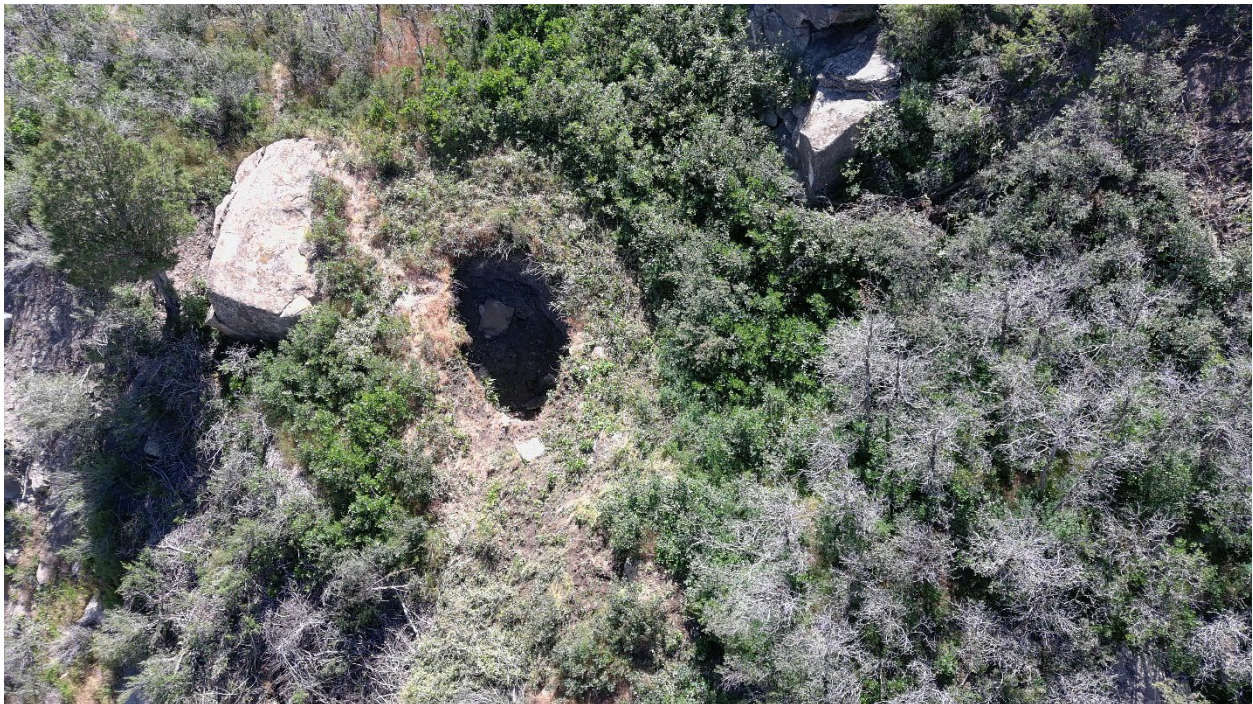
Figure 5: Close up of prominent vent, June 15, 2022

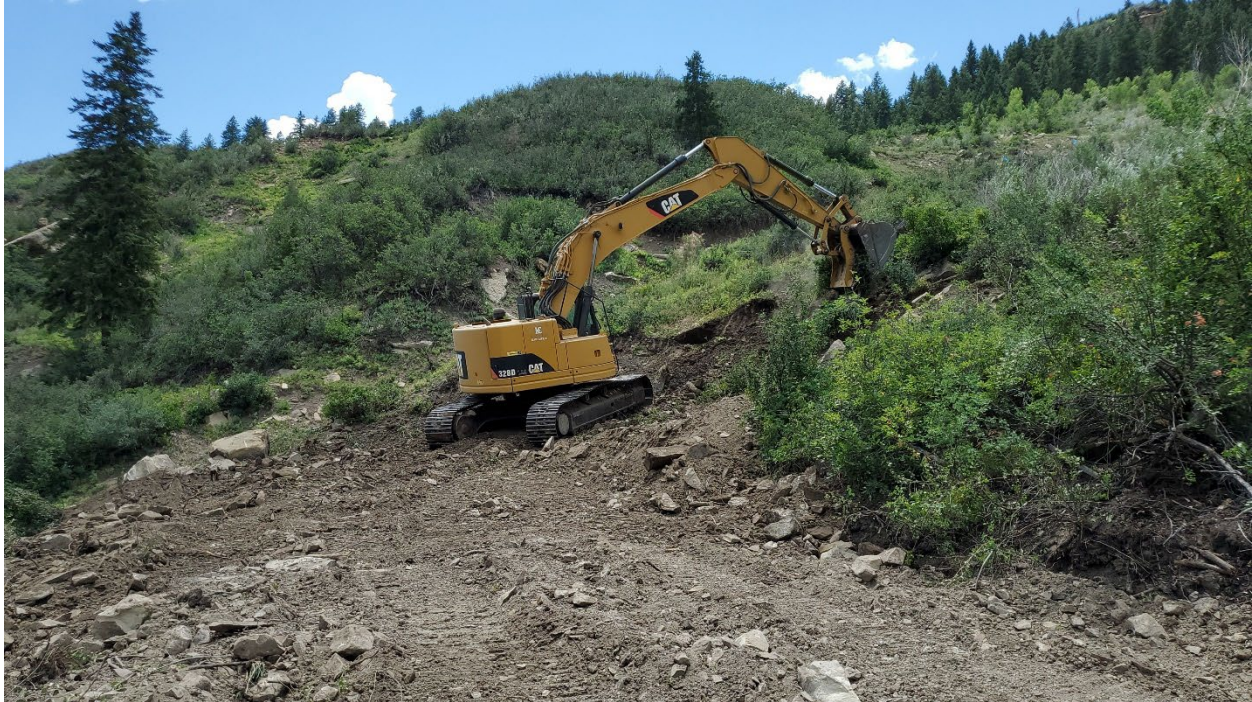
As described below, a new road has been constructed on site. Sediment control devices were employed to minimize the impacts of surface run-off to the surroundings.

Figure 6: Road under construction, July 13, 2022

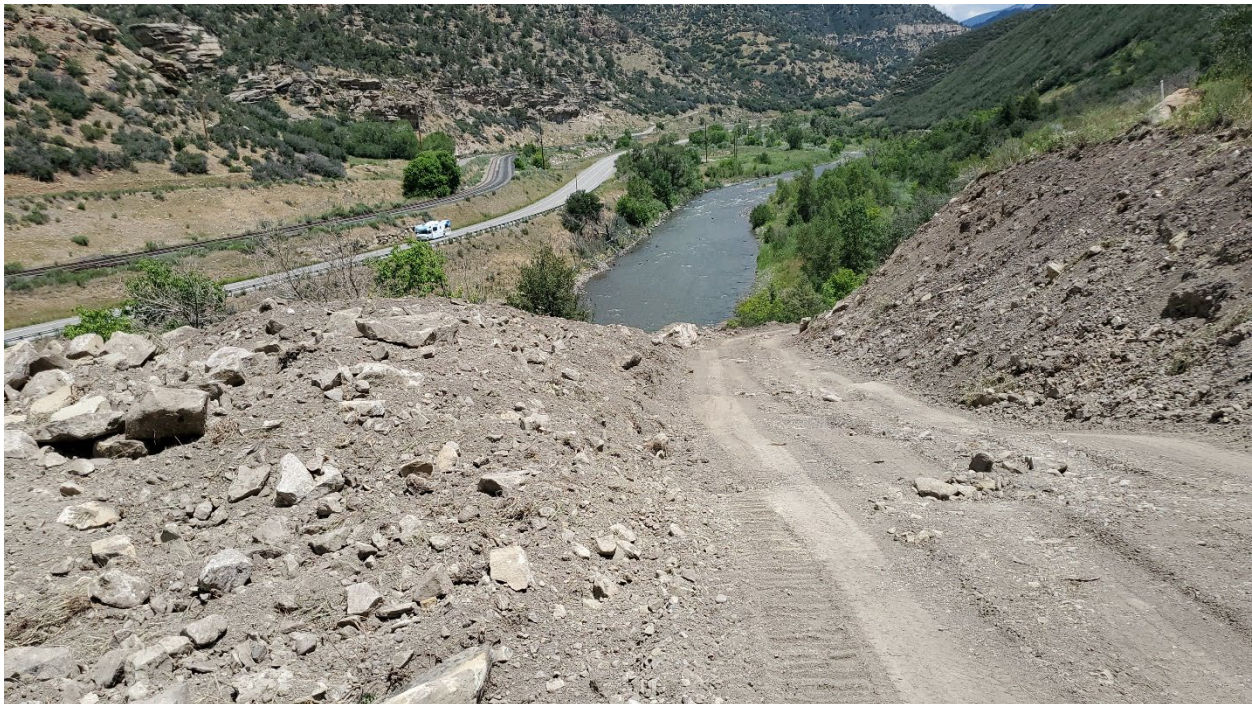
Figure 7: Partially constructed road, July 13, 2022

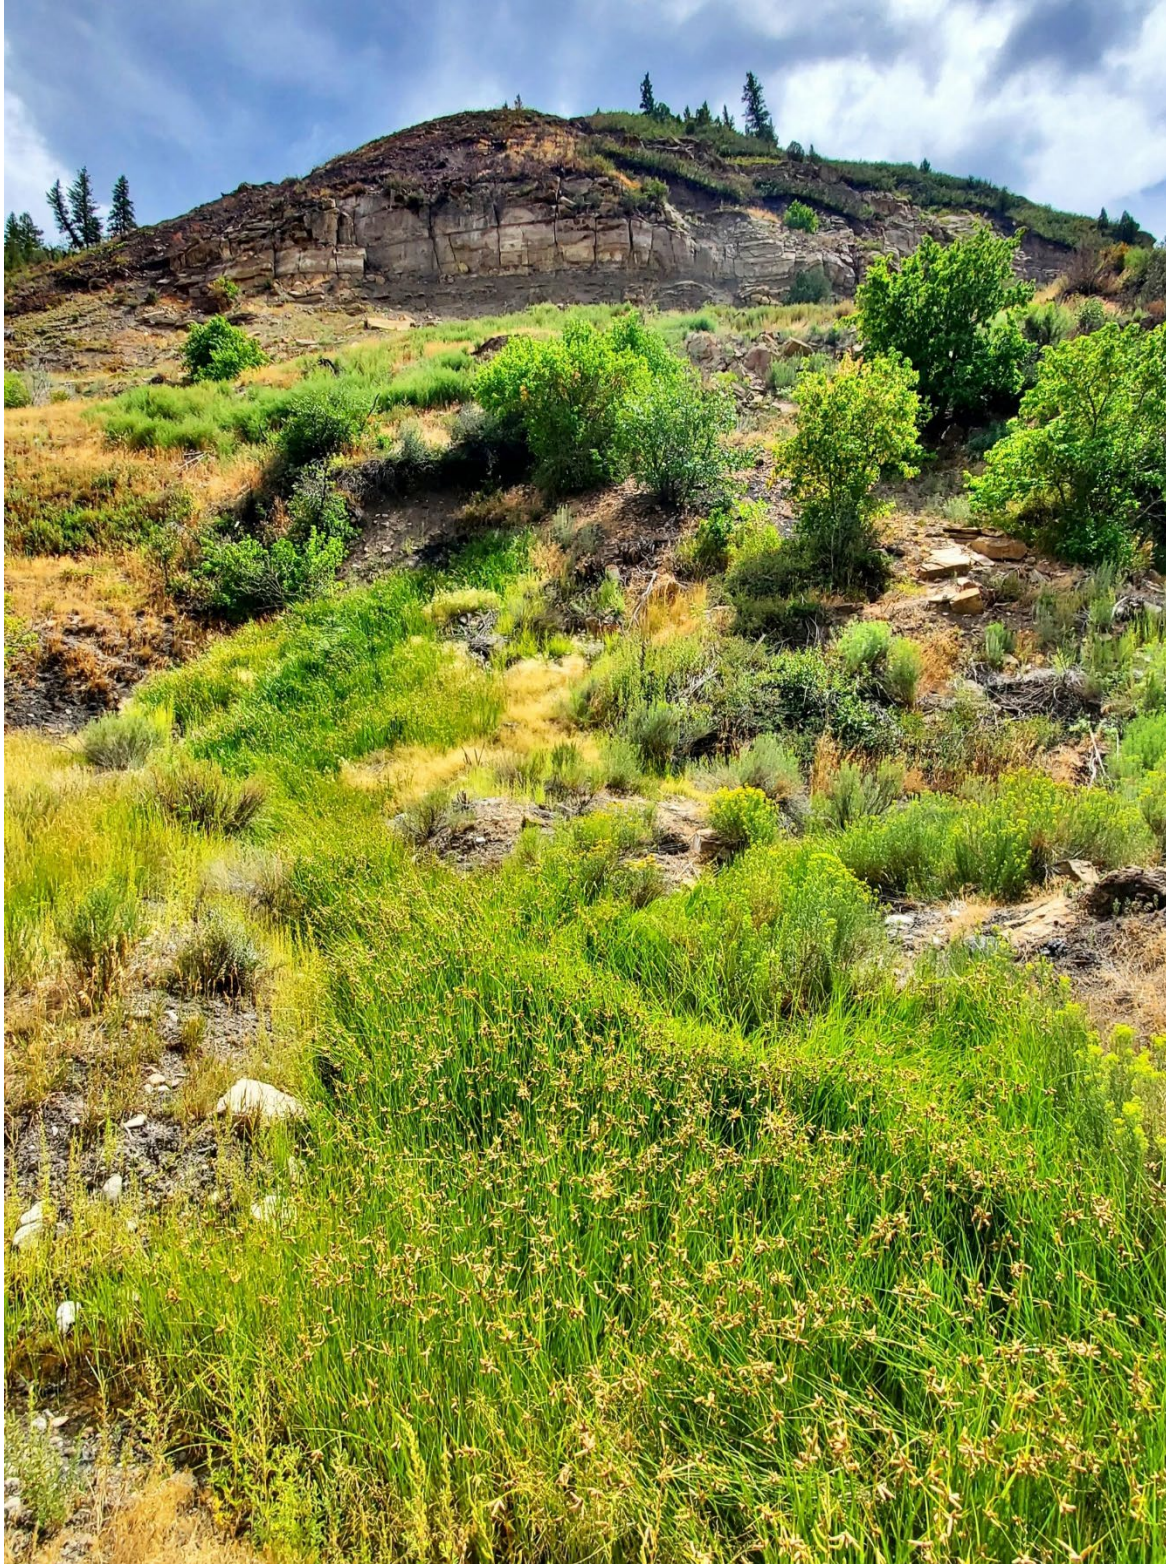
Figure 8: Burned vegetation above escarpment, with toe of slide area in foreground, August 22, 2022

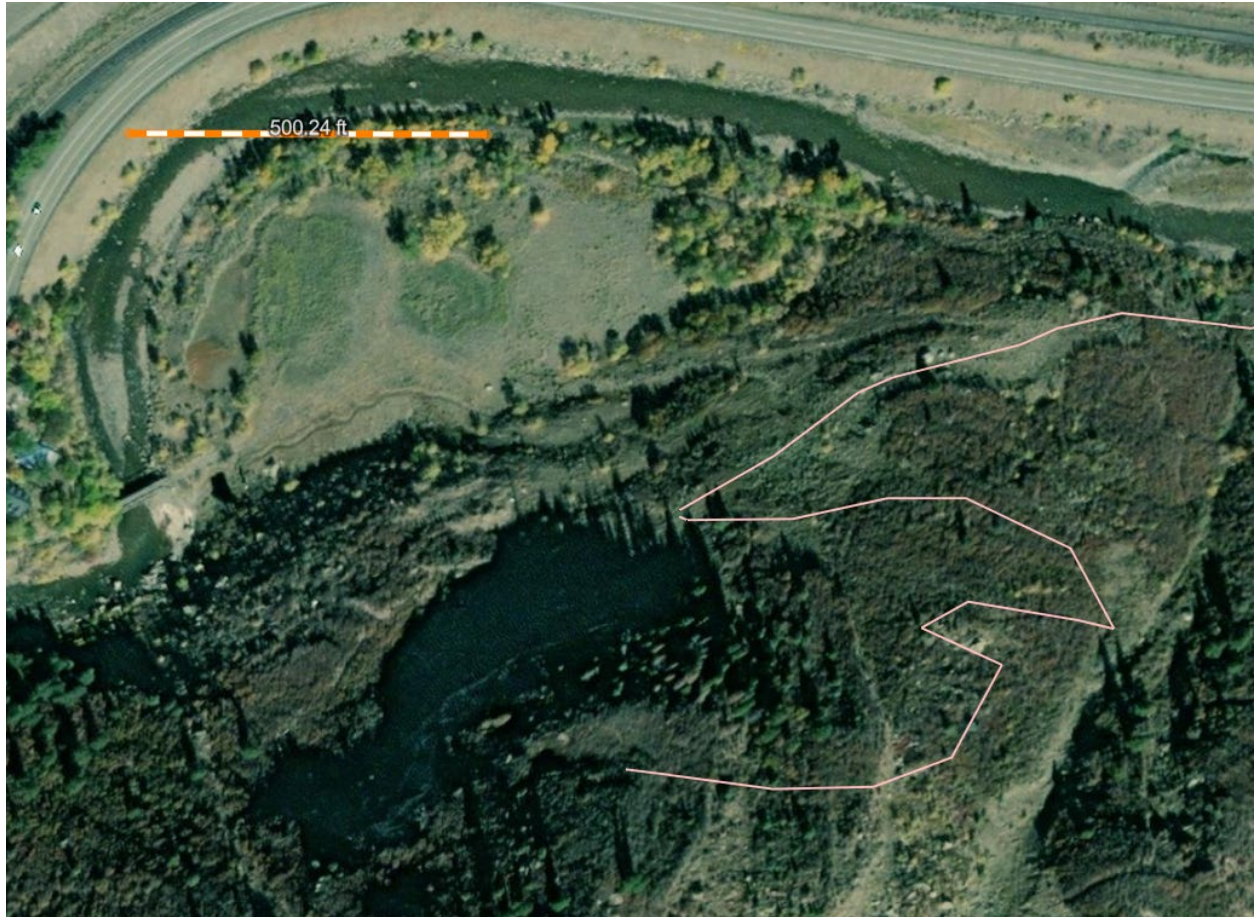
Figure 9: GPS track showing path of new road overlain on earlier aerial image

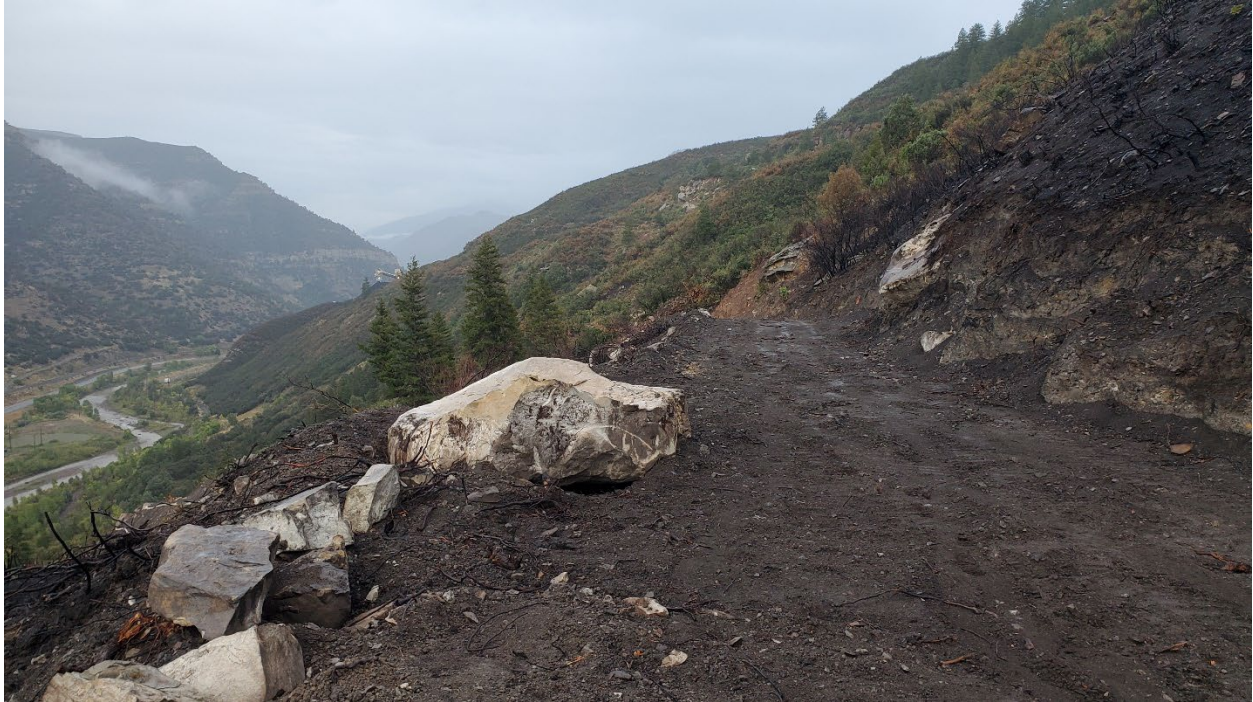
Figure 10: Top of new road, September 14, 2022

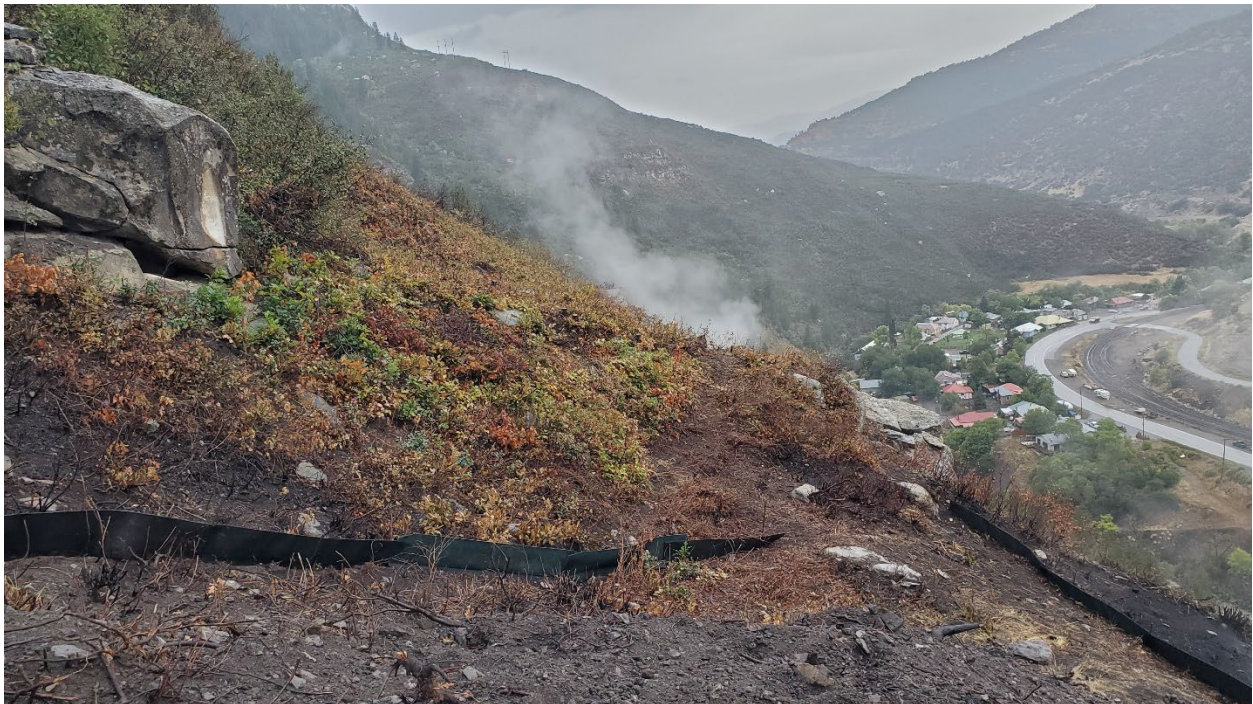
Figure 11: Sediment control in place, September 14, 2022

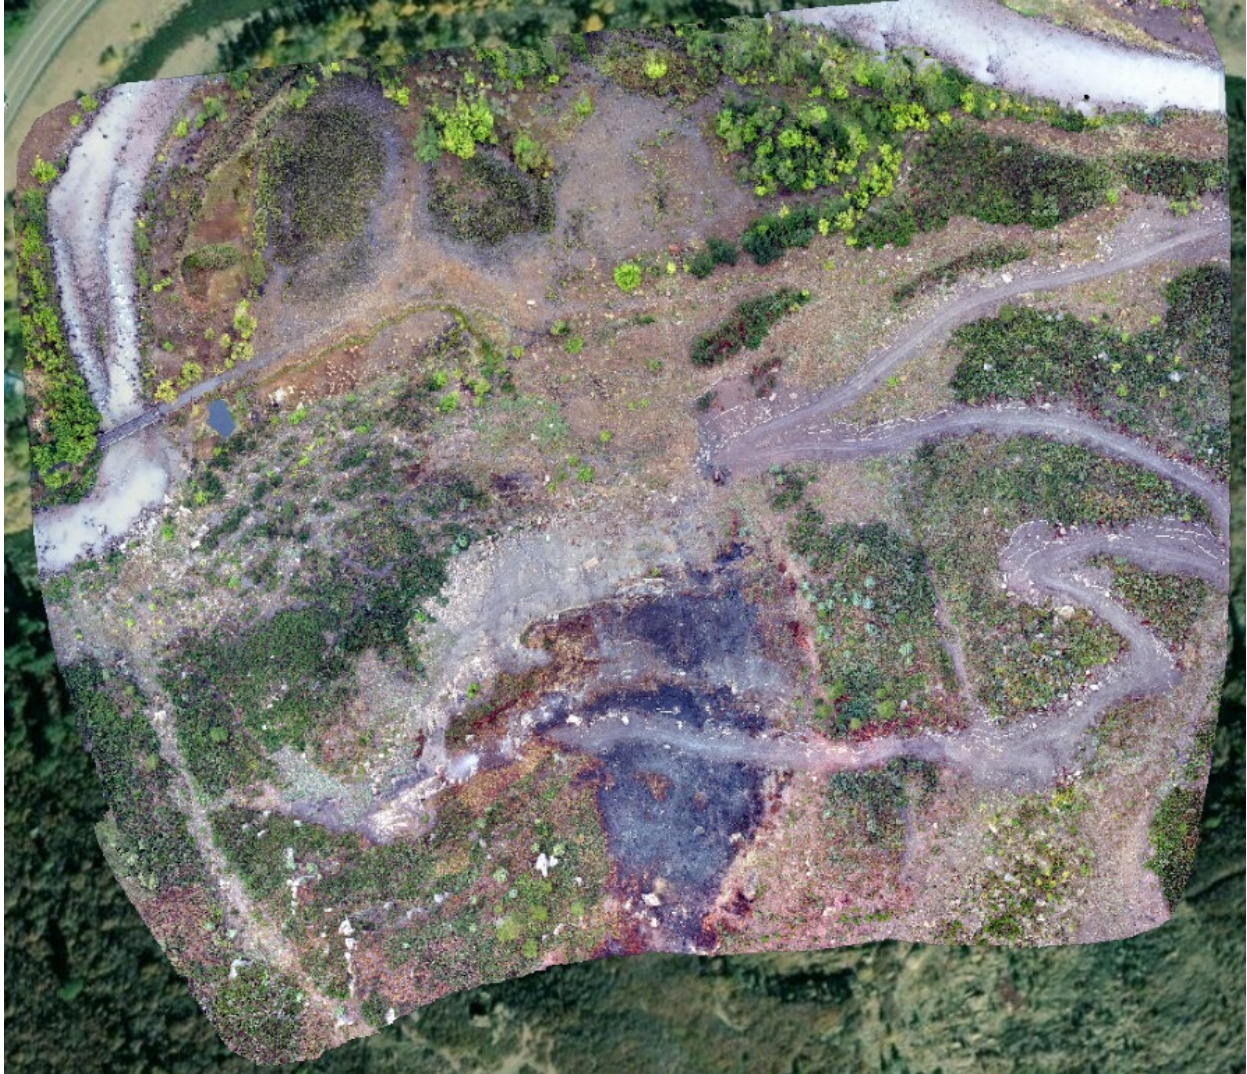
Leigh Simmons made further visits to the site on August 22 and September 14. During the September 14 inspection a survey was conducted using an Autel Evo II 640T drone, which carried a dual sensor (Visual and Infra-Red). The imagery was processed using Pix4D Mapper software to derive various data products including a high resolution ortho-image, and a lower resolution IR reflectance raster which was symbolized to allow the identification of areas of relatively high surface temperature.

Figure 12: High resolution ortho-image from drone survey, September 14, 2022

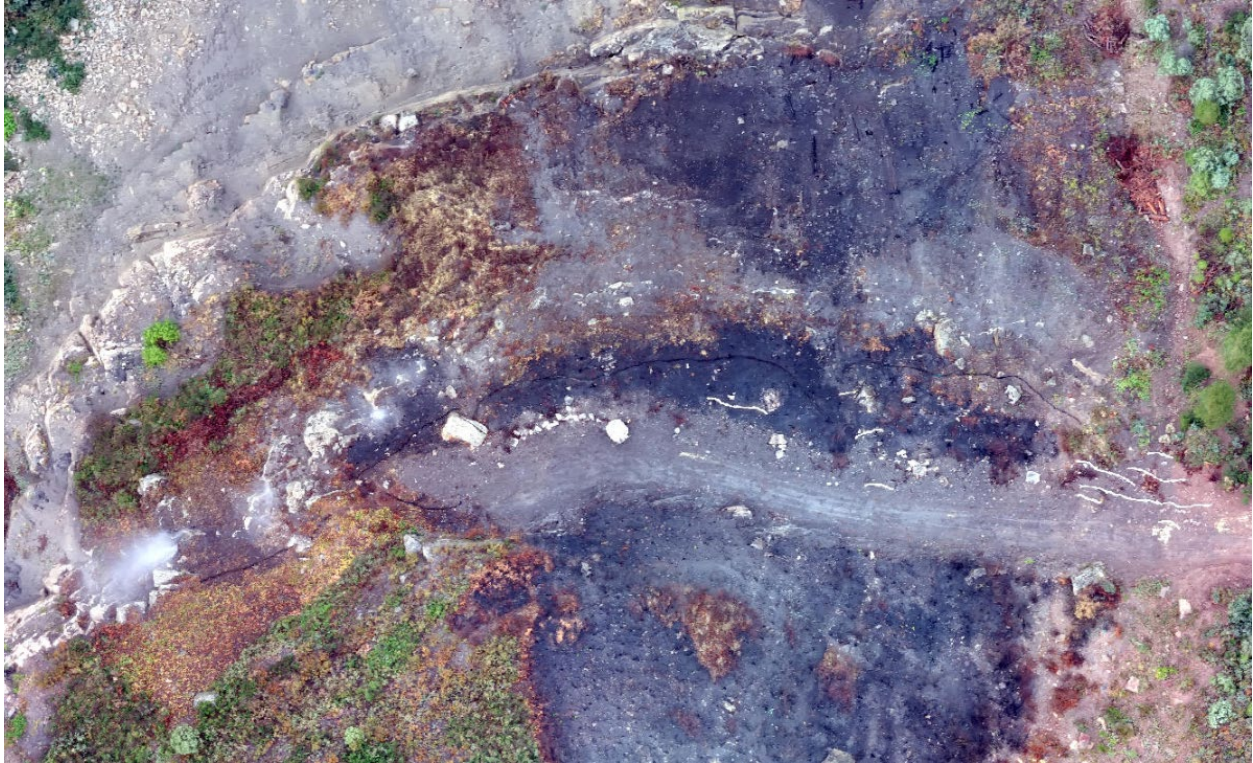
Figure 13: Close up of bench

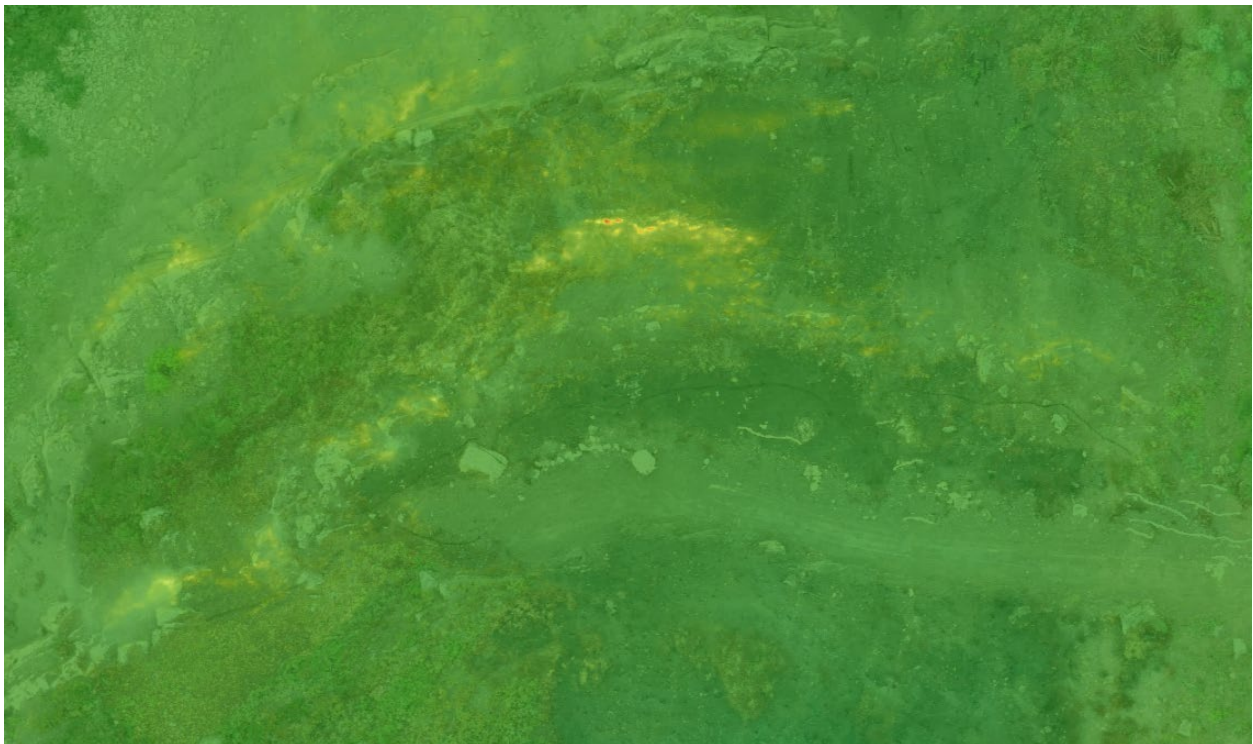
Figure 14: IR reflectance raster overlain on ortho-image, showing anomalously high surface temperatures (warm colors) downslope of bench, to north and west

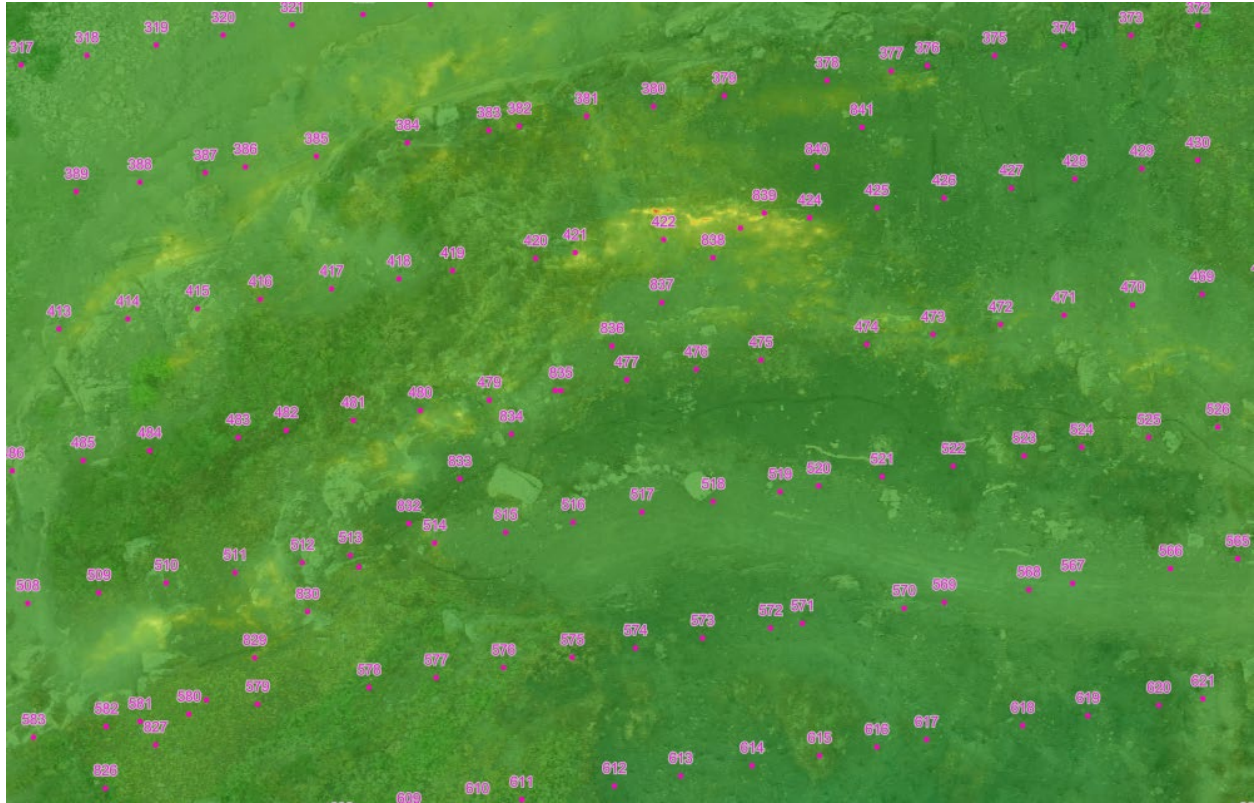
Figure 15: Point layer showing locations of individual images

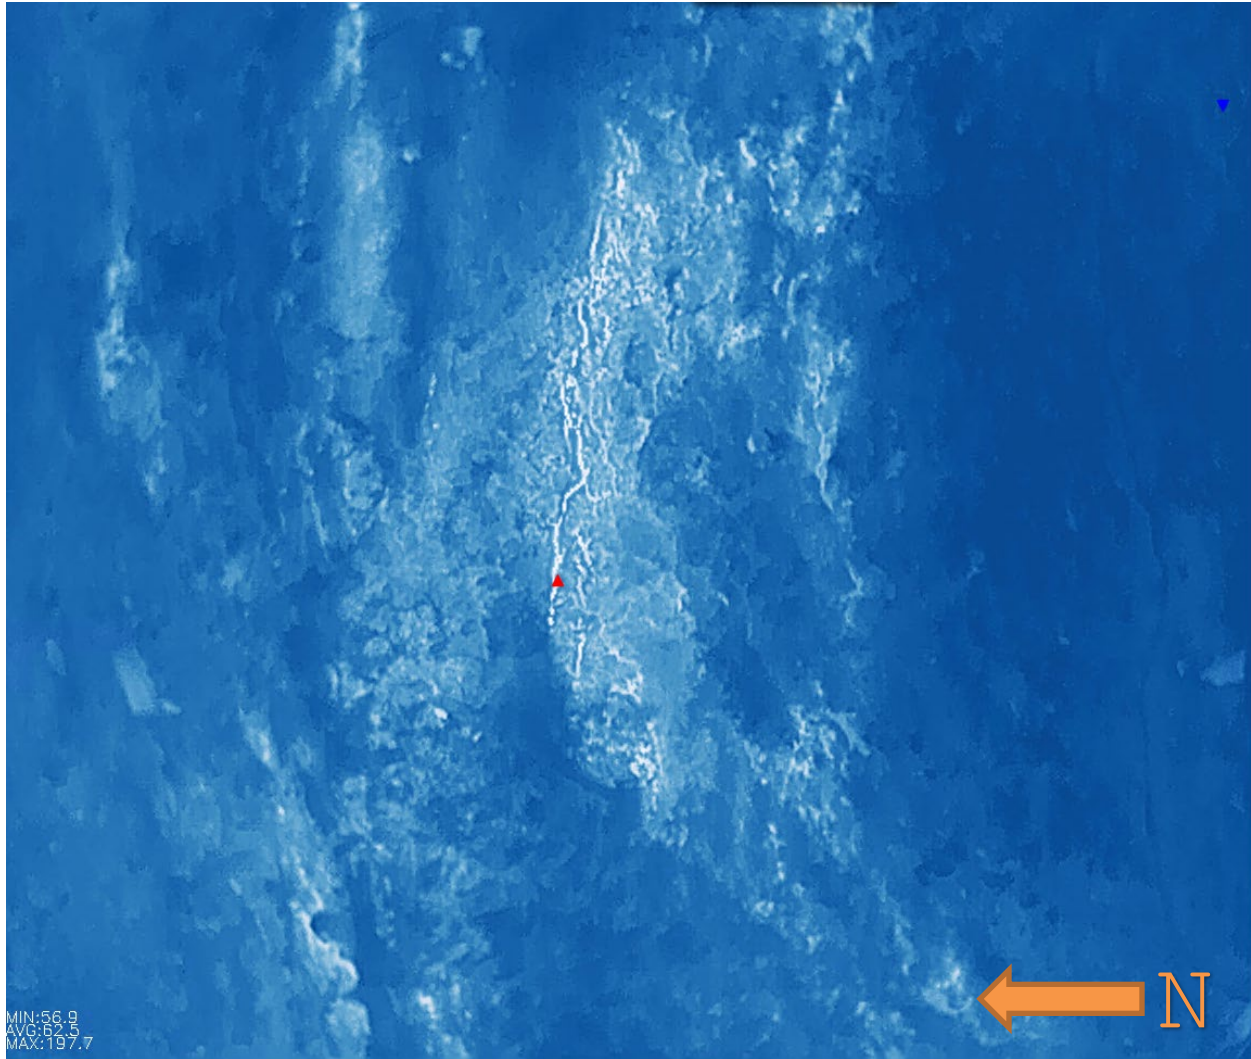
Figure 16: Thermal image captured at point 422, showing warmer areas in white and cooler areas in blue. Peak temperature ~200F, location marked with red triangle.
