MINERALS PROGRAM INSPECTION REPORT
PHONE: (303) 866-3567

MINE NAME: Maryland Creek Ranch	MINE/PROSPECTING ID#: M-1996-049	MINERAL: Sand and gravel	COUNTY: Summit
INSPECTION TYPE: Monitoring	WEATHER: Clear	INSP. DATE: October 6, 2022	INSP. TIME: 09:30
OPERATOR: Kilgore Companies, LLC dba Peak Materials	OPERATOR REPRESENTATIVE: Ty Shearer	TYPE OF OPERATION: 112c - Construction Regular Operation	
REASON FOR INSPECTION: Normal I&E Program	BOND CALCULATION TYPE: None	BOND AMOUNT: \$864,000.00	
DATE OF COMPLAINT: NA	POST INSP. CONTACTS: None	JOINT INSP. AGENCY: None	
INSPECTOR(S): Eric Scott	INSPECTOR'S SIGNATURE:

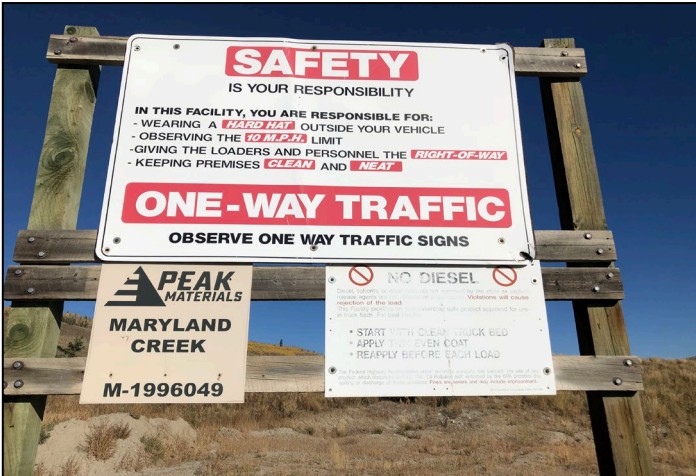
Photo 1 – Site identification sign at site entrance.

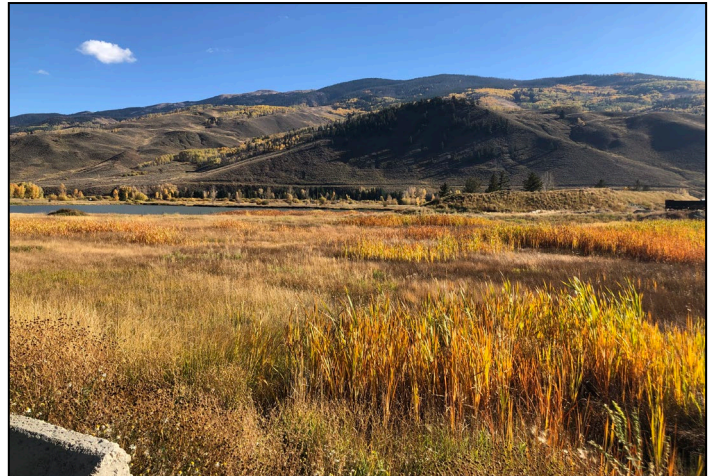
The north end of the site is largely reclaimed to rangeland with several small unlined lakes. There are also larger sediment settling ponds currently in use in this area (photo 2).

Photo 2 – North end of site reclaimed to rangeland with open ponds.

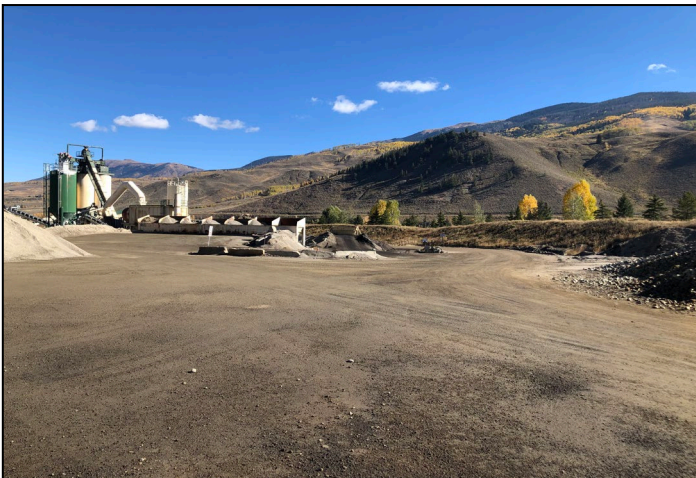
South of the settling pond is the "process area" of the site. This area is surrounded by large vegetated earth berms on the south and east sides as required by the county. The site offices, washing and sorting plants, concrete plant, asphalt recycling plant, and shop are all located in this "process area" (photo 3).

Photo 3 – Site "Process Area" and visual barrier berm.

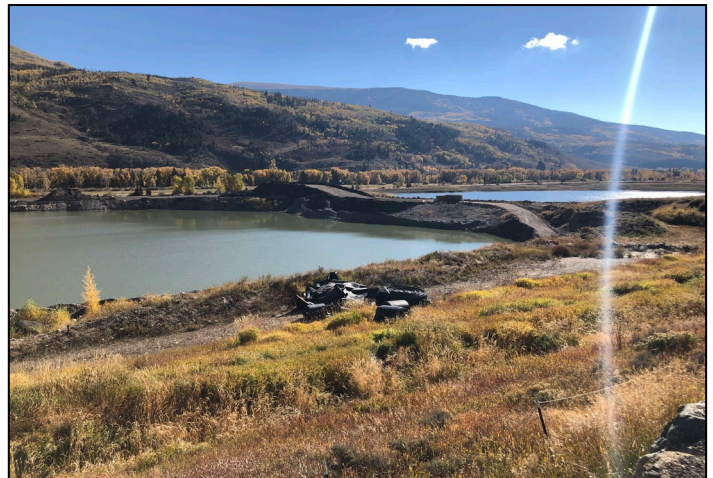
South of cell 5 is cell 4. This area is mined out and is currently being backfilled and reclaimed/re-sloped to the final shoreline configuration (photo 4).

Photo 4 – Mined out Cell 4 being reclaimed. Reclaimed Cell 3 in background.

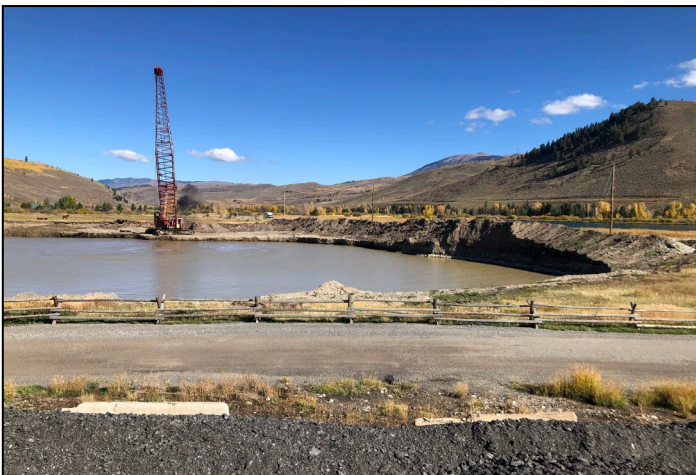
South of the process area near the middle of the permit is cell 5. Dredge mining has just recently begun in this area (photo 5). Material mined from this area is conveyed to the process area by belt for washing and sorting.

Photo 5 – Dredge mining commencing in Cell 5 at center of permit area.
