**MINERALS PROGRAM INSPECTION REPORT**  
**PHONE: (303) 866-3567**

<b>MINE NAME:</b> Mascot Placer	<b>MINE/PROSPECTING ID#:</b> M-1998-052	<b>MINERAL:</b> Sand and gravel	<b>COUNTY:</b> Summit
<b>INSPECTION TYPE:</b> Monitoring	<b>WEATHER:</b> clear	<b>INSP. DATE:</b> October 6, 2022	<b>INSP. TIME:</b> 11:00
<b>OPERATOR:</b> Kilgore Companies, LLC dba Peak Materials	<b>OPERATOR REPRESENTATIVE:</b> Ty Shearer	<b>TYPE OF OPERATION:</b> 112c - Construction Regular Operation	
<b>REASON FOR INSPECTION:</b> Normal I&E Program	<b>BOND CALCULATION TYPE:</b> None	<b>BOND AMOUNT:</b> \$72,000.00	
<b>DATE OF COMPLAINT:</b> NA	<b>POST INSP. CONTACTS:</b> None	<b>JOINT INSP. AGENCY:</b> None	
<b>INSPECTOR(S):</b> Eric Scott	<b>INSPECTOR'S SIGNATURE:</b>

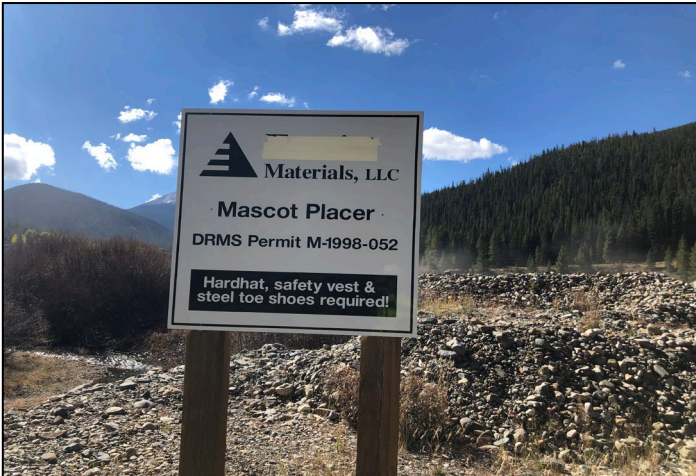
**Photo 1 – Site identification sign at site entrance.**

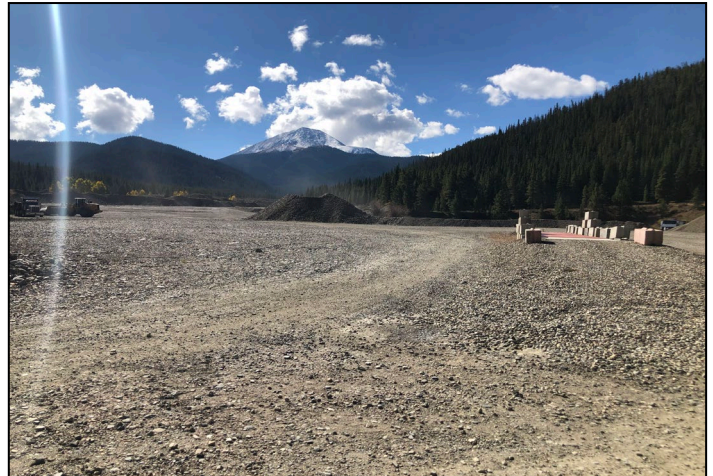
**Photo 2 – Scale and loading area near site entrance.**

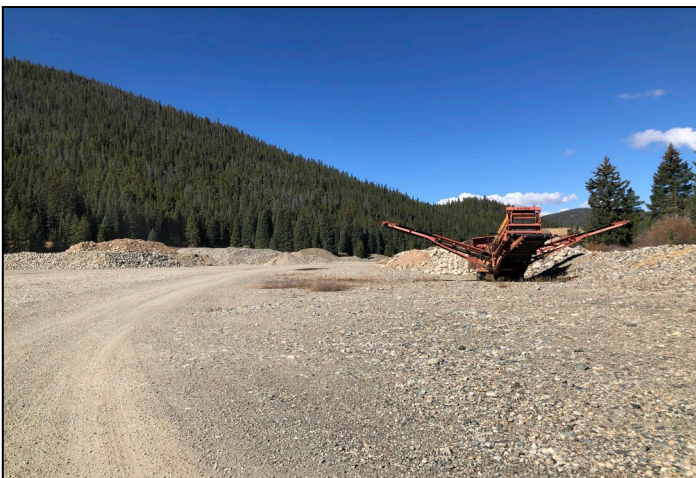
**Photo 3 – Material sorting equipment located on site.**
