MINERALS PROGRAM INSPECTION REPORT
PHONE: (303) 866-3567

MINE NAME: Hunt Water, LLC Gravel Mine	MINE/PROSPECTING ID#: M-2018-027	MINERAL: Overburden and sand	COUNTY: Weld
INSPECTION TYPE: Monitoring	WEATHER: Clear	INSP. DATE: October 5, 2022	INSP. TIME: 09:45
OPERATOR: Hunt Water, LLC	OPERATOR REPRESENTATIVE: David Hunt	TYPE OF OPERATION: 112c - Construction Regular Operation	
REASON FOR INSPECTION: Normal I&E Program	BOND CALCULATION TYPE: None	BOND AMOUNT: \$586,345.00	
DATE OF COMPLAINT: NA	POST INSP. CONTACTS: None	JOINT INSP. AGENCY: None	
INSPECTOR(S): Eric Scott	INSPECTOR'S SIGNATURE:

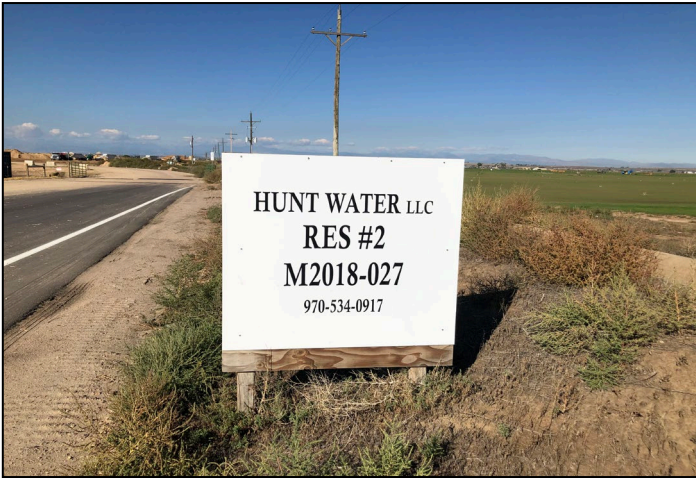
This was a routine monitoring inspection conducted by Eric Scott for the Division of Reclamation Mining and Safety (DRMS). DRMS met with permittee representatives David Hunt and Andrew Rodriguez of Civil Resources LLC at approximately 0945 at the site entrance located on the west side of WCR 27 at the northeast corner of the site. The permit boundary is still defined by existing fences and the site identification sign was present (photo 1).

Photo 1 – Site identification sign located at site entrance.

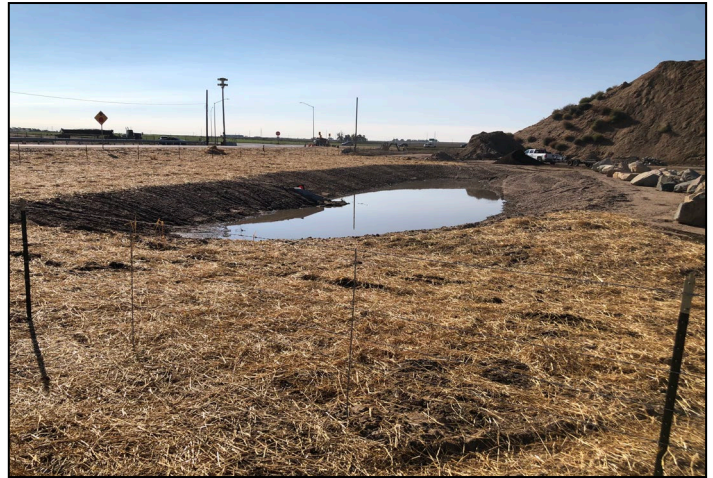
It was noted by DRMS that the site entrance has been modified by the permittee to comply with CDOT requirements and a permanent storm-water retention pond has been added (photo 2). A technical revision detailing these modifications should be submitted to the Division. Additional items that were discussed in the field that should be included in future revision(s) for this permit include: the proposed connecting piping under CO 85 to link the reservoir to the lined pond in the SE corner of the permit; and mining of additional area within the slurry wall when existing gas and oil pipelines and structures have been removed/relocated (photo 4).

Photo 2 – New storm water/settling pond located near improved site entrance.

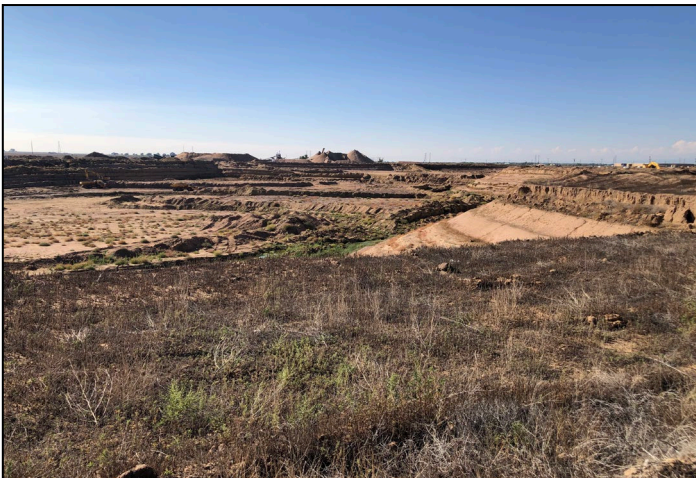
Mining activity at the site was proceeding within the lined reservoir area according to the approved mining plan at this time (photo 3). No other issues were noted during this inspection, and DRMS left the site at approximately 1130.

Photo 3 – Mining within the provisionally approved slurry wall.

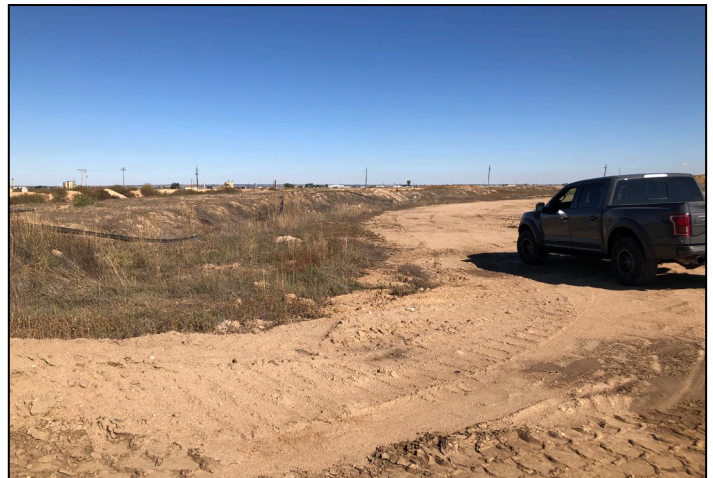
Photo 4 – Area in NW corner of existing slurry wall that will be mined when existing gas and oil features are removed.
